Seismic retrofit of masonry-to-timber  
connections in historical constructions

Tese de Doutoramento  
Engenharia Civil

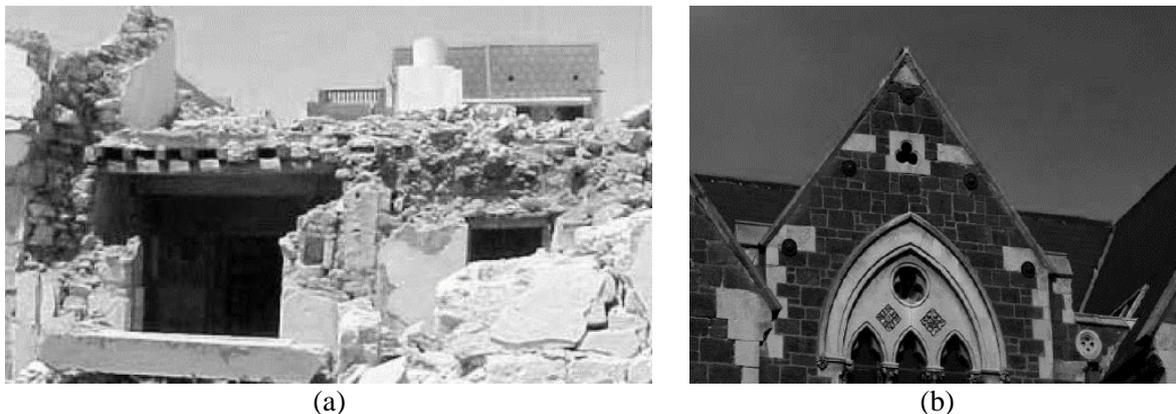
**Figure 1.1** URM seismic performance: (a) Inadequacy of wall-to-floor connections leading to wall collapse (Bothara & Brzev, 2011); and (b) successful case of wall-to-floor anchorage (Dizhur et al., 2011).

In Christchurch 2011 earthquake, as in other earthquake scenarios, it was observed that strengthened wall-to-floor connections prevented effectively out-of-plane collapses (see Figure 1.1b), allowing the development of a global response of the structure (Bruneau, 1994; Dizhur et al., 2011). However, little research has been carried out in the past

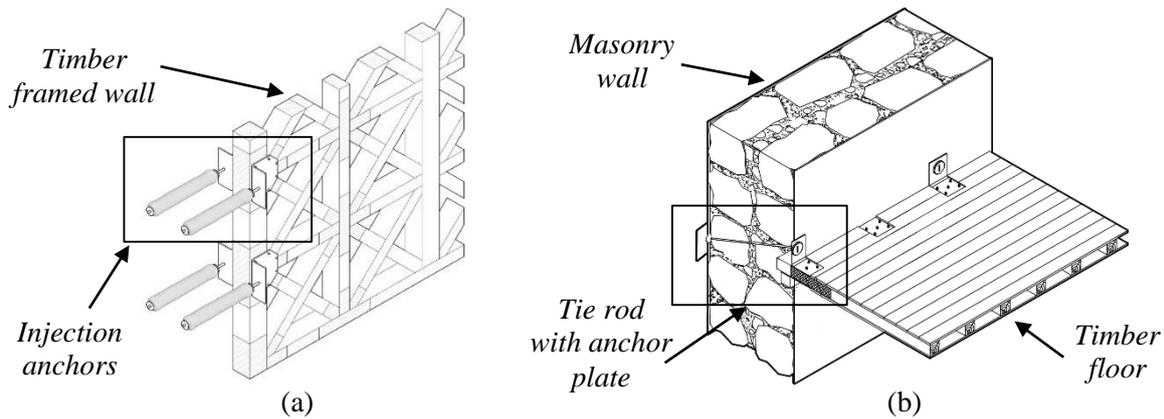
**Figure 1.2** Sketches of the adopted connections and strengthening solutions (Cóias e Silva, 2007): (a) wall-to-timber framed wall; and (b) wall-to-floor.

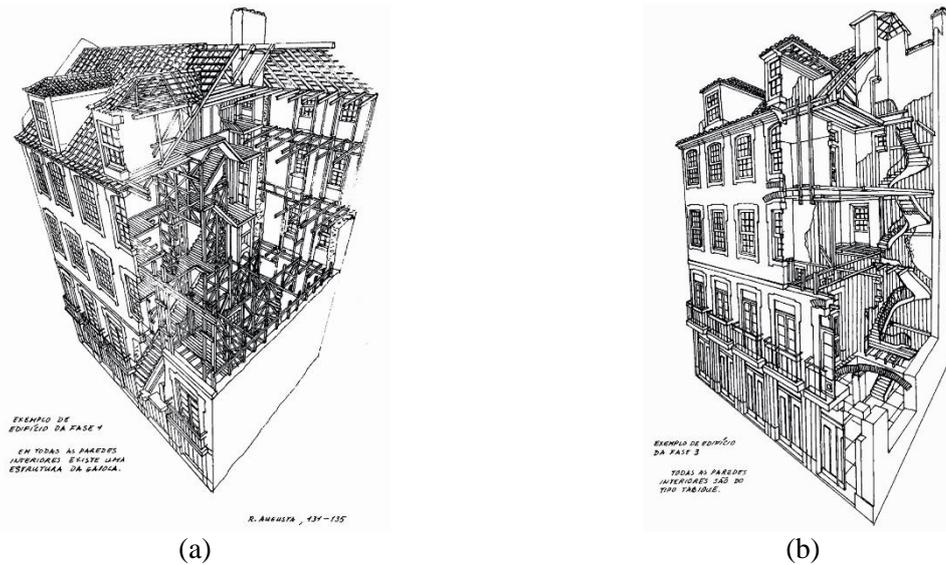
**Figure 2.1** Typologies of buildings: (a) *Pombalino* building and (b) *Gaioleiro* building [in Mascarenhas (2004)].

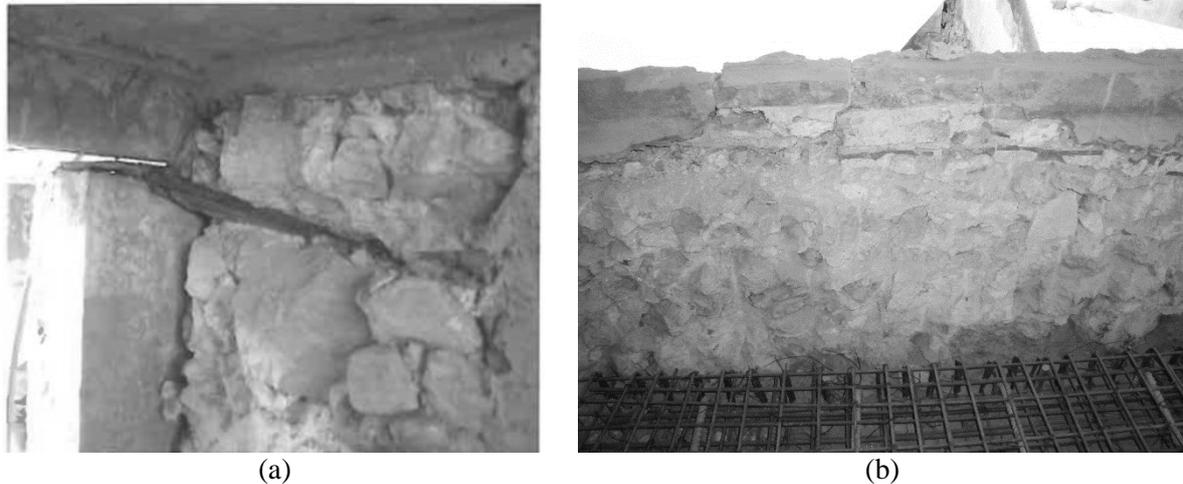
**Figure 2.3** Cross-section of peripheral masonry walls of *Pombalino* building: (a) in Appleton (2009); and (b) taken in Liberdade Av.

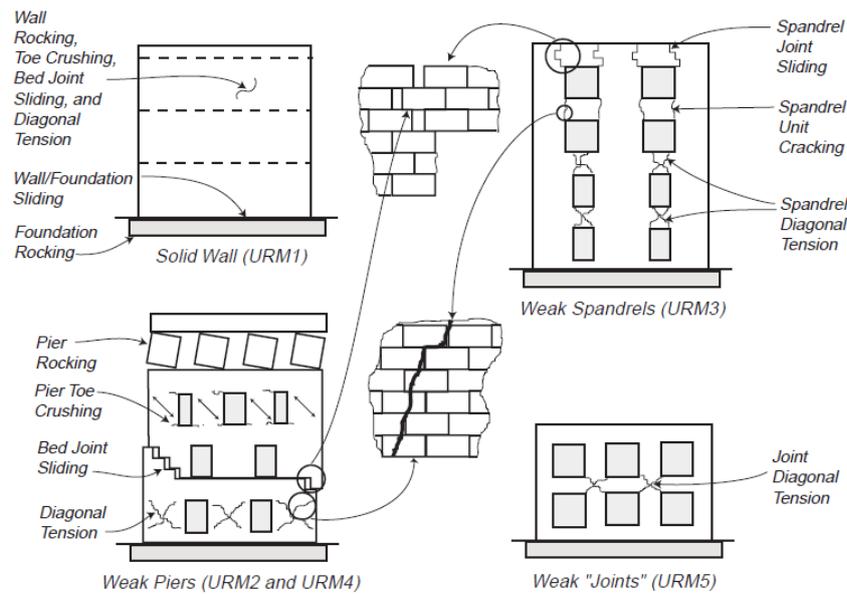
**Figure 2.5** In-plane failure mechanisms [in FEMA 306 (ATC-43 Project, 1998)].

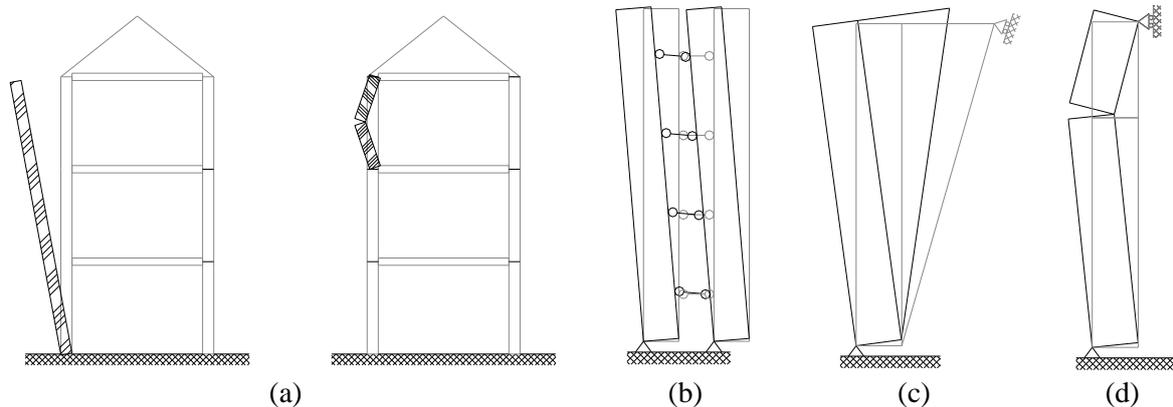
**Figure 2.6** Different types of overturning of a façade (adapted from Binda & Saisi, 2005)

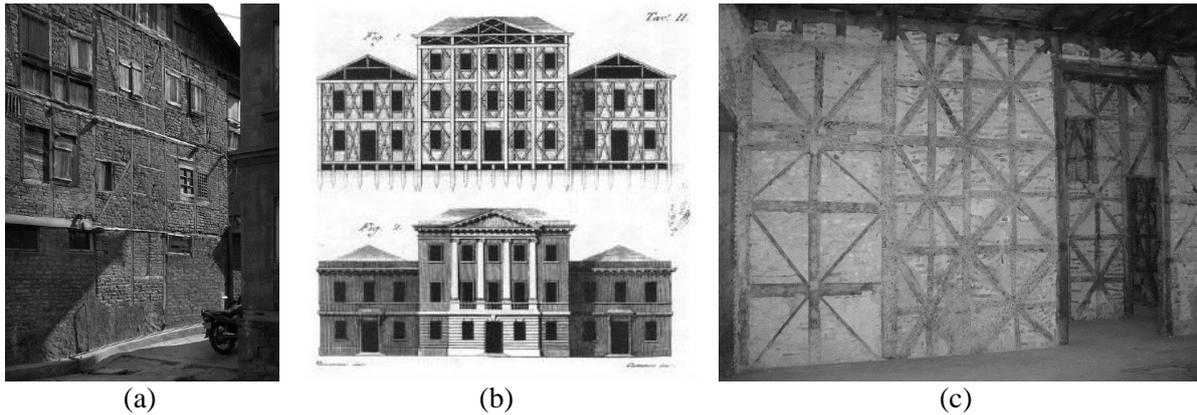
**Figure 2.7** Timber-framed construction: (a) *dhajji-dewari* in India (Langenbach, 2007); (b) *Casa baraccata* in Italy (Vivenzio (1783) in [www. architetturaecosostenibile.it](http://www.architetturaecosostenibile.it)); and *frontal Pombalino* (by Monumenta Lda.).

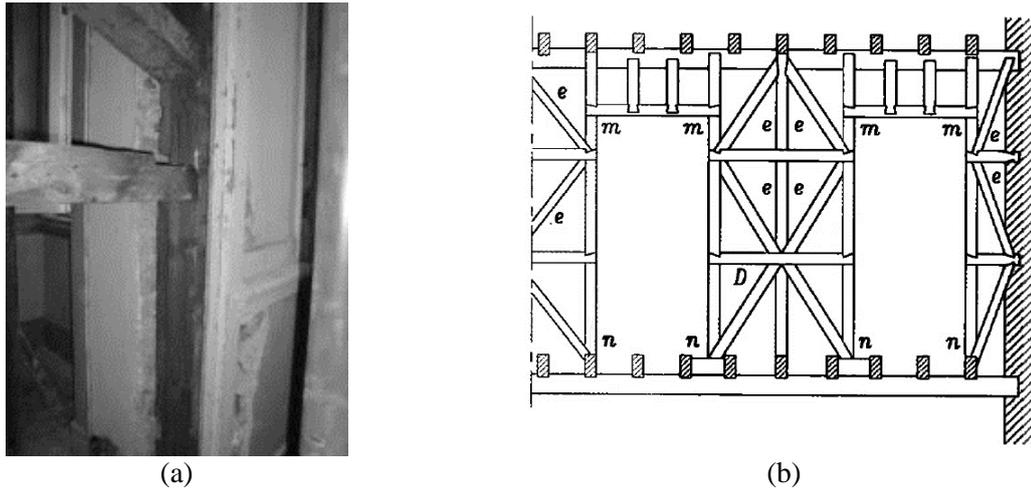
**Figure 2.9** Wall-to-timber framed wall connections of a *Pombalino* buildings: (a) photograph of type C1; and (b) sketch of type C4 (in Pinho, 2008).

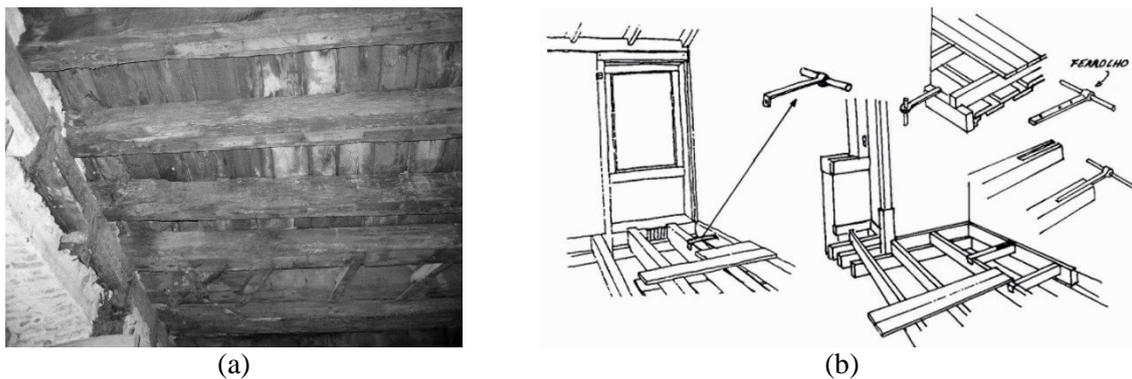
**Figure 2.11** Wall-to-floor connection found in *Pombalino* buildings: (a) in Comércio st.; and (b) sketch in Mascarenhas (2004).

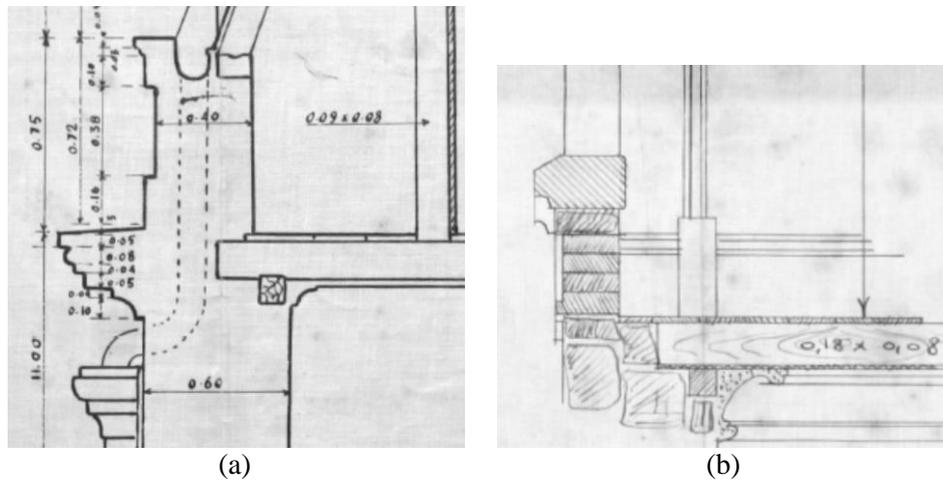
**Figure 2.12** Details of a wall-to-floor connections found in the survey: (a) in a *Pombalino Tardio* building; and (b) in a *Gaioleiro* building.

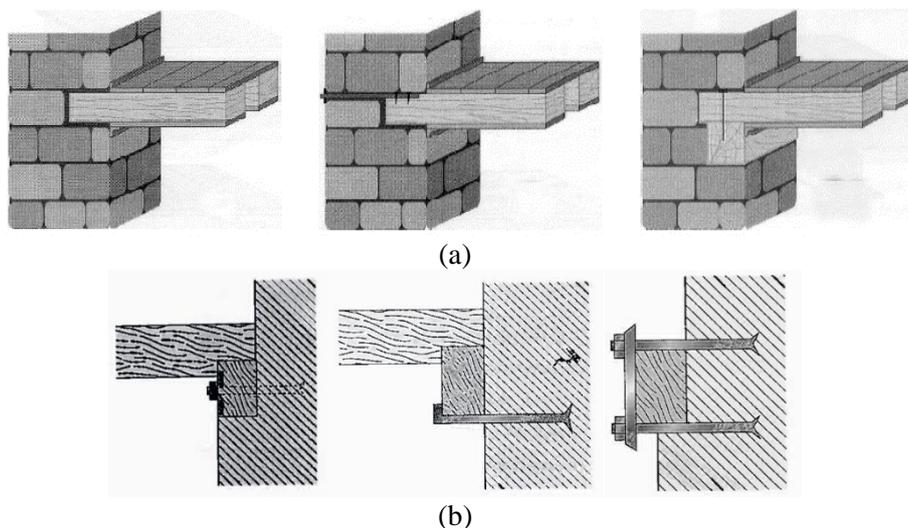
**Figure 2.13** Typologies of wall-to-floor connections of *Gaioleiro* buildings: in the end of the 19<sup>th</sup> century; and (b) beginning of the 20<sup>th</sup> century (Appleton, 2005).

presented in Figure 2.13b (Appleton, 2005). These configurations had to adapt to the decrease of thickness of the walls over the height of the building, since the pocket hole in the masonry wall was not possible anymore.

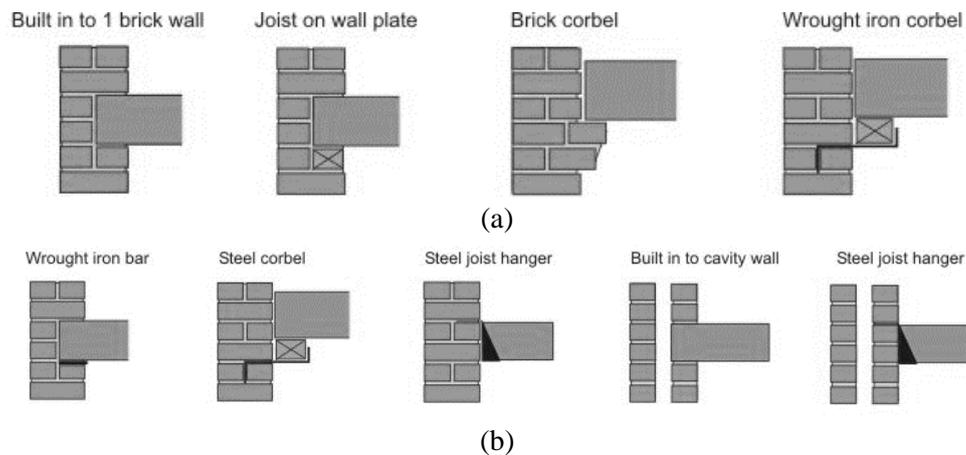
**Figure 2.14** Drawings of wall-to-floor connections found on masonry buildings in the UK: (a) late 19<sup>th</sup> century; (b) in the 1930s (University of the West of England, 2009).

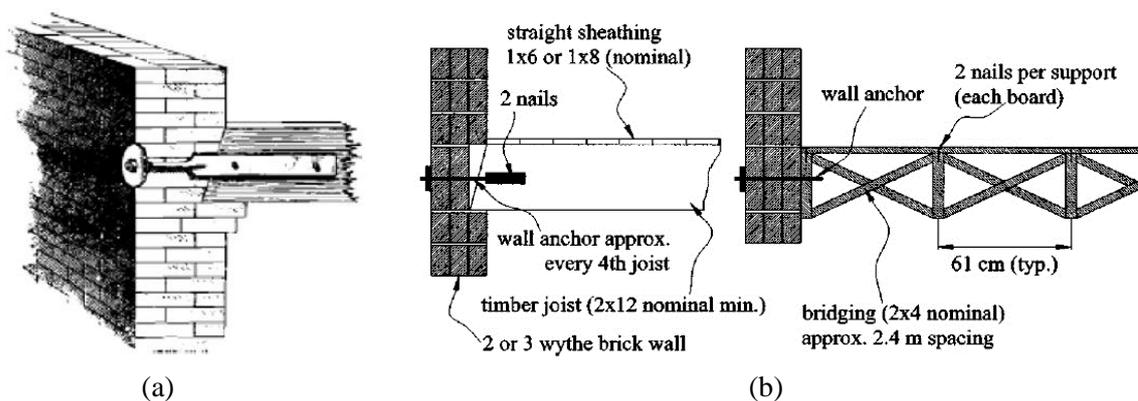
**Figure 2.15** Drawings of wall-to-floor connections from pre-50s buildings in the US (Lin & LaFave, 2012; Peralta et al., 2004).

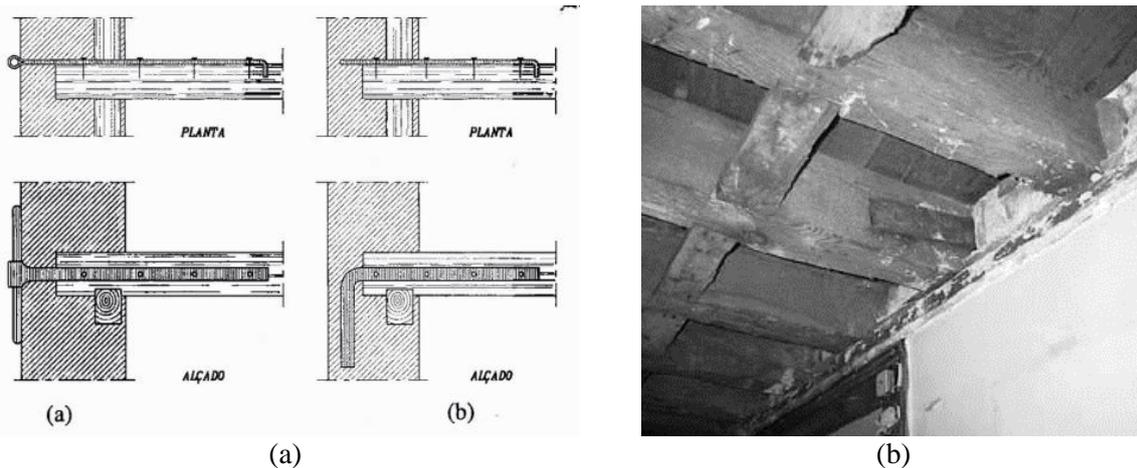
**Figure 2.16** Wrought iron straps (a) in Pinho (2008); and (b) in Córias e Silva (2007).

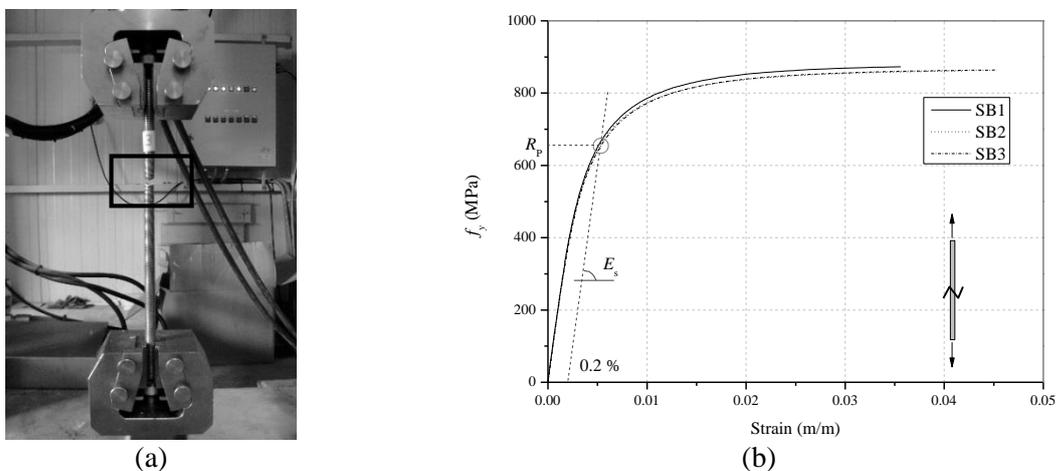
**Figure 3.1** Tensile tests of steel rods: (a) typical failure mode; and (b) stress-strain curves.

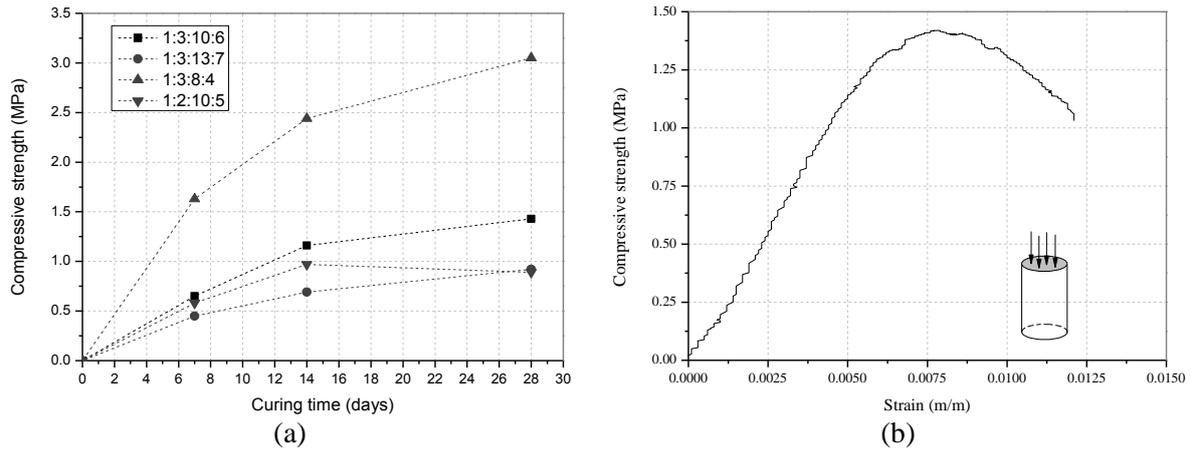
**Figure 3.2** Compression tests of mortar samples: (a) compressive strength vs. curing time; and (b) average stress-strain curve.

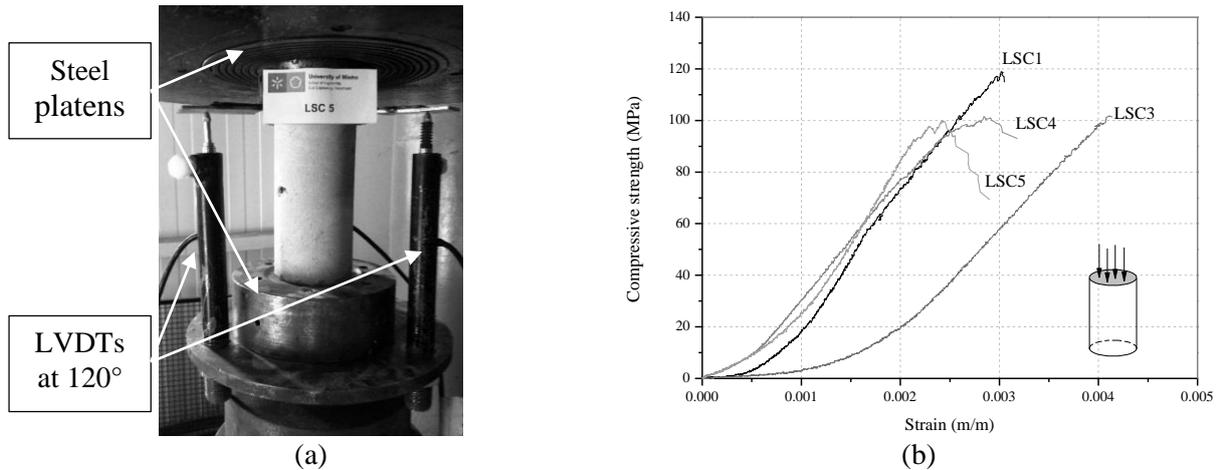
**Figure 3.3** Compression tests of limestone cores: (a) test apparatus; and (b) stress-strain curves.

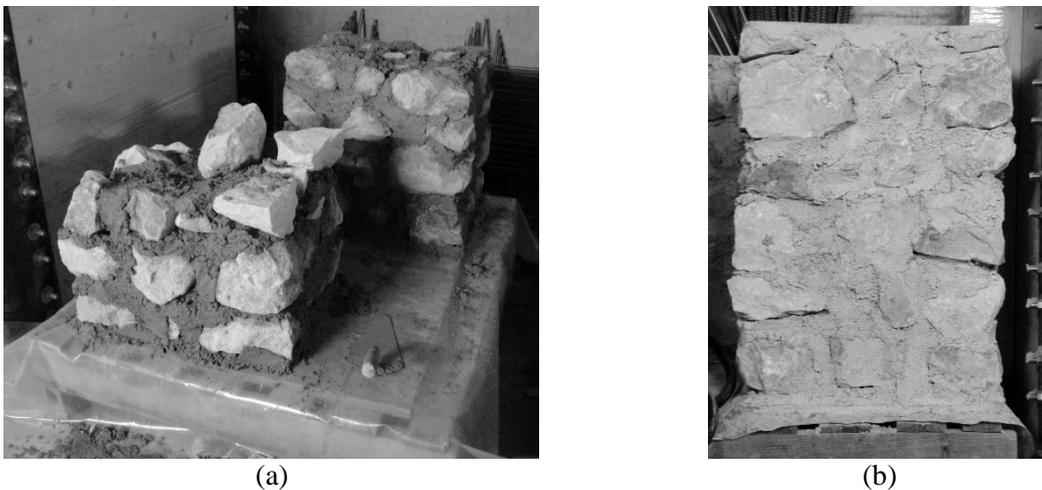
**Figure 3.5** Construction of the masonry prisms: (a) halfway construction; and (b) complete prism.

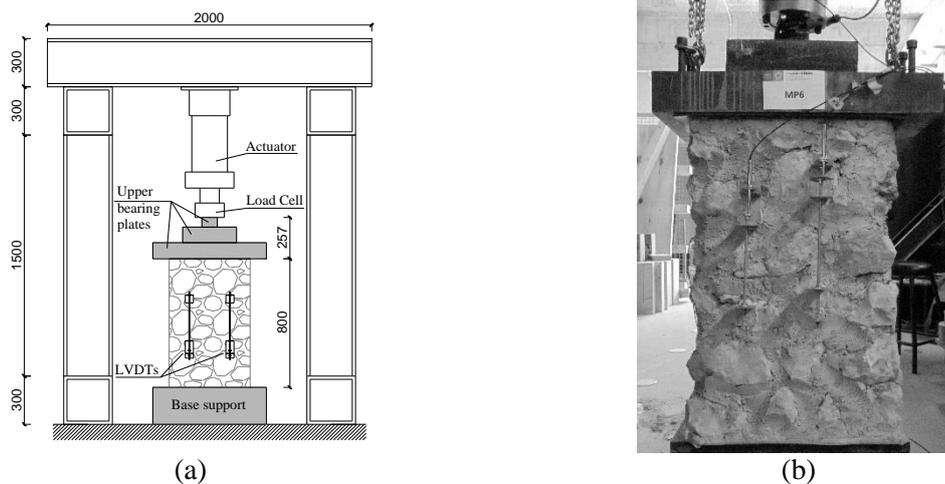
**Figure 3.6** Compression test set-up for masonry prisms: (a) sketch of the entire set; and (b) instrumentation of the specimen.

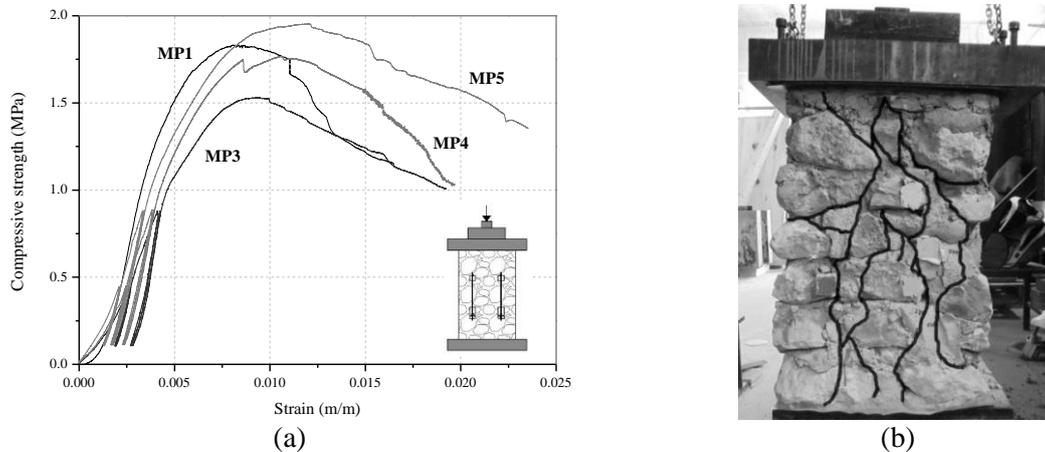
**Figure 3.7** Compression tests of masonry prisms: (a) stress-strain curves; and (b) typical crack pattern.

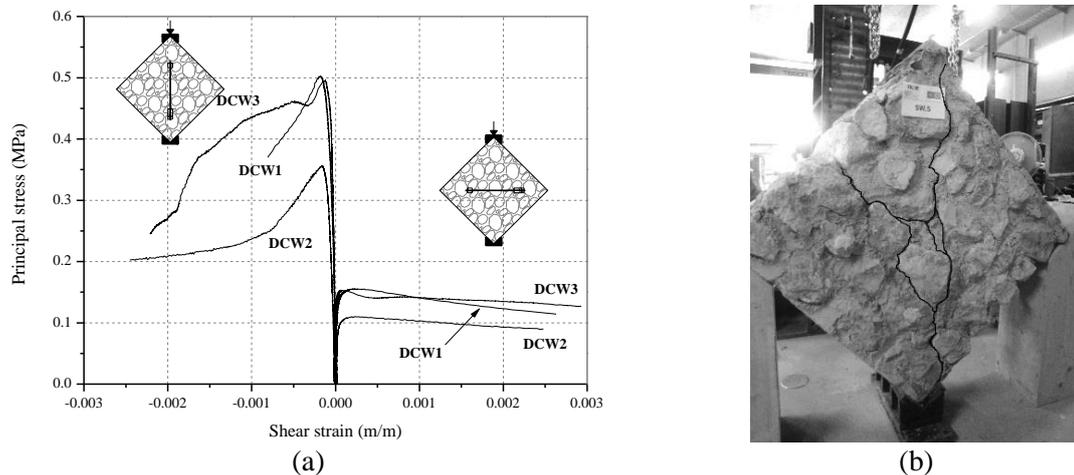
**Figure 3.9** Diagonal compression test of masonry wallets: (a) stress-strain curves; (b) typical crack pattern.

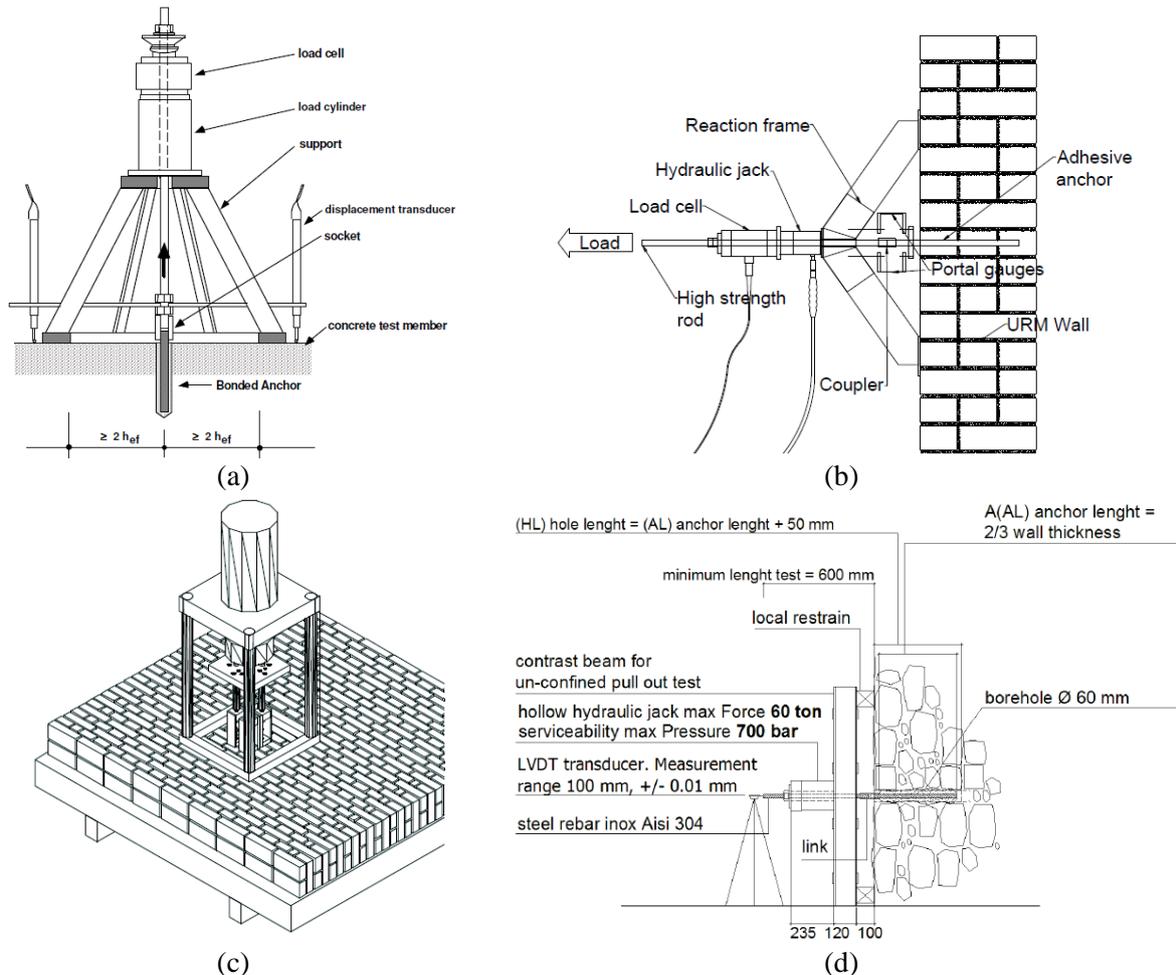
**Figure 4.2** Different test set-ups for bonded anchors: (a) in ETAG 001 (EOTA, 2008); (b) by Dizhur et al. (2013); (c) by Arifovic & Nielsen (2004); and (d) Algeri et al. (2010).

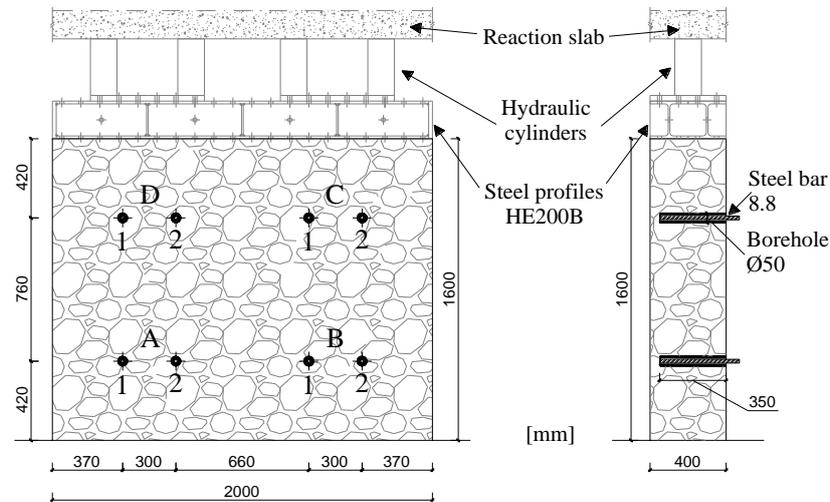
**Figure 4.4** Disposition of the pullout test specimens.

using letters: “A” and “B” to the bottom of the wall, “C” and “D” to the top of the wall (see Figure 4.4).

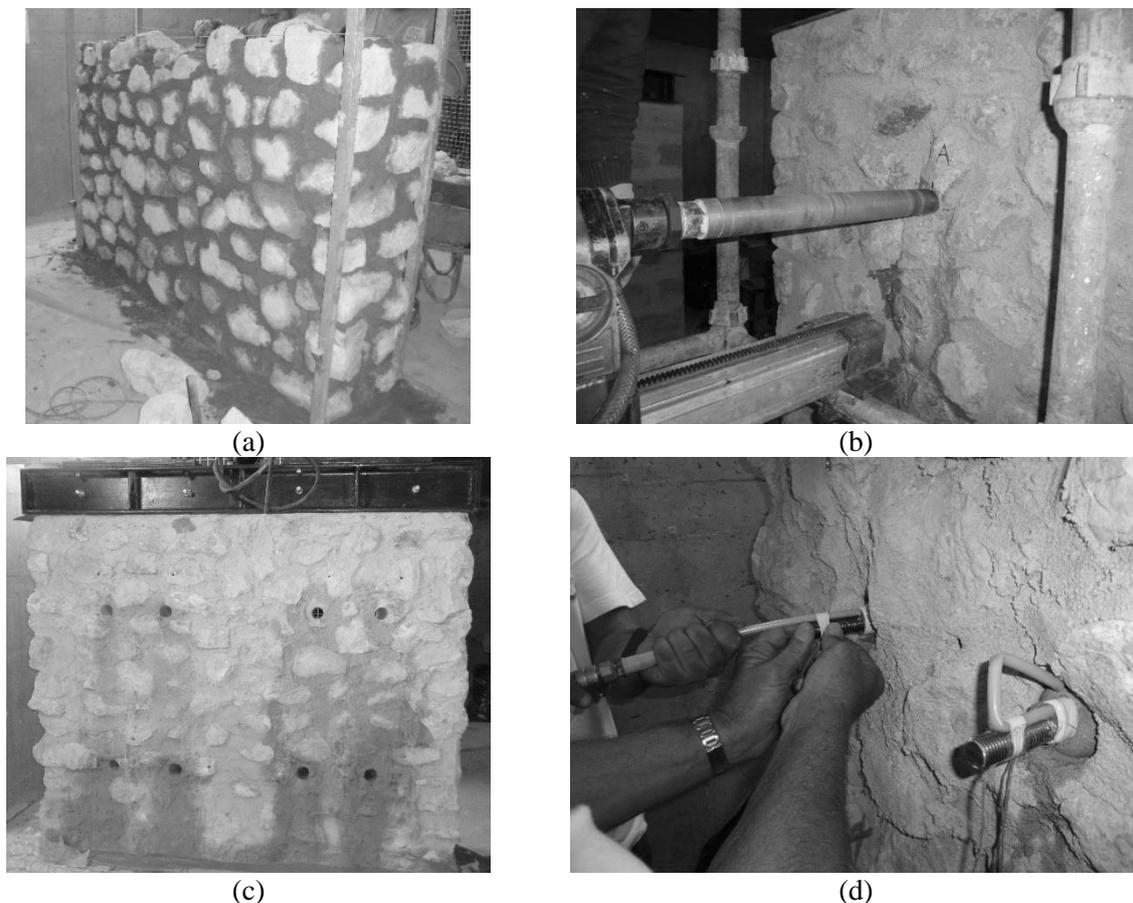
**Figure 4.5** Construction of the specimens: (a) construction of the walls; (b) core drilling; (c) specimen with all cores drilled; and (d) installation of the injection anchors.

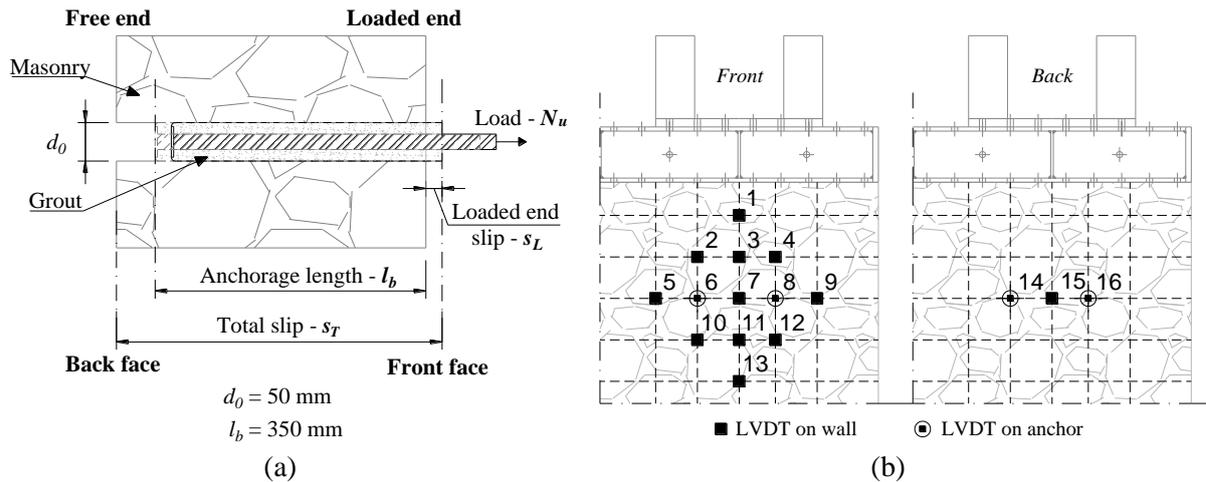
**Figure 4.8** Instrumentation: (a) idealized model of the displacements to be measured; (b) detailed look on the LVDTs

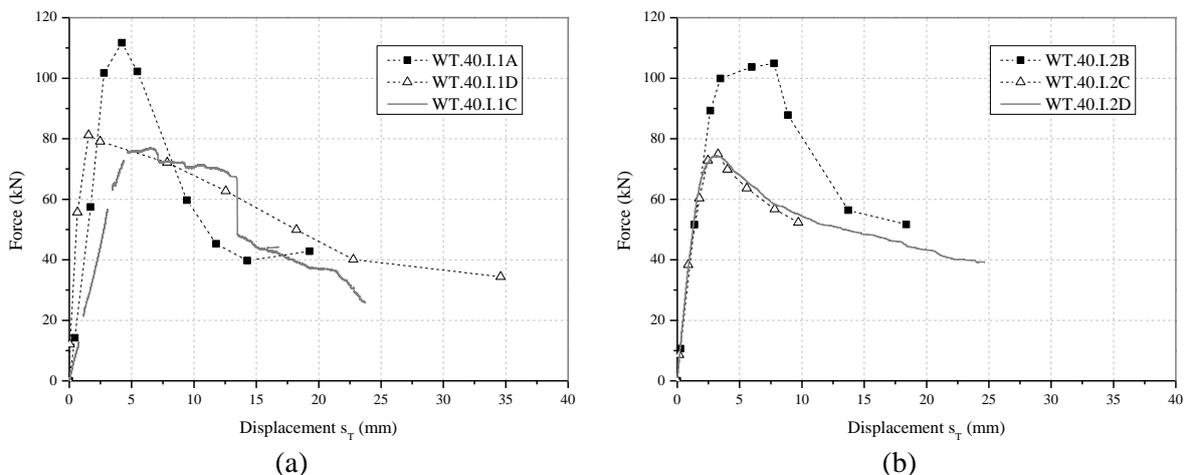
**Figure 4.10** Monotonic and envelope curves based on  $s_T$ : (a) Wall 1; (b) Wall 2.

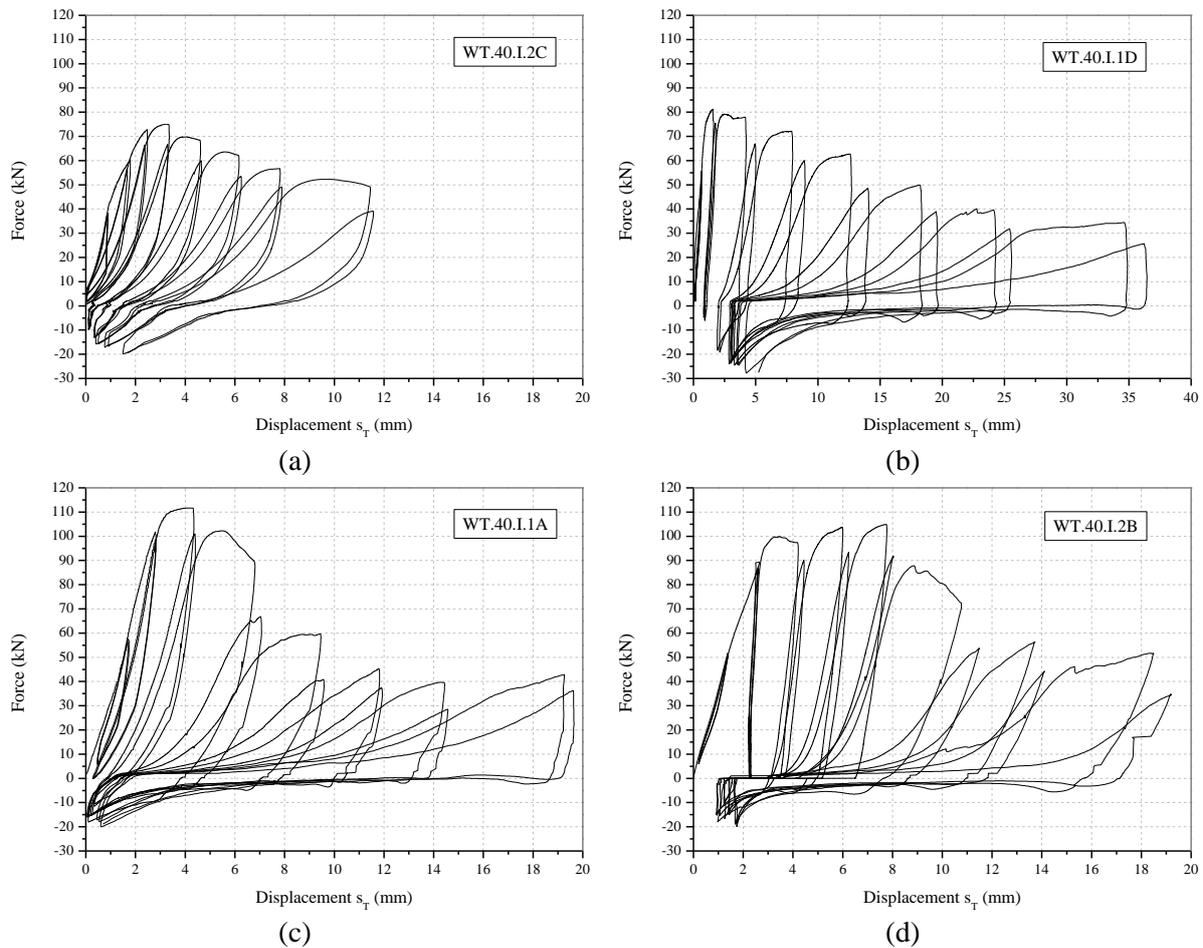
**Figure 4.11** Force-displacement curves for cyclic tests, based on  $s_T$ : (a) bottom of the wall; (b) top of the wall.

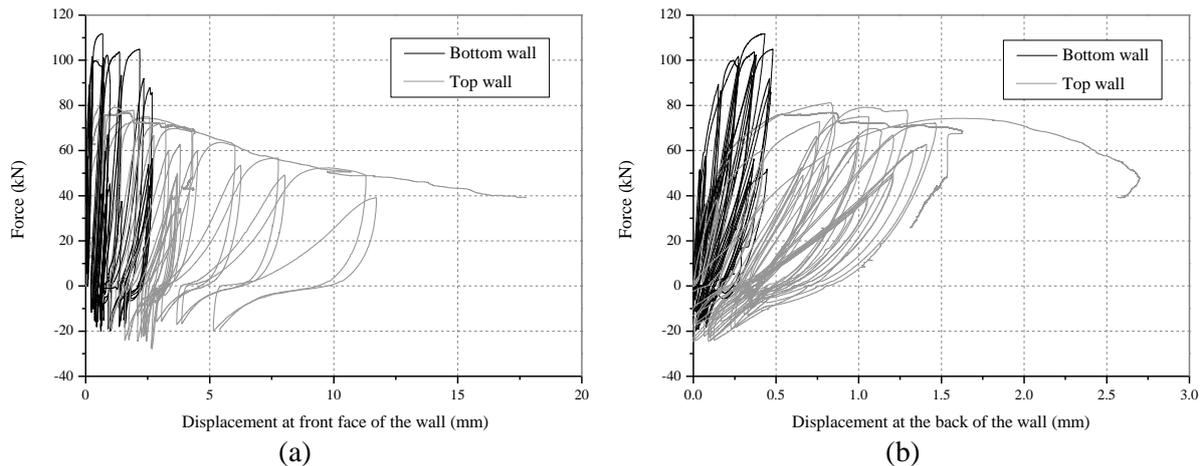
**Figure 4.12** Force-displacement curves of the wall: (a) average of the front face of the wall; (b) back face of the wall.

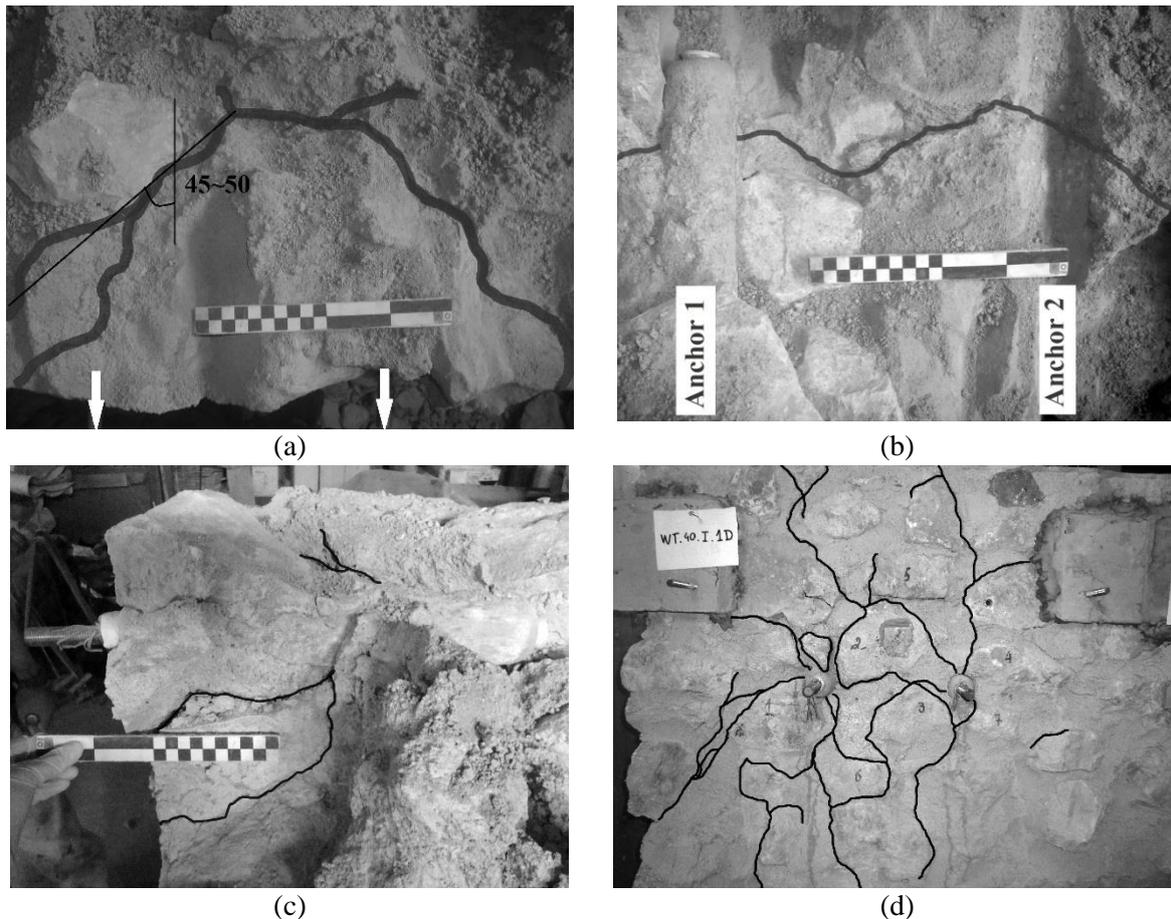
**Figure 4.13** Observed damage on tests at the top: (a) top view of a fully formed cone (WT.40.I.2C); (b) cone intersecting the anchors (WT.40.I.2C); (c) side view of the masonry cone (WT.40.I.2D); and (d) generalized cracking (WT.40.I.1D).

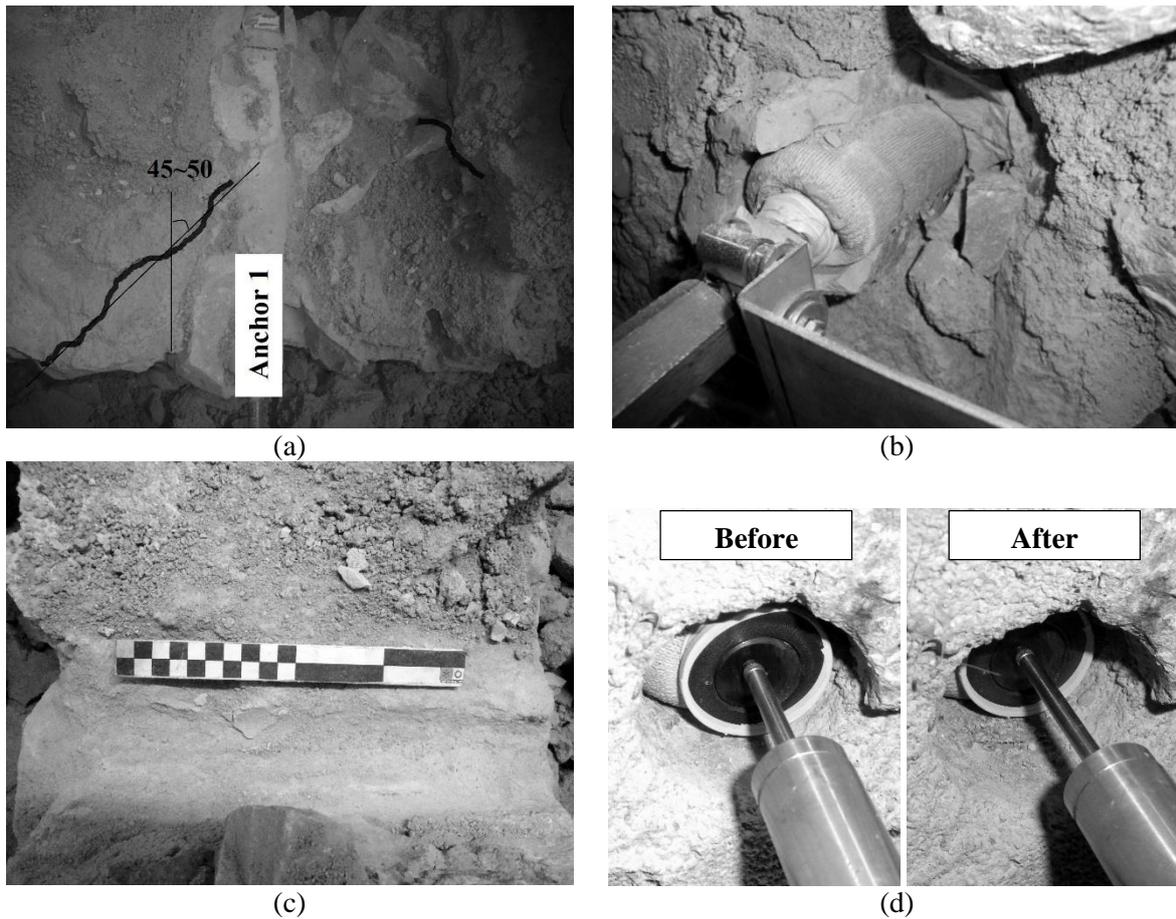
**Figure 4.14** Damage observed on tests at the bottom: (a) crack due to masonry cone breakout on specimen (WT.40.I.2A) (b) sliding on the interface grout/masonry with detachment of a shallow masonry cone (WT.40.I.2B); (c) no cracks across the borehole (WT.40.I.1D); and (d) sliding at the free end (WT.40.I.1D).

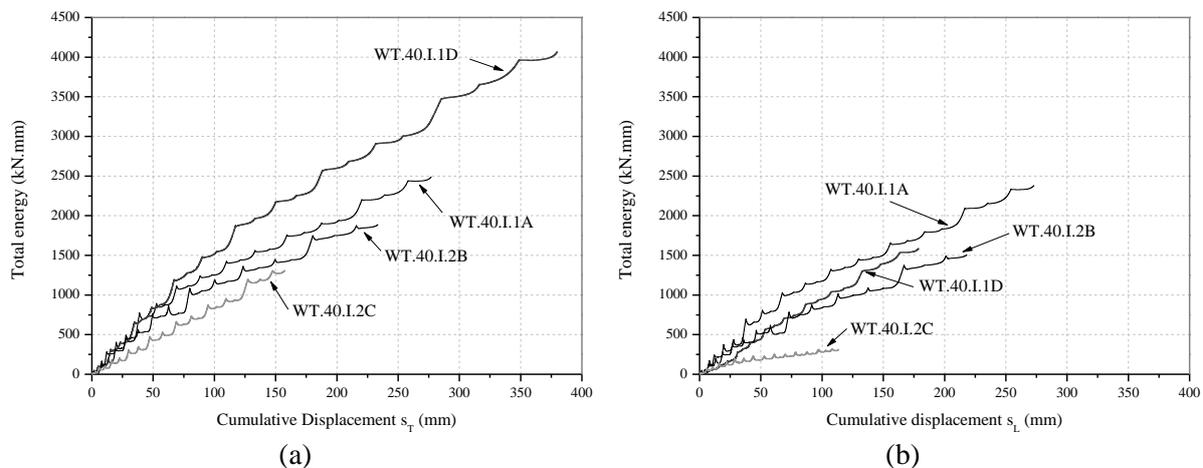
**Figure 4.16** Total energy analysis (a) based on  $s_T$ ; (b) based on  $s_L$ .

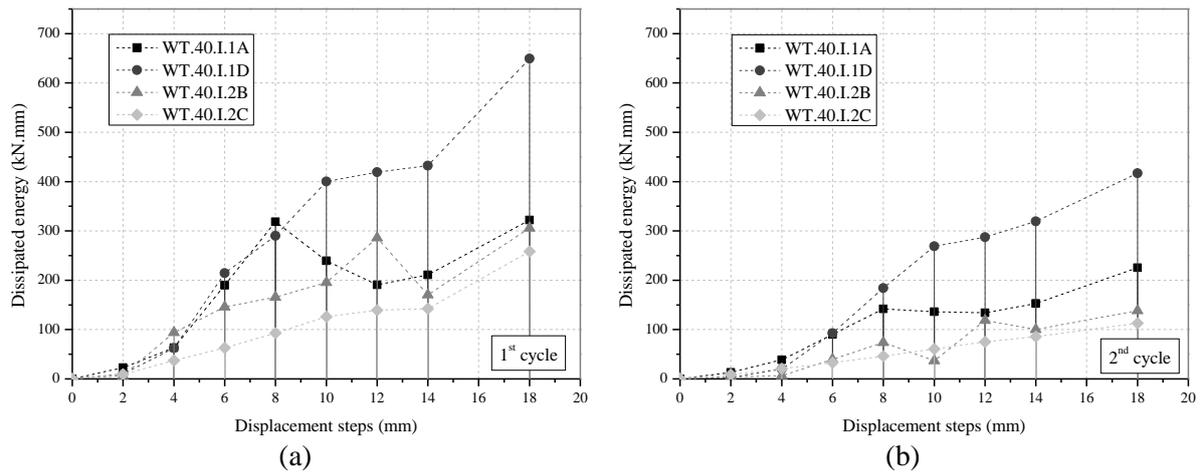
**Figure 4.17** Dissipated energy analysis per cycle: (a) 1<sup>st</sup> cycle; (b) 2<sup>nd</sup> cycle.

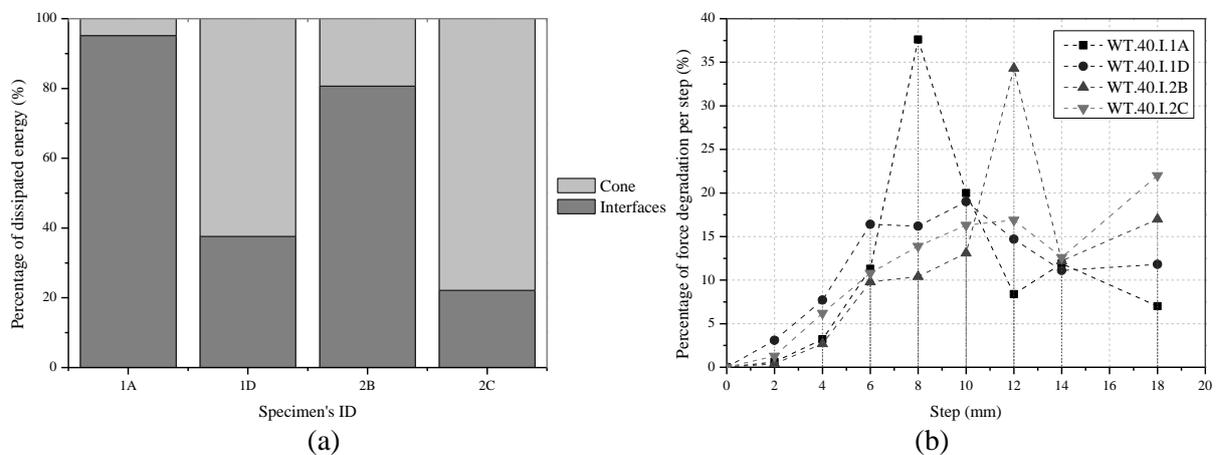
**Figure 4.18** Dissipated energy per displacement contributions (interface and cone); (b) Force degradation between cycles per displacement level.

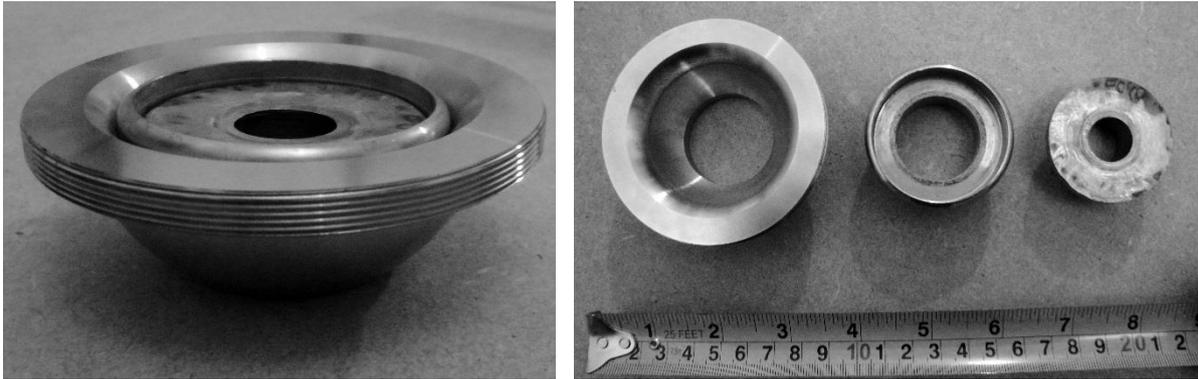
**Figure 5.2** The hinge and its components.

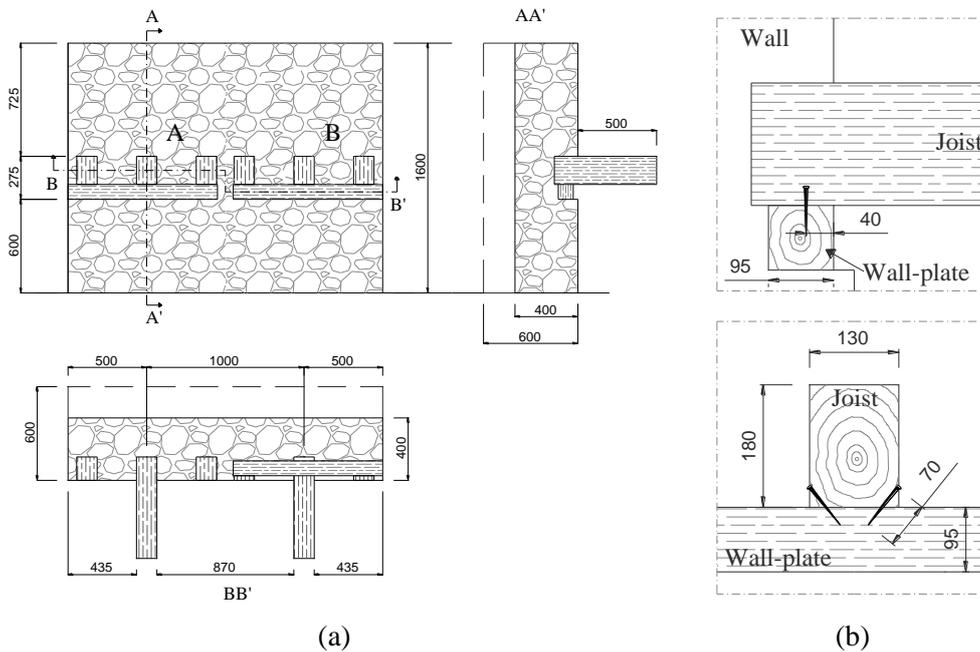
**Figure 5.3** Sketch of the unstrengthened specimens (dimensions in mm): (a) general configuration; and (b) detail of the nailed connection.

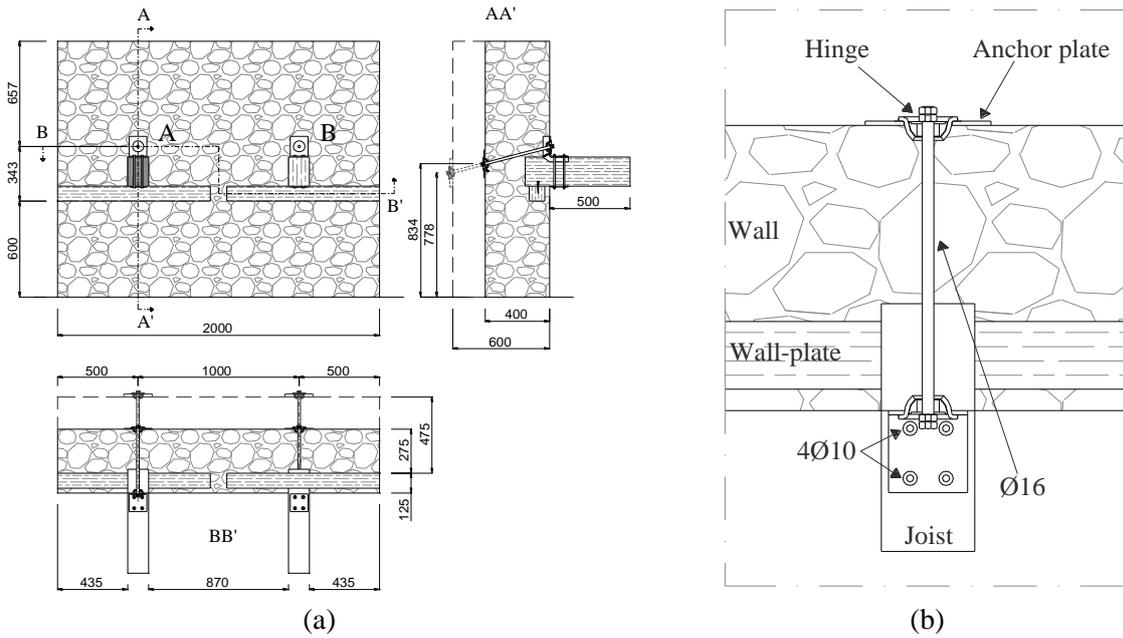
**Figure 5.6** Sketch of the strengthened connection (dimensions in mm): (a) general configuration; and (b) plan view of detail of the strengthening.
