Seismic retrofit of masonry-to-timber  
connections in historical constructions

Tese de Doutoramento  
Engenharia Civil

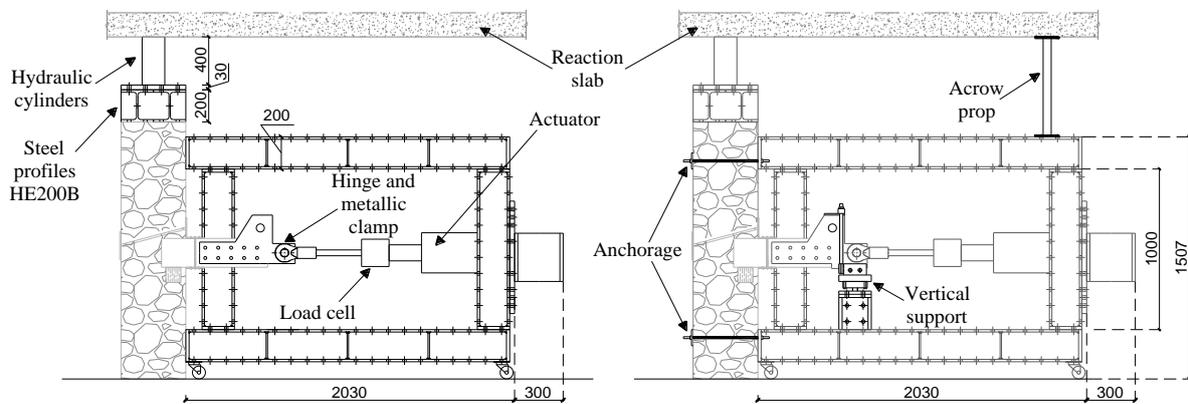
**Figure 5.8** Test apparatus of the pullout tests of wall-to-floor connections.

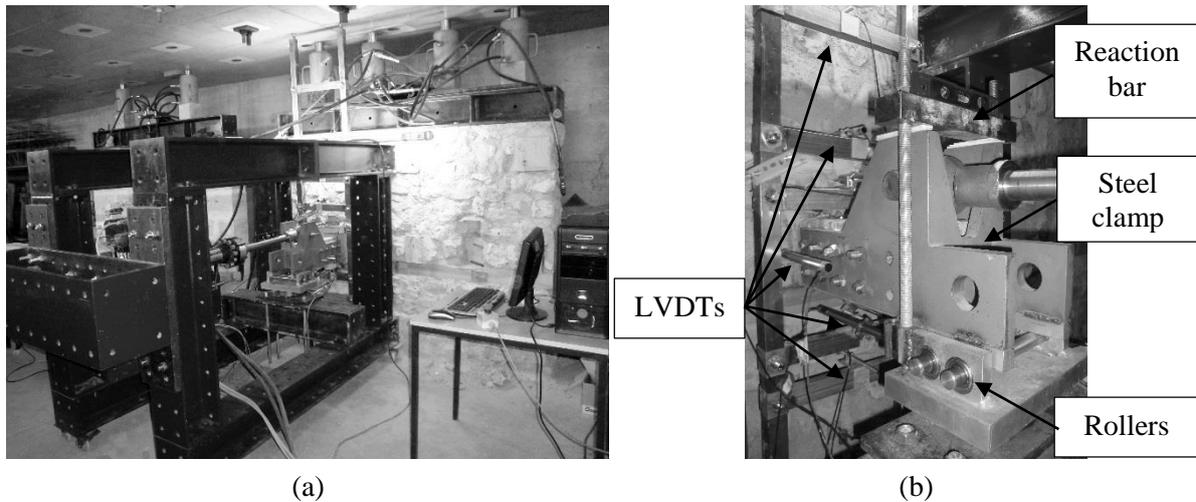
**Figure 5.9** Test set-up: (a) entire set; and (b) detail of the vertical support and instrumentation at the front of the wall.

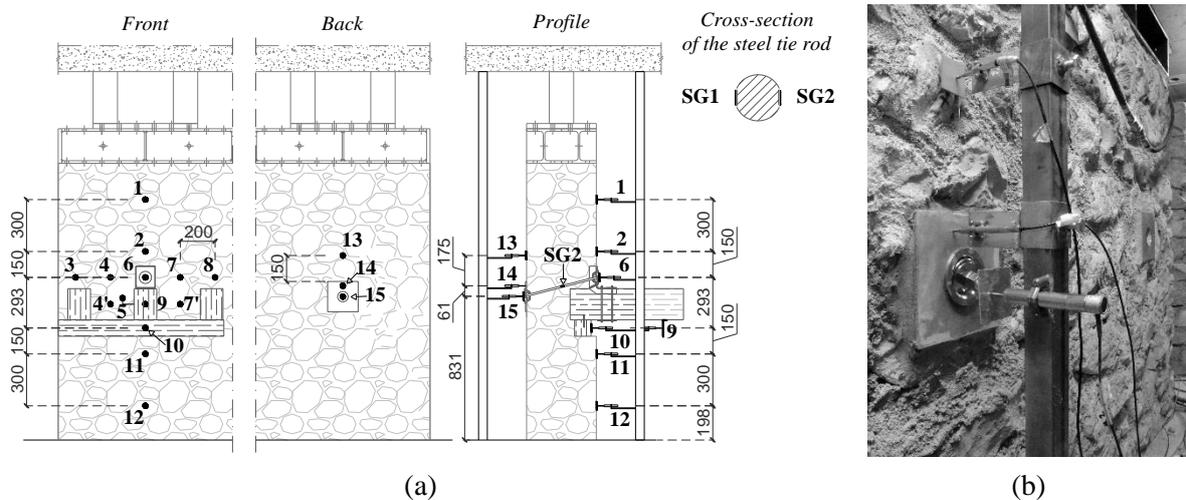
**Figure 5.10** Test set-up (dimensions in mm): (a) location of the LVDTs; and (b) detail of the instrumentation at the back.

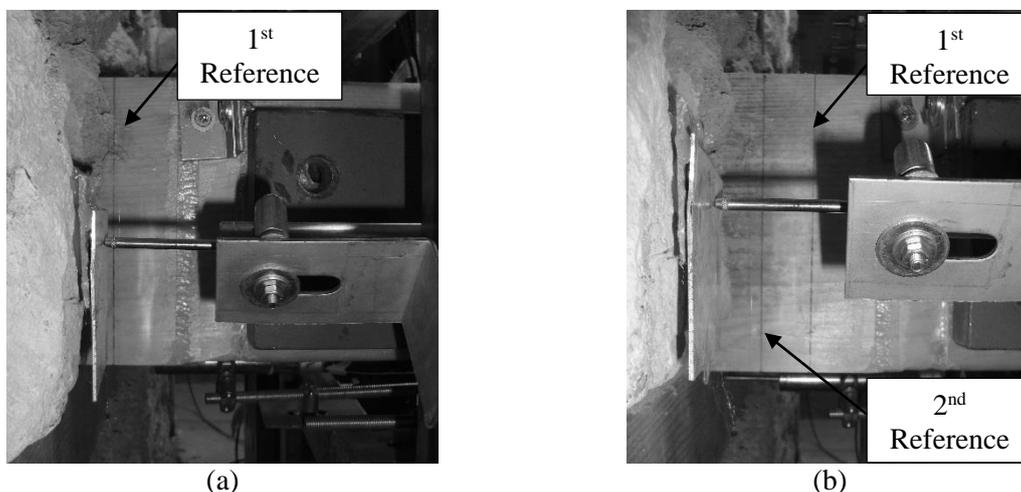
**Figure 5.15** Sliding of the joist: (a) Initial position; and (b) final position.

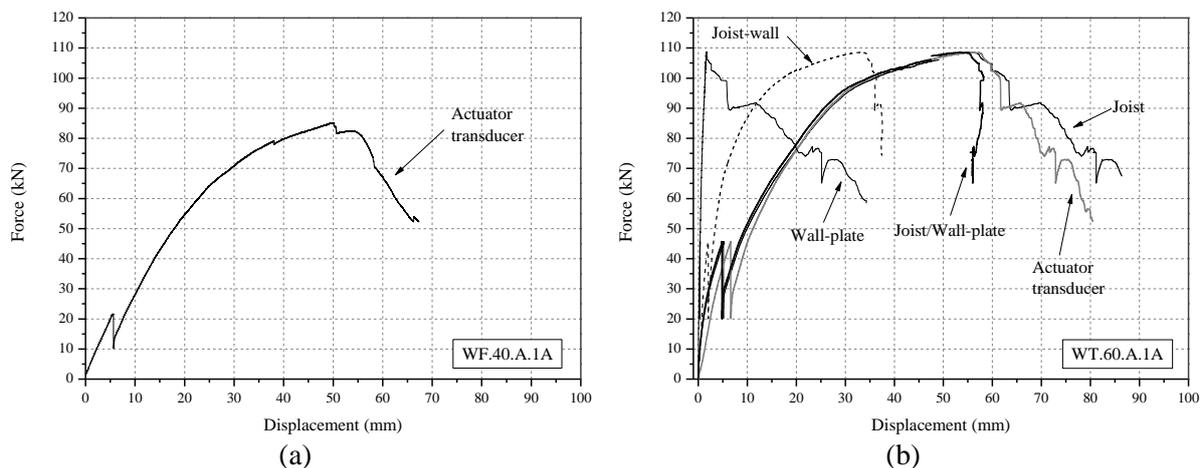
**Figure 5.17** Force-displacement curves of monotonic tests: (a) WF.40.A.1A; and (B) WF.60.A.1.

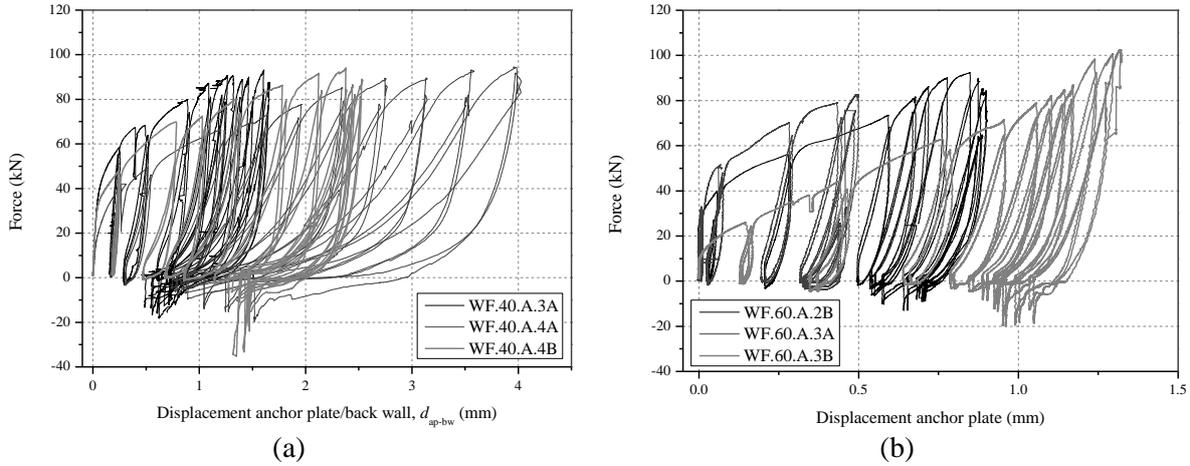
**Figure 5.22** Force-displacement curve relative to  $d_{ap-bw}$ : (a) WF.40 tests; and (b) WF.60 tests.

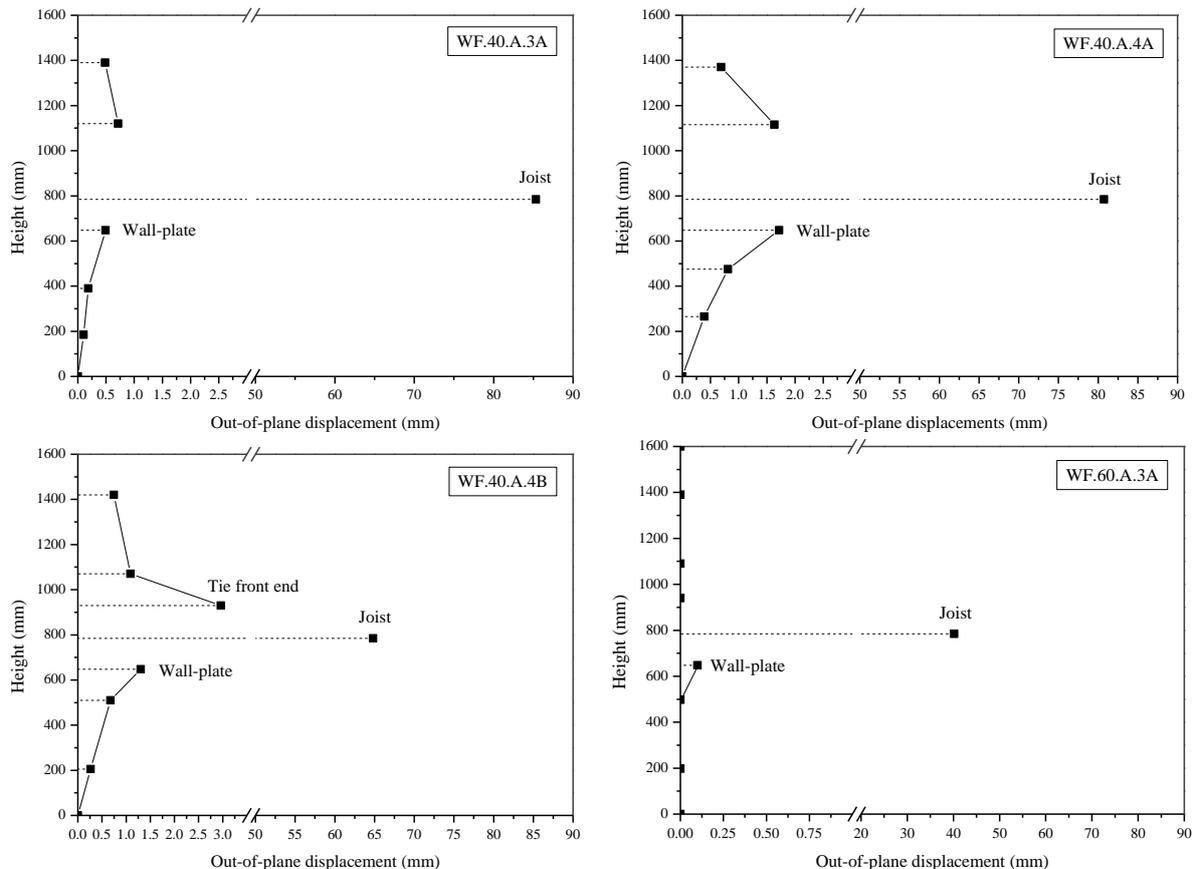
Figure 5.24 Out-of-plane displacements at the front face.

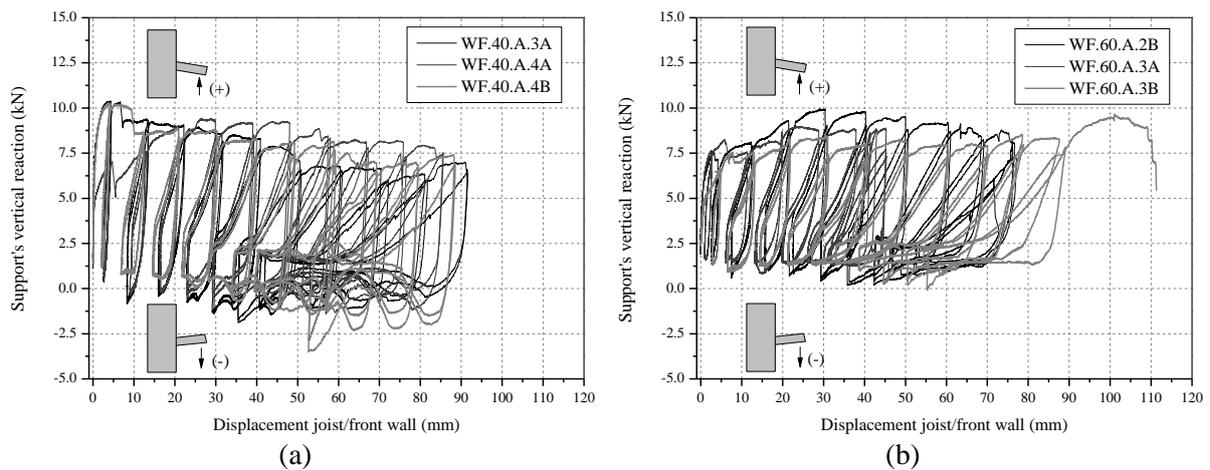
**Figure 5.26** Support's vertical reaction vs. displacement joist/front wall: (a) WF.40 tests; and (b) WF.60 tests.

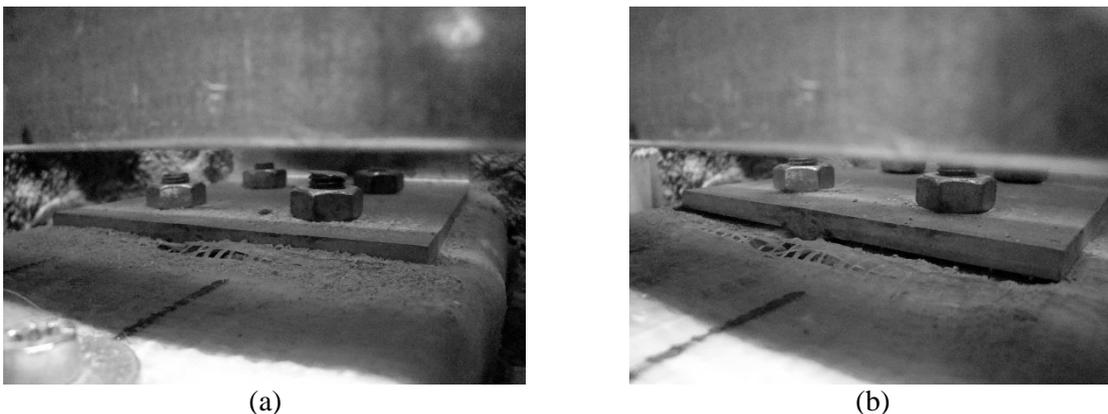
**Figure 5.27** Detachment of the steel angle: (a) before; and (b) after.

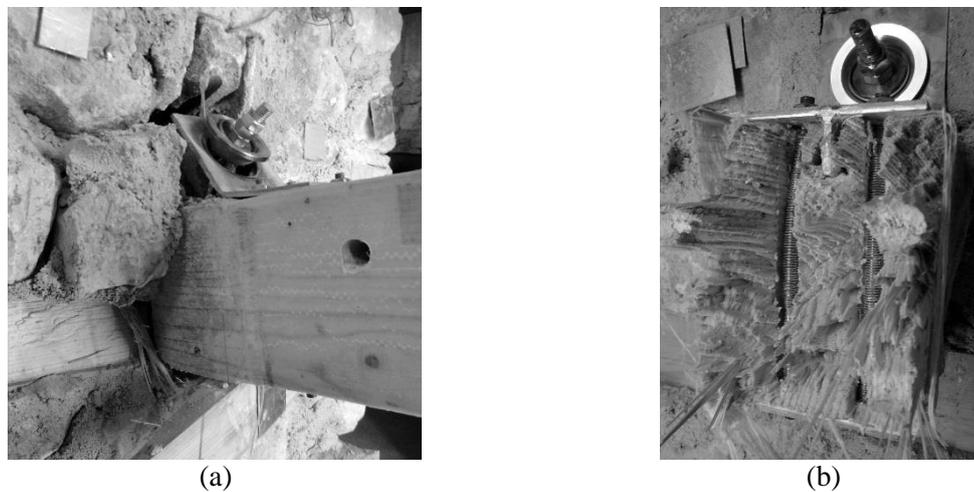
**Figure 5.29** Failure modes: (a) WF.60.A.1B; and (b) WF.60.A.3A.

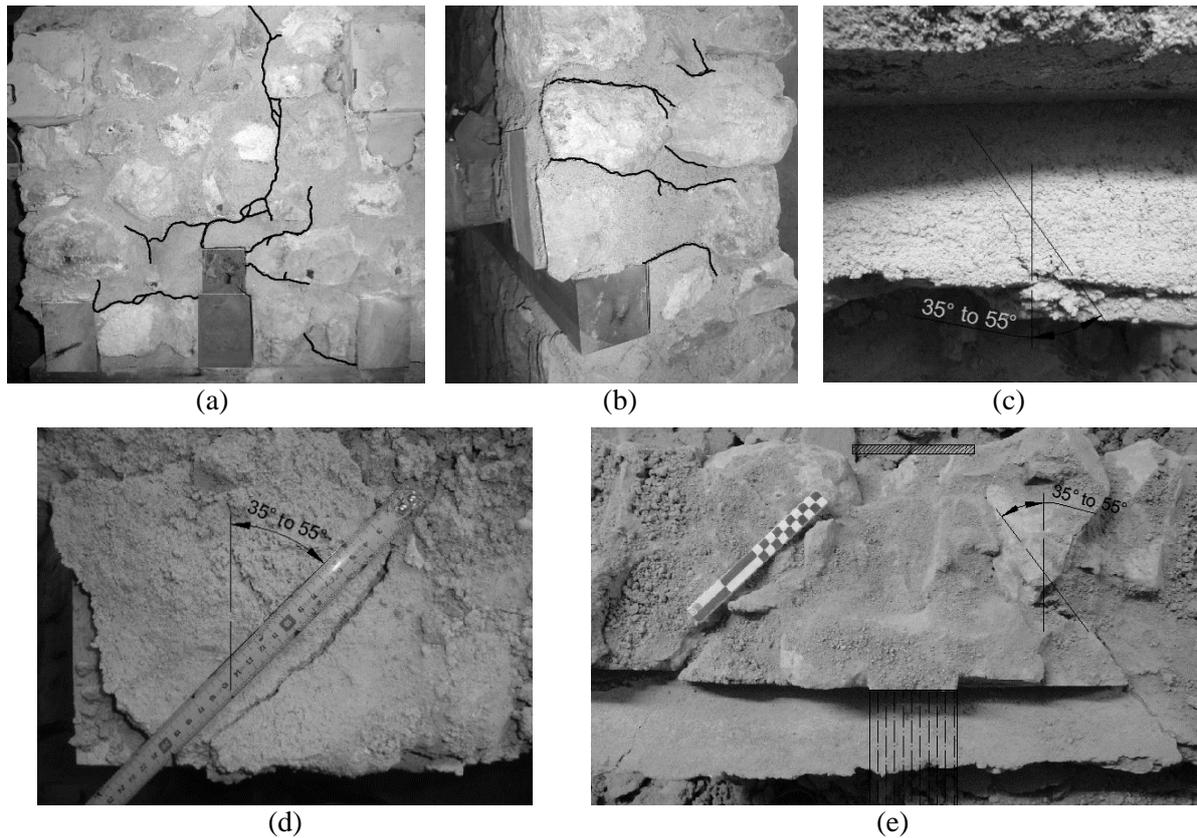
**Figure 5.30** Damage observed descriptive of FM1: (a) cracked face; (b) cracked lateral; (c) cracks under the wall-plate; (d) cracks above the joists; and (e) complete cone breakout (WF.40.A.1A).

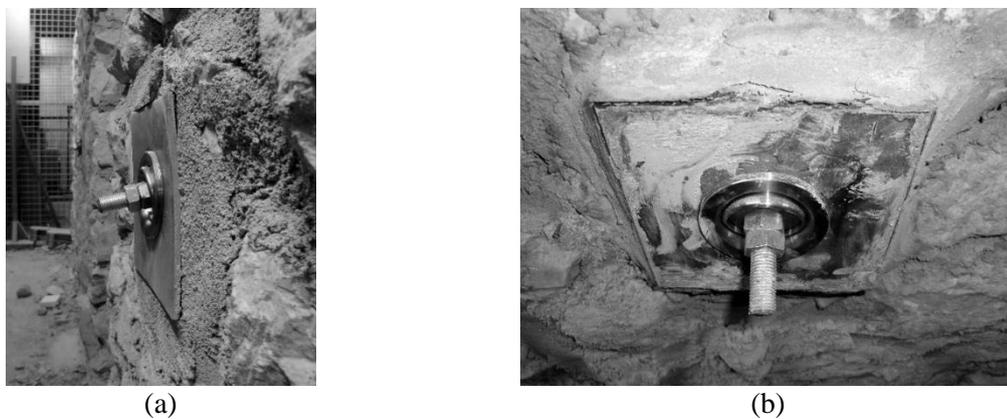
**Figure 5.31** Damage observed descriptive of FM2: (a) WF.40.A tests; and (b) WF.60.A tests.

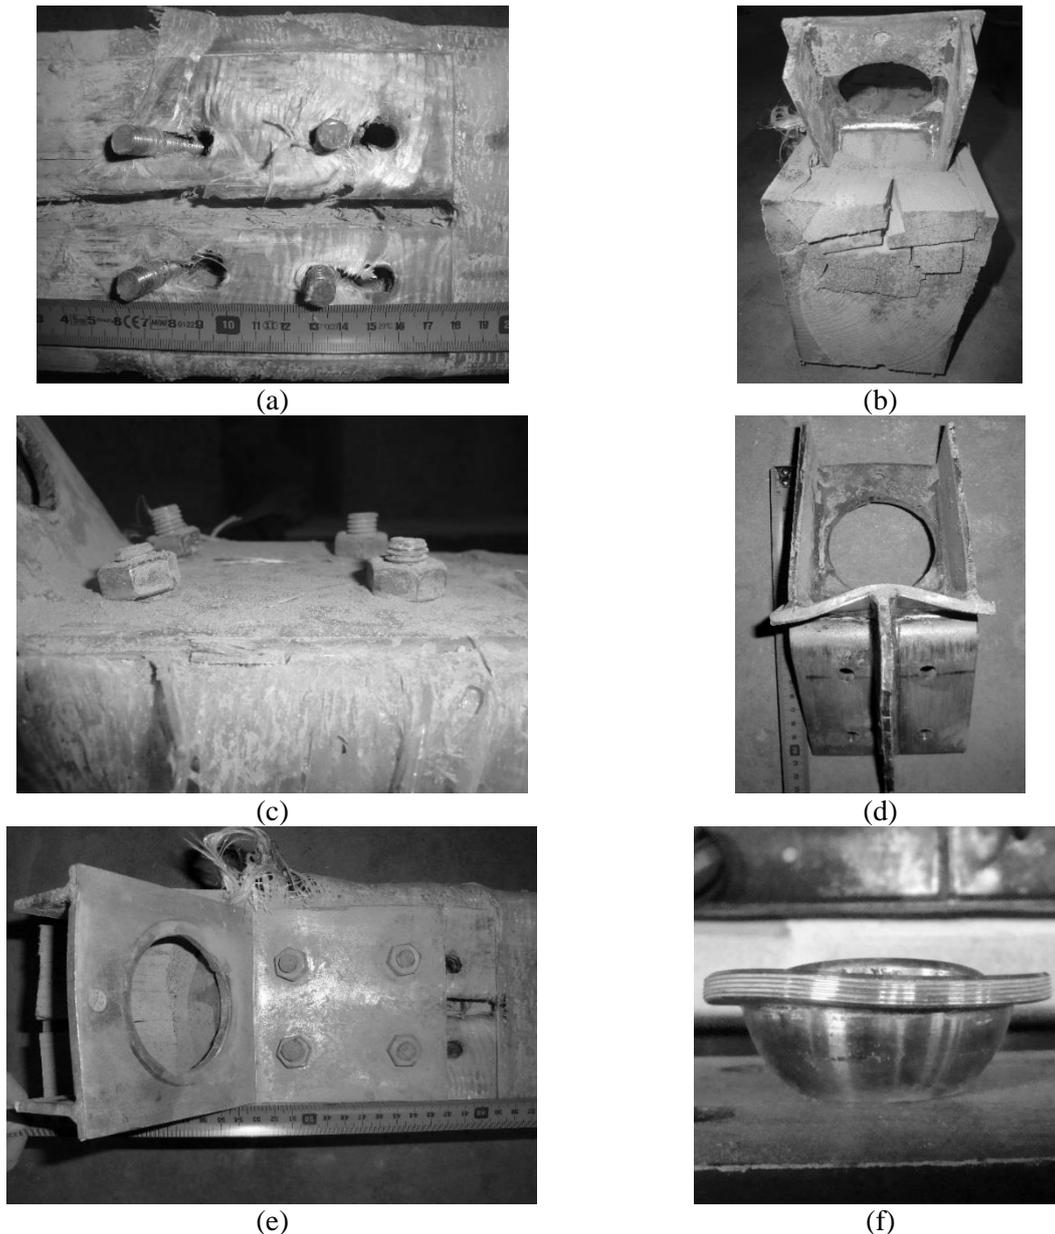
**Figure 5.33** Different types of damage within FM3 category: (a) crushing of the timber under the bolts; (b) shearing of the timber; (c) bending of the bolts; (d) yielding of the steel angle's reinforcements; (e) opening of the steel angle; and (f) yielding of the hinge's cup.

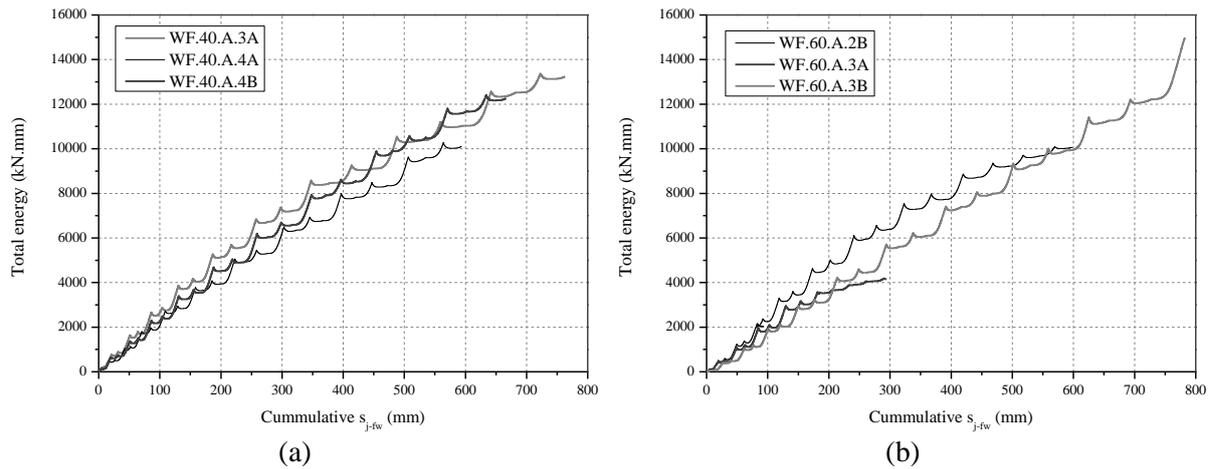
**Figure 5.34** Total energy based on  $s_{j-fw}$ : (a) WF.40 tests; and (b) WF.60 tests.

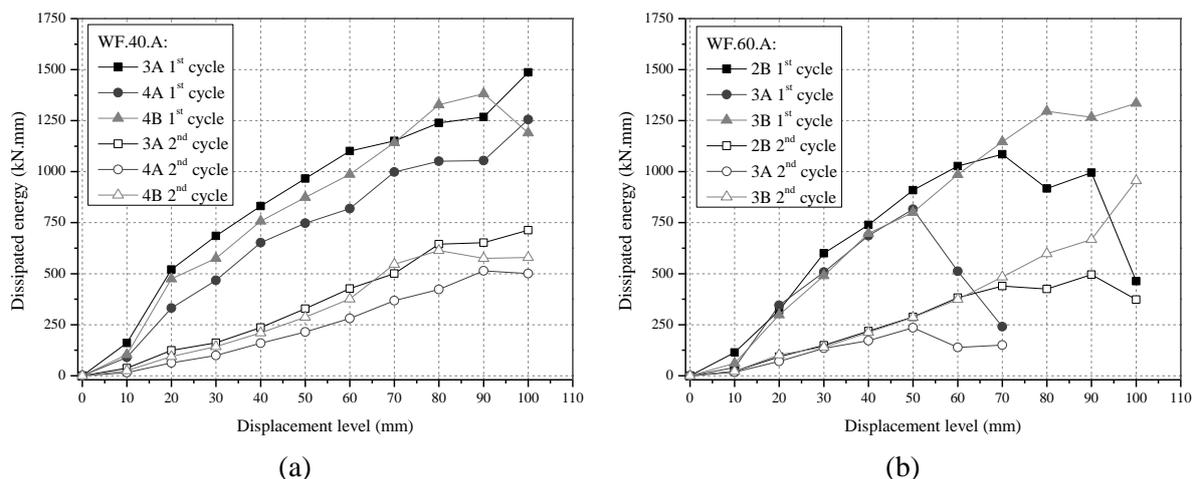
**Figure 5.35** Dissipated energy per level based on  $s_{j-fw}$ : (a) WF.40.A tests; and (b) WF.60.A tests.

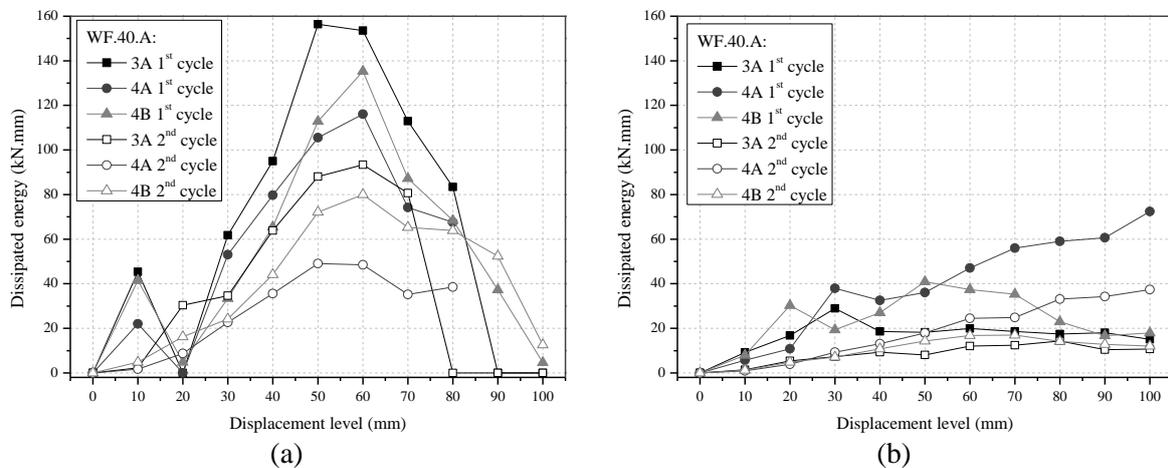
**Figure 5.36** Dissipated energy per level for WF.40.A tests: (a) based on  $d_{cone}$ ; and (b) based on  $d_{ap-bw}$ .

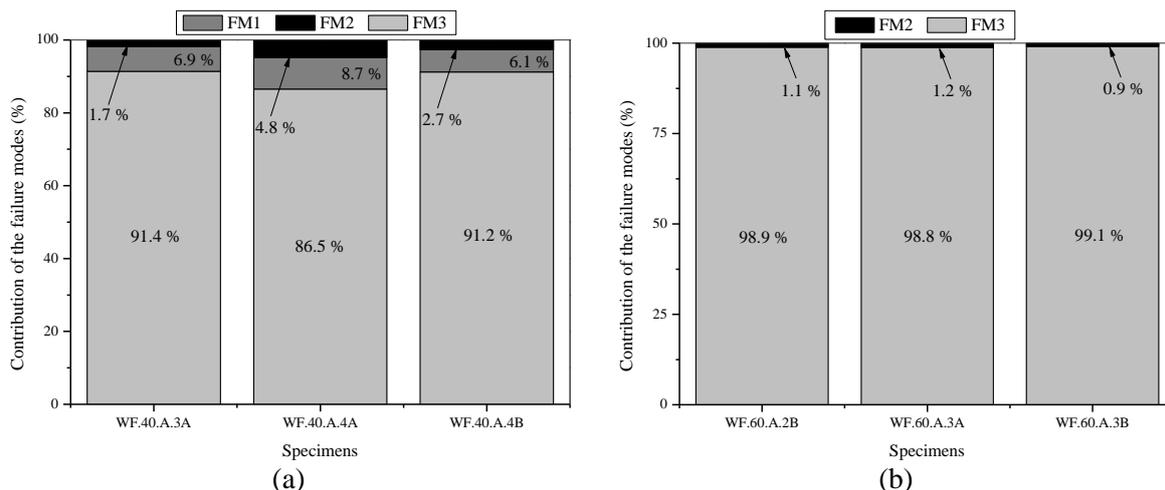
**Figure 5.38** Contribution of failure modes to the dissipated energy.

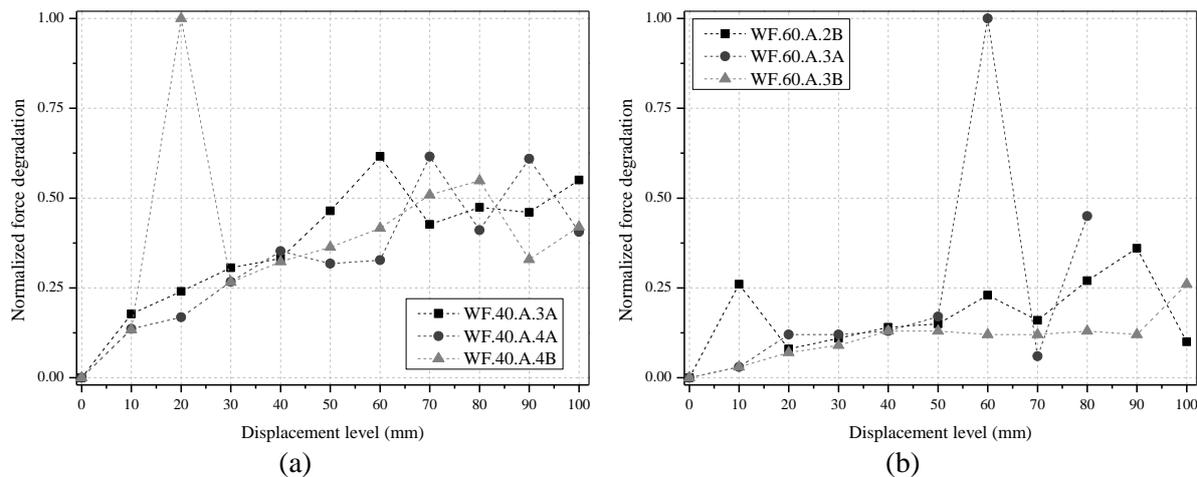
**Figure 5.39** Normalized force degradation per displacement level: (a) WF.40 tests; and (b) WF.60 tests.

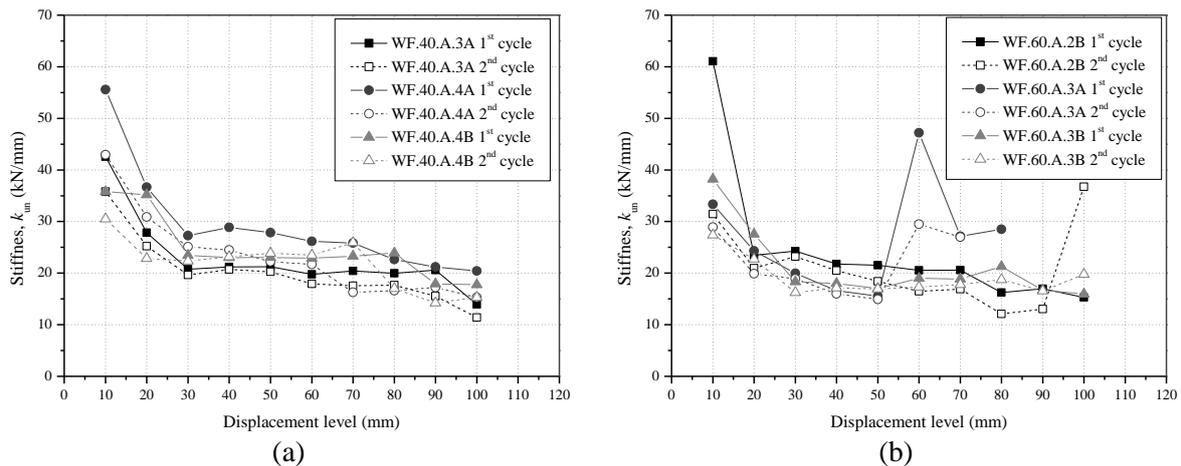
Figure 5.40 Evolution of unloading stiffness throughout cyclic loading.

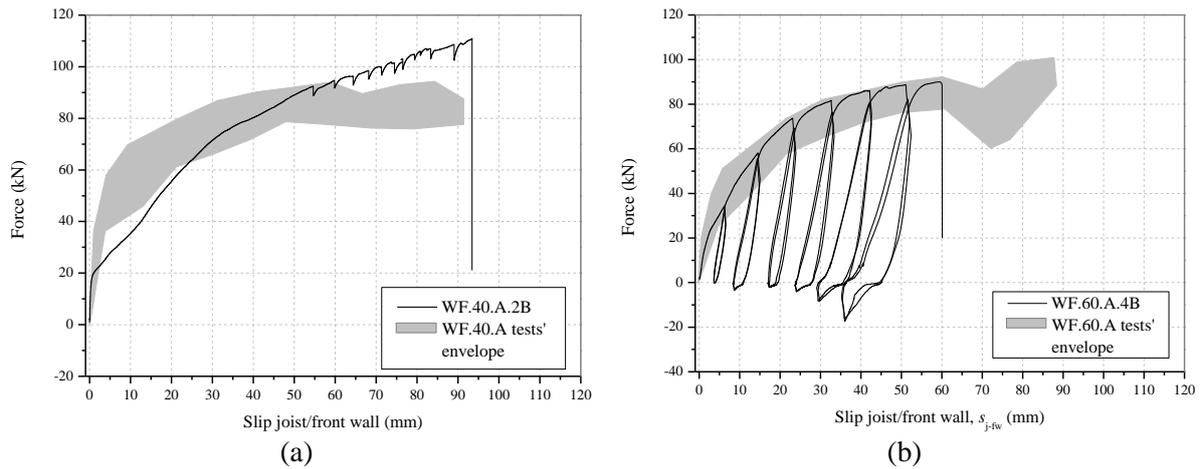
**Figure 5.41** Force-displacement curves of specimens w/o the steel angle being glued: (a) WF.40.A.2B; and (b) WF.60.A.4B.

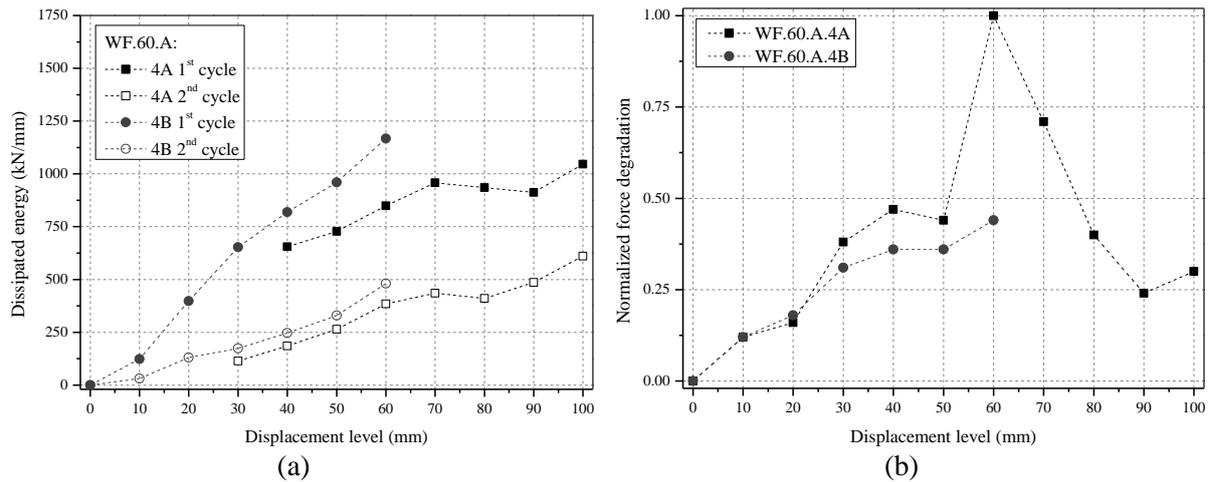
**Figure 5.44** Cyclic parameters for specimens WF.60.A.4A and WF.60.A.4B: (a) dissipated energy; and (b) force degradation.

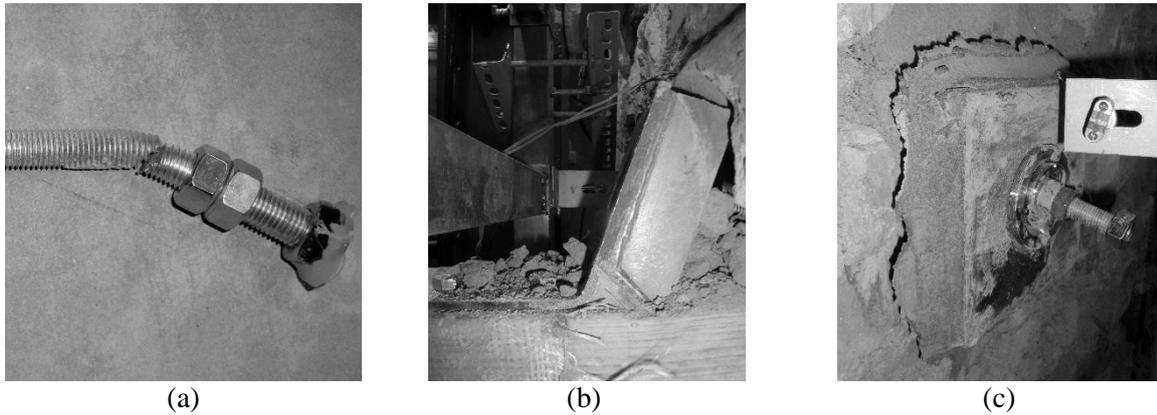
**Figure 5.45** Damage related to FM4: (a) broken steel tie; (b) projection forward of the hinge components; and (c) detachment of layer of mortar and anchor plate.

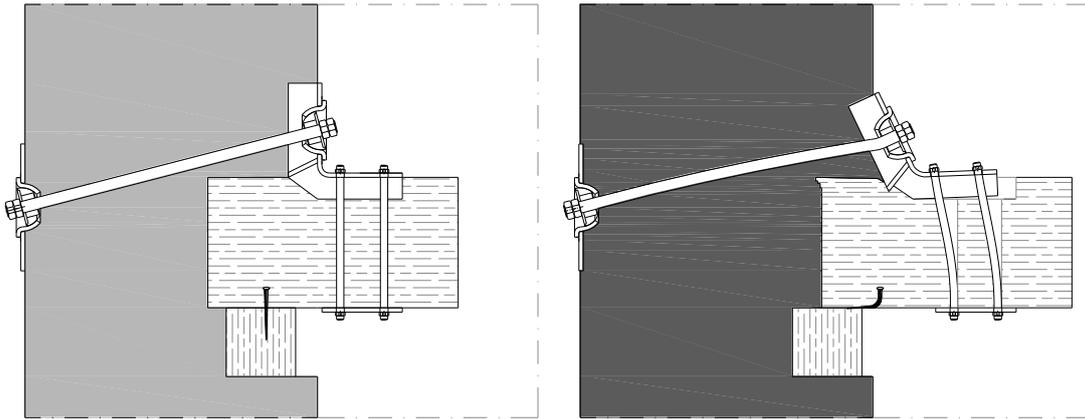
**Figure 5.48** Sketch of the strengthened connection before and after testing (deformation in the same scale as the dimensions)

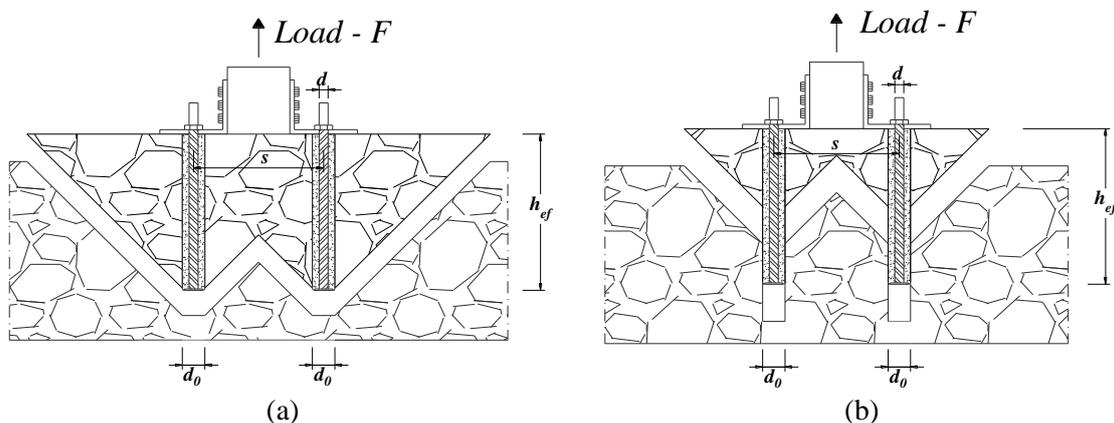
**Figure 6.1** Failure modes: (a) substrate cone failure; and (b) combined cone-bond failure (adapted from (Zamora et al., 2003)).

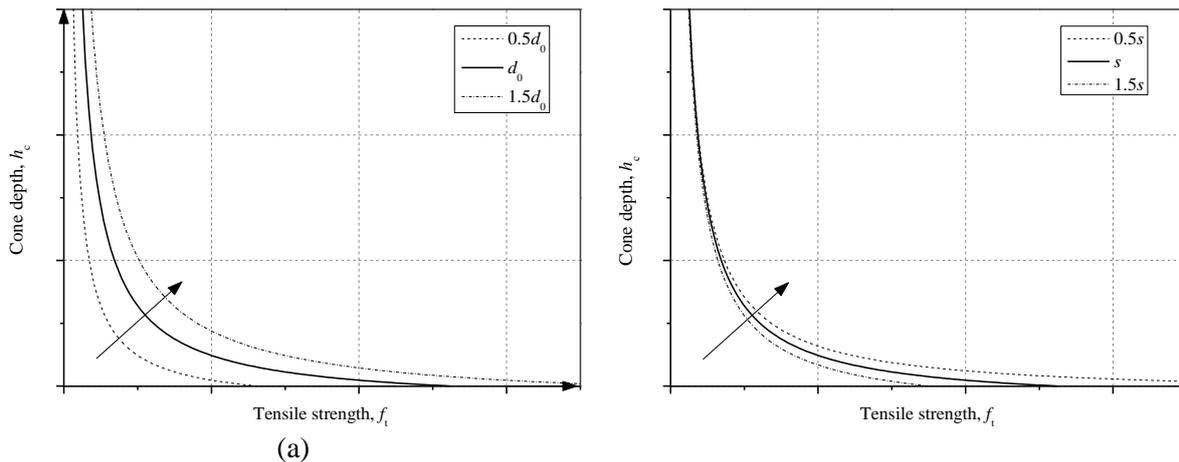
**Figure 6.4** Parametric sensitivity of  $h_c$ : (a) to  $f_t$  and  $d_0$  (also valid for  $\tau_0$ ); and (b) to  $f_t$  and  $s$ .

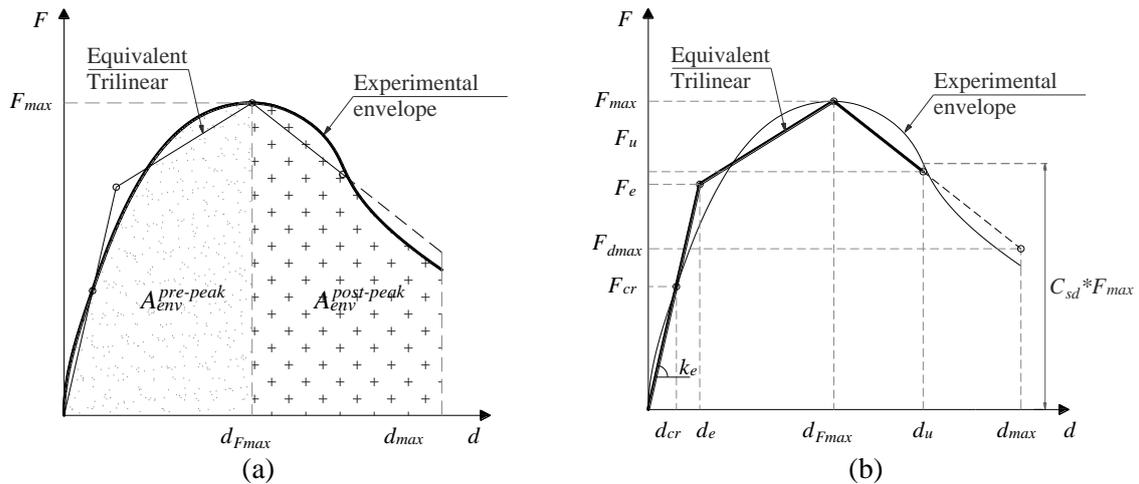
**Figure 6.9** Trilinear idealization: (a) backbone curves' areas; and (b) defining points.

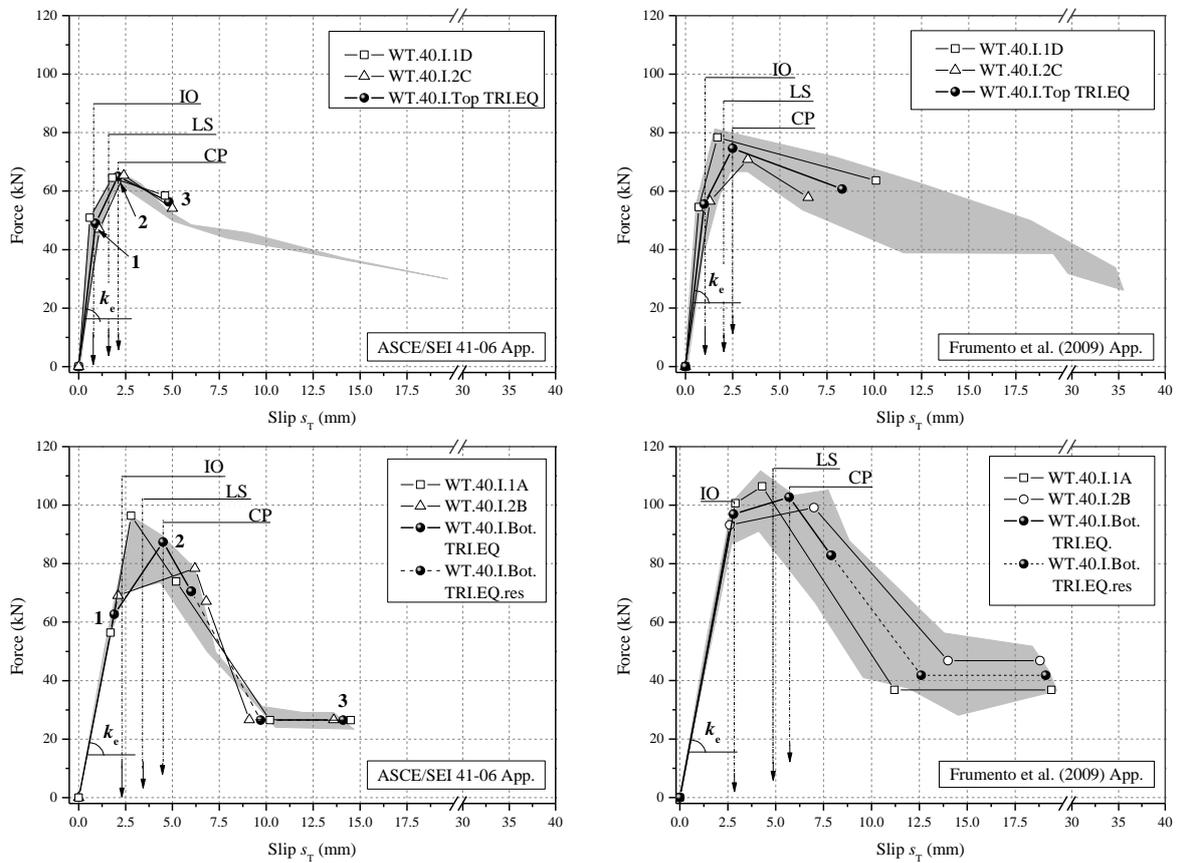
**Figure 6.10** Equivalent trilinear curves for the injection anchors specimens.

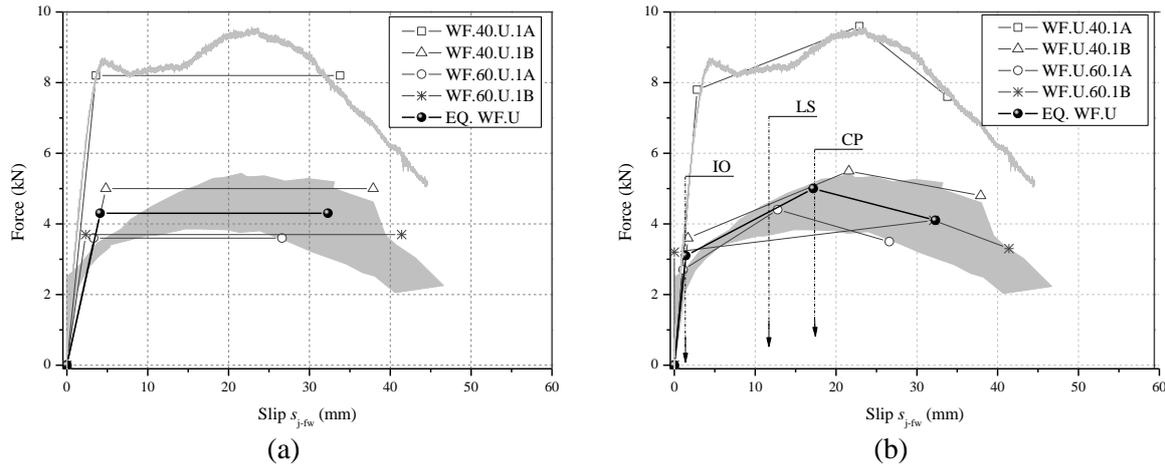
**Figure 6.11** Idealized unstrengthened wall-to-floor connections: (a) Bilinear curves; and (b) Trilinear curves.

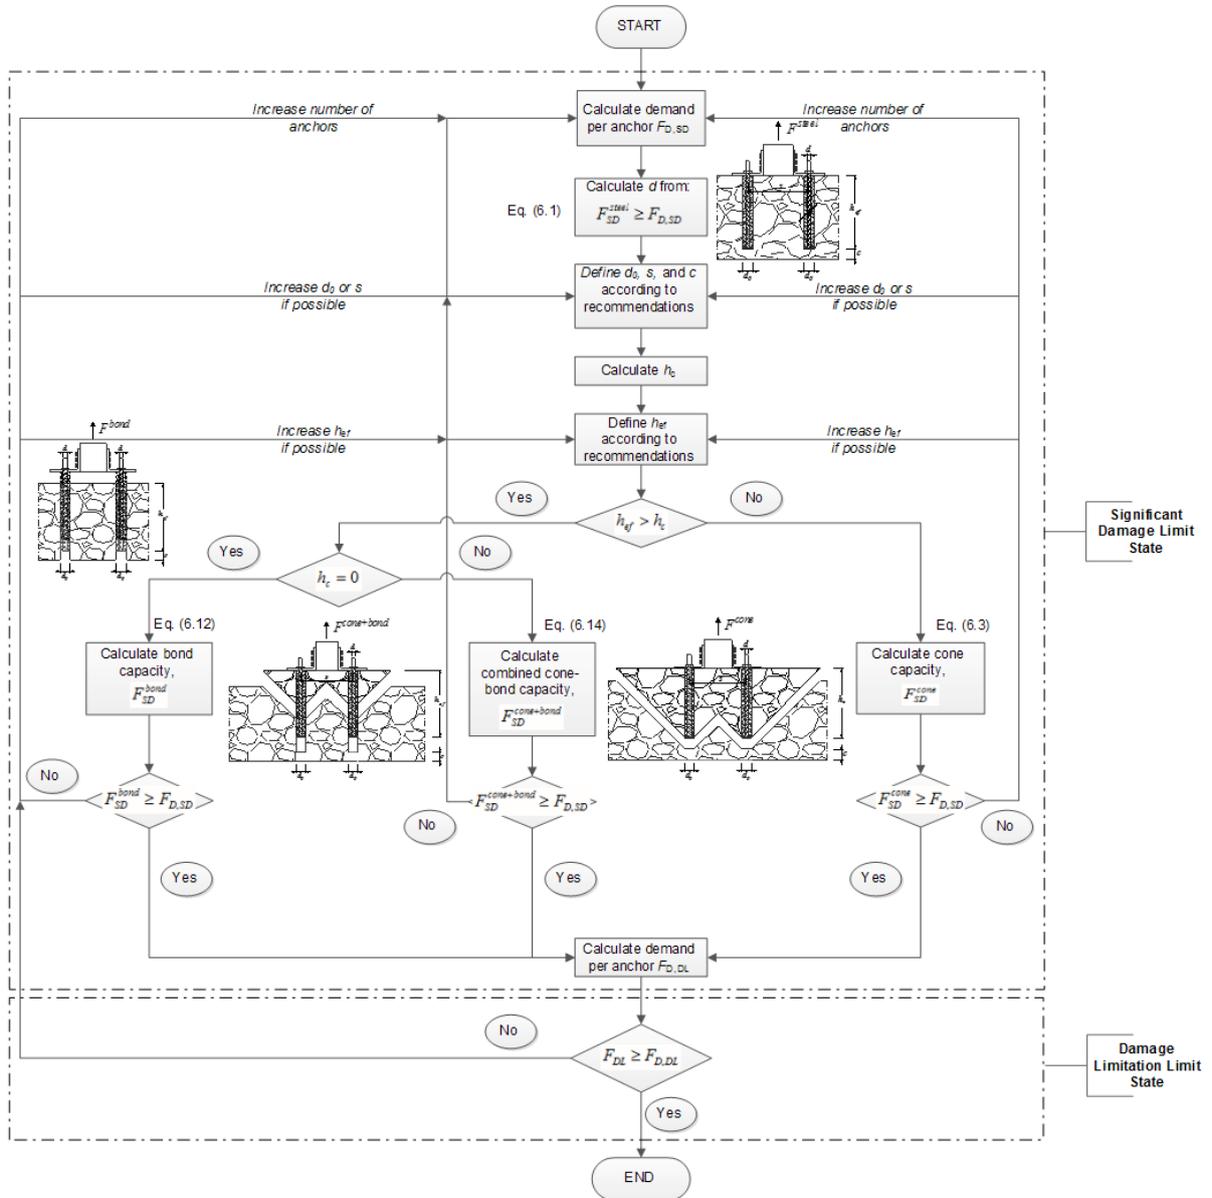
Figure 6.14 Flowchart for the design of injection anchors.

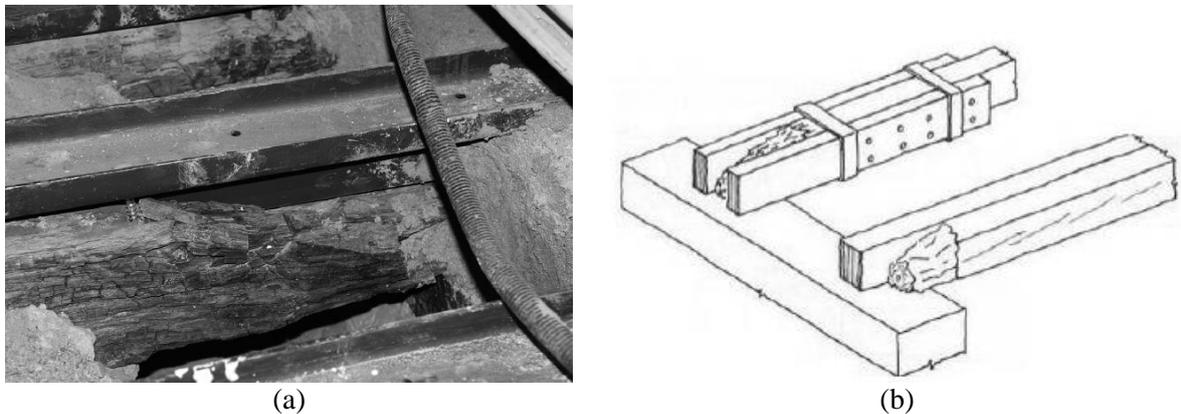
**Figure 6.16** Retrofit of the joist: (a) Strengthening with steel profiles (González-Bravo et al., 2011); (b) strengthening by adding new timber elements to the existing one (Arriaga, 2000).

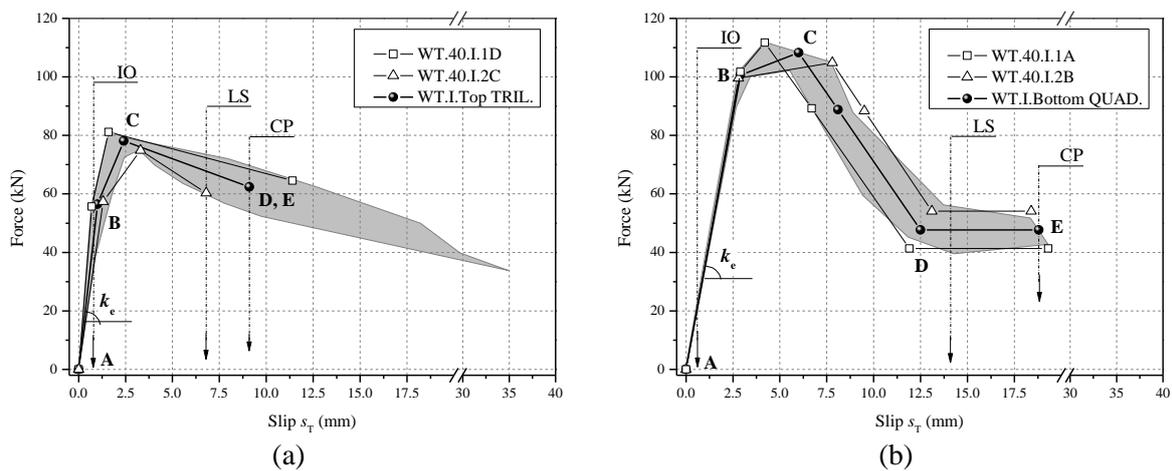
**Figure 6.17** Idealized trilinear and quadrilinear curves for injection anchors' specimens: (a) WT.40.I.Top; and (b) WT.40.I.Bottom

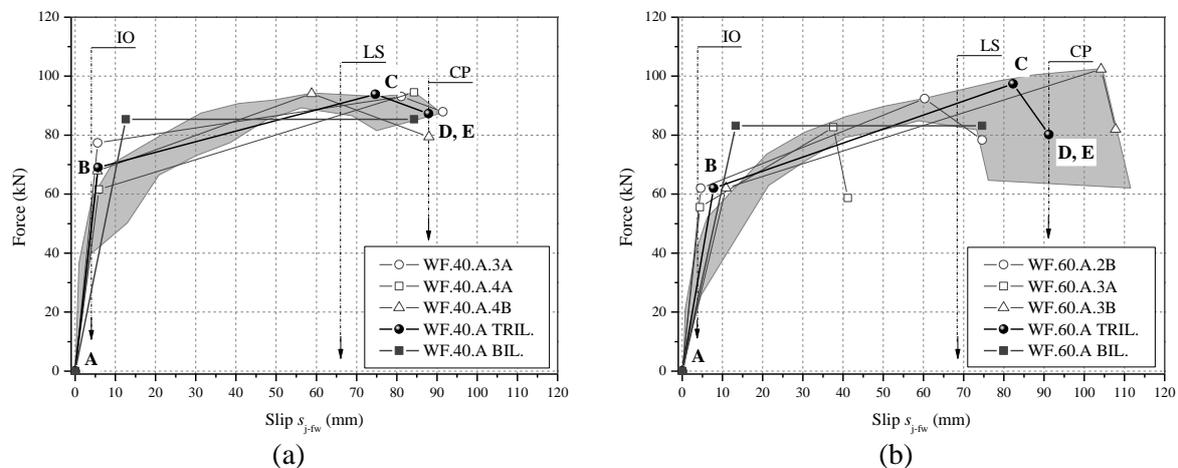
**Figure 6.18** Idealized bilinear and trilinear curves for strengthened wall-to-floor specimens: (a) WF.40.A specimens; and (b) WF.60.A specimens.
