Survey and dynamic behaviour of the Our Lady of Conception Church, Portugal

The Our Lady of Conception church (Fig. 1) is located in village of Monforte (Portugal) and is not in use nowadays. The church presents structural damage and, consequently, a study was carried out. The study involved the survey of the damage, dynamic identification tests under ambient vibration and the numerical analysis.

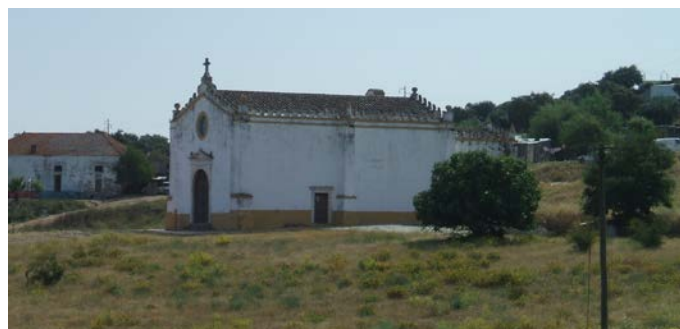
Fig. 1. Our Lady of Conception church

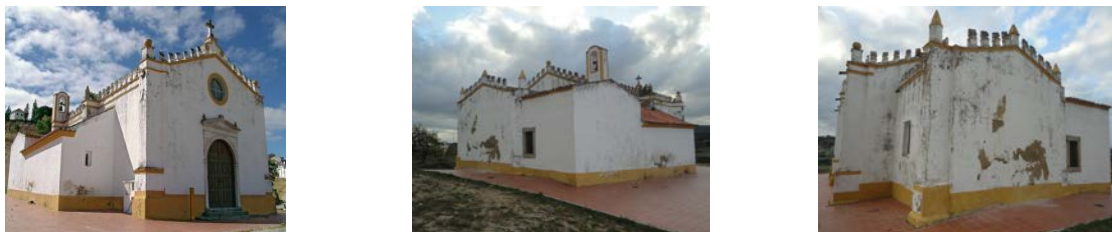
Figure 1. Our Lady of Conception church.

The Our Lady of Conception church (Fig. 1) is located in the village of Monforte (Portalegre, Portugal) at 600 m from the downtown and outside the ancient medieval walls of the village, which previously protected the village of Monforte. This church is part of the complex of three churches (church of *Calvário* and the church of *S. João Baptista*), which corresponds to the magical-religious triangle of the place of village of Monforte. The churches were metrically positioned in correspondence with the vertices of a triangle. The triangle is a geometrical shape used in the mystical and religious traditions, through which the central mystery of Christian is represented – The Trinity. Furthermore, the triangle together with the number three is symbol of the highest wisdom and of the perfect harmony, and represents the spiritual perfection and the Supreme Being.

The Our Lady of Conception church presents features that allow to identify it as a church of Manuelino-Mudejar style and is composed by the central nave, the chancel, the sacristy and the corridor to access the pulpit. The masonry walls present different thickness, namely 0.65 m in the chancel, 0.70 m in the sacristy, 0.92 in the central nave and 0.65 m in the corridor. The masonry walls present 8 buttresses with different dimensions. The total longitudinal and transversal dimensions of the church are equal to 21.10 m and 14.26 m, respectively. The central nave has 14.26 m and 6.33 m in the longitudinal and transversal direction, respectively. The maximum external height of the church is equal to 10.3 m. The Our Lady of Conception church is classified as a Public Interest Building and presents several pathologies in the structural and decorative elements, which require a multidisciplinary teamwork to evaluate the conservation status of the church, involving civil engineers, architects, restoration technicians, geologists and archaeologists.
