Shivangi Shukla Seismic strengthening of rammed earth constructions using reinforced coatings

Master's Thesis

University of Minho

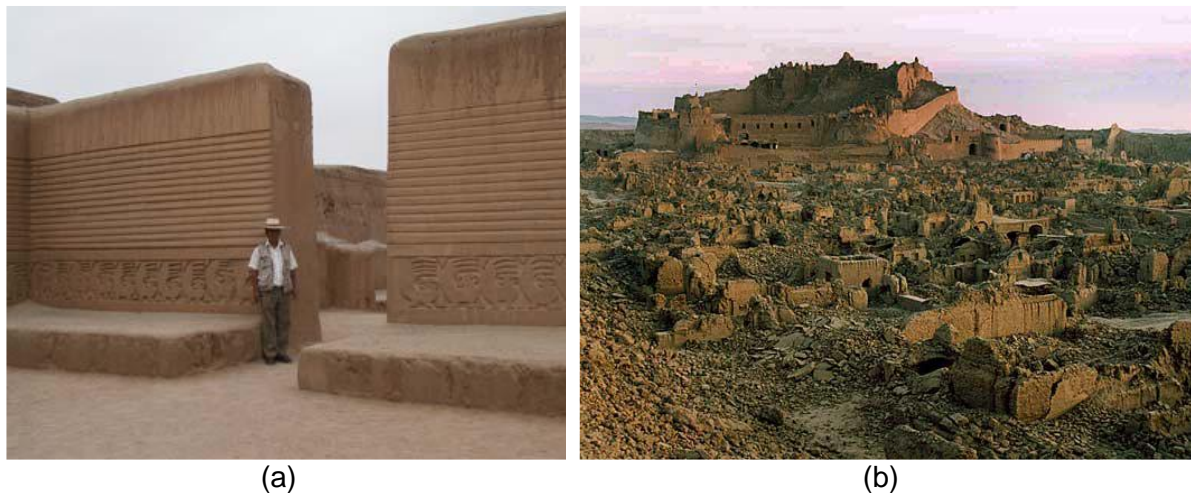
Figure 5: Ancient earthen structures (a) citadels of Chan-Chan and (b) Arg-e Bam (*Blondet & Aguilar, 2007*)

Looking at the seismic behaviour of historic earthen structures, some massive earthen structures in Peru have been able to survive earthquakes because of their massiveness and regular configuration. The Chan-Chan city (1200AD) built with adobe walls, survived many severe earthquakes during the past 600 years. Some walls are up to 9m tall and 3m wide at the base and many slender walls are still standing without any support, a citadel shown in Figure 5. While, Bam earthquake (2003) in Iran destroyed the historic earthen citadel of Arg-e Bam built in adobe (500 BC) including several adobe houses (Blondet & Aguilar, 2007). The architectural design of the citadel and surroundings includes upper thin walls standing over thick base walls, irregular plan configurations, and high wall densities. It seems that slender walls have collapsed, impacting adjacent walls and constructions, causing total destruction of the site, in spite of its massiveness. (Blondet & Aguilar, 2007)

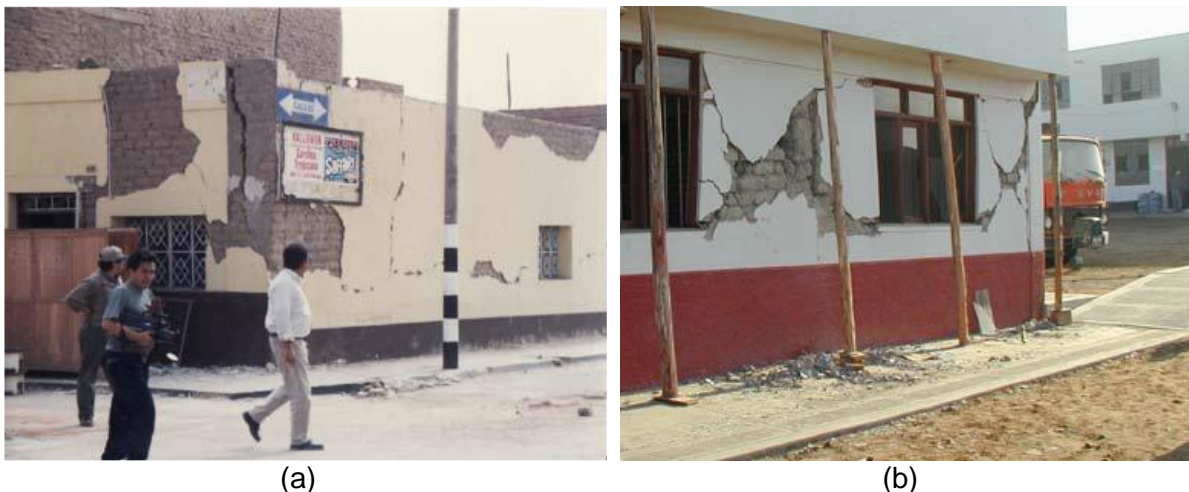
Figure 6: Adobe houses with seismic damage (a) Vertical cracks at corner of front wall and (b) Diagonal shear cracks (Blondet & Aguilar, 2007)

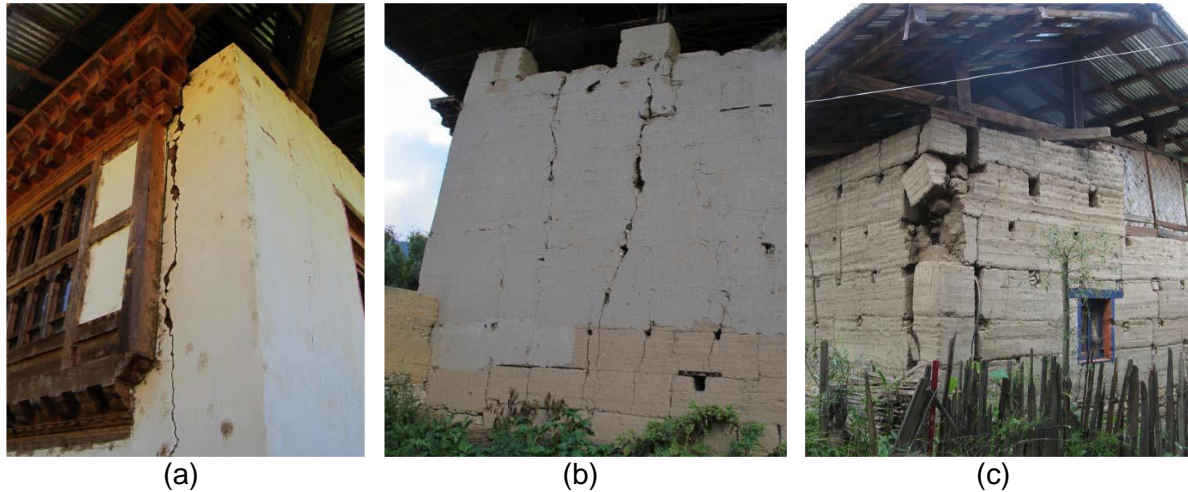
Figure 10: Typical damages of RE constructions (a) Separation of corner walls; (b) vertical wall cracks and (c) corner failure

Another type of damage noticed was displacement of *rabsey*, (Figure 10 (a)), a full height window at upper floors which is anchored in the walls preventing out of plane movement. Some places were not anchored, were just resting with the weight (Bhutan, 2011).

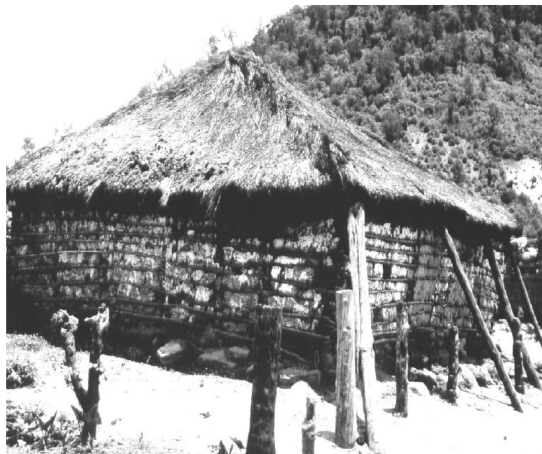
Figure 11: Wattle-and-daub structure that survived after a heavy earthquake in Guatemala (Minke, 2001)

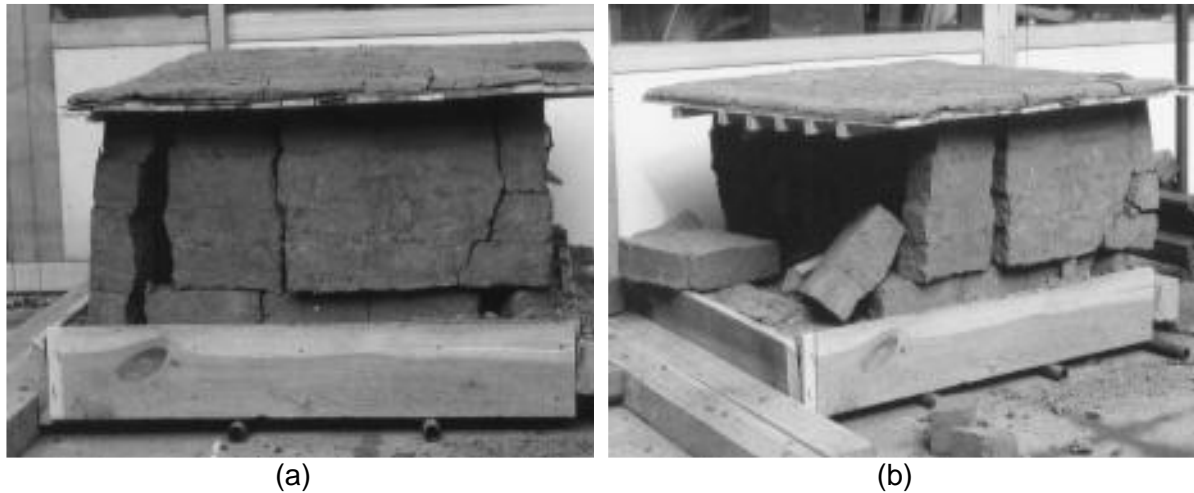
Figure 14: RE model with square plan developed a large crack after the 2nd stroke, (a) one part separated after 3rd strokes and (b) collapse after 4th stroke (*Minke, 2001*)

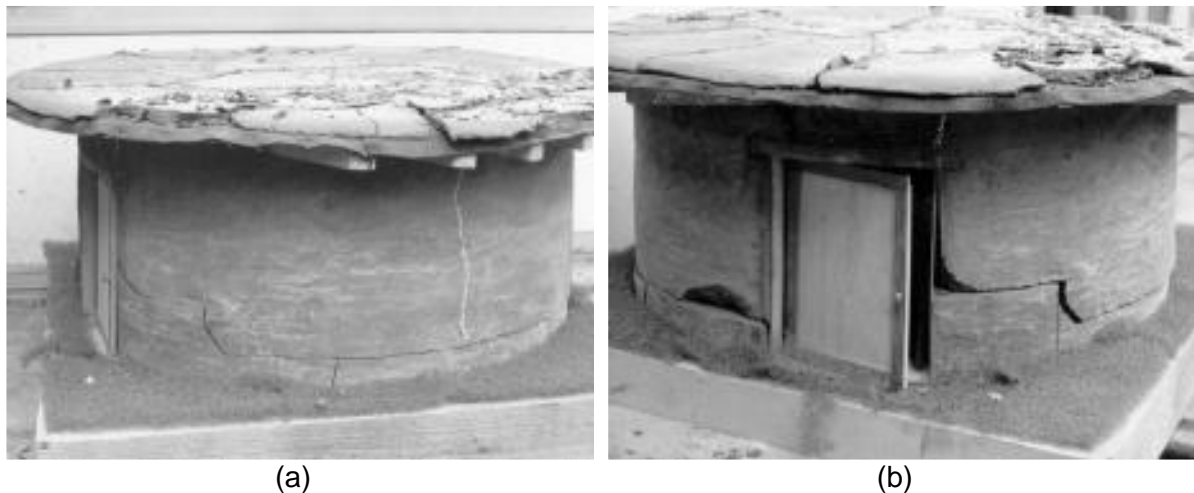
Figure 15: Circular RE models (a) first crack appeared only after 3rd stroke and (b) after 6th stroke a small part was separated (*Minke, 2001*)

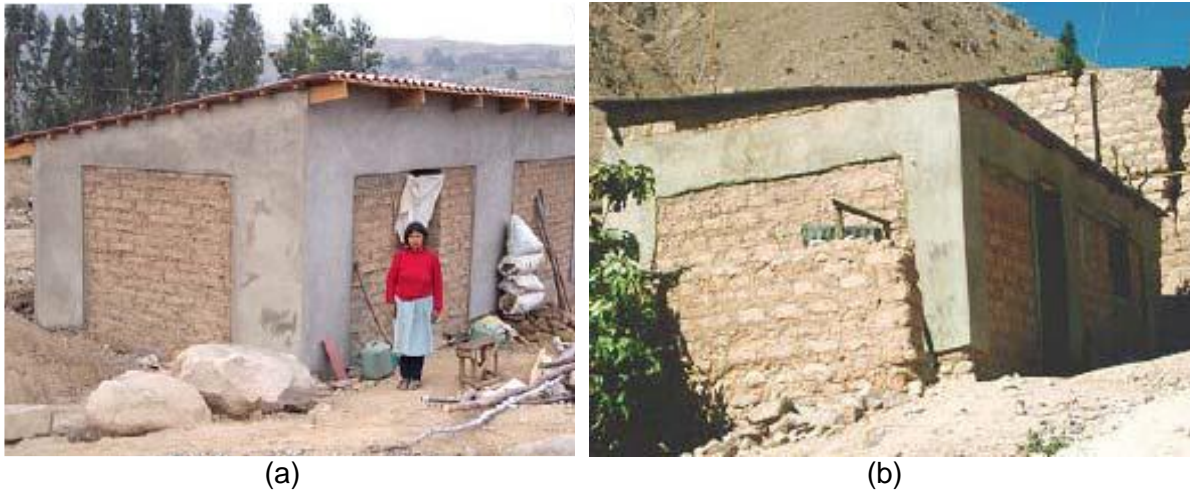
Figure 25: Reinforced model after seismic test reinforced house after the 2001 earthquake
Adobe buildings with external wire mesh reinforcement (*Blondet & Aguilar, 2007*)

Adobe houses constructed in Peru (Figure 25) with wire mesh bands nailed on the walls and plastered with cement mortar could stand under moderate earthquakes. The models in experiments (Figure 24 (c)) showed increased strength but had brittle failure. Material cost is a big limitation for this system in Peru.

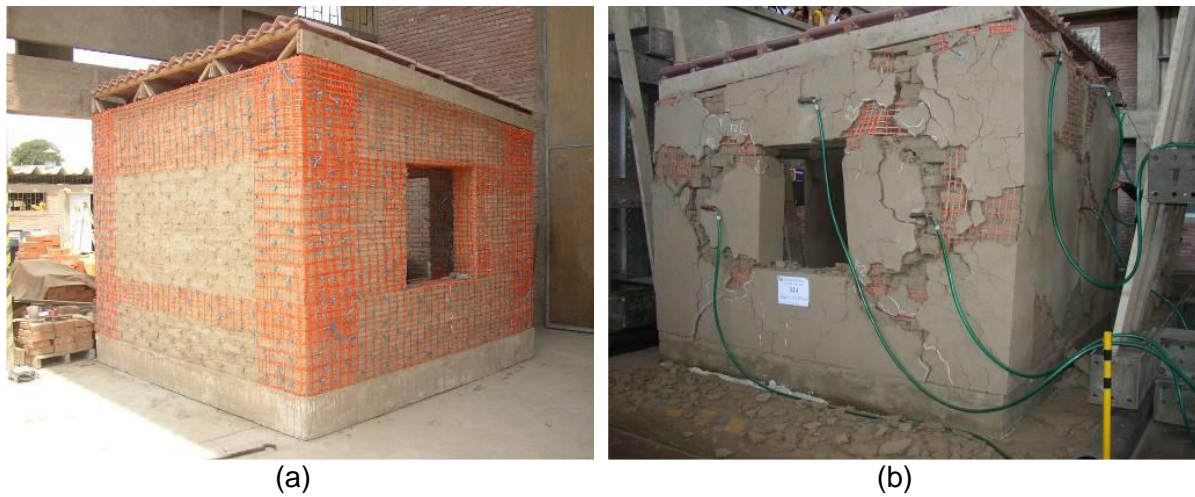
(a) (b)
Figure 28: Real scale adobe model (a) with plastic mesh reinforcement and (b) laboratory experiment (*Blondet, et al., 2006*)

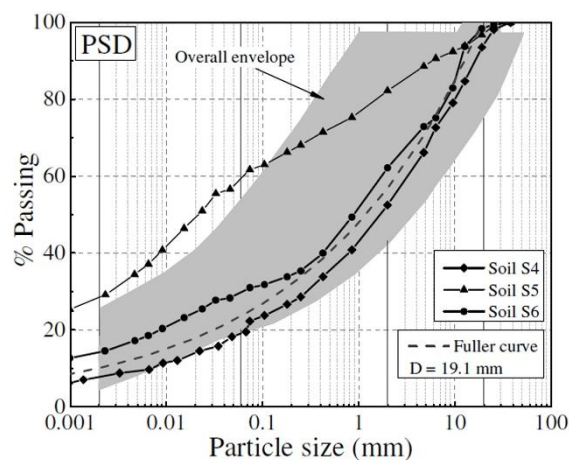
Figure 32: PSD curve of the soil S6 (corrected with soil S5 and S4 types) (Silva, 2013)

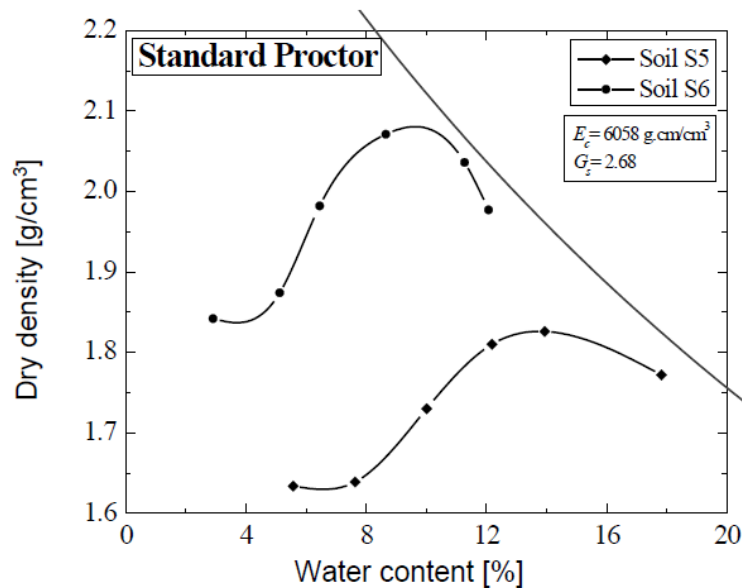
Figure 34: Compaction curve of soils S6 (Silva, 2013)

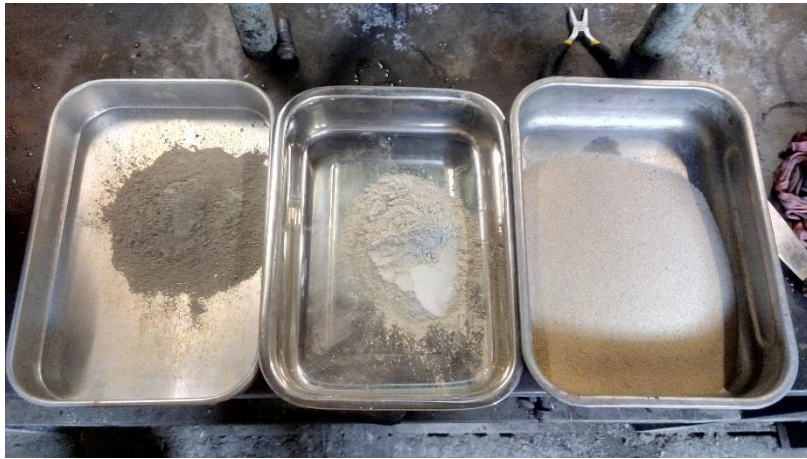
Figure 35: Cement, hydraulic lime and sand used to manufacture mortar M1.

The first mortar chosen was cement mortar which consisted of cement: hydraulic lime: sand in the proportions 1:0.47:9.67 (in weight), respectively (Figure 35). This composition resulted from the conversion of the typical composition of 1:1:6 (in volume) used for plastering works in current constructions. All three components were obtained from a local supplier.

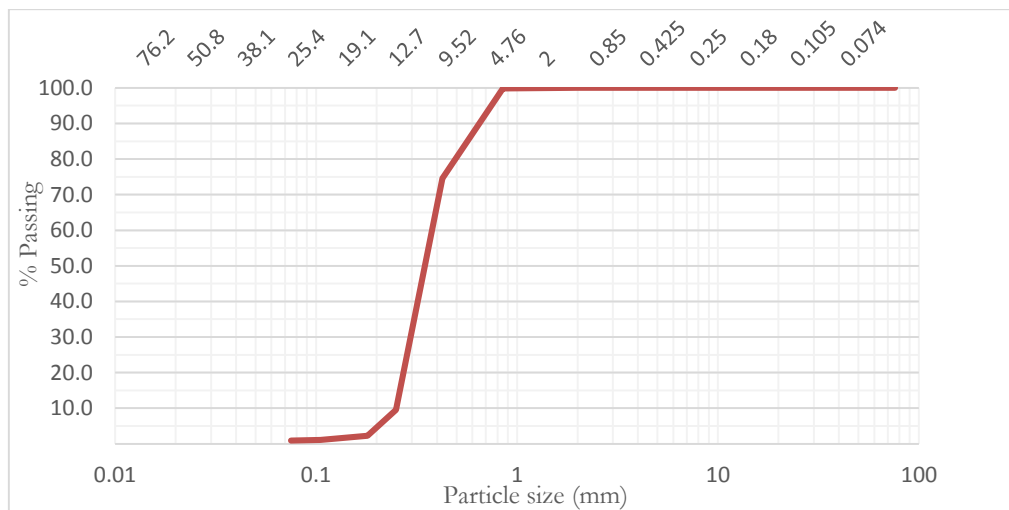
Figure 37: PSD curve of the sand for M1

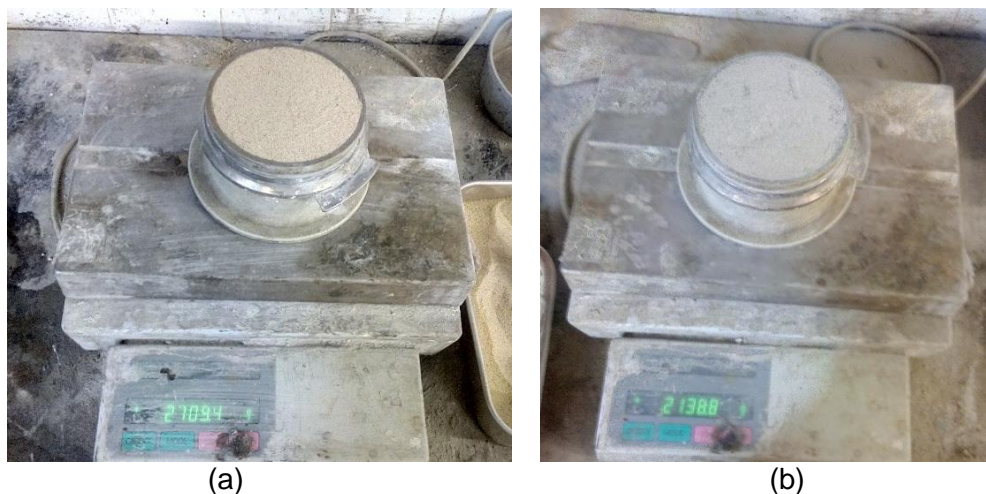
Figure 41: Mass of the material weighed in 1000ml container for (a) sand and (b) cement

A clean container is taken followed by weighing it. The container is filled with the material with a shovel to overflowing (Figure 41). The excess material is removed and the surface is flattened with a ruler. The full container is weighed. The procedure is repeated with 3 samples.

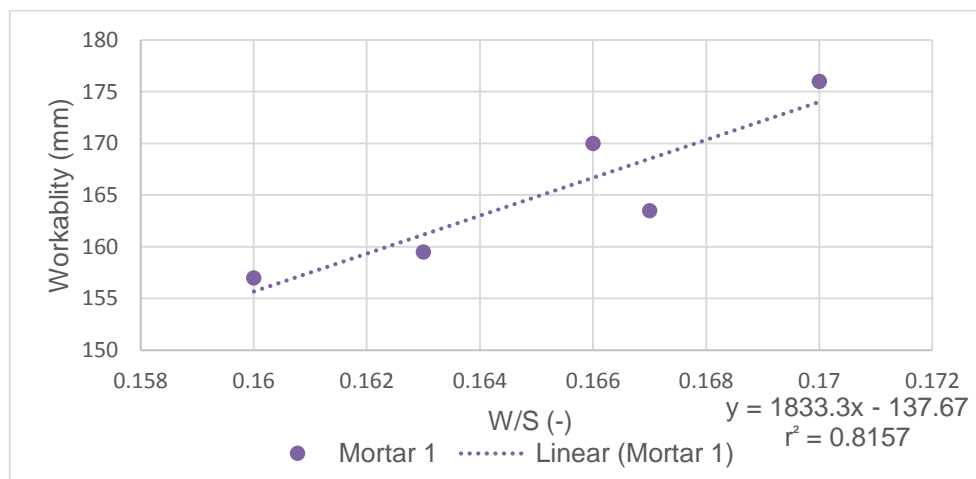
Figure 44: Variation of the workability with the W/S for cement mortar M1

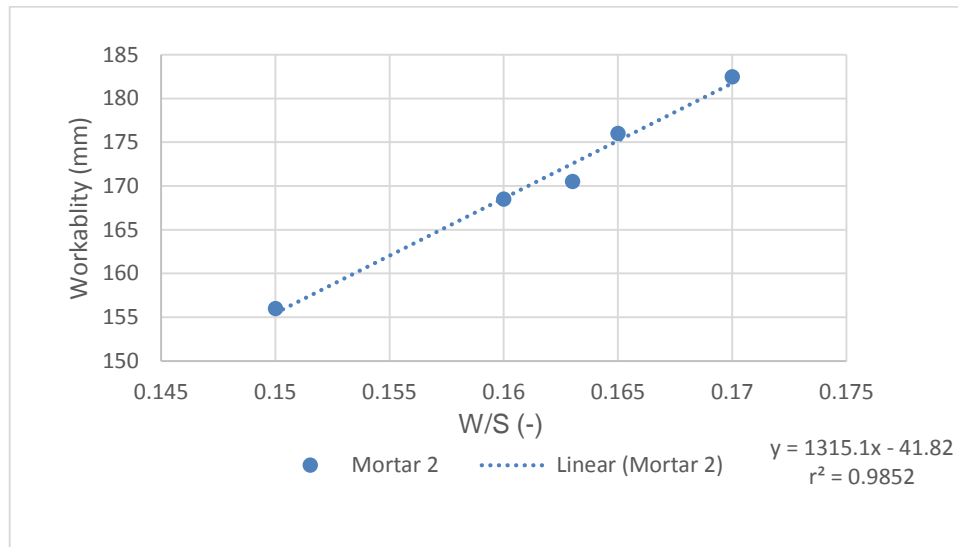
Figure 45: Variation of the workability with the W/S for earth mortar M2.

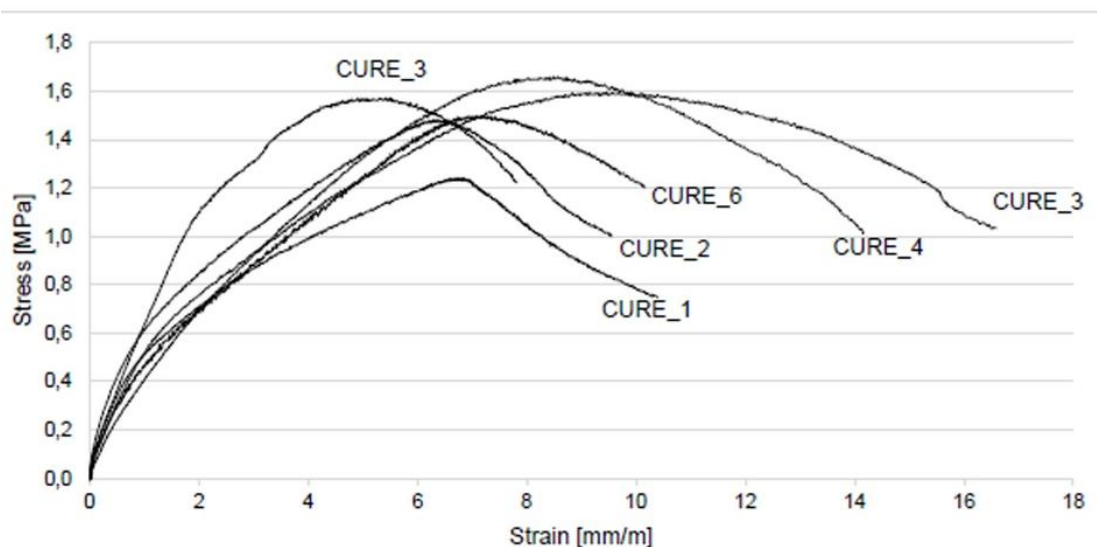
Figure 49: Stress-strain curves of the RE cylindrical specimens manufactured with soil S6 (Dominguez, 2015)

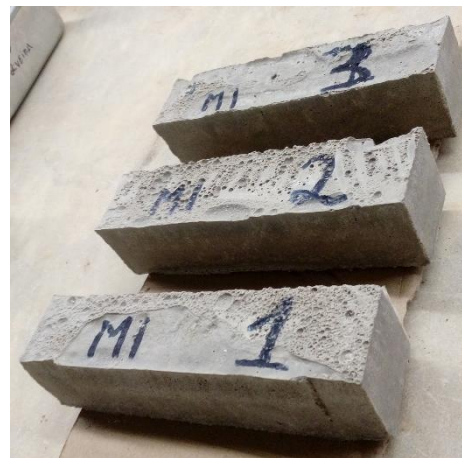
Figure 50: Cement mortar M1 in (a) fresh state and (b) hardened state after demoulding

Figure 50 shows the different stages of cement mortar M1 specimens preparation. The mould with fresh mortar was kept sealed with a plastic film for 7 days in the mould to protect from atmospheric drying. After 7 days, the film was removed and specimens were demoulded and kept in climatic chamber with 20 ± 2 °C and $50 \pm 5\%$ RH for the next 14 days. Whereas for earth mortar M2 the mould (Figure 51 (a)) with fresh mortar specimens was directly moved to the climatic chamber for drying in a controlled atmosphere. For both mortars, the total curing period was 21 days from the day of casting. In this period the beams were tested for weight at specific intervals to calculate moisture content. When the specimens hardened and reached the age of 21 days (Figure 52) they were tested for mechanical properties.

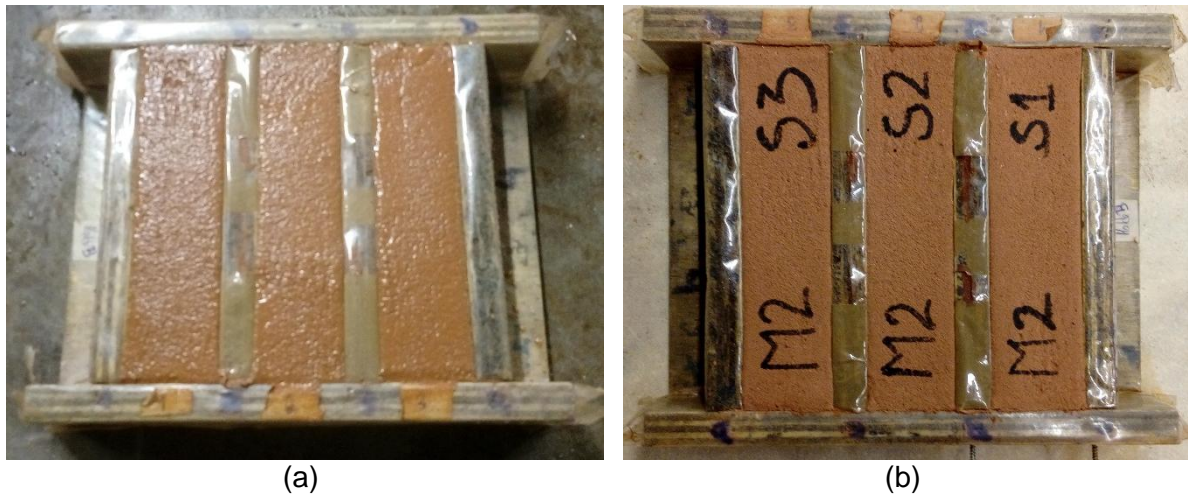
Figure 51: Earth mortar/M2 in (a) fresh state and (b) hardened state before demoulding

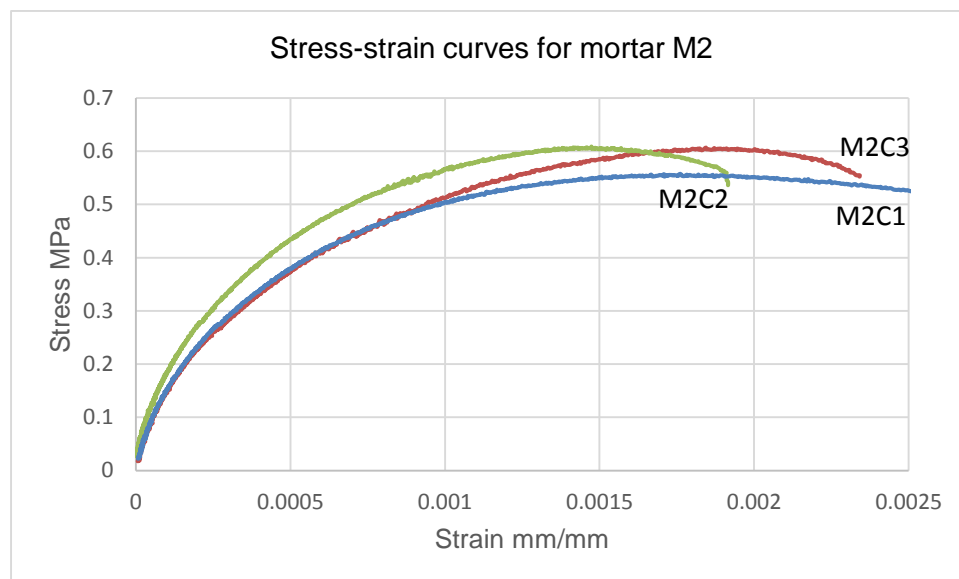
Figure 58: Stress-strain curves for three earth mortar M2 specimens i.e. M1C1-M1C3 plotted using internal LVDTs reading

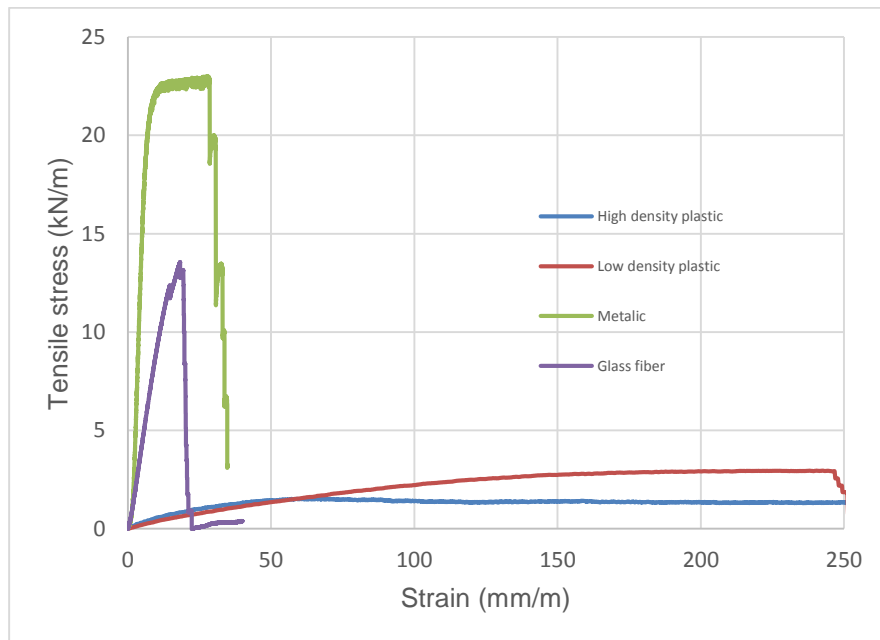
Figure 66: Tensile stress-axial strain curves for some of the tested meshes in the y direction
