Assessment of Seismic Vulnerability of Vernacular Buildings in Urban Centers:  
The Case Study of Vila Real de Santo Antonio

ADVANCED MASTERS IN STRUCTURAL ANALYSIS  
OF MONUMENTS AND HISTORICAL CONSTRUCTIONS

## Master's Thesis

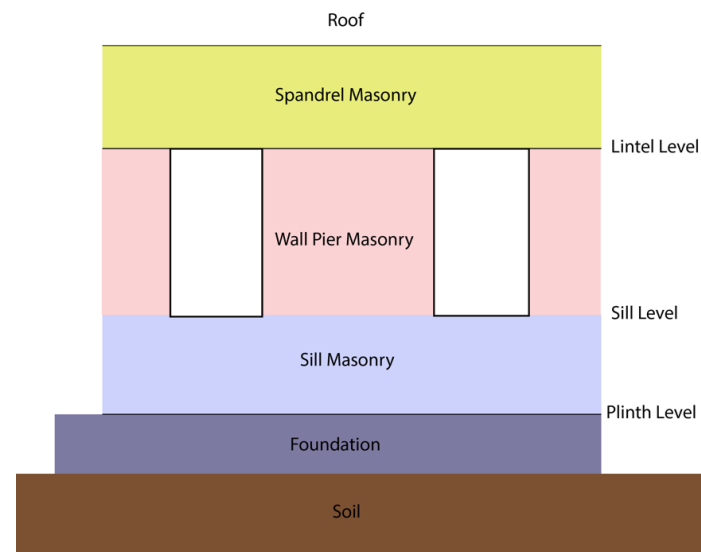
Figure 1: Example of shear walls in masonry structure (credits: U. Vong).

In general, masonry buildings are composed of load-bearing walls (Figure 1), and sometimes include partition walls in the interior. As the in-plane wall dimensions (length and height) are usually greater than the thickness, the in-plane stiffness is substantially higher than the out-of-plane stiffness (Lourenço et al. 2011).

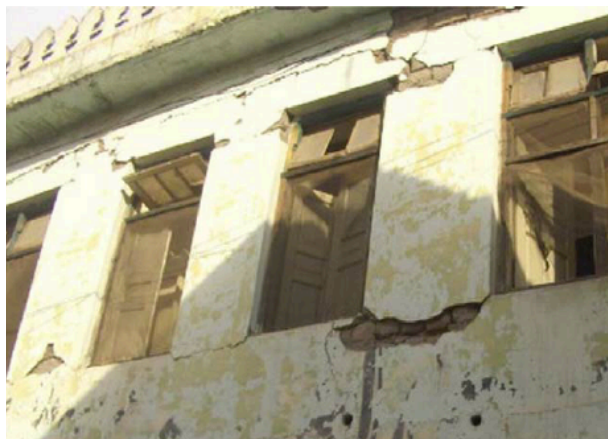
Figure 3: Rocking failure of masonry pier in 2005 Kashmir earthquake (credits: Javed, 2008).

the bed joints. Sliding occur at different levels, such as at the connection of the piers to the spandrels (Figure 3). The predominance of different crack and failure modes depends on several factors: the magnitude of the earthquake - induced inertia force; the building weight (the vertical load); the area of opening; and the framing type, namely at the level of the height to length ratio of the piers. Nonetheless, the most common failure mechanism for masonry buildings is diagonal cracking associated. When the principal tensile stresses resulted by the combination of vertical and horizontal forces exceed the tensile strength of masonry, diagonal cracks are propagated along the bed and head joints, or through the units depending on the strength of the mortar, units and the unit-mortar interface. As the toes of the wall piers are usually subjected to high compressive stresses, compressive failure (which is known as crushing) occurs when the principal compressive stress exceeds the compression strength of masonry. Toe crushing is often appeared in combination with flexural rocking or diagonal tension (Mendes & Lourenço 2013).

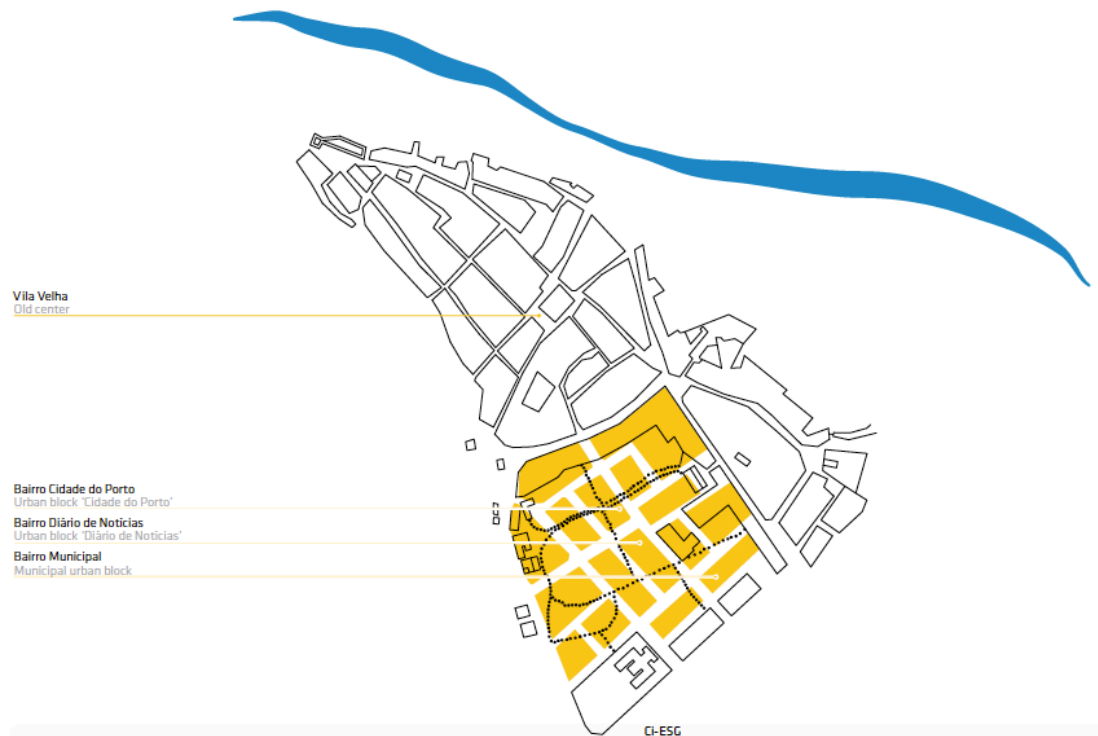
Figure 7: Benavente Plan after 1909 earthquake; new extension of city highlighted in color (credits: CI-ESG).

original urban context with an extension of new part of the city after an earthquake. This can be illustrated by the case of Benavente in Portugal. In Figure 7, the highlighted area represents the new development after the 1909 earthquake. This part as an expansion for the population affected by the earthquake adopted some strategies that can be seen in the seismic-oriented urban plan previously mentioned.

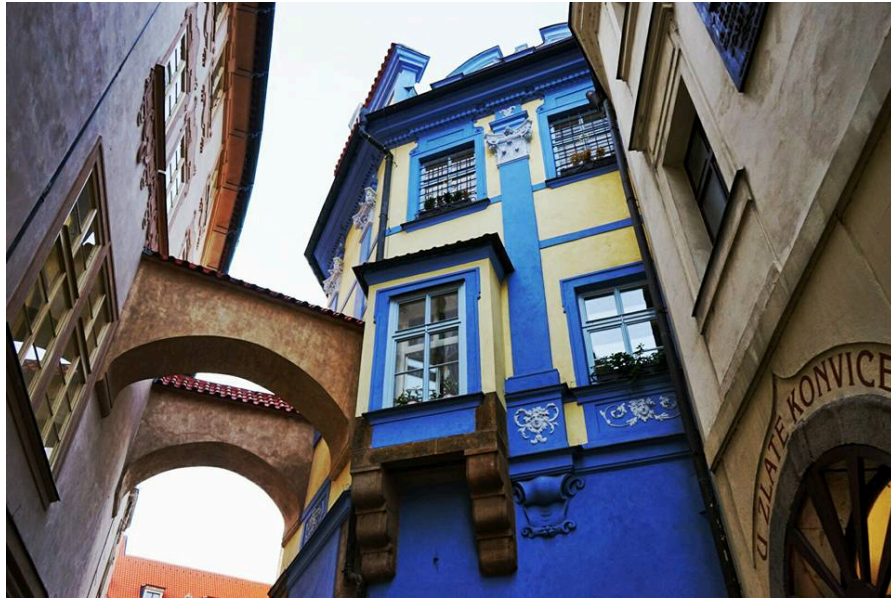
*Figure 12: Counter - arch in Prague, Czech Republic (credits: U. Vong).*

Counter – arch and continuous cornice are reactive reinforcements used for connecting adjacent and adjoining structures, respectively. Counter – arch is frequently used in historical centers between adjacent structures. This structural element was intended to block the collapse mechanisms between adjacent buildings at different heights. In the past, it was assumed to be used for consolidating already damaged structures. However, the main purpose of this structural element is to impose a collaboration between the adjacent structures, so that they behave uniformly under seismic loadings. By redistributing the horizontal forces from one building through the floor structure to the vertical walls of the adjacent building, consecutive collapse of the built structures is therefore limited. On the other hand, continuous cornice is used to tie the adjoining structures together in order to prevent separation between contiguous walls. Typically, it is made of solid brick or stone masonry, but sometimes metal straps are used to constitute this element. Metal strap cornice is often left at sight in stonework. When the structure is built with brick masonry, the metal strap cornice is usually plastered and painted. Nonetheless, both of these reinforcements can be used for preventing the hammering or pounding action from one structure to the neighbouring one.

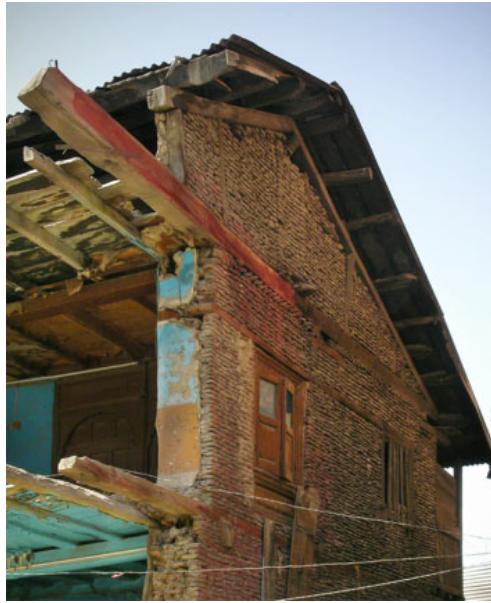
Figure 21: Taq timber - laced system, Srinagar, Kashmir, India (credits: R. Langenbach).

The term *Taq* or known as *bhatar* in Pakistan, refers to the modular layout of piers and window bays. It was used to define or describe one of the timber laced seismic – resistant systems because *taq* is the name for the building type in which the system is usually found. The *taq* construction consists of load – bearing masonry walls with horizontal timbers embedment. Similar to the hoop systems, the timber elements in *taq* are tied together like horizontal ladders at each floor and lintel level. Each of them is placed into the masonry walls and secured by the ends of floor joists that penetrate through the exterior walls. This detail confines or prevents splitting within the masonry walls, and at the same time, holding the timber elements in place. Without any vertical reinforcements, the *taq* system is able to resist to the earthquake forces. It is because of, according to Langenbach (2015), the vertical compression resulted from the overburden weight of the masonry. The lack of vertical reinforcements enhances the overburden weight of masonry to act in a vertical manner and without shifting this weight onto the columns buried in the walls (Langenbach 2015).

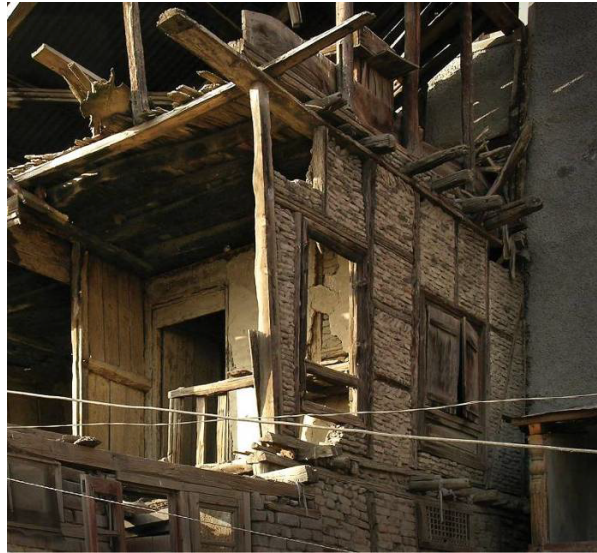
Figure 22: Building system of dhajji dweari (credits: R. Langenbach).

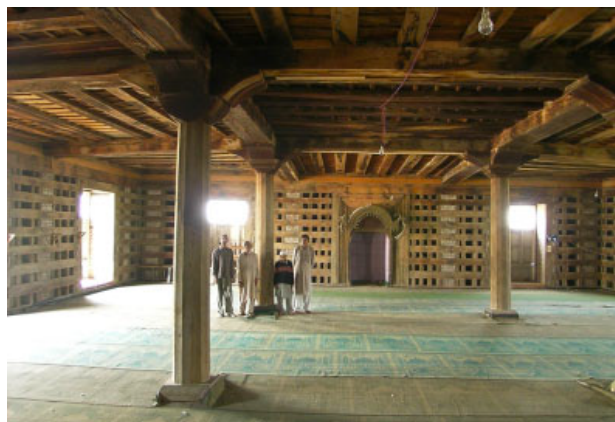
Figure 23: Cribbage construction system. The interior is clad with plywood in this photo (credits: R. Langenbach).

Another specific timber construction, *cator and cribbage*, can be found in the Himalayan mountains of northern India, northern Pakistan near the Chinese border, and parts of Afghanistan. This robust construction technique is only executed in the regions where wood supplies are abundant. It is a heavier and more timber – intensive version of *taq*, which might be an evolution of the *cator and cribbage* system due to the limited amount of wood used in the construction. Similar to the *taq* system, the timber belts (*cators*) extend across the walls. However, the corner of the walls consists of a cribbage of timber that filled with masonry. Its variations can also be seen in the Middle East, North Africa and Central Asia, Nepal, Bhutan, Tibet and other parts of China (Langenbach 2015).

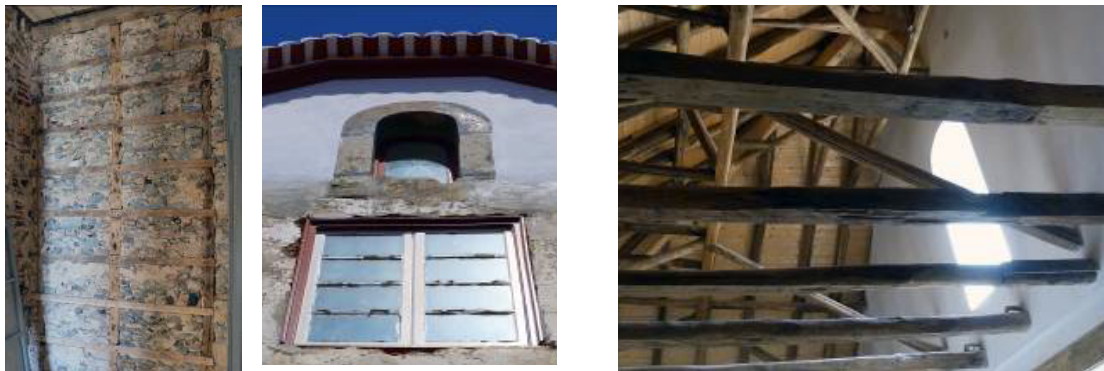
Figure 35: Current Condition. (From left to right) timber partition wall; new gable at the back of Central Building; and reconstruction of mansard roof (credits: J. Ortega).

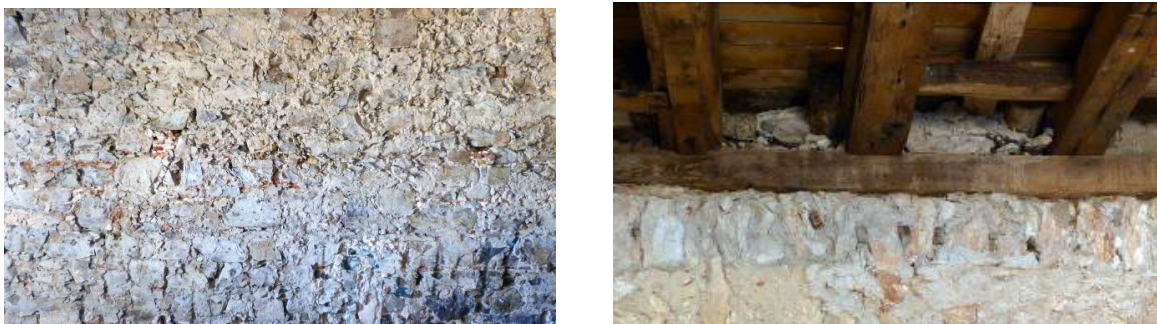
Figure 36: Current state of Central Building. (Left) Morphology of stone masonry wall; (right) timber floor beams on transversal timber plate (credits: J. Ortega).

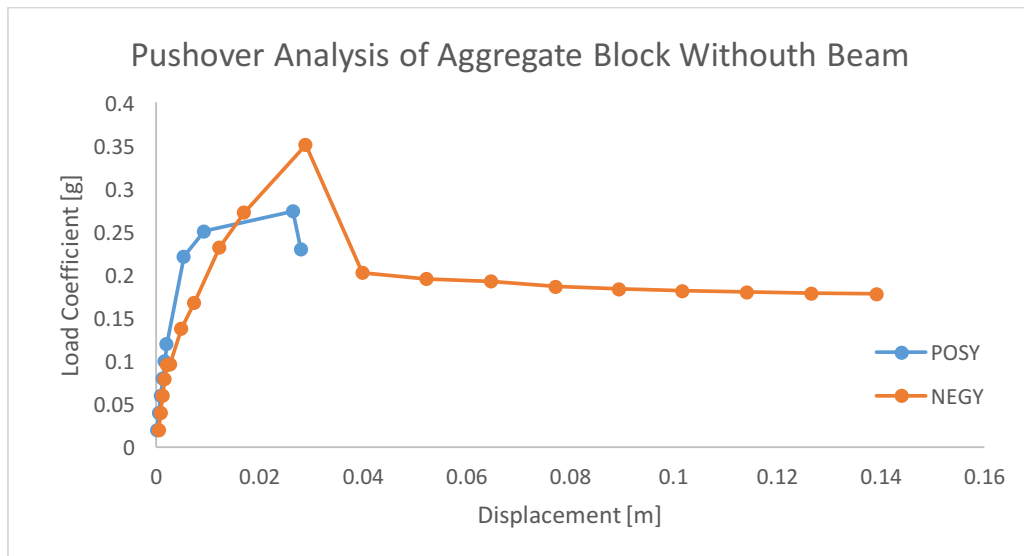
Figure 78: Capacity curve of Aggregate Block without beams in Y directions.
