FROM FRACTURE MECHANICS TO CASE STUDIES: THE ISSUE OF CULTURAL HERITAGE

P. B. Lourenço

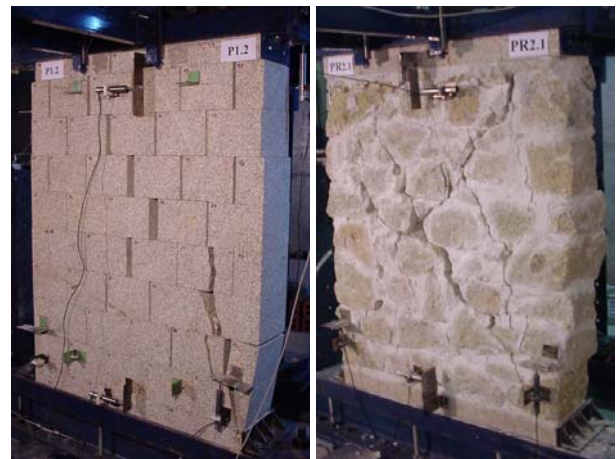
Fig. 3. Aspects of shear wall failure under cyclic loading, for regular and irregular stone masonry [6].

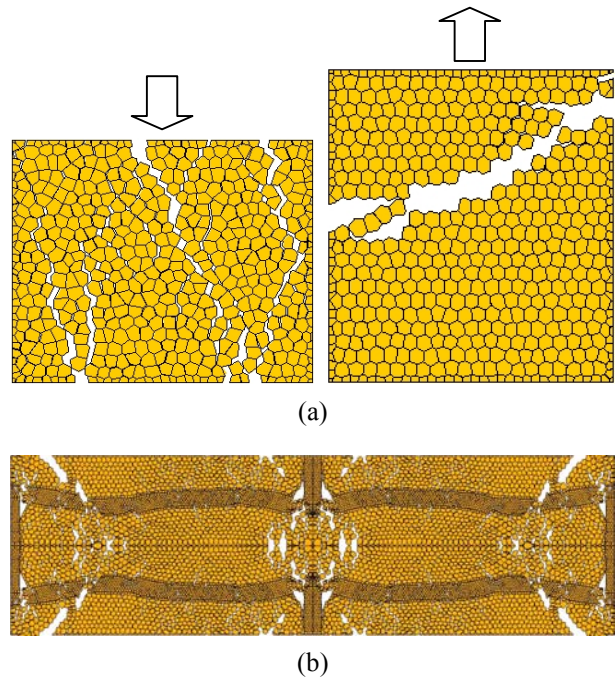
Fig. 5. Usage of a particle model to understand the mechanics of masonry under compression: (a) simulated compressive and tensile failure; (b) collapse of a masonry basic cell under vertical compression.

Recent advances include, for example: (a) an interface model for the cyclic loading of masonry structures [7]; (b) a novel solution procedure and a three-dimensional yield surface for limit analysis of blocky masonry structures [8], Fig. 4; (c) advances in the non-linear homogenization of masonry due to the incorporation of internal deformation modes [9]; (d) understanding of the mechanics of masonry under compression using meso-scale approaches [10], Fig. 5.

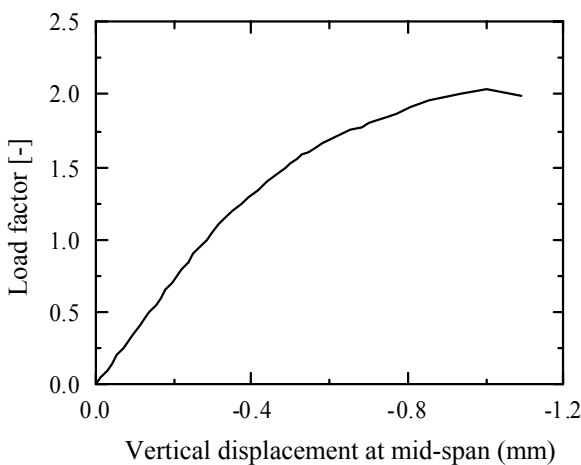
Fig. 8. Force-displacement diagram for the non-linear analysis (internal arching system ignored). Vertical displacement measured at mid-span of a side lintel.

Fig. 8 shows the force-displacement diagram for the mid-span of the side lintels, where the non-linear behavior is clearly visible. The global response is approximately linear until a load factor of 1.0. Afterwards, a progressive non-linear response dominates until collapse, followed by a descending branch (softening regime) captured only with a reduction of the applied load. Obviously, in a real physical situation a load reduction would be impossible and the chimney would just collapse in an uncontrolled manner.

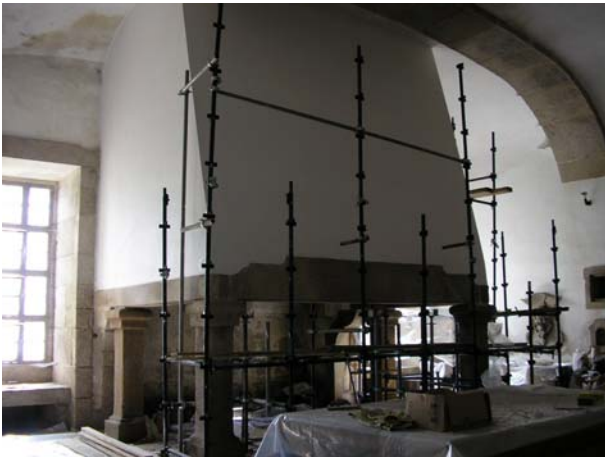
Fig. 9. Aspects of the works carried out in the chimney: (a) detail of anchoring zone; (b) conclusion of the works.

The solution for repair consists of strengthening and repairing the main lintel including: (a) reconstitution of the original stone integrity by injection of epoxy resins; (b) hole drilling of the stone along its full length (4.70 m); (c) insertion of bars and injection of the hole. Fig. 9 illustrates various details of the solution, which includes two stainless steel rods with a diameter of 25 mm as internal ties / reinforcement of the granite lintel. The ties were designed after the integration of the tensile stresses of the linear elastic results for the numerical model without arching action, which is conservative. These rods are inserted in drilled holes of 50 mm and are provided with anchoring plates of 120 mm. After adjustment of the bolts, the drilled holes are injected with fluid lime mortar (Albaria Iniezione 200). Stone stoppers at both ends of the bottom tie are also included so that the anchoring plates are not visible. The stoppers are glued with epoxy resin and are made from the actual core removed from the lintel, after cutting. For the top tie, this operation is not needed because the surface finishing is plaster. It is noted that the usage of stone stoppers in both ends of the ties requires the drilling to be executed from both sides, which requires precision and qualified workers.

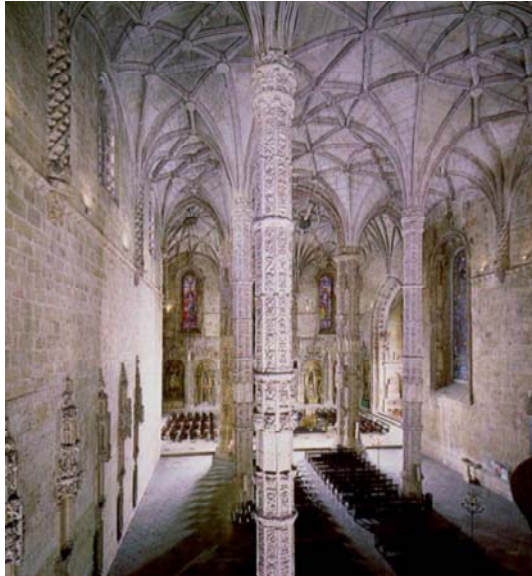
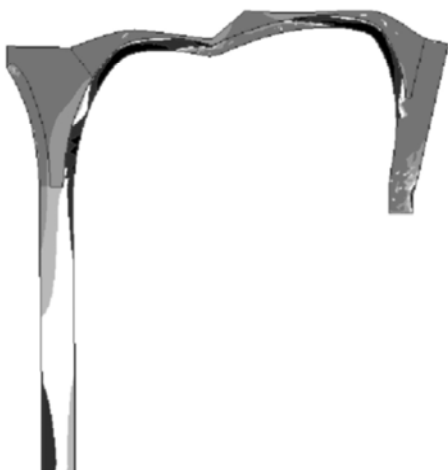
Fig. 10. Monastery of Jerónimos: (a) aspect of the nave; (b) model of the nave, with deformed mesh at collapse; (c) model of the transept, with deformed mesh at collapse and minimum principal stresses (compression). The darker color indicates higher stresses.

The church has considerable dimensions, namely a length of 70 m, a width of 40 m and a height of 24 m, see Fig. 10a. The nave is divided by two rows of columns, with a free height of around 16.0 m. Each column possesses large bases and fan capitals. The transverse sections of the octagonal columns have a radius of 1.04 m (nave) and 1.88 m (nave-transept). The columns seem to be made of a single block or two

The adopted model for the main nave includes the structural detail representative of the vault and more unfavorable, see Fig 10b. Appropriate symmetry boundary conditions have been incorporated. The model includes three-dimensional volume elements, for the ribs and columns, and curved shell elements, for the infill and stones slabs. The external (south) wall was represented by beam elements, properly tied to the volume elements. The supports are fully restrained, being rotations possible given the non-linear material behavior assumed. All elements have quadratic interpolation, resulting in a mesh with 33335 degrees of freedom. The deformed mesh at failure indicates that the structural behavior is similar to a two-dimensional frame, with a collapse mechanism of five hinges (four hinges at the top and base of the columns and one at the key of the vault).

Given the complexity of the vault and the time consumed in the model of the nave, a simplified two-dimensional model of these arches was adopted for the structural analysis. Figure 10c illustrates the conservative adopted model, which includes the arch, the infill, the nave column and the external wall, with appropriate stiffness values and boundary conditions. All elements have quadratic interpolation, resulting in a mesh with 3530 degrees of freedom. Again, the actions considered in the analysis include only the self-weight of the structure. Collapse occurs with a typical four hinges mechanism, being three hinges located in the vault and one hinge located in the right support.
