ADVANCED MASTERS IN STRUCTURAL ANALYSIS
OF MONUMENTS AND HISTORICAL CONSTRUCTIONS

Master's Thesis

Structural performance of shells of historical constructions: The Municipal Theatre of Rio de Janeiro.

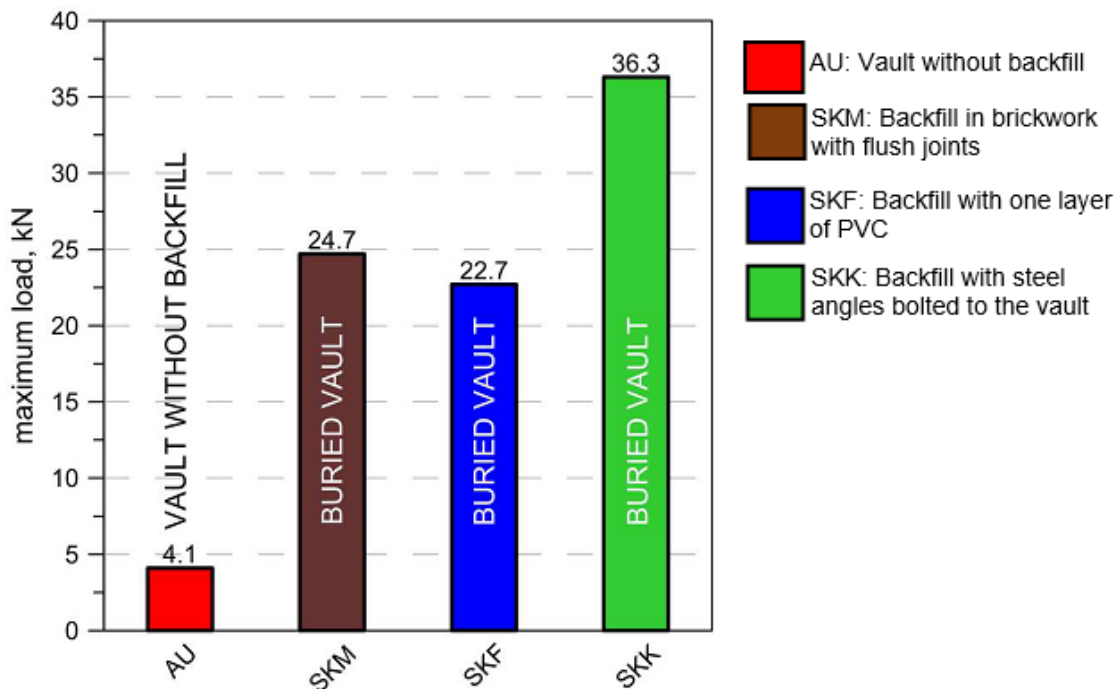
Figure 8 – Maximum capacity of non-symmetrically loaded barrel vaults with different types of filling material (Hojdis & Krajewski, 2014)

The presence of loose fill (non-structural material) or structural backing (structural material) also influences considerably the vault behaviour. Filling material increases the self-weight, creating extra compression in the vault, reducing the horizontal thrust, while the structural backing rises the range where the thrust line can pass and decrease the span, increasing the stability of the structure. These elements are especially relevant when vaults are submitted to non-symmetrical loads, leading to a high increase in the bearing capacity (Santos, 2014). However, this increment is only meaningful in cases of semi-circle cross-section. If the vaults present segmental cross section with angle smaller than 158° the presence of infill is not meaningful for the structural behaviour (Canhão, n.d.). Hojdis & Krajewski (2014) performed non-symmetrical load tests in barrel vaults with filling materials presenting different levels of lateral constraints and the results are presented in Figure 8.

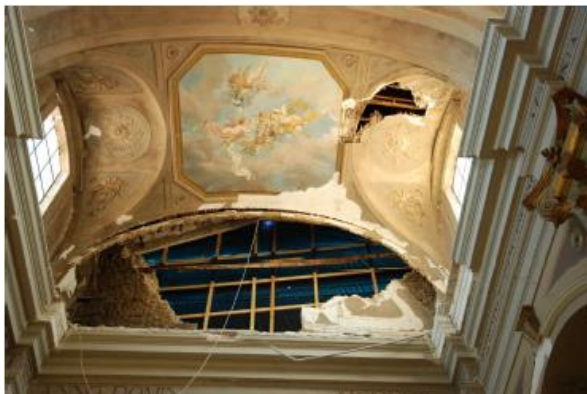
Figure 18 – Partial collapse of the barrel vault in Saint Biaggio Church from L'Aquila earthquake (Binda et al., 2010)

Examples of damages caused by earthquakes in vaults are presented by Binda, Chesi, & Parisi (2010), based on the survey of damages carried out after L'Aquila earthquake in Italy in 2009 at the Saint Biaggio Church. Two main types of damage were observed, namely the partial collapse of a barrel vault due to debris failure (Figure 18) and the parallel circular cracks close to the base of spherical vaults in the lateral naves, that are connected to the cracking over the arches between chapels (Figure 19).

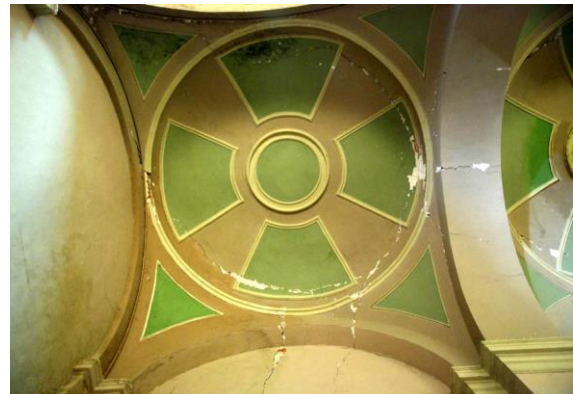
Figure 19 – Circular cracks in spherical vaults of lateral naves in Saint Biaggio Church from L'Aquila earthquake (Binda et al., 2010)

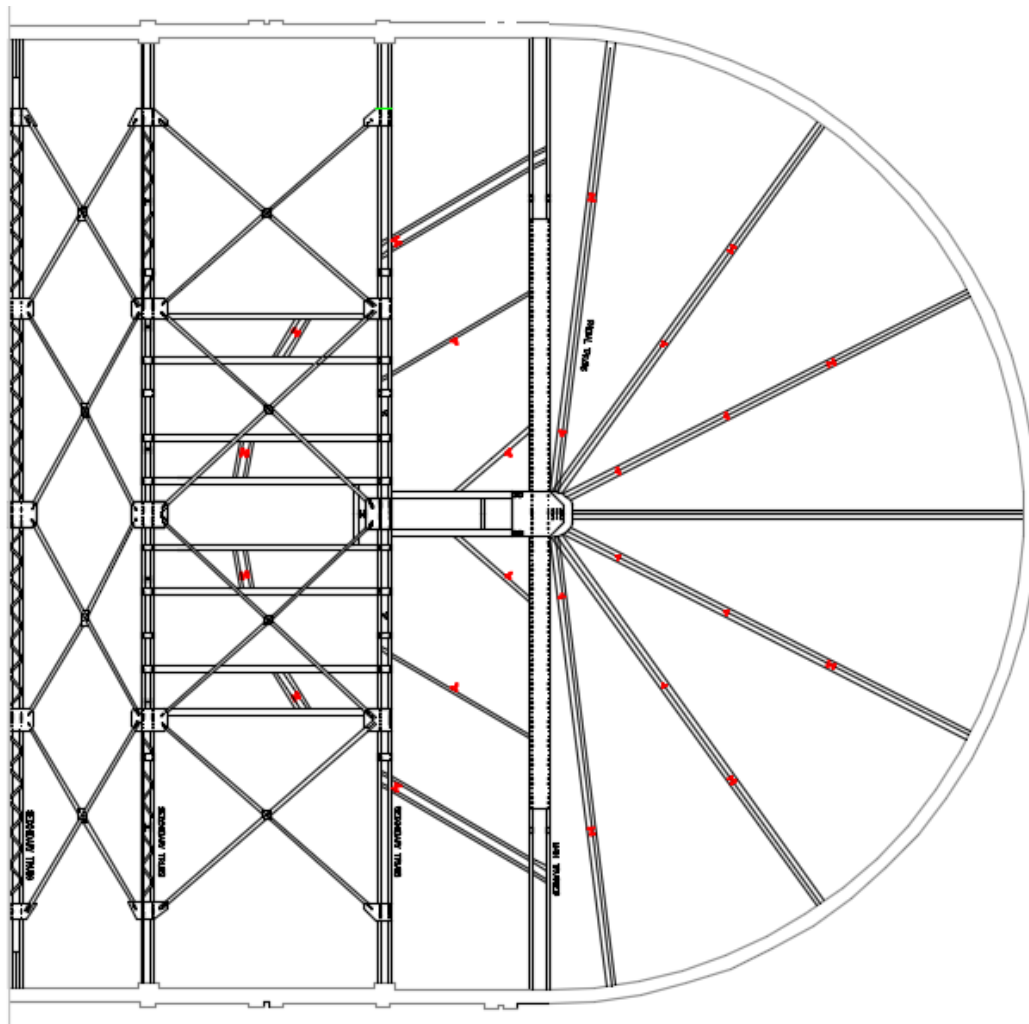
Figure 45 – Position of the ties that support the main internal vault (Adapted from Cerne Engenharia e Projetos, 2006a)

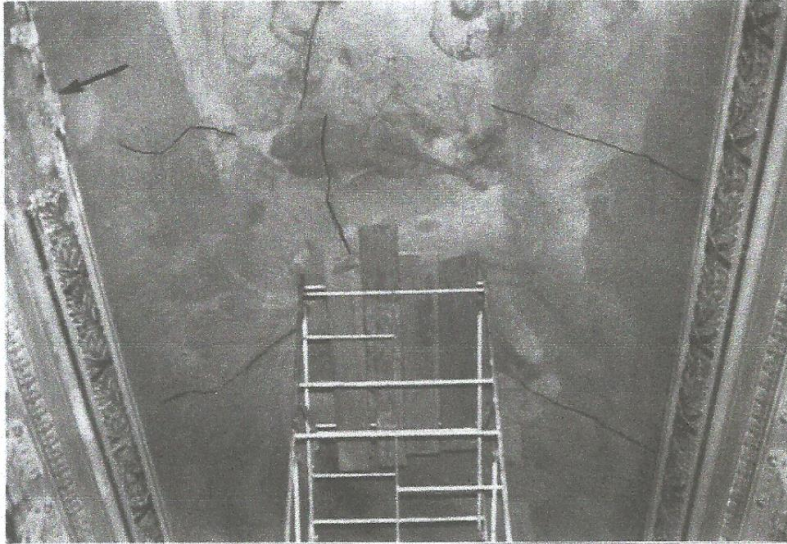
Figure 50 – Cracks in the vault over the *foyer* (Schiros, 1975)

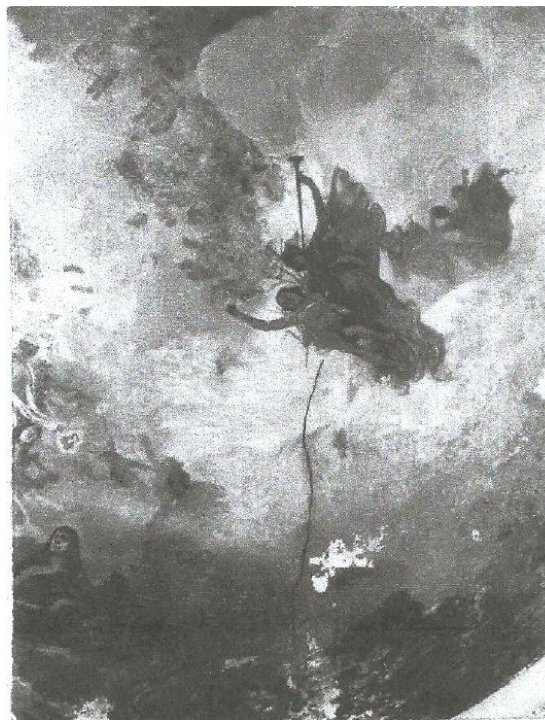
Figure 51 – Cracks in the lateral dome (Schiros, 1975)

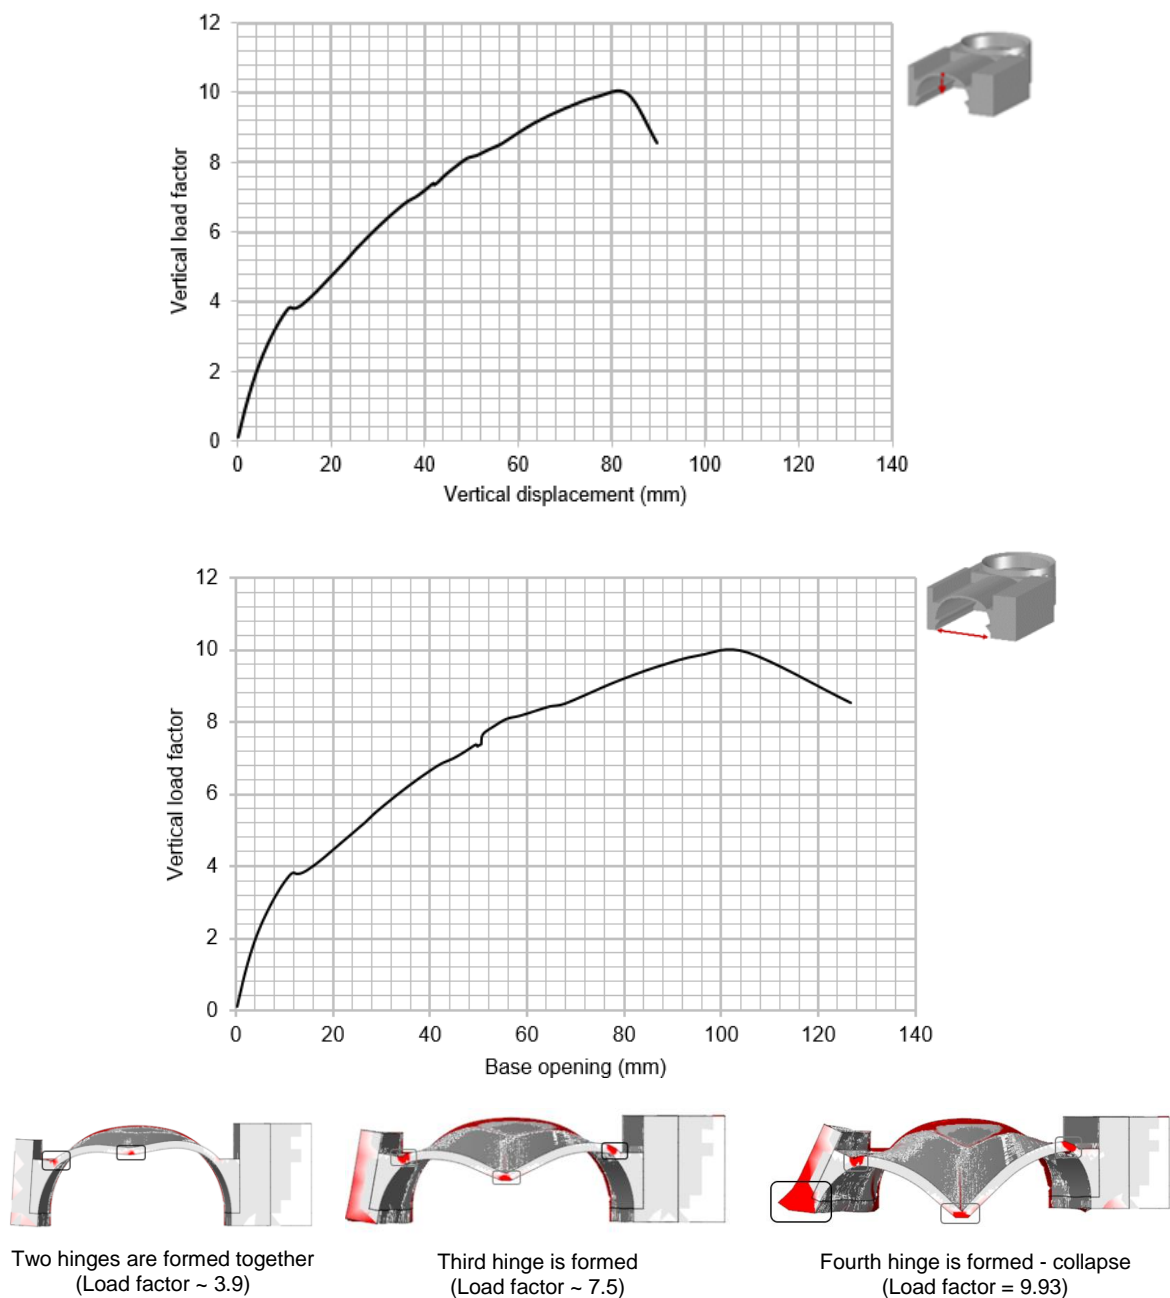
Figure 105 – Capacity curve of the barrel vault (damage represented in red)
