Verbist, M., Branco, J.M., Poletti, E., Descamps, T., Lourenço, P.B. (2018, accepted manuscript). Experimentations on the retrofitting of damaged Single Step Joints with Self-Tapping Screws. *Materials and Structures*. (doi.org/10.1617/s11527-018-1234-8)

Experimentations on the retrofitting of damaged Single Step Joints with Self-Tapping Screws

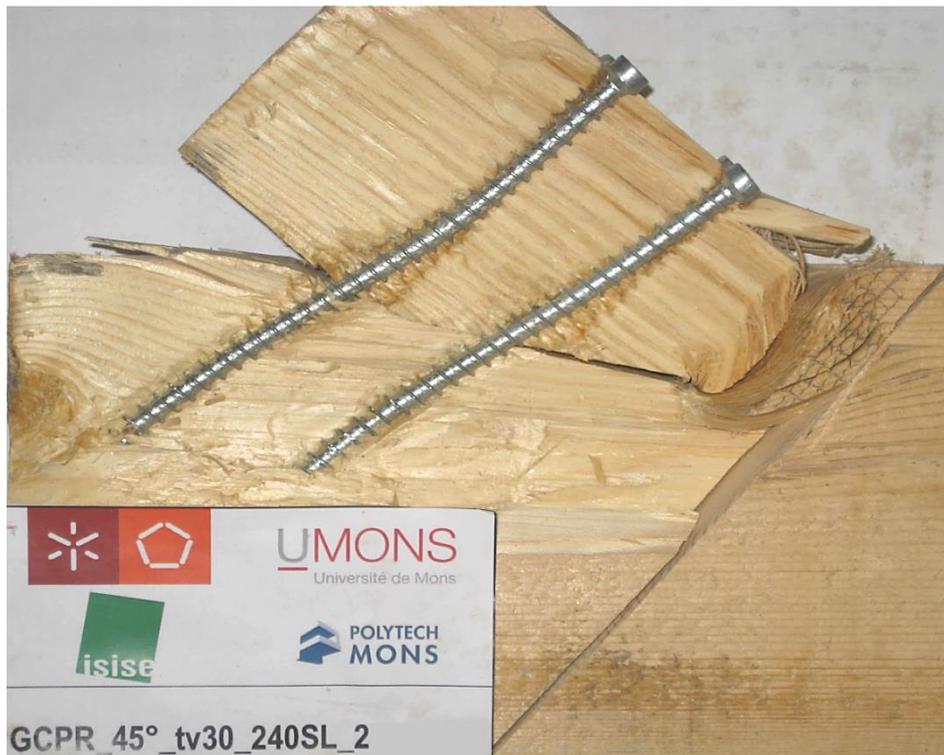
Fig. 9 Double plastic hinges of FTS implemented in the rafter at the bottom-notch surface.

Regarding the SSJ specimens retrofitted according to the first strategy (R1), the single and double plastic hinges of Fully Threaded Screws (FTS) implemented in the rafter have been observed, as illustrated in Figure 9 and Table 5. Since the stiffness of the front-notch surface is higher than that from the bottom-notch connection retrofitted with FTS, the maximal

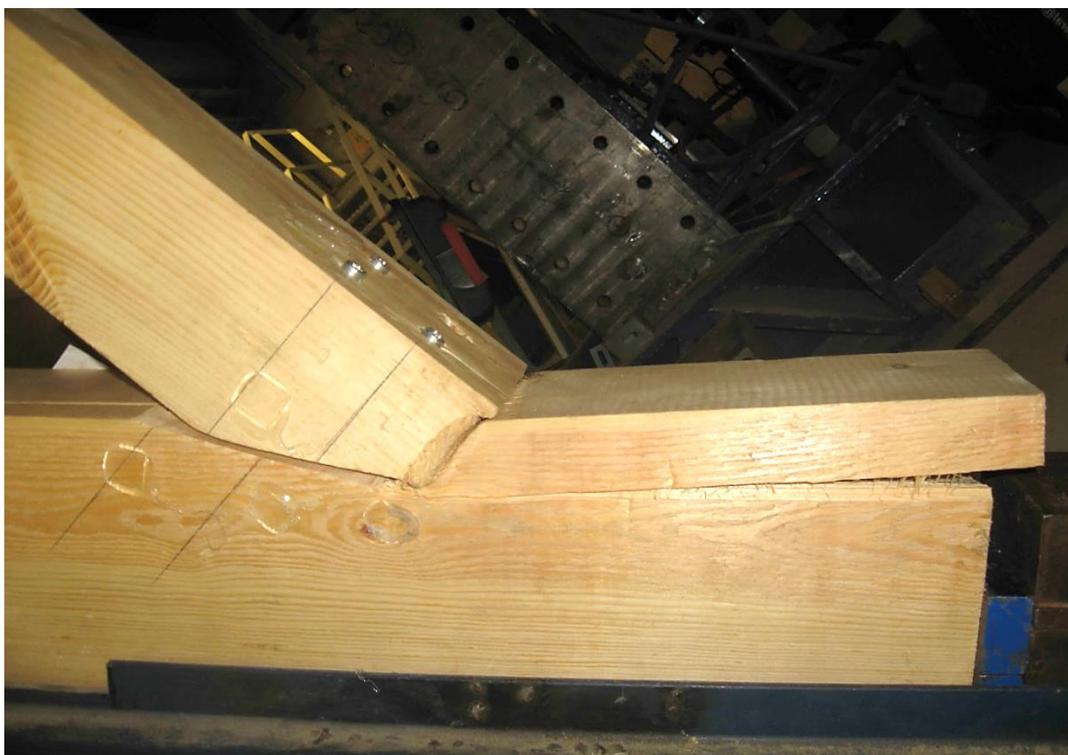
Fig. 10 Shear crack at the heel depth along the grain in the tie beam.

compressive strength of the former or the maximal shear strength in the tie beam can be reached before the maximal load-bearing capacity $R_{V,bott}$ does (Figure 3). Therefore, the plastic hinges of FTS may be not fully achieved after ending the monotonic compression tests. Another explanation may come from the late appearance of shear row splitting in the rafter, which slows down the yielding of FTS. Although it causes minor damage in the rafter, the shear row splitting should nevertheless be prevented or delayed as much as possible in order to avoid any reduction of the ultimate force in the rafter and provide better the ductile force-displacement response. In addition to the crushing at the front-notch surface, the shear crack may emerge in the tie beam as the final failure mode in the retrofitted SSJ specimens, causing the drop of the normal load in the rafter after reaching the ultimate force. In fact, the shear crack may occur for the SSJ specimens if the tie beam has not been retrofitted with Partly Threaded Screws (PTS) beforehand as shown in Figure 10.

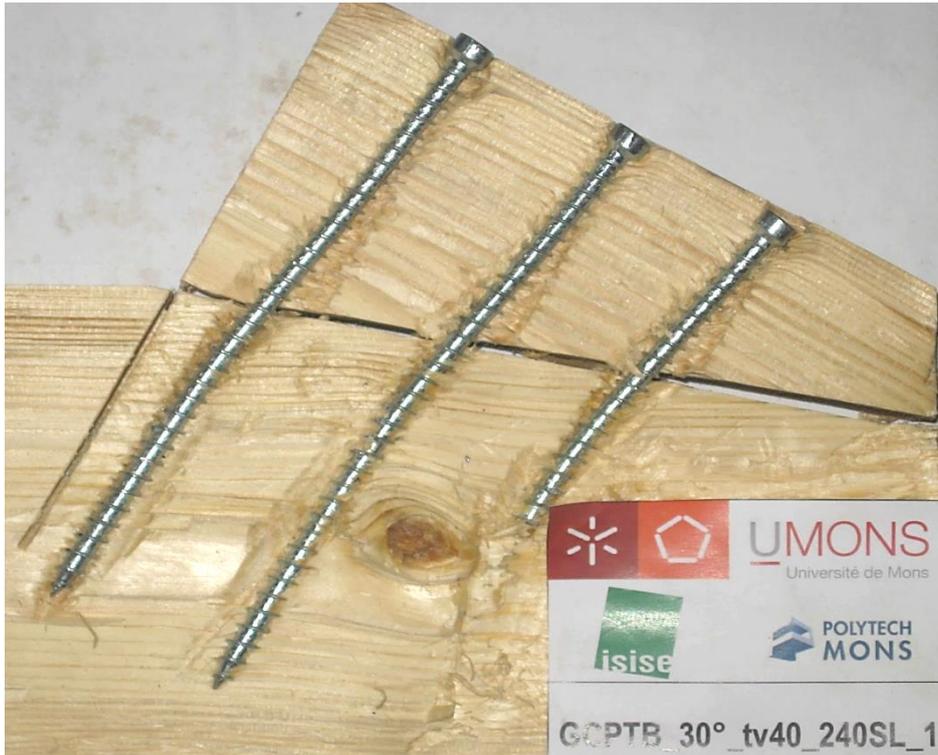
Fig. 11 Plastic hinges of FTS implemented in the rafter at the bottom-notch surface.

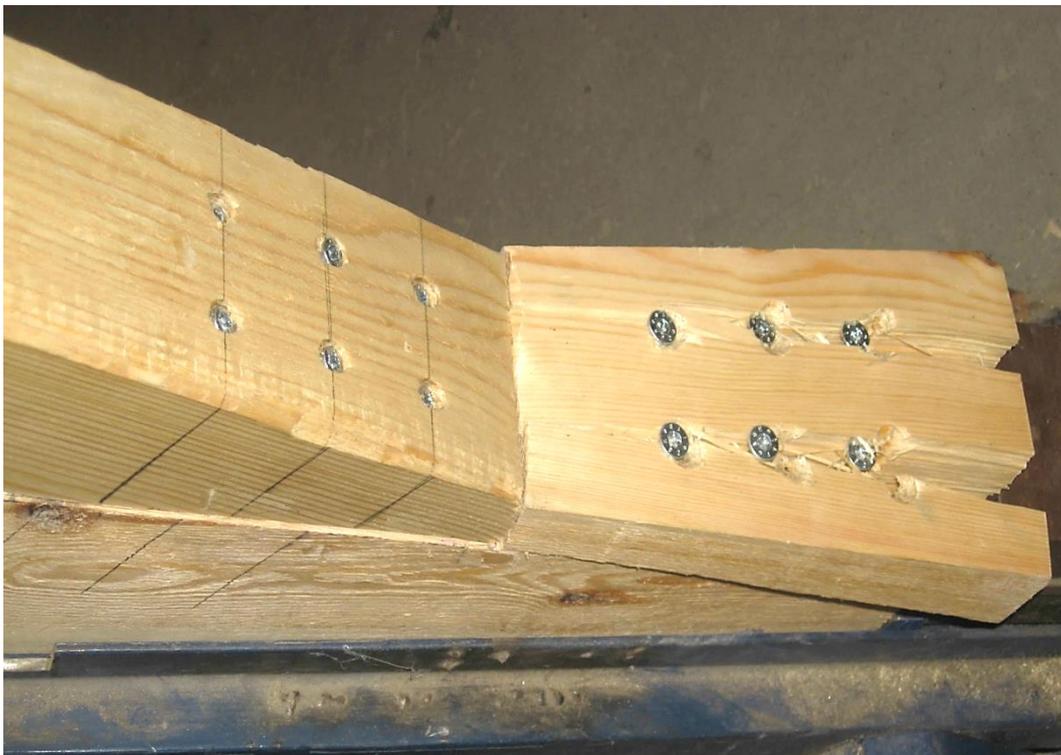
Fig. 12 Shear row splitting in the upper part of the tie beam retrofitted with PTS.
