Universidade do Minho
Escola de Engenharia

The rural vernacular construction of the
Entre-Douro-e-Minho

Tese de Doutoramento
Engenharia Civil

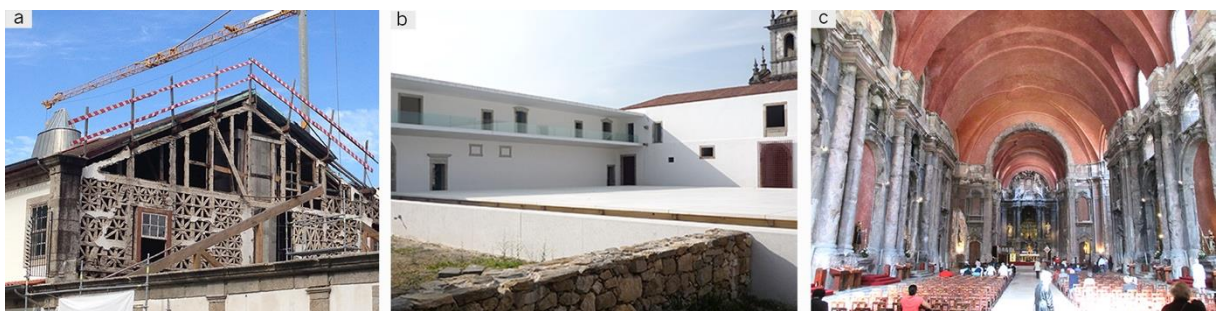
Fig. 2.6 – Examples of different rehabilitation operations: a – adaptation and upgrade of an heritage building (Guimarães, Portugal); b – introduction of a new use and new elements into a ruin area of the Tibães Monastery (Braga, Portugal); c – rehabilitation and reconstruction of the St. Domingos church, keeping the memory of the fire that ruined it (Lisbon, Portugal).

Based on Petzet et al. [47] description regarding different types of preservation actions, rehabilitation interventions are described as able to reach a compromise between the spirit of The Venice Charter [26], and the typically adaptations and upgrades required to make vernacular heritage buildings able to sustain contemporary life standards. Therefore, such type of interventions can reach high levels of intrusion, due to typical upgrades such as replacing vernacular kitchens and bathrooms (if existent) by contemporary ones, the installation of infrastructures (e.g. electricity, water, or gas supply) or the improvement of buildings internal environmental conditions (e.g. adding heating systems, changing frames, or adding thermic insulation). In this sense, risks, and the need for suitable methodologies to implement such deep changes, without compromising cultural value and authenticity are high. Examples of several types of rehabilitation interventions are shown in Fig. 2.6.

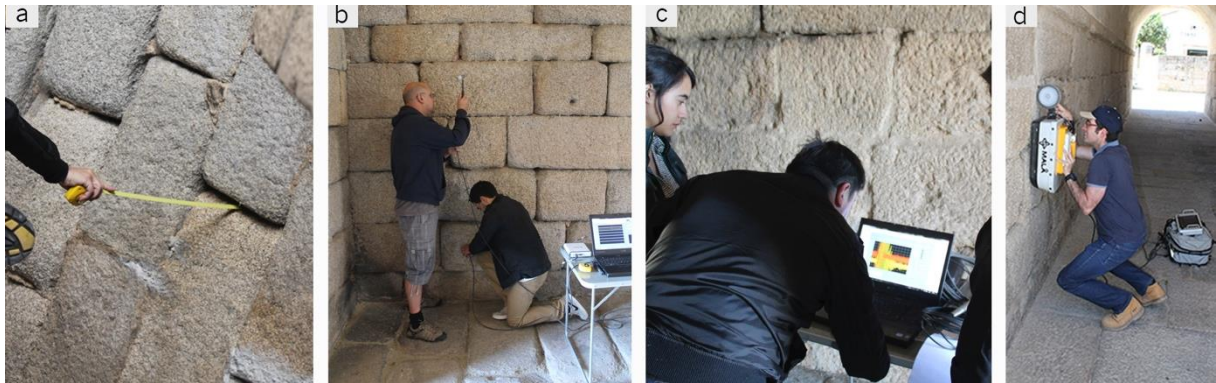
Fig. 2.8 – Examples of different on-site structures analysis techniques, applied to heritage buildings (Almeida city wall, Portugal): a – visual inspection of damage; b and c – dynamic identification through sonic testing; d – inspection by geo-radar [50].

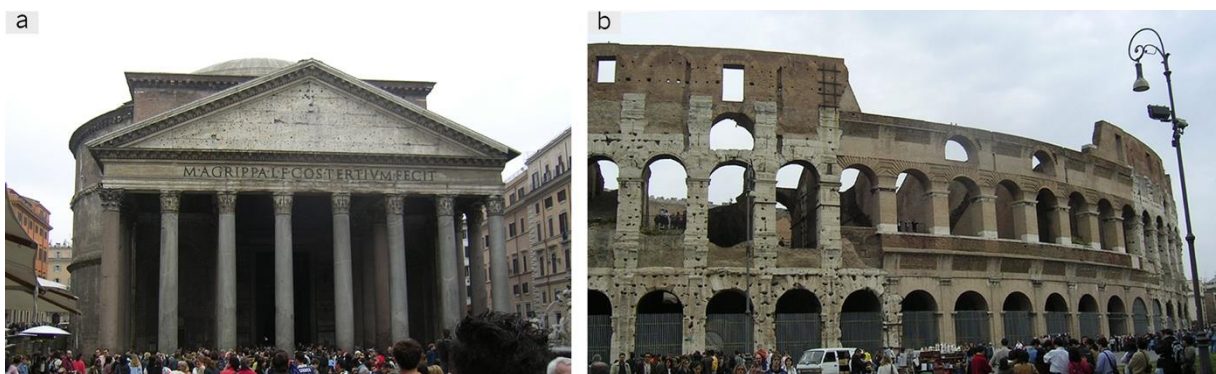
Fig. 2.9 – Monumental heritage preservation examples: a – preservation of the historical damage in the Pantheon (Rome, Italy); b – stabilization and reconstruction intervention using new but clearly distinguishable materials in the Colosseum (Rome, Italy).

- iv) The principle of heritage truthfulness by clearly distinguishing new from original, although not compromising heritage cultural values, see Fig. 2.9b;

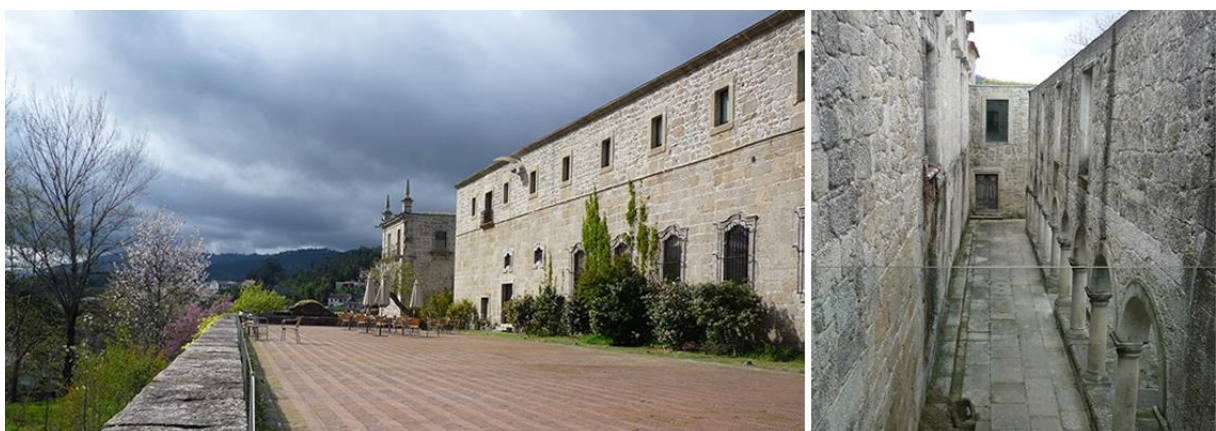
Fig. 2.10 – Transformation of the St. Mary of Bouro monastery into an hotel, by rehabilitating and modernizing specific areas of the building, and keeping others as stabilized ruins not to alter the present aesthetics (Terras de Bouro, Portugal).

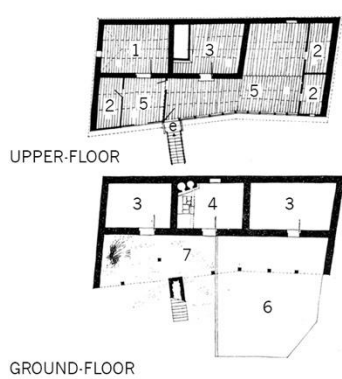
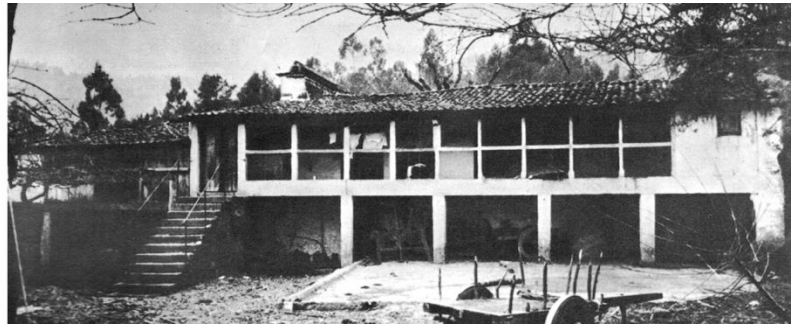
Fig. 5.4 – Literature example of a “casa sequeiro” (Carapeços, Barcelos) [27].

1 - common areas/living room; 2 - private areas/ bedrooms; 3 - agrarian compartments; 4 - kitchen; 5 - dry house/balcony; 6 - threshing floor; 7- porch; e - access

dwelling/dry granary type of building. Designated by the author as “*casa sequeiro*” (dry granary house), see Fig. 5.4, it was the outcome of the transformation of porches and large-size balconies into fully operational dry granaries and grain storage area. In this type of building, that in some cases replaced the individual large-size dry granary building, both agrarian area and domestic space kept a close dynamic by sharing the same external covered space.

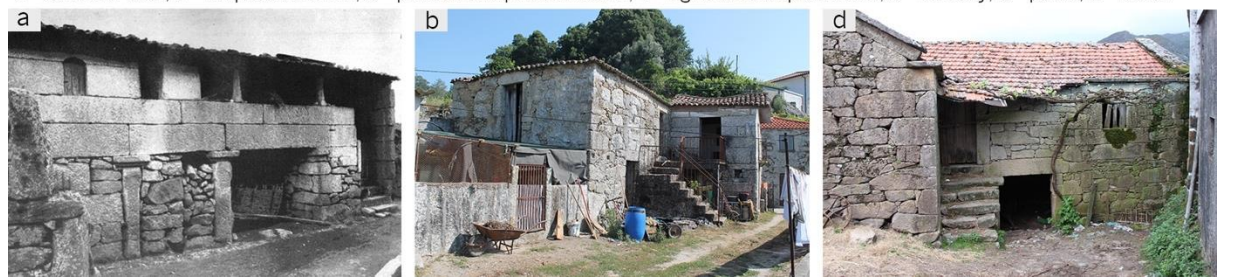
Fig. 5.5 – Examples from highland two-storey simplified houses: (a) Soajo, Arcos de Valdevez [27]; (b) Vale, Arcos de Valdevez (drawing by the author); (c) Vale, Arcos de Valdevez (drawing by Francisco C. Barros); (d) Padrão, Arcos de Valdevez [102].

As said, although existing in the entire region [14,27,57], two-storeys smaller rural houses morphologies were observed in the highland but seemed not a common solution in the lowland, see Fig. 5.3. However, during the exploratory visits at the highlands, the identification of examples of one-storey smaller houses was not frequent, therefore seeming that such typology was either not a common solution, or its examples were over time transformed into agrarian buildings.

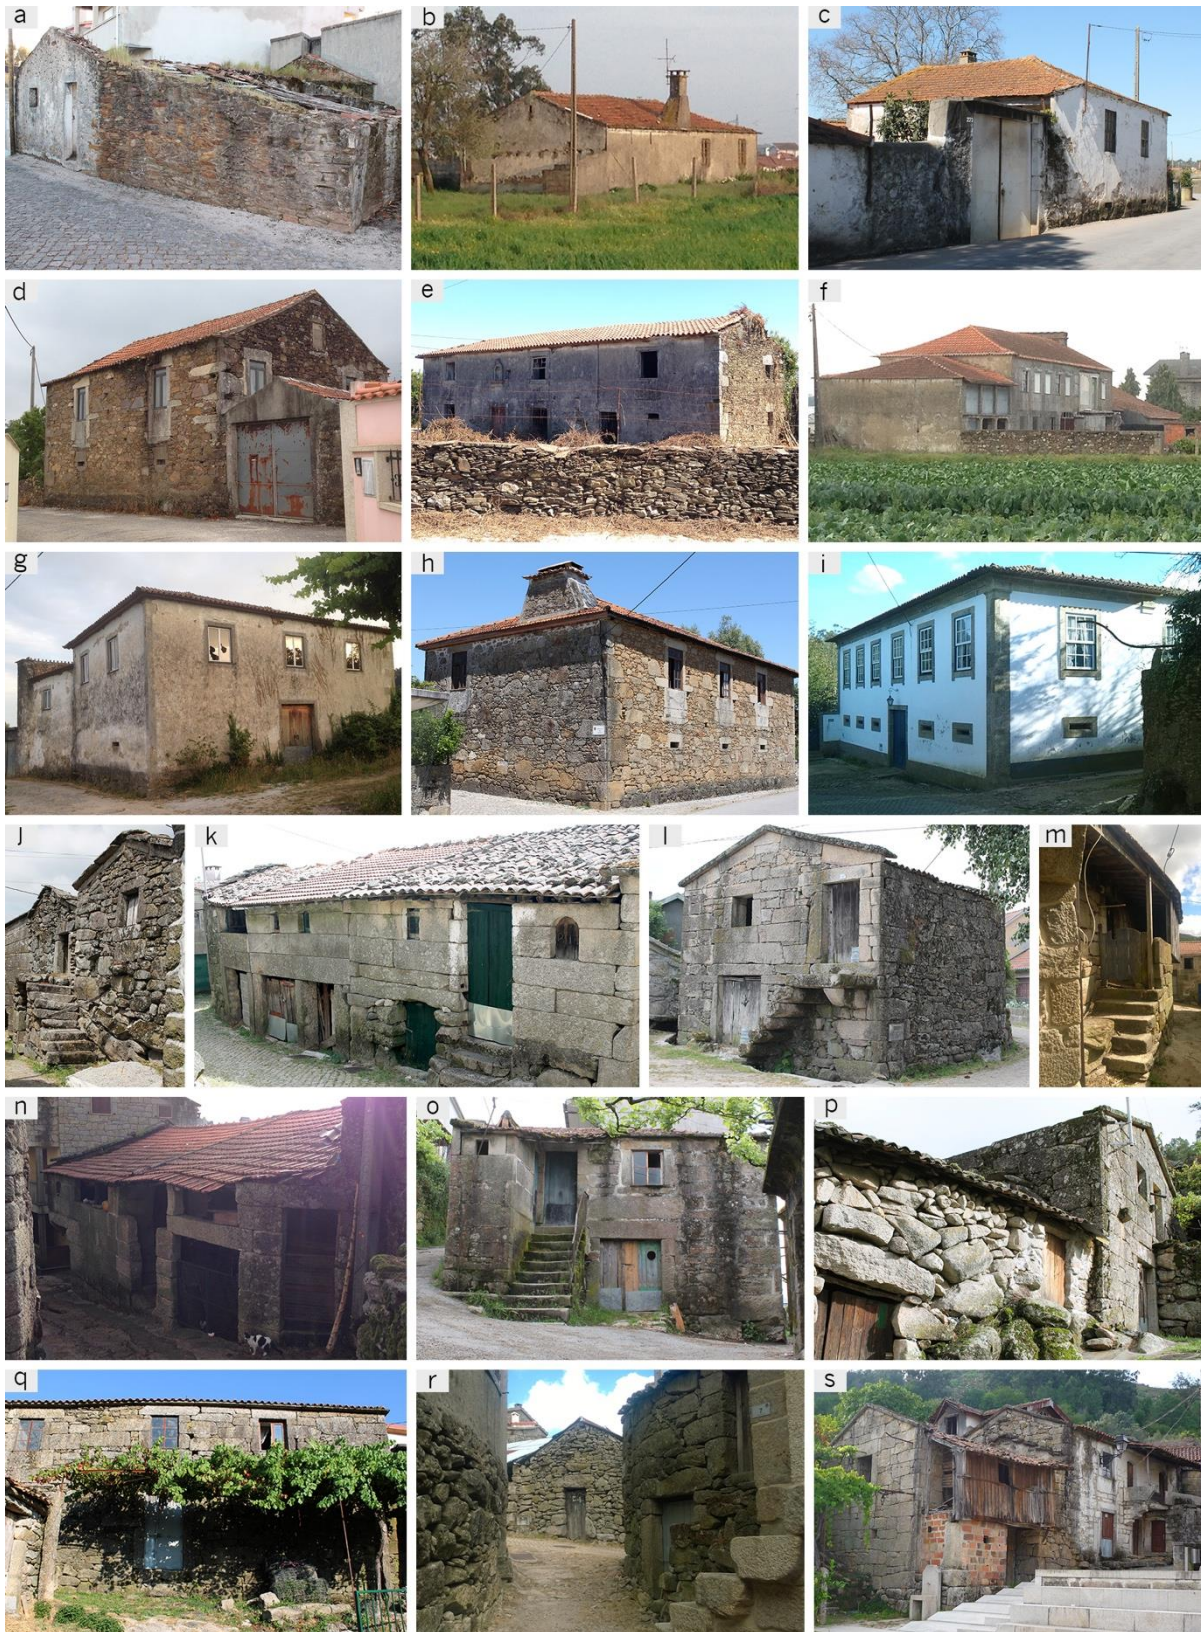
Fig. 5.7 – Examples of lowland small houses: a and (b) basic and simplified (Barqueiros, Barcelos); (c) composed (Balazar, Póvoa de Varzim). Examples of lowland large houses: (d) Vilar de Figos, Barcelos; (e) Fonte Boa, Esposende; (f) Apúlia Esposende; (g) Tamel de S. Pedro Fins, Barcelos; (h) Areias de Vilar, Barcelos; (i) Cristelo, Barcelos. Examples of highland small houses: j, l, and r – Ermida, Ponte da Barca; p – Lindoso, Ponte da Barca. Examples of highland large houses: k and m – Ermida, Ponte da Barca, n – Gavieira, Arcos de Valdevez; o – Padrão, Arcos de Valdevez; q – Cabreiro, Arcos de Valdevez; s – Ermelo, Ponte da Barca.

From the organizational and morphological points of view, Oliveira et al. [14] established two main groups of rural houses: *i)* the rural houses of horizontal organization, or one-storey houses, known as *“casas térreas”* (ground-floor houses), in which all dwelling and agrarian compartments were organized at ground-level; and *ii)* the rural house of vertical organization, or two-storeys houses named by the author as *“casas bloco”* (container houses), in which the dwelling areas are moved to the upper-floor, therefore overlapping the agrarian compartments. Examples of layouts of rural houses from the first group are presented ahead in Fig. 5.2., whereas examples from the second group are presented for lowland houses in Fig. 5.3, and for the highland in Fig. 5.5 and Fig. 5.6. Images of examples of rural houses observed during the exploratory visits are presented ahead in Fig. 5.7.

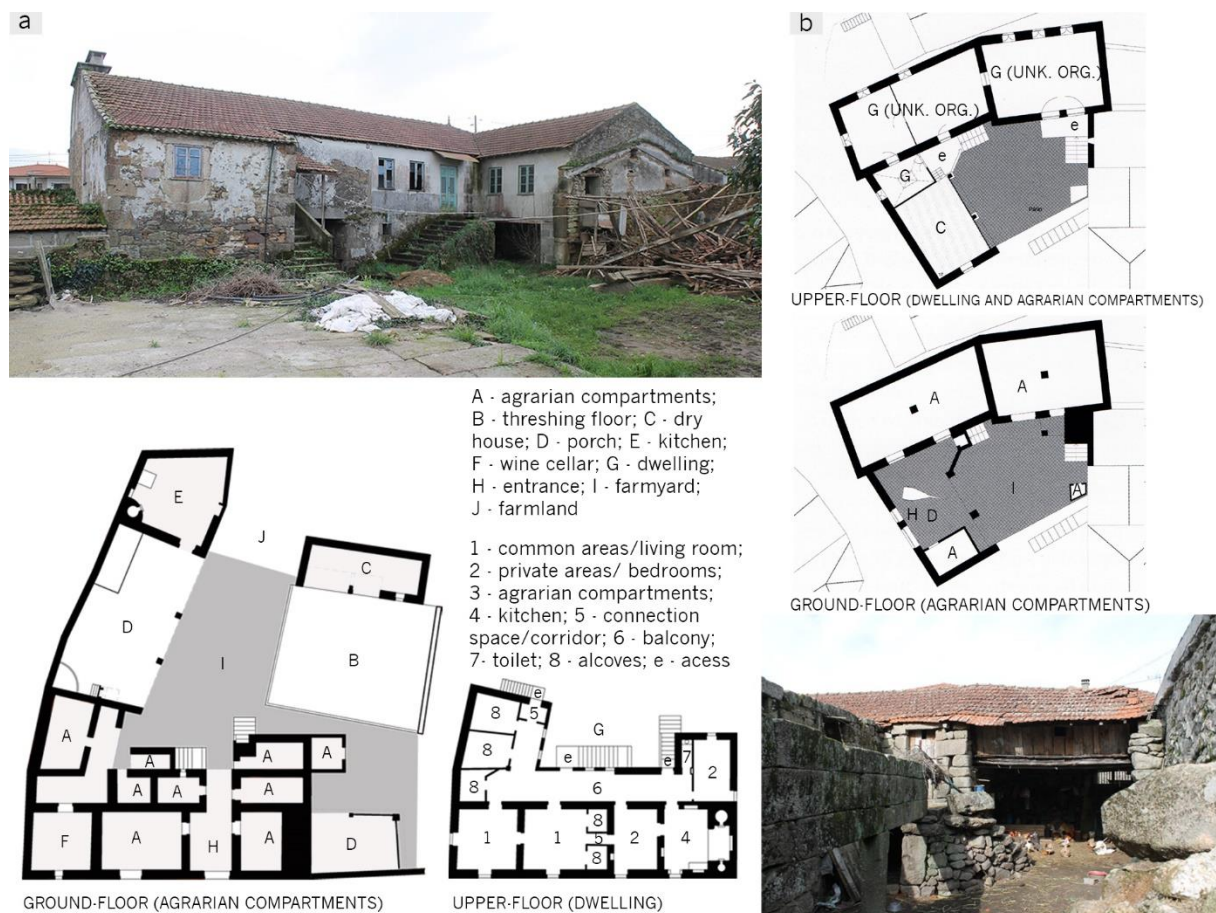
Fig. 5.8 – Examples of farmhouses: (a) lowland large farmhouse with a complex dwelling (Fonte Boa, Esposende) (drawing and image from the author); (b) highland farmhouse with a full organized dwelling [139] (image from a similar farmhouse).

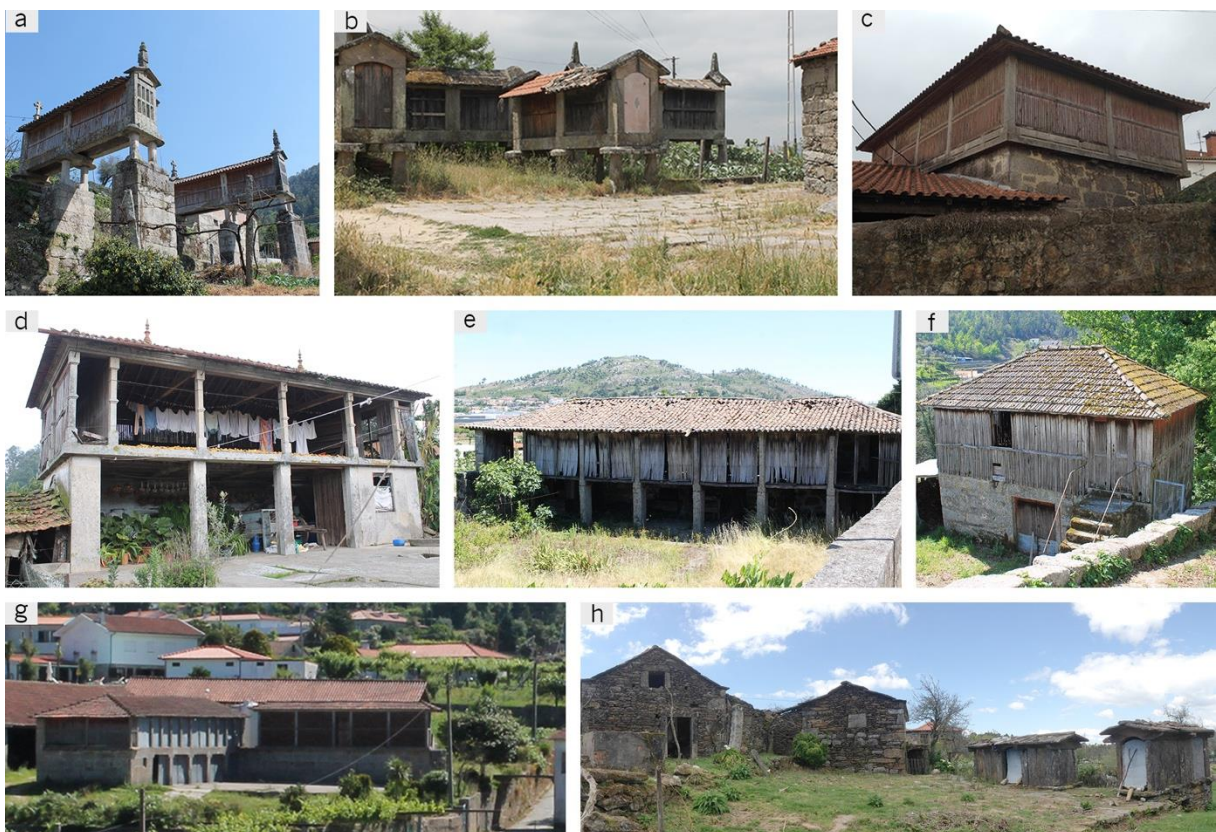
Fig. 5.9 - Examples of grain production infrastructures seen during the exploratory visits: (a) two “*espigueiros*” placed over the road and facing a threshing floor (Paço Vedro de Magalhães, Ponte da Barca); (b) group of “*espigueiros*” placed around a common highland threshing floor (Ermida, Ponte da Barca); (c) “*sequeiro*” (Vilar de Figos, Barcelos); (d) “*sequeiro*”, with built in “*espigueiros*” on both sides, and threshing floor located outside the farmstead (Paradela, Barcelos); (e) large-size “*sequeiro*” and threshing floor (Sequeira, Braga); (f) isolated “*sequeiro*” with threshing floor (Vila Nova de Muía, Ponte da Barca); (g) isolated grain production compound formed by a large a “*sequeiro*” with built in lateral “*espigueiros*”, a large-size “*espigueiro*” and threshing floor (Rio Covo de Santa Eulália, Barcelos); (h) group formed by threshing floor, threshing floor house and “*espigueiros*” (Arga de Cima, Caminha).

- iii) A two or three-storeys large-size drying granary, called “*varandões*” or “*sequeiros*” (resembling a *linhay*), also built adjacent and fully opened with lifting doors to the threshing floor and to the farmstead, see Fig. 5.9c to g. Examples could vary from models with just ventilation openings in the remaining walls, see Fig. 5.9d,e and g, or with the remaining facades fully opened and protected with vertical timber slats, see Fig. 5.9c and f. The ground-floor had a similar use as the threshing floor shed, being the upper-floor used to store and dry grain. More elaborated examples had small granaries (“*espigueiros*”) built into them, see Fig. 5.9d and g. Access to the upper-floor were either through an internal timber stair or a lateral masonry one. Due to lower productions, large-size drying granaries were not common in the highland;

- iv) Small individual granaries, named “*espigueiros*”, were individual grain drying and storage units, placed elevated from the ground over pillars with a capital to protect grain from rodents. These could vary from much elaborated ones with high construction quality, see Fig. 5.9a to g, to more harsh aspect ones with lower construction quality examples, see Fig. 5.9b and h.

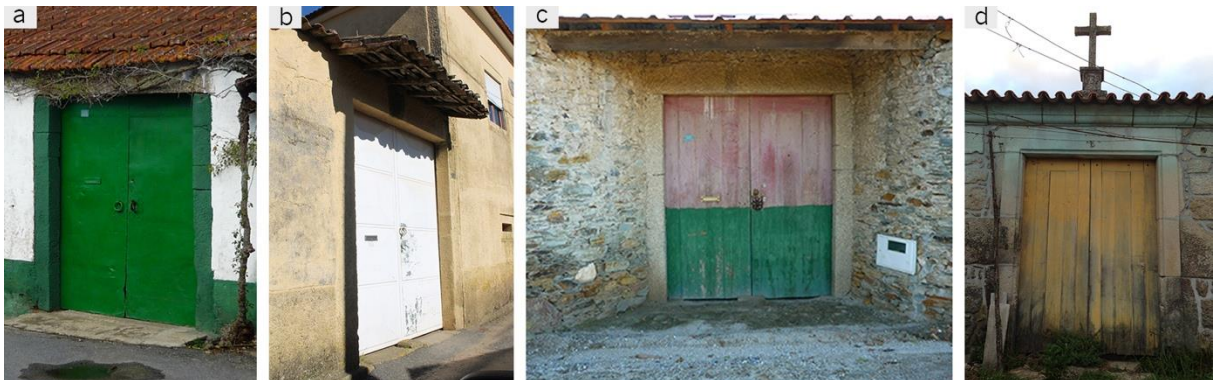
Fig. 5.10 – Images of typical Entre-Douro-e-Minho oxcart portals seen during the exploratory visits: (a) common portal (Barqueiros, Barcelos); (b) portal with porch (Balazar, Póvoa de Varzim); (c) recessed portal with porch (Barqueiros, Barcelos); (d) high status portal (Durrães, Barcelos).

According to Oliveira et al. [14], the large farmstead oxcart portal, or “*porta carral*”, was one of northwestern farmhouses’ main identity elements. It was the main, and in most cases, the only entrance to the farmstead. Regarding its location, according to the author, it could be placed: *i*) in the dwelling buildings under the dwelling, taking to an internal corridor (at least of 2 m of width) giving access to adjacent compartments and to the farmyard; or *ii*) placed under an internal porch, creating a covered entry area inside the farmstead. Gates simply placed into the farmstead external masonry walls without any internal covered area were not very frequent solutions. Solutions combining the oxcart gate and a lateral door (e.g. Agra mountain range) were also not common. Examples observed during the exploratory visits are presented in Fig. 5.10. According to Oliveira et al. [14], the basic geometric configuration of the “*minhoto*” oxcart gate was of rectangular proportion or with a top arch lintel. Regarding its different typologies, the author reported the following [14]: *i*) simple gates without any kind of external covered area, see Fig. 5.10a; *ii*) gates protected by a small external cantilever porch or by the extension outwards of the roof of the internal porch, see Fig. 5.10b; *iii*) recessed gates, creating a covered area under the dwelling or under the internal porch, see Fig. 5.10c; or *iv*) gates misaligned with the facade, thus gaining an external area covered by the roof of the porch. Elaborated gates were common on higher status farmhouses, see Fig. 5.10d, whereas non-conventional or monumental gates, were typical in estates belonging to religious orders or in “*solares*”, normally showing the family’s coat of arms [27]. In later 19th century “*bourgeois*” and “*brazilian*” farmhouses, monumental and highly elaborated gates became common, as proof of status.

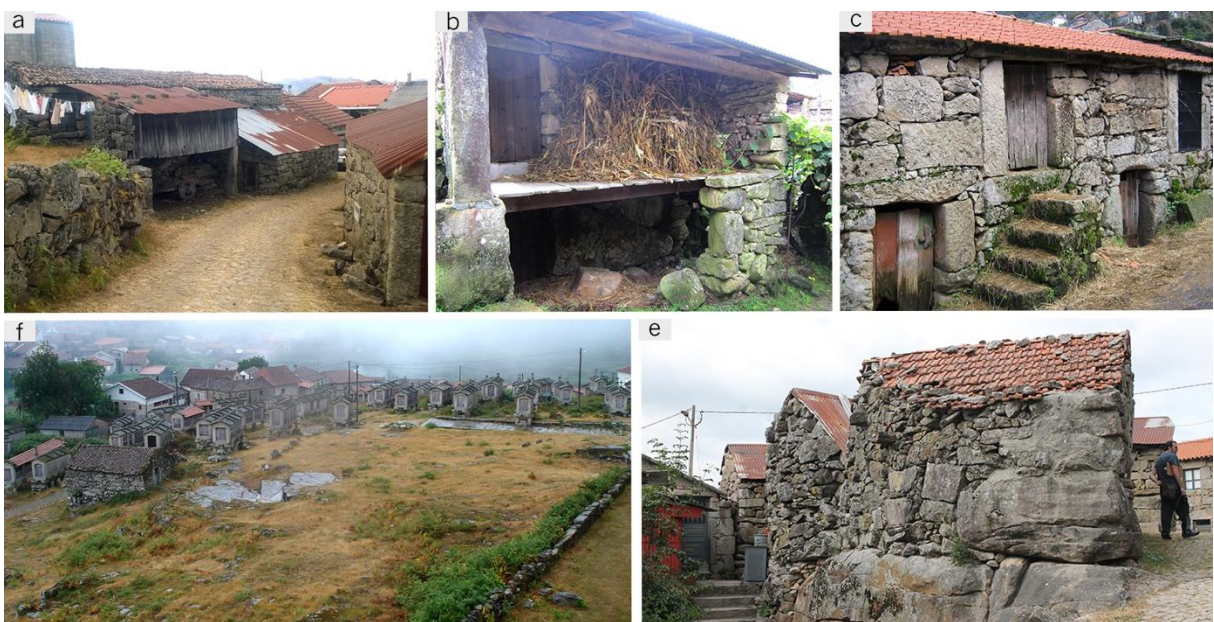
Fig. 5.11 – Examples of typical agrarian buildings of the highland settlements (common and privately-owned): (a) storage (upper-floor) and stables (ground-floor) building (Ermida, Ponte da Barca); (b) storage (upper-floor) and stable (ground-floor) (Lindoso, Ponte da Barca); (c) storage (upper-floor) and stables (ground-floor) (Penacova, Arcos de Valdevez); (f) group of “*espigueiros*” and common threshing floor (Lindoso, Ponte da Barca); (e) group of stables (Ermida, Ponte da Barca).

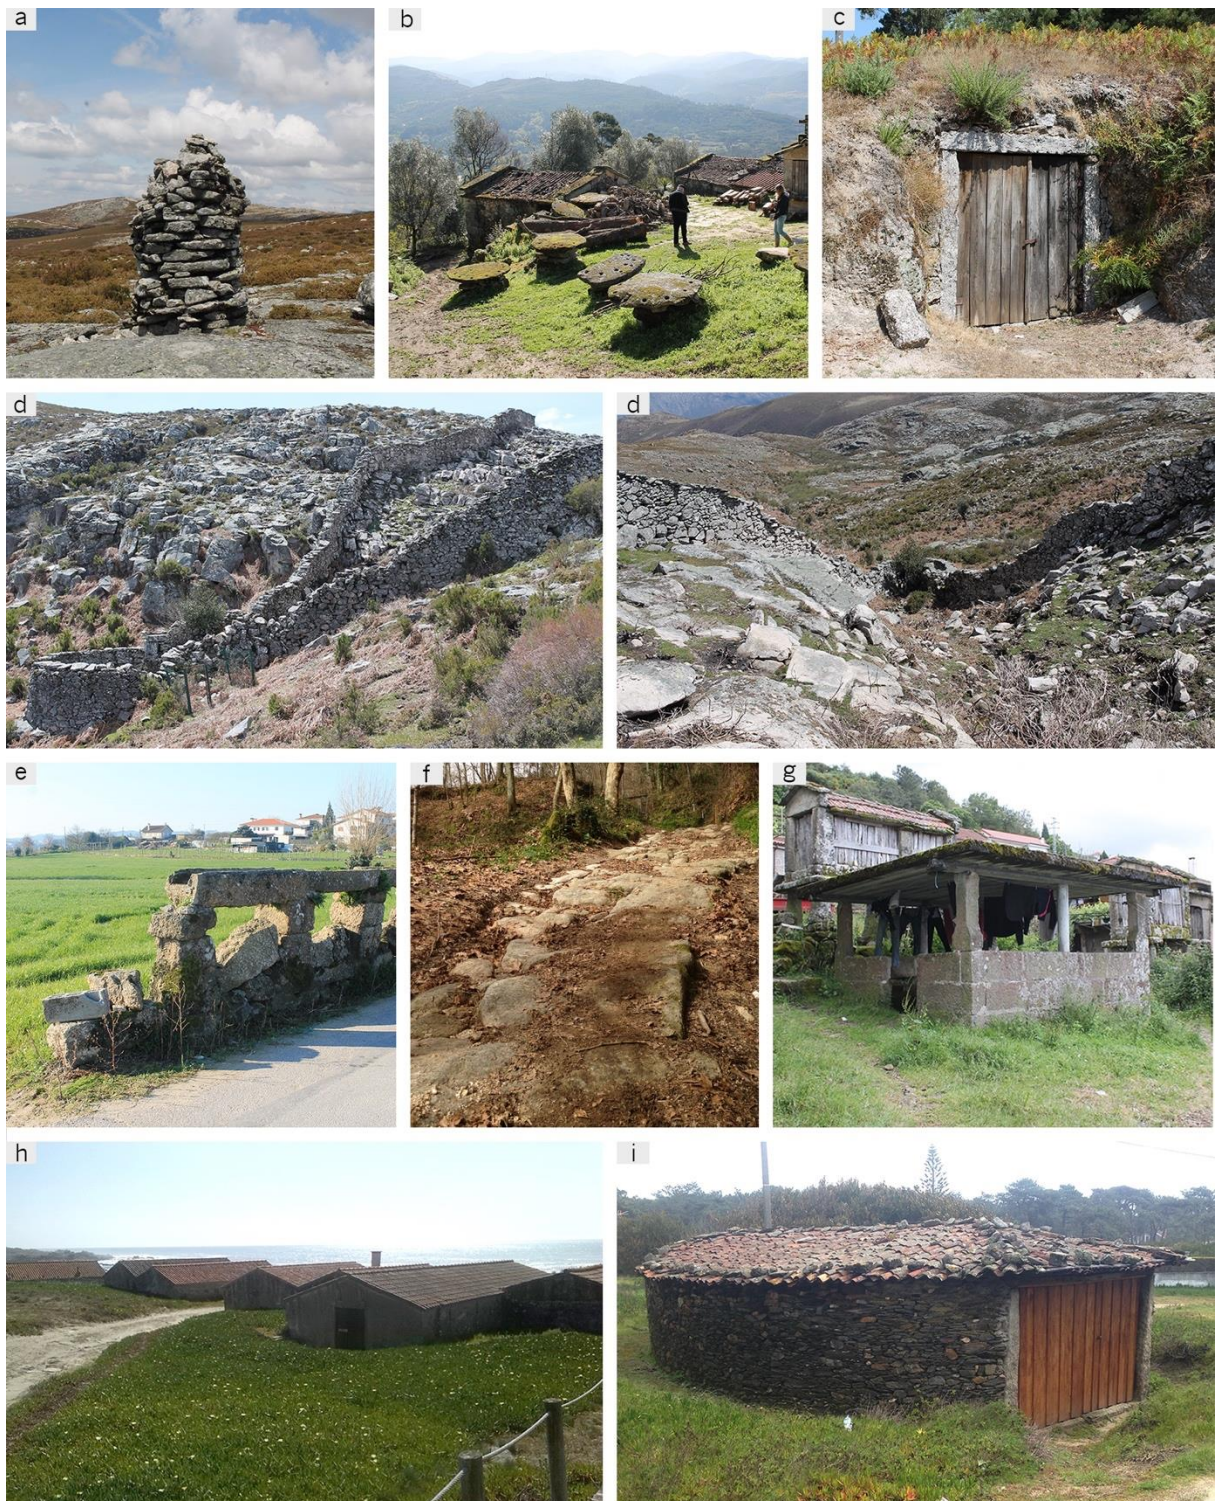
Fig. 5.12 - Examples of production buildings and infrastructures observed during the exploratory visits: (a) landmark (Gavieira, Arcos de Valdevez); (b) common threshing floor with the support for straw granaries named “*canastros*” (Vilarinho do Souto, Arcos de Valdevez); (d) wolf pit trap (Gavieira, Arcos de Valdevez); (e) masonry aqueduct (Barcelos); (f) granite paved rural path (Felgueiras); (g) common washing tank (Padrão, Arcos de Valdevez); (h) fishermen’s sheds (Carreço, Viana do Castelo); (i) “*sargaço*” storage shed (Apúlia, Esposende).

- ii) To store productions and tools, and to produce manures, all types of sheds were constructed in the farmland and near the coast [10,14,90,93,103], see Fig. 5.12b, c, h, and e;

- vi) To shape the territory and improve farming conditions, retaining walls and farming terraces were built [14,123]; reservoirs to manage water streams to feed mills, named "*açudes*", and complex irrigation and water distribution systems and all sorts of management were constructed [92], see Fig. 5.12e and g;

Despite the severe state of ruin or the loss of most of the above-mentioned types of production buildings and infrastructures, an overview of the examples observed during the exploratory visits are shown in Fig. 5.12. For their representativeness, touristic potential, and landscape impact, this section will address in more detail the mills, the farm walls, and the temporary settlements built in the highland mountain range plateaus.

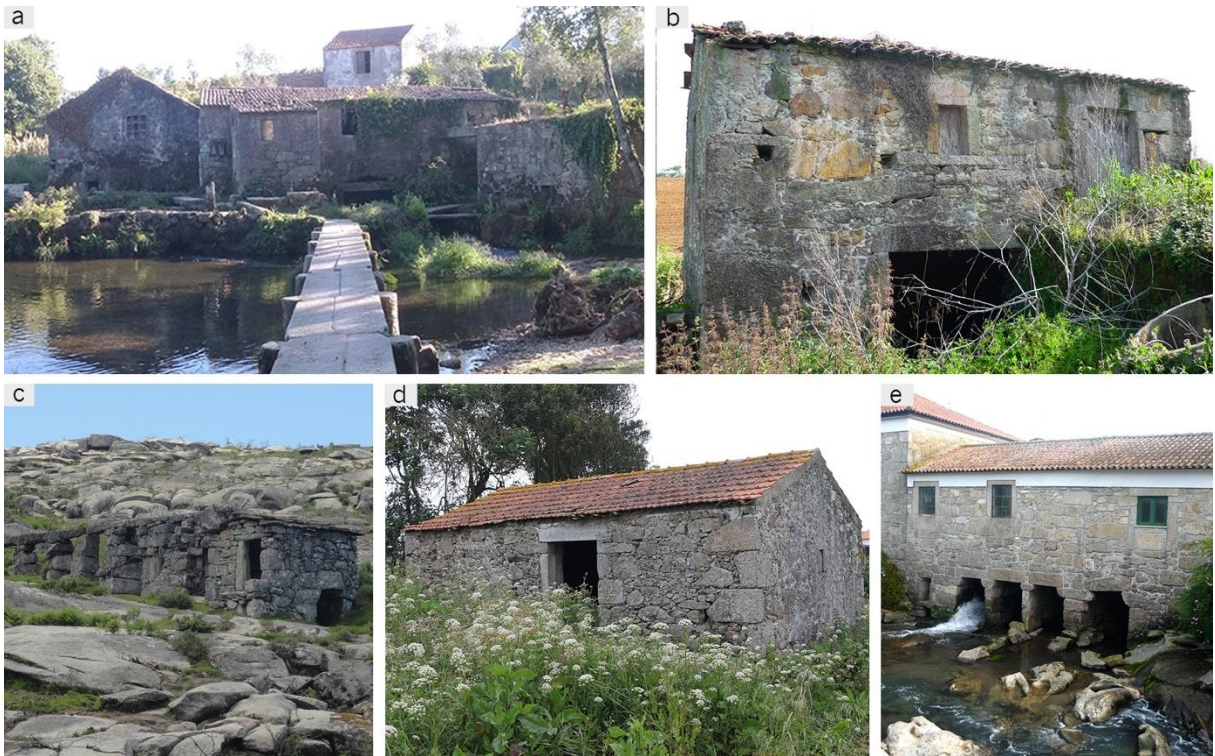
Fig. 5.14 - Examples of watermills observed during the exploratory visits (in ruins or disabled): (a) large milling complex with combined vertical and horizontal wheel systems (Antas, Esposende); (b) schist individual mill of horizontal wheel (Rio Tinto, Barcelos); (c) example of a mountain range “*cubo*” mill of horizontal wheel, belonging to a group of several mills align down slope (Agra mountain range, Caminha); (d) individual mill of several horizontal wheels (Aguçadoura, Póvoa de Varzim); (e) large mill with several horizontal wheels integrated in a farmstead (Medros, Barcelos).

As shown in Fig. 5.14, regarding size and typological diversity, watermills could vary from small to large-size buildings, and from very simplified to much elaborated geometries. Regarding their construction process, there were similar to all common buildings, except for the propelling wheel chamber, located at the inferior level or to the side of the building. Masonry structural reinforcements called “*quebra-mar*” were

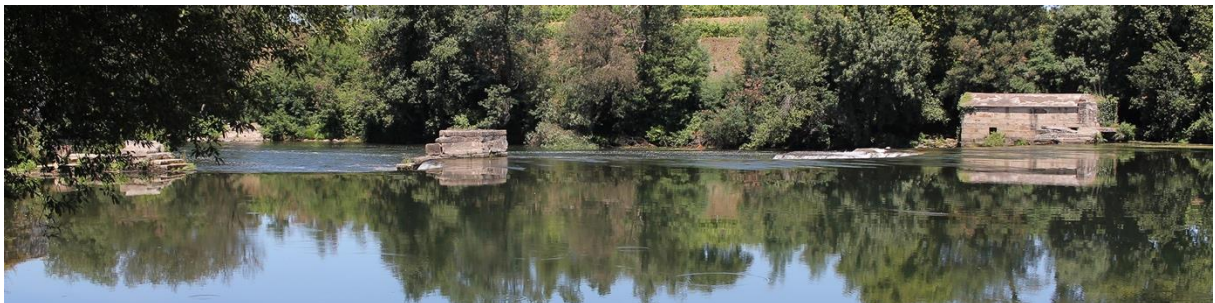
Fig. 5.15 - Example of a ruined watermill group built in the Cávado river on top of the small dam wall. These were mills of vertical wheel, with “*quebra-mar*” reinforcements. The image shows the two remaining mills (left and right), and the foundations of other two (centre).

observed in watermills built in larger rivers to resist stronger water streams [145,146], see Fig. 5.15. Oliveira et al. [94] reported watermills formed by an upper-level built in perishable timber structures, reconstructed every year, over the propelling wheel chamber built in stone masonry, Fig. 5.13c. From Oliveira et al. [94] exhaustive inventory, the typical lowland watermills can be described as a rectangular shape gable roof building, with specific areas to accommodate the milling mechanisms (entirely built in timber elements), storage areas for grain and flour, and the larger ones, with a dwelling or a temporary lodging for the miller.

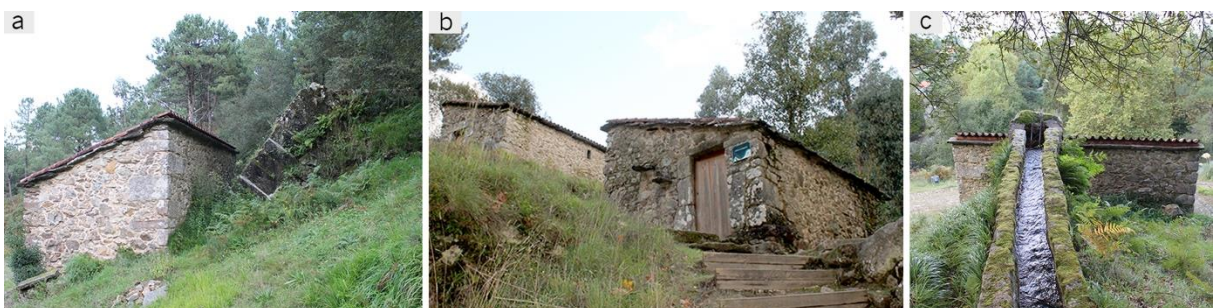
Fig. 5.16 – Example of mountain watermill rehabilitated for museum, feed by conducted water system: (a) masonry pipe named “*cubo*”, that feeds the horizontal wheel; (b) view of the mills aligned down slope to maximize water strength and management; (c) water aqueduct, named “*levada*”, that feeds the masonry pipe.

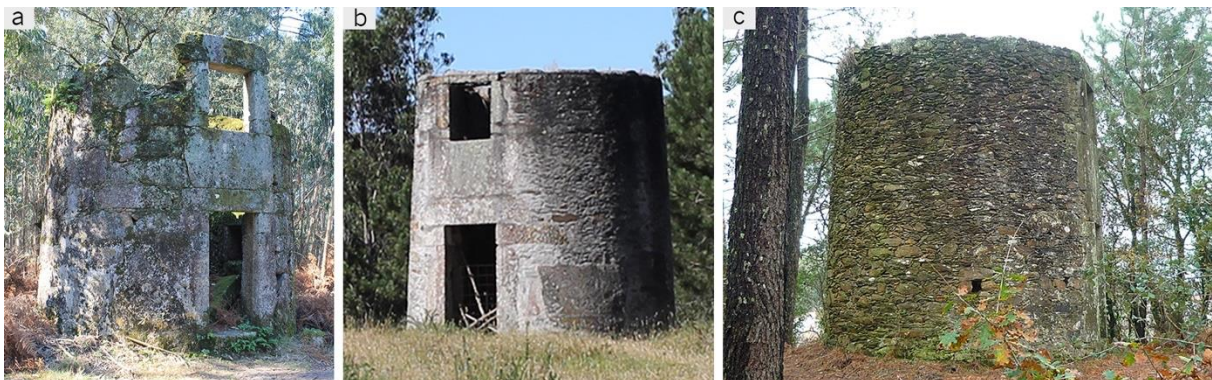
Fig. 5.18 - Examples of windmills in ruins seen during the exploratory visits: a and b - granite constructed mills (Monte of Fralães and Cristelo, Barcelos); (c) schist constructed mills (Barqueiros, Barcelos).

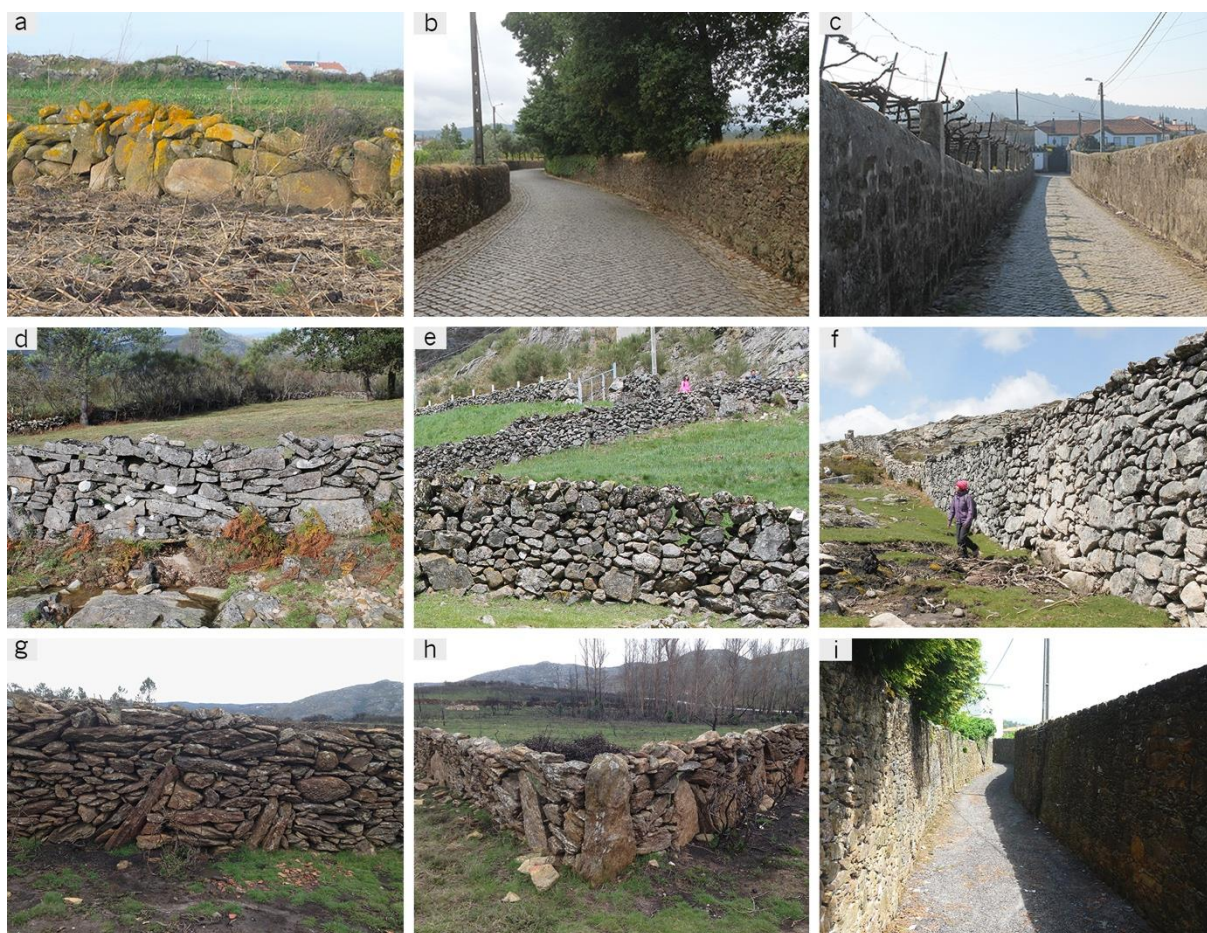
Fig. 5.20 - Images of different farm walls seen during the exploratory visits. In the lowland: (a) low boundary farm wall in granite (Póvoa de Varzim); (b) medium-height boundary (on the right) and high full protection farm wall in granite (on the left) (Barcelos); (c) high full protection farm wall in granite (Barcelos); (i) full protection high farm wall in schist (Barcelos). In the highlands: (d) low animal intrusion protection farm wall in granite (Peneda mountain range, Arcos de Valdevez); (e) medium-height boundary and animal intrusion protection farm wall in granite; (f) wolf pit trap high farm wall in granite (Peneda mountain range, Arcos de Valdevez); g and (h) low animal intrusion protection farm walls in schist (Agra mountain range, Viana do Castelo).

Analysing the above-explained typologies, one can conclude that farm walls uses depended on height. Therefore, higher farm walls allowed more uses, but also implied a larger built volume and higher technical complexity to ensure structural stability, resulting in higher construction and maintenance costs. Table 5.4 and Fig. 5.19 present the main morphological and most common building features for the typical Entre-Douro-e-Minho farm walls. Examples observed during the exploratory visits are presented in Fig. 5.20.

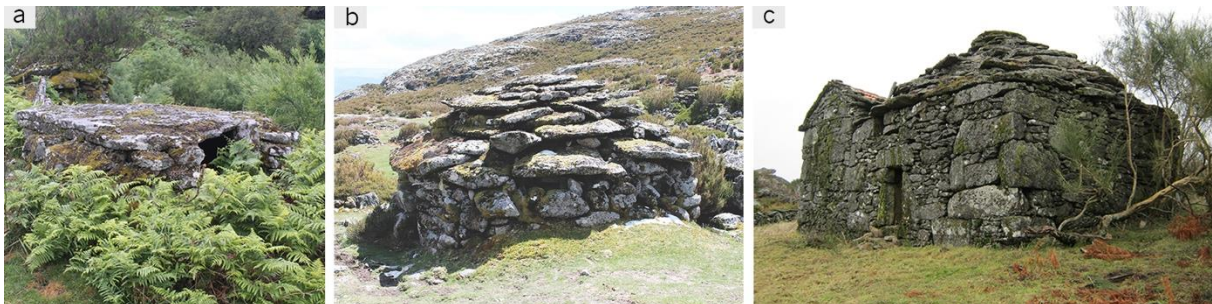
Fig. 5.23 – Examples of different corbelled domes and construction quality of the highland vernacular heritage: (a) poor construction quality; (b) low construction quality; (c) improved construction quality.

As shown in Fig. 5.23, observed examples varied from very harsh and primitive constructions built in cyclopean masonry with a single stone block roofing, to buildings with proper hammer-dressed stone blocks, with ashlar reinforcements in corners and openings.

However less common, improved construction quality corbelled dome buildings show an aesthetics of an orthogonal box, like any ordinary local building, but covered with a cone shaped roof, see Fig. 5.23c. According to Barros [124], corbelled dome roof solutions can also be found at the base settlements, being used in watermills or scattered buildings such as stables and sheds built in the farming terraces [102,106], see Fig. 5.27a.

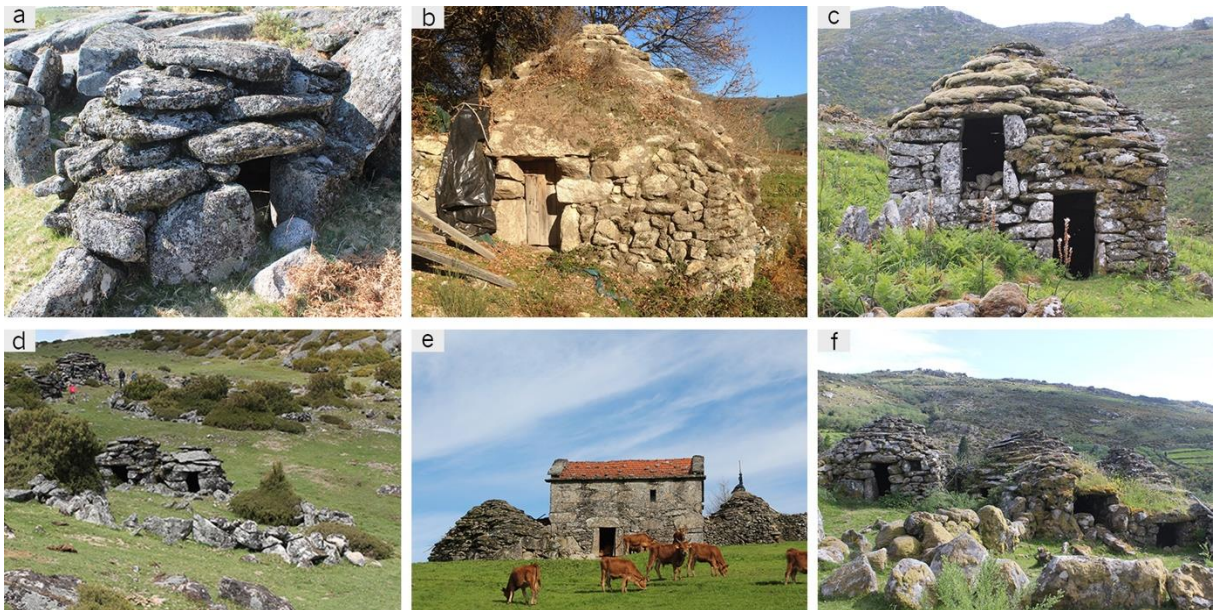
Fig. 5.26 – Examples of corbelled dome isolated and grouped buildings (see Fig. 5.25): (a) small one-storey shelter; (b) larger one-storey shelter with dome covered with earth; (c) two-storey shelter; (d) simple group; (e) composed group; (f) complex group.

Regarding buildings and their location in the territory, these could either be found isolated or forming different types of groups, as shown in Fig. 5.26 and Fig. 5.27, distinct due to their complexity. Thus, one could observe during the exploratory visits: *i*) isolated shelters, with or without a corral, scattered in the territory or part of a temporary mountain range settlement; *ii*) simplified groups of two one-storey shelters associated to a corral; *iii*) composed groups formed by a short number of one-storey shelters and a two-storeys shelter or gable roof building, generally with a corral; *iv*) complex groups combining several one-storey shelters, a one two-storey shelter and one gable roof building associated to external

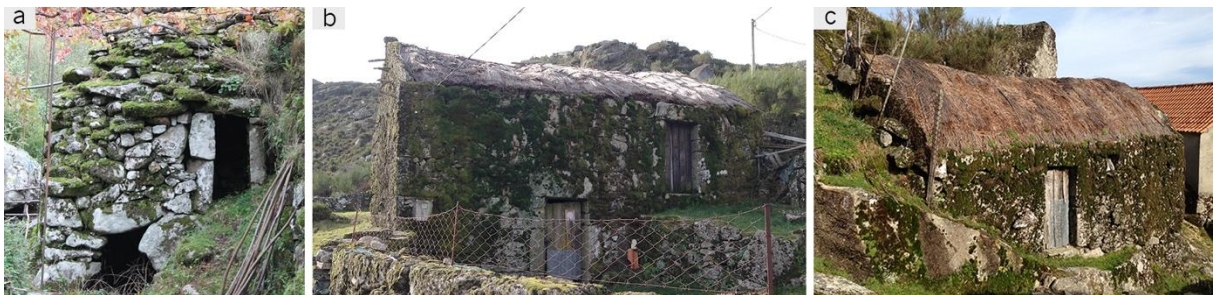
Fig. 5.27 – (a) example of corbelled dome watermill (Padrão, Arcos de Valdevez); b and (c) examples of “*branda*” houses still with original straw roofing (“*branda*” of Busgalinhas, Gavieira, Arcos de Valdevez).

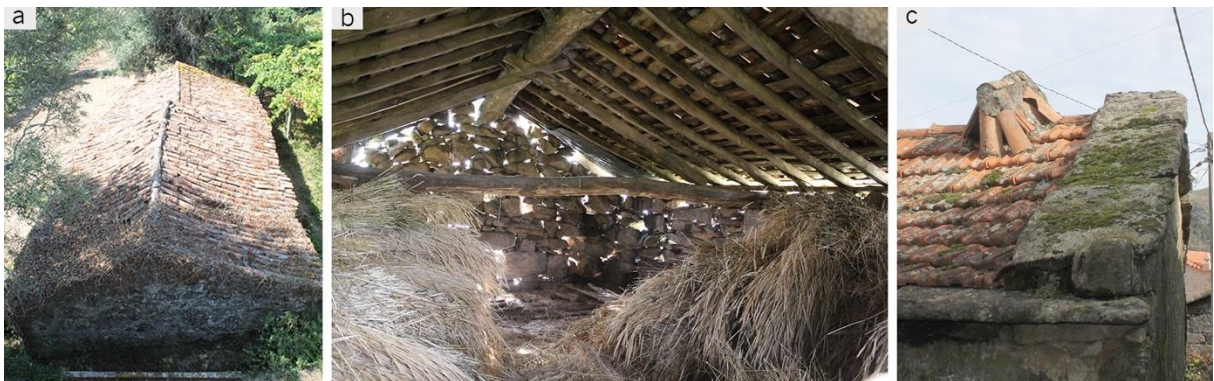
Fig. 6.2 – Images of three gable roofs: (a) external view of a roof with “*lusa*” tiles (Vale, Arcos de Valdevez); (b) internal view of the structure of a gable roof covered with “*lusa*” tiles (Lindoso, Ponte da Barca); (c) detail view of a roof originally covered with straw replaced by “*marselha*” tiles, showing the granite wind protection capstone, and chimney built in “*lusa*” tiles.

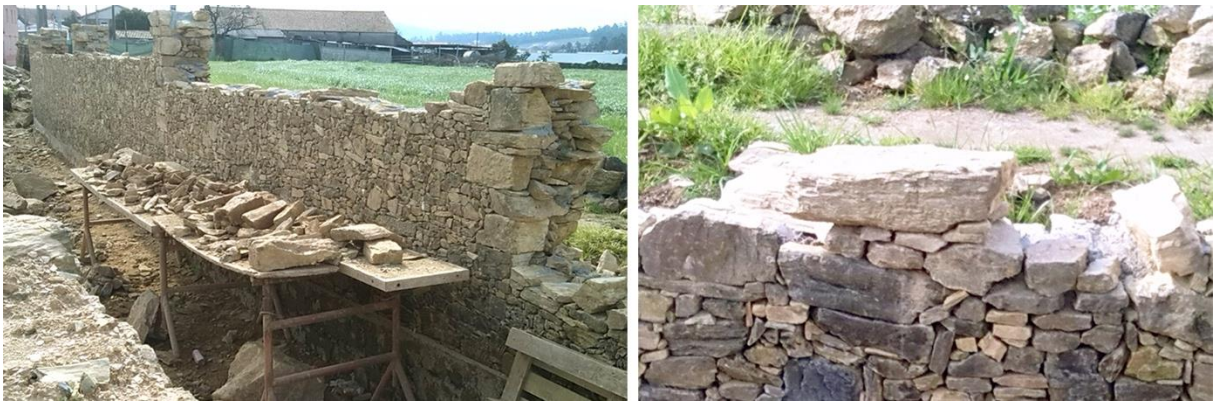
Fig. 6.4 – High farm wall under construction, with details of schist stones blocks bedded into position (S. Pedro de Rates, Póvoa de Varzim).

The construction of masonry walls, either building's load-bearing walls or simple farm walls, was executed by portions or stages, described ahead. Fig. 6.4 shows a new schist farm wall under construction, and Fig. 6.5 shows schematic examples of the different construction phases.

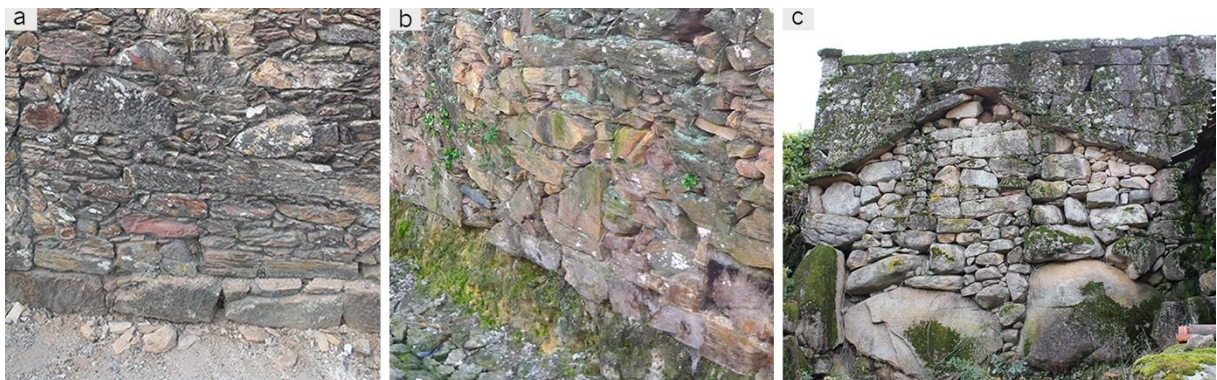
Fig. 6.6 – Examples of different types of foundations found on load-bearing walls during the exploratory visits: (a) shallow foundation, 0.05 m wider than the cross-section (Barqueiros, Barcelos); (b) direct foundation with the first row of masonry made of large stone blocks (Barqueiros, Barcelos); (c) granite massif used as foundation (Lindoso, Ponte da Barca).

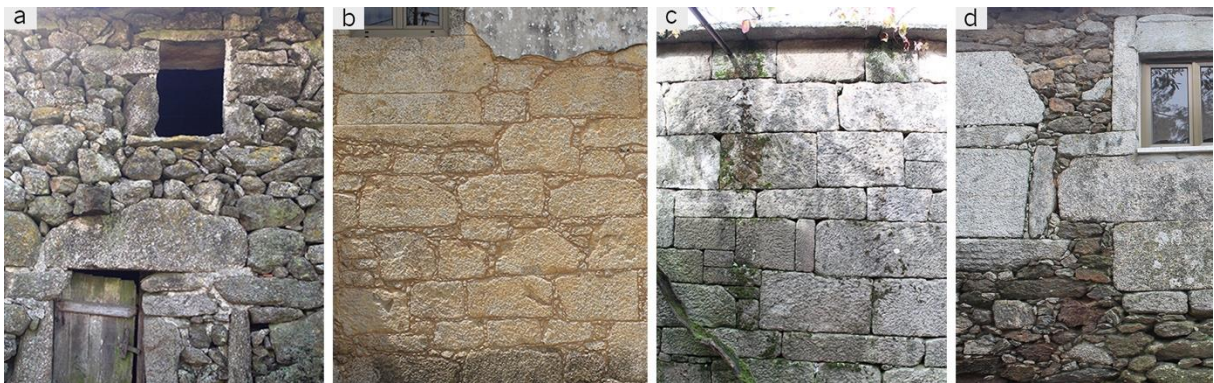
Fig. 6.7 – Different types of superficial masonry textures observed during the exploratory visits: (a) random joints (rubble masonry); (b) uncoursed joints (irregular shaped stone blocks); (c) coursed joints (ashlars or large regular stone blocks); (d) mixed joints (combining different types of schist and granite stone blocks).
