Universidade do Minho
Escola de Engenharia

The rural vernacular construction of the
Entre-Douro-e-Minho

Tese de Doutoramento
Engenharia Civil

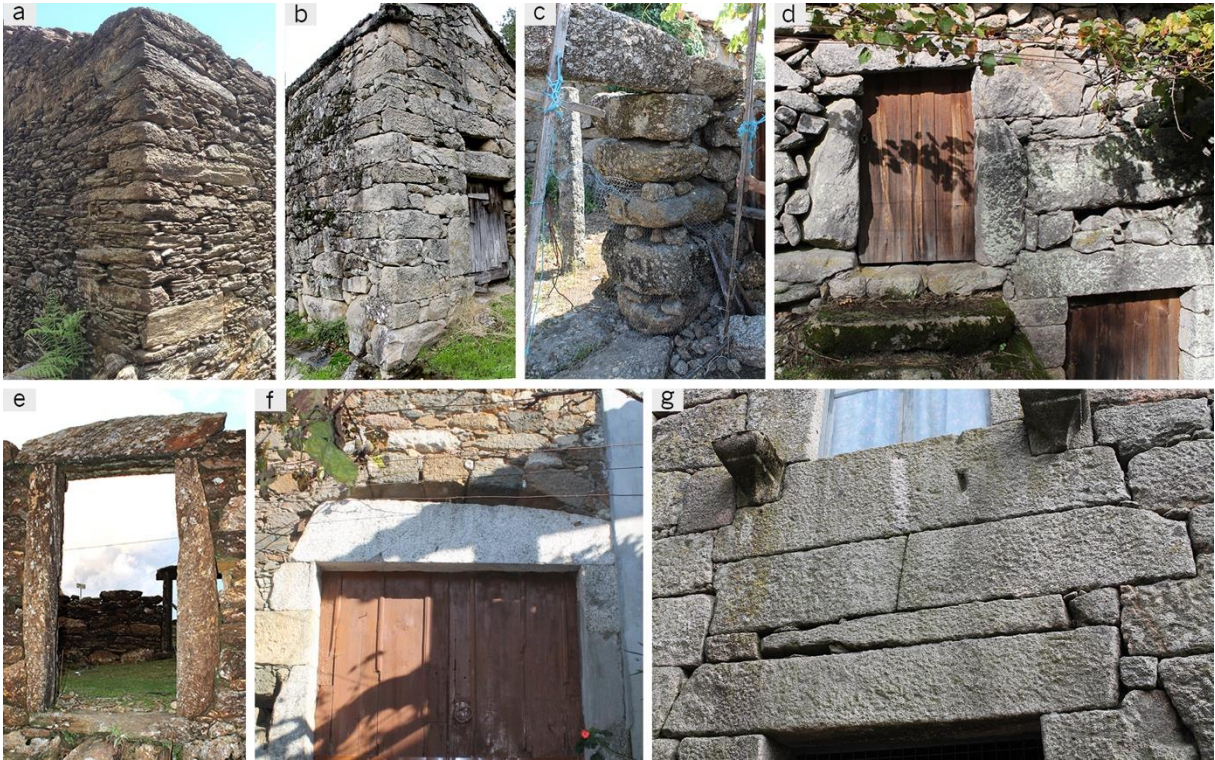
Fig. 6.8 – Examples of load bearing walls' fragile points improvements: a and (b) improvement of schist and granite different load-bearing walls on corners (Agra mountain range, Viana do Castelo; and Padrão, Arcos de Valdevez); (c) improvement of vertical edges with bondstones (Vale, Arcos de Valdevez); (d) improvement of vertical edges with large-size and irregular stone blocks and jamb stones (Lindoso, Ponte da Barca); (e) improvement of vertical edges with large-size schist stone blocks (Agra de Cima, Caminha); (f) lintel protected by an arch (Paradela, Barcelos); (g) lintel protected by a flat arch (Ermida, Ponte da Barca).

When needed, openings are created into masonry fabric and improvements are applied on the edges, either by using large-size stone blocks, see Fig. 6.8d and e, or by building an edge by alternating headers and bondstones see Fig. 6.8c. A few cases of edges built with artisanal clay bricks were seen. Most common improvement solution was to use of large-size hammer-dressed jamb stones covering the full wall's thickness, interlocked to cross-sections by large headers, see Fig. 6.8d and f. Lintels were generally formed by two large-size hammer-dressed stone blocks placed over the edges, being the external lintel's bottom face an average of 0.03 m lower than the internal one, see Fig. 6.8c to g. Cases of both, or just the interior lintel, made in timber, were also observed. To protect lintels from excessive loads, shallow, flat, or triangular-shaped arches were typically built over them to divert load to the edges, see Fig. 6.8f. Cases of the use logs for the same purpose were also identified. In higher standard buildings, particularly "*bourgeois*" and "*brazilian*" houses, jamb stones and lintels were also used as decorative elements. In these buildings, the construction of granite "*sacadas*" (short balcony with the size of the door) was common.

As shown on see Fig. 6.8a and b, interlocking different masonry walls in corners was made by overlapping, from top to bottom, headers and stretcher quoin stones, that could either be large-size stone blocks or ashlar [154]. The same technique was used to interlock intersecting walls. On rare cases, metal connectors would also be used. Connections between timber beams and trusses and load-bearing walls was performed in most cases by simply embedding these elements into cross-sections, over regular and levelled stones to avoid excessive tension points [165]. Other more elaborated solutions included to support beams over cantilever stone supports named "*cachorros*", or over built-in plate timber beam. On improved construction quality buildings, metal connectors were used to reinforce these types of connections [162,164]. Examples are shown in Fig. 6.9.

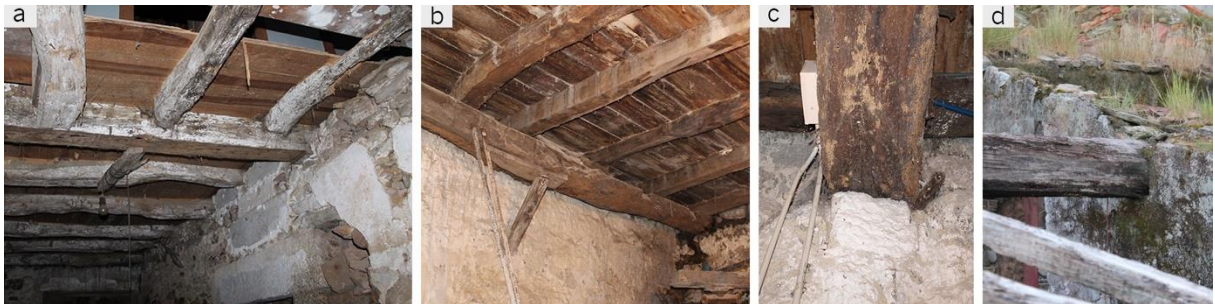
Fig. 6.9 – Examples of connections between timber beams and load-bearing walls: (a) pavement beam embedded into the wall (Barqueiros, Barcelos); (b) pavement main support beam embedded into the wall, and supporting secondary beams (Santa Maria of Bouro, Terras de Bouro); (c) pavement support beam supported over a "cachorro" (Santa Maria of Bouro, Terras de Bouro); (d) roof beam embedded into the wall (Barqueiros, Barcelos).

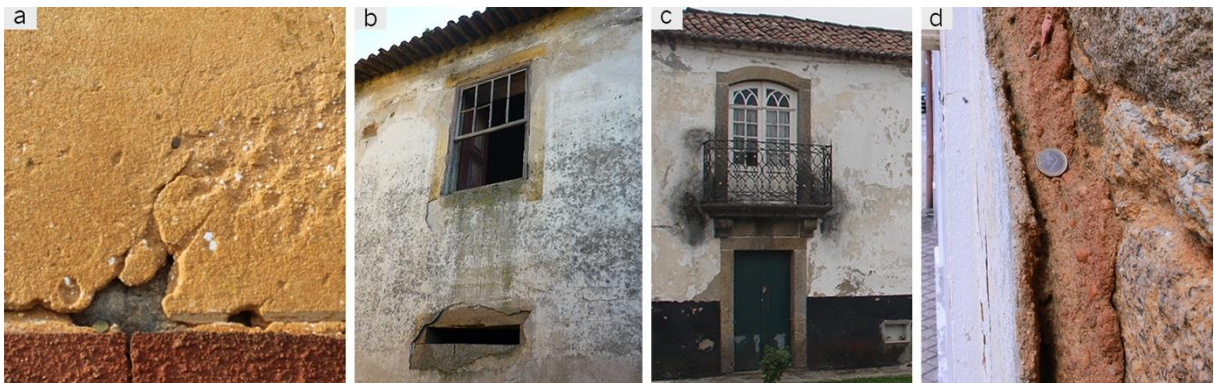
Fig. 6.11 – Examples of renders and painting: (a) “*saibro*” yellowish and reddish render (Laúndos, Póvoa de Varzim); (b) white lime painted renders with painted yellowish frames and bands (Balazar, Póvoa de Varzim); (c) façade showing a lower darker band (Barqueiros, Barcelos); (d) example of a thick render with inner layers in “*saibro*” render, and an external layer of lime render (Barcelos).

Except for buildings constructed in ashlar masonry or regular stone blocks with narrow joints, most buildings facing the main roads were covered with soil renders. On improved quality construction, the typical granitic soil render (< 0.04 m of thickness) was improved with a final layer of lime-soil mixed mortar (< 0.01 m thickness), see Fig. 6.11d. Internal dwelling or commercial and services compartments also had render. On both cases, renders were painted with lime paint, a process named “*caiação*” [14,195]. White was a quite common colour, although yellows, reds, blues and greens were also used, see Fig. 6.11a. Lime paint had the double function of aesthetically improving buildings and protecting renders from biological colonization, due to lime caustic action on biologic agents [14,195].

As shown in Fig. 6.11b, several observed high-status farmhouses houses presented painted bands and decorative elements. In these houses, it was a common practice to paint a darker band (using oil based ink) at the basis (average 1 m of wide) and at the top of the facades (average of 0.2 m of wide) to protect walls and paint against dirt and rain water drops [127], see Fig. 6.11c.

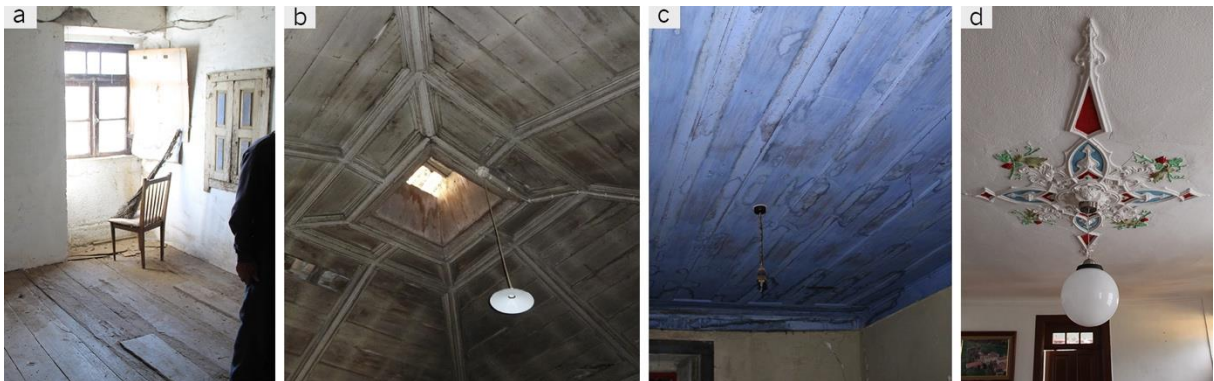
Fig. 6.12 – Detailed view from the interior of visited vernacular buildings: (a) view of a bedroom (Fonte Boa, Esposende); (b) “*masseira*” ceiling without paint (Barqueiros, Barcelos); (c) flat ceiling built in painted timber panels (Barqueiros, Barcelos); (d) plaster “*tabique*” ceiling with a plaster decorative element at the centre (Paradela, Póvoa de Varzim).

- i) Light frame walls, used either as internal partitioning walls or as structural external walls, were built with the “*tabique*” technique, and were covered with plasters and painted with lime paint [164];
- ii) Timber panelled partitioning walls were painted with lime paint;
- iii) Ceilings, typically not existing in kitchens of the humbler buildings, were made of timber beams and boards. These could either be horizontal or in “*masseira*” shape built in simple painted timber panels. On higher status houses, “*bourgeois*” and “*brazilian*” houses, ceilings were built in “*tabique*” covered with plaster and with plaster decorative elements, see respectively Fig. 6.12b, c, and d;
- iv) Timber pavements were only polished and waxed, see Fig. 6.12a;
- v) Frames and other timber decorative elements were polished and painted with oil-based paint.

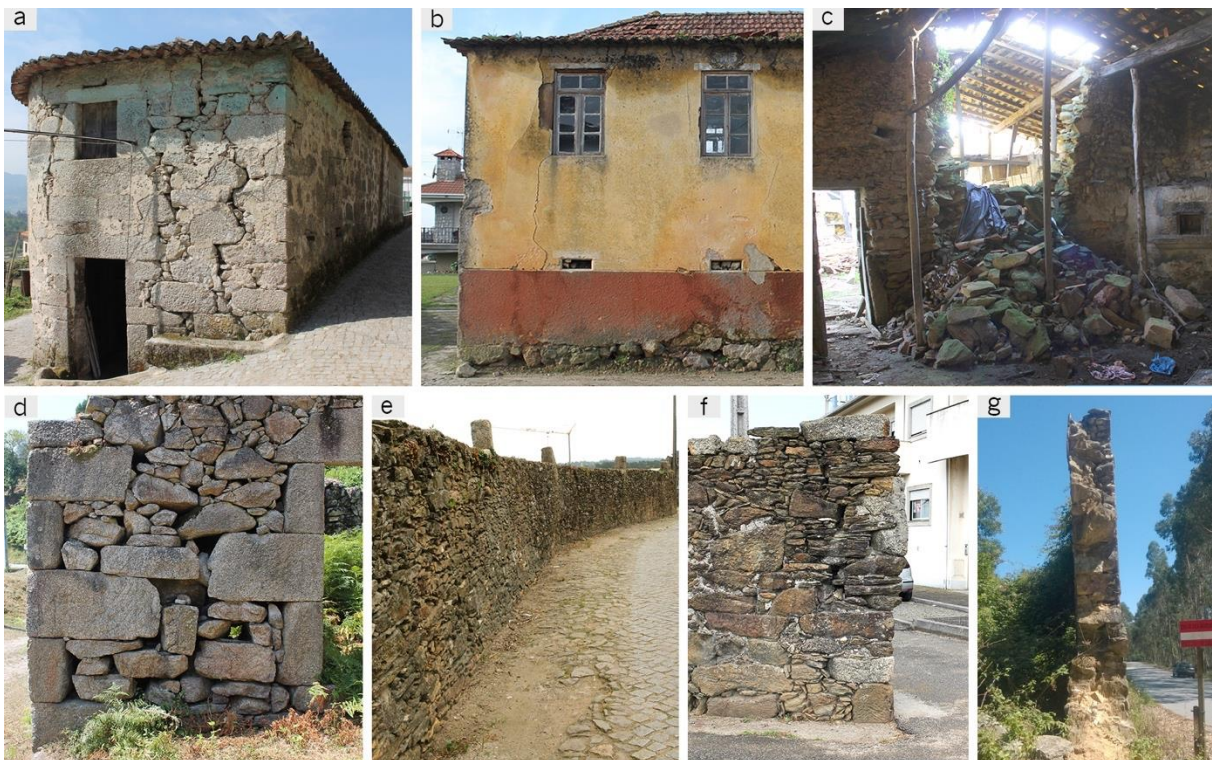
Fig. 6.13 – Some example of structural damage seen during the exploratory visits: (a) multiple cracks caused by the opening of joints (Paço Vedro de Magalhães, Ponte da Barca); (b) vertical cracks on facade with render (Laúndos, Póvoa de Varzim); (c) partial disaggregation and collapse due to push-over load caused by a roof beam (Fonte Boa, Esposende); (d) partial disaggregation of masonry superficial texture (Vale, Arcos de Valdevez); (e) high farm wall out-of-plane deformation (Barqueiros, Barcelos); (f) deformation and opening of joints crack on farm wall corner (Barqueiros, Barcelos); (g) out-of-plane deformation caused by the loss of monolithic behaviour and deformation at the base of the wall (Laúndos, Póvoa de Varzim).

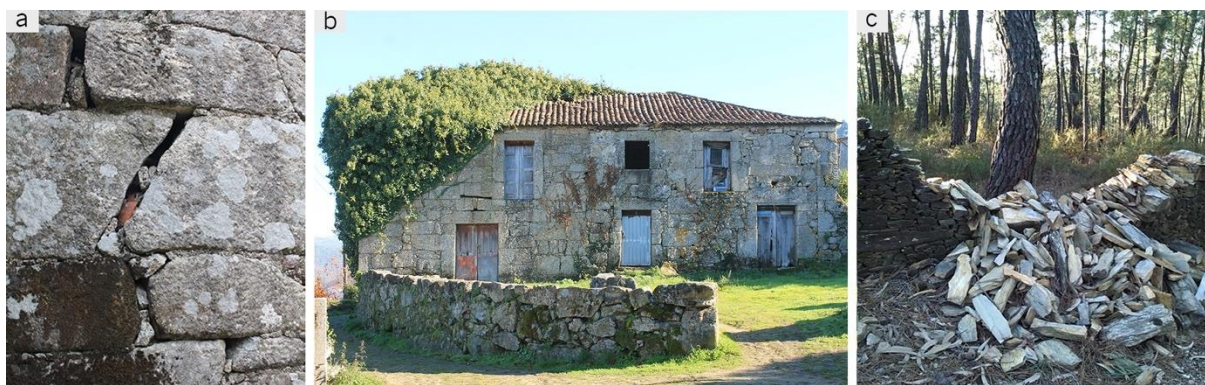
Fig. 6.14 – Examples of seen non-structural damage caused by biological colonization: (a) micro species colonization on exposed granite wall showing a large structural crack (Ermida, Ponte da Barca); (b) several smaller and a large-size specie colonizing abandoned rural house (Vila Nova de Muía, Ponte da Barca); (c) collapse on dry-stack wall caused by tree (Paradela, Barcelos).

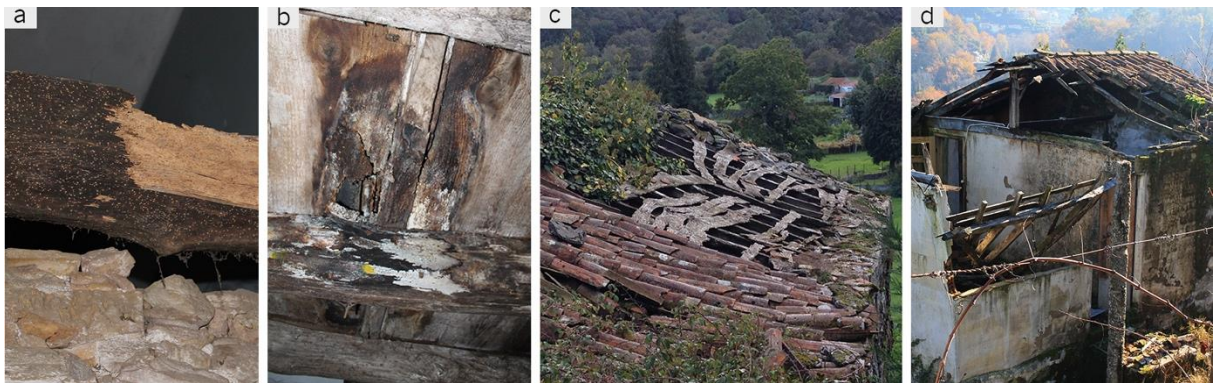
Fig. 6.15 – Examples of damage seen on timber structures: (a) insect colonization on pavement beam (Barqueiros, Barcelos); (b) rotting of timber pavement due to infiltration from the roof (Barqueiros, Barcelos); (c) decaying roof structure due to the loss of the roof tiles (Tumio, Paredes de Coura); (d) building in ruins due to collapsed roof (Vila Nova de Muía, Ponte da Barca).

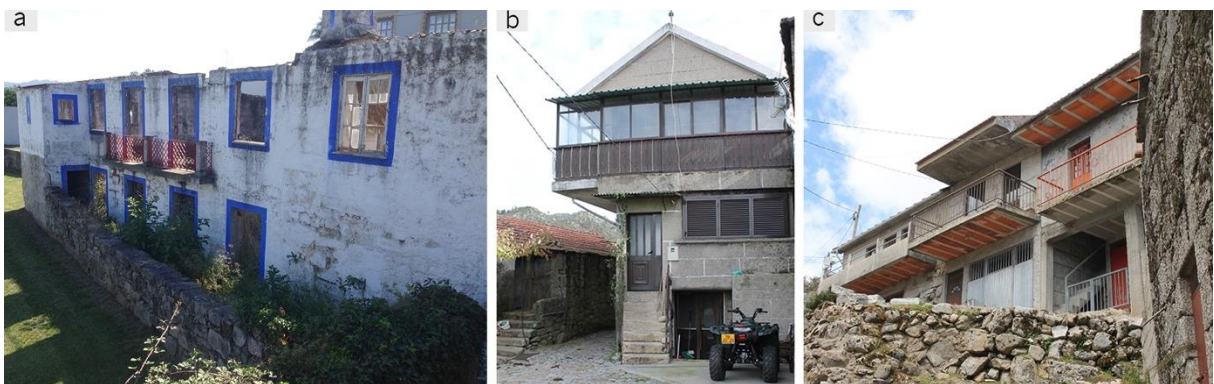
Fig. 6.16 – Examples of human caused damage over vernacular heritage: (a) state of ruin caused by abandonment (Arcozelo, Ponte de Lima); (b) loss of authenticity and identity of vernacular building due to poorly planned changes (Padrão, Arcos de Valdevez); (c) “branda” loss of identity due to the introduction of foreign models and building materials (“branda” of Gorbelas, Arcos de Valdevez).

Although in most cases not being the direct cause, as observed during the exploratory visits, the over time effect of human actions over Entre-Douro-e-Minho vernacular buildings frequently resulted on structural and material damage. As explained in Section 3.2, the mid-20th century changes to the rural way of life [12,14], caused significant changes in the way rural populations saw and used their buildings. From the contact with local populations during the exploratory visits, as previously-mentioned, it was noticed the strong will not to adapt, but to radically transform or replace owned vernacular buildings for new and more contemporary buildings. At the exception of the high status buildings, it was seen that humbler vernacular buildings either underwent a systematic destruction and replacement by new building, or underwent profound upgrades that compromised their identity [126]. It is noteworthy, the difficulties felt during the exploratory visits in the lowland, to find examples of smaller rural houses and farmhouses. Fig. 6.16 shows three of the most common types of such destruction and losses of authenticity and identity, observed during the exploratory visits.

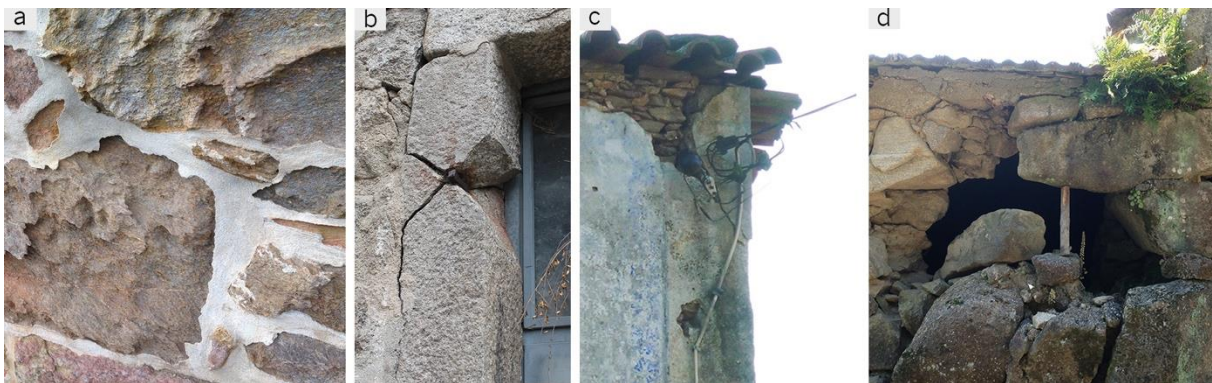
Fig. 6.17 – Some of the typical example of poor intervention on vernacular buildings found during the exploratory visits: (a) the use of incompatible materials (Barqueiros, Barcelos); (b) the insertion of metal elements on stone blocks (Ermida, Ponte da Barca); (c) new infrastructures poorly introduced (Balazar, Póvoa de Varzim); (d) unsuitable reinforcement solutions (Antas, Esposende).

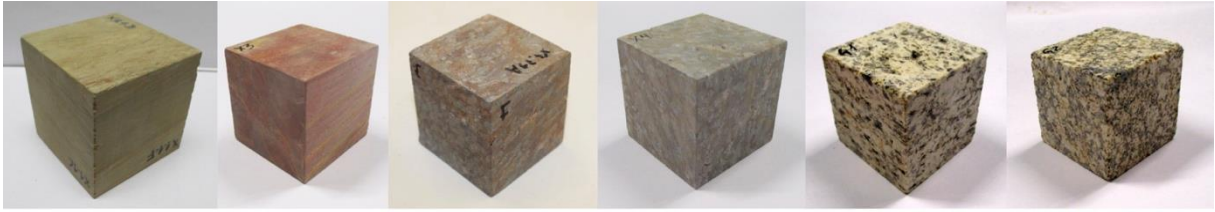
Fig. 7.1 – Examples of 50x50x50 mm³ specimens of each different type of rock tested (see Section 6.1) for rocks geological characterization.

As shown in Fig. 7.1, specimens were cut using a diamond blade saw, and according to their natural bedding orientation, following existing foliation or preferred orientations, as required by the criteria specified on the NP EN 1926:2000 standard [217].

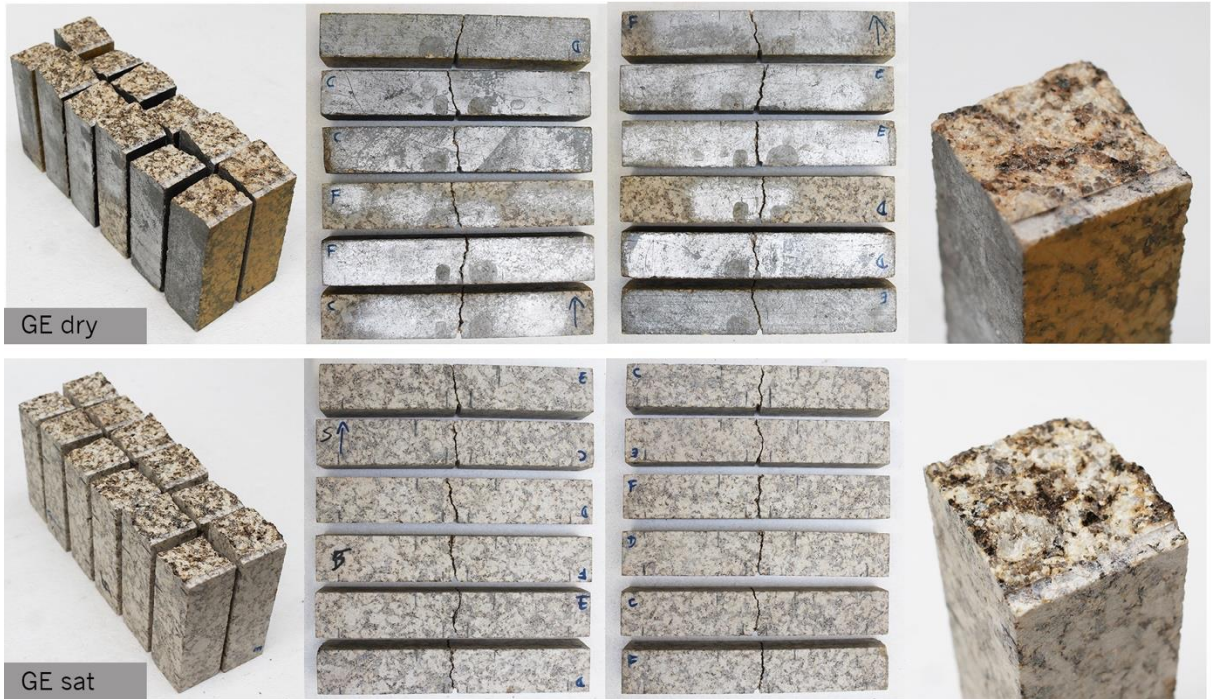
Fig. 7.33 – Images from GE specimens tested for flexural strength (4-points bending test). Rupture plans (right); front and back views (centre); detail from a rupture surface interface (left).

To analyse failure on specimens under four-points bending testing, in Fig. 7.33, Fig. 7.34 and Fig. 7.35, are shown images from the groups of specimens tested under dry mass and saturated conditions. Analysing the images, one can conclude that the most typical failure was due to tensile crack formation from the notch upwards and inwards, causing specimens to split into two independent halves. Cases of eccentric cracking were residual. In the previously reported cases of catastrophic brittle failure, the rupture plane and the tensile crack would seem to split the entire specimen at once, without any visible propagation.

Analysing the above-mentioned images, GE specimens' failures are shown in Fig. 7.33, and can be described as the most regular failure observed on the tested rocks, with rupture being caused by a single vertical or slightly diagonal crack. As observed, either under dry mass or saturated conditions, excessive stress lead to the formation of regular rupture planes, with a low roughness interface surface.

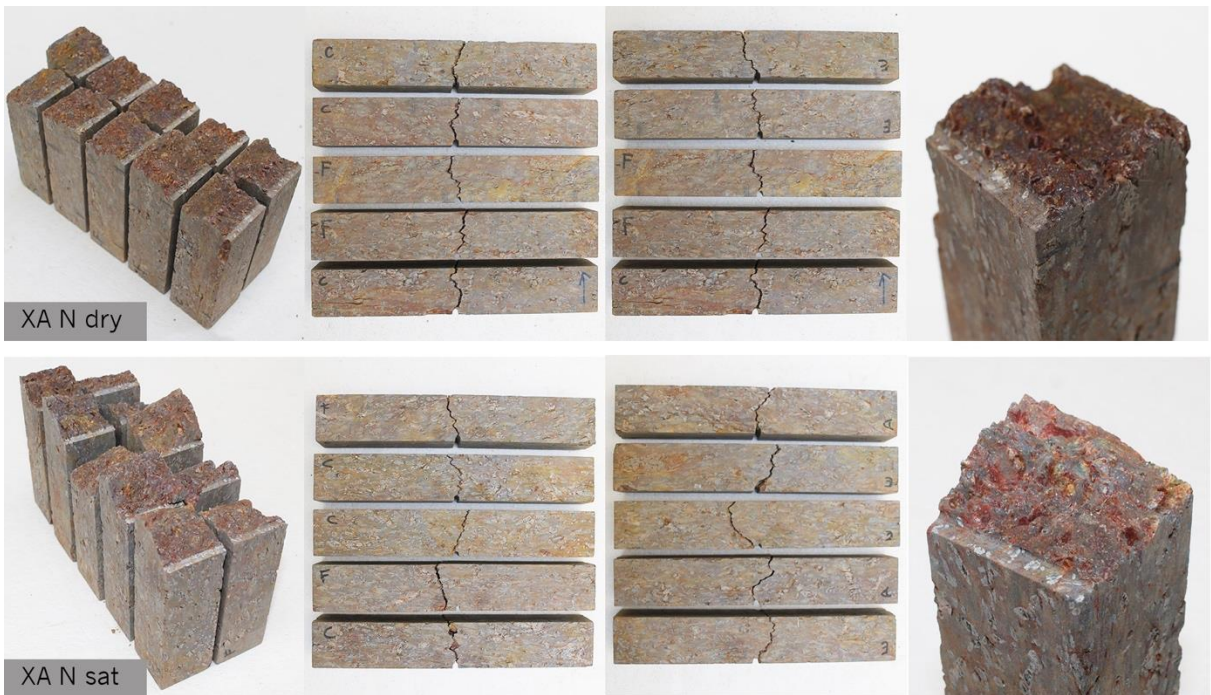
Fig. 7.34 – Images from XA specimens tested for flexural strength (4-points bending test). Rupture plans (right); front and back views (centre); detail from a rupture surface interface (left).

Regarding XA specimens tested under dry mass conditions, as shown in Fig. 7.34, tensile cracks propagated from the notch to the top following irregular vertical and slightly diagonal or curved paths. Nonetheless, under saturated conditions, tensile cracks showed a higher level of regularity, mostly following vertical paths. Under both testing conditions, rupture planes exhibit high irregularity and a strong roughness interface surface. Causes for such type failure may be attributed to this type of poorly-defined foliation and medium-grain mineral arrangement schist, that in comparison with the granite, caused frequent weaker planes and stress to relocate and change path. Analysing XR specimens' failures shown in Fig. 7.35, the previously described anisotropic behaviour becomes clear, with water significantly changing the rocks behaviour under transversal to foliation loading (N direction).

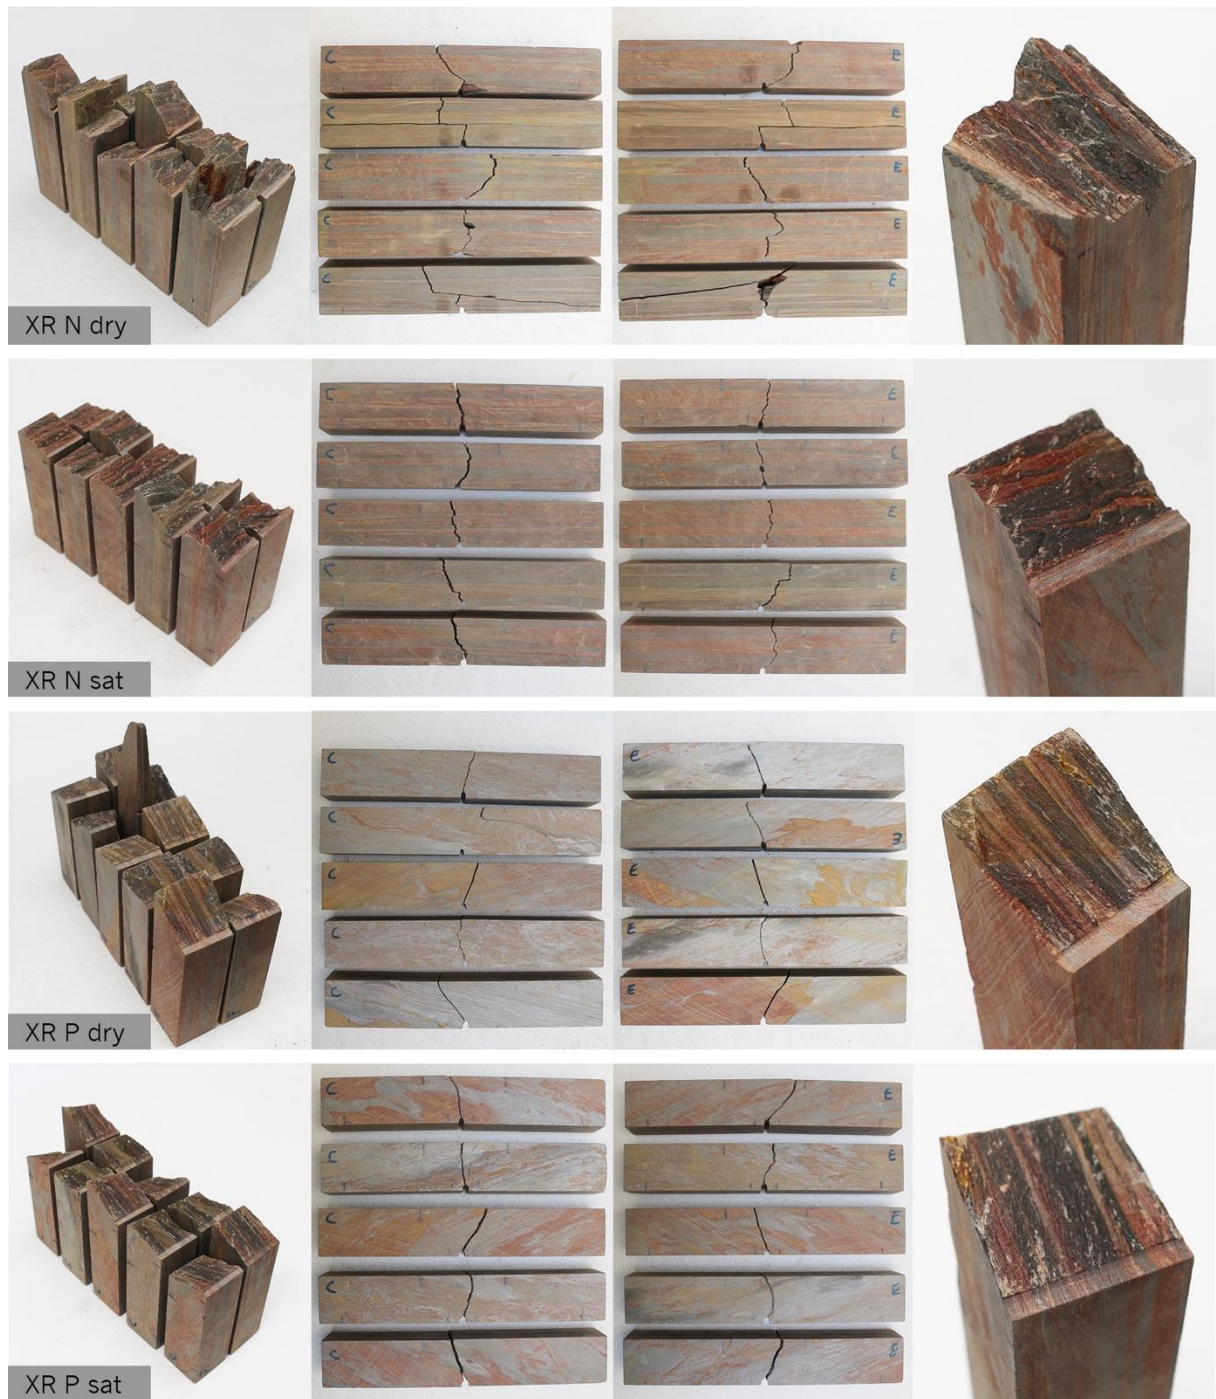
Fig. 7.35 – Images from XR specimens tested for flexural strength (4-points bending test). Rupture plans (right); front and back views (centre); detail from a rupture surface interface (left).

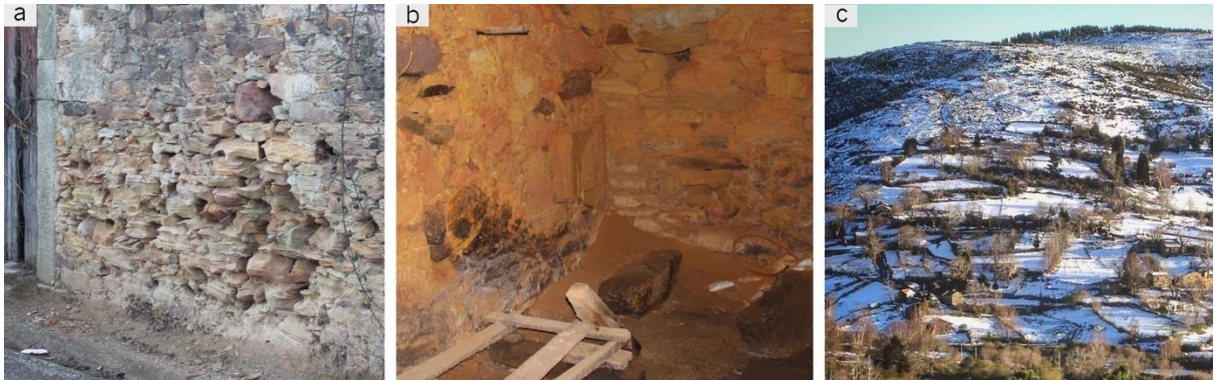
Fig. 8.1 – Examples of damage observed during the fieldwork: (a) severe salt damage on well-defined foliation schist masonry wall (livestock compartment); (b) severe salt damage on well-defined foliation schist masonry wall (wine cellar), with large amounts of disaggregated material (powdering) accumulated at the base of the wall; (c) “branda” of Aveleira (Peneda mountain range) covered with snow during the winter.

As observed during the fieldwork, salt and freeze-thaw damage are two of the most devastating types of material damages identified in vernacular masonry. As shown in Fig. 8.1, salt weathering in the study area represent very different levels of risk to vernacular buildings. Fieldwork observations revealed that in masonry built with strong rocks such as granites, salts damage was of non-structural type and generally located at superficial levels (see Fig. 8.2b). However, on masonry built with soft stones such as schists, cases of severe salt damage, that posed threats to structural safety of masonry walls, were identified (see Fig. 8.2a). Several origins for salts in the observed masonry walls can be pointed out, from human origin such as the contact between masonry and livestock (manures) or the proximity to agricultural fertilizers, or from environmental origin such as soils with high water table or exposure to sea spray [216].

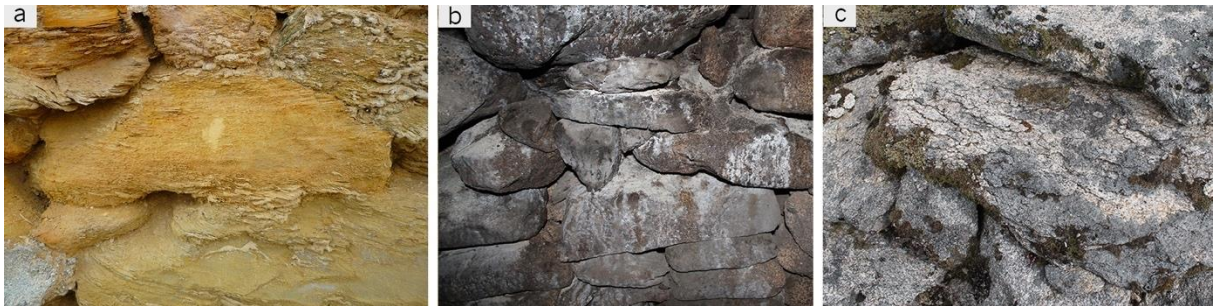
Fig. 8.2 – (a) intense powdering and lamellar disaggregation caused by salts on XL and XR schists [36]; (b) example of salt efflorescence and sanding on GE granites [36]; (c) superficial disaggregation (splintering) caused by frost damage on GE granite corbelled dome platy shape stone blocks [36].

Regarding frost damage, as described in Chapter 4, yearlong high humidity levels combined with very low temperatures, create the perfect conditions for peaks of superficial freezing in stones, at the lowland sub-region, and for intense frost weathering at the highland sub-region due to snow, see Fig. 8.2c. Frost damage was observed on buildings and granite masses at the temporary settlements built on the mountain range plateaus. Superficial damage was observed on granite structures at these remote locations, particularly on the platy shape stone slabs of corbelled domes, that due to superficial irregularities, allowed water to easily accumulate on its horizontal surfaces. As shown in Fig. 8.3, this specific type of stone blocks detached naturally from the larger granite masses, due to the water freezing on natural foliation or voids of rock outcrops.

Comparison between the level of damage observed during the fieldwork shown in Fig. 8.2, with the damage observed on the tested specimens, see Fig. 8.9, showed that to achieve the same level of damage, more than 15 cycles (indicated in the standard) were required. Therefore, the testing was extended for an additional period of 15 cycles, being the first 15 cycles (15c) of salt loading named as short-term exposure period, and the additional 15 cycles (30c) named long-term salt loading period.

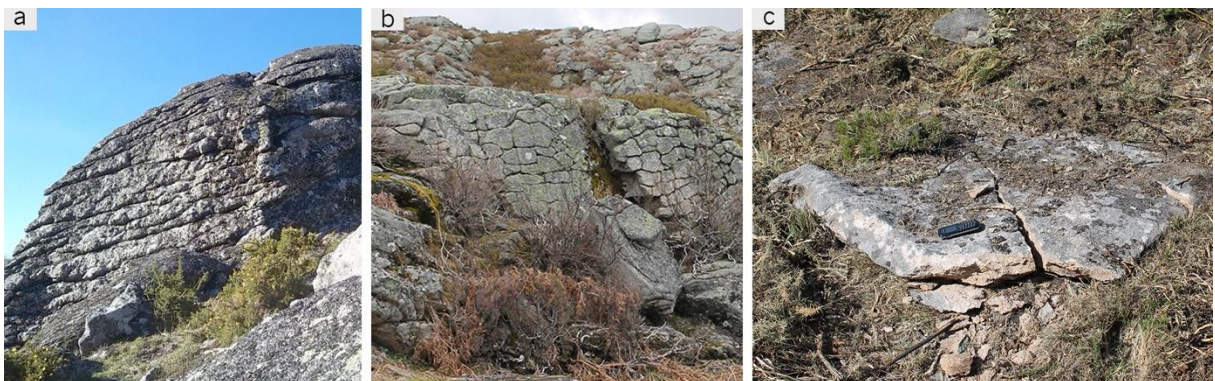
Fig. 8.3 – Examples of frost damage on granite outcrops: (a) failure along a preferred orientation; (b) fracturing of a face of granite outcrop; (c) detachment of a small platy shaped granite stone block.

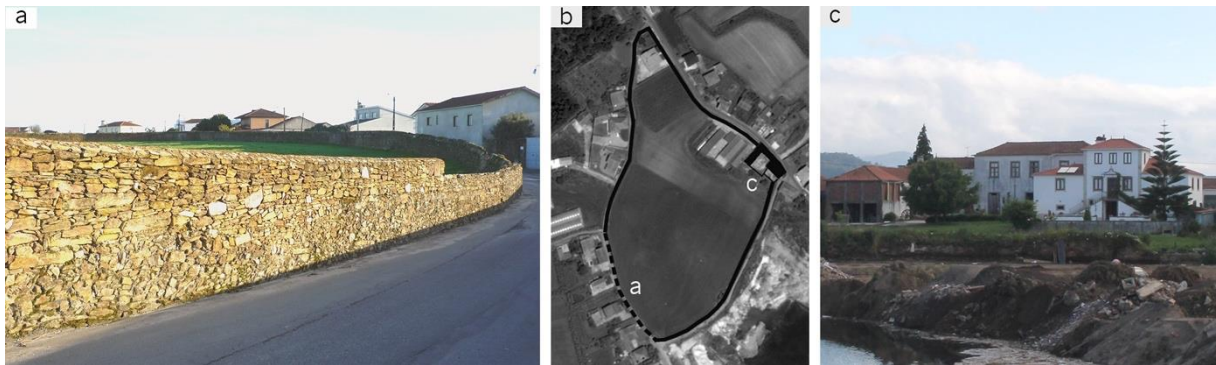
Fig. 9.2 – Images from the case study farm wall and its context: (a) view of the vernacular farm wall before the intervention; (b) aerial view of the farm; (c) view of the farmstead and its buildings (the farmstead enclosing walls were demolished).

to farmland and road sides. The compound and farmland are surrounded by roads, originally rural dirt paths, that from 80's onwards were progressively converted into urban paved roads (see Fig. 9.2a and b). The farmhouse kept active farming until the late mid-20th century. As for the origin of the farm, first documental evidences point to the mid-18th century, period when this area was first referred to as having farms [119].

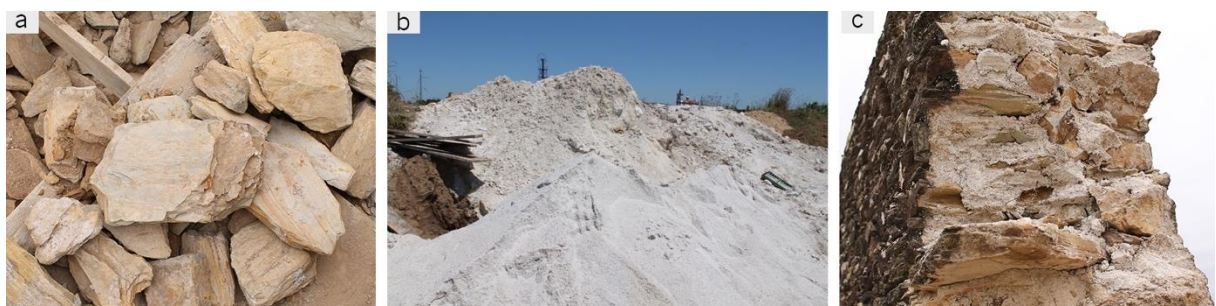
Fig. 9.3 – Images from the case study farm wall building materials: (a) well-defined foliation XO schist stones; (b) clayey soil gathered from the farm; (c) mix of both on the vernacular farm wall cross-section.

The existing farm wall was built according to the local building tradition described for load-bearing walls on Chapter 6. It was built with local schist stone blocks and soil mortar for bedding, as shown in Fig. 9.3. Regarding the stones, although a wide diversity of schists was identified among the farm wall demolished materials, well-defined foliation XO and poorly-defined foliation XM schists were the most representative ones (for both rocks physical, mechanical and durability information see Chapter 7 and Chapter 8). As for the mortars, two types of soil bedding and pointing mortars were used in different stretches of wall. Granitic residual soil (orange and yellowish shade), or “*saibro*”, was the prevailing type of used mortar, whereas mortar made of clayey soil with kaolin (whitish shade) was used on smaller sections of the wall [126,264,265]. Both types of soil are available at the farm and were prepared by simply adding water. Regarding the cross-section, it matches the typical regional mortar bonded cross-section, described on Section 6.1.2 (see group M walls ahead). However, as shown in Fig. 9.4a, b and c, different thickness and slight facades misalignments observed were the outcome of slight cross-section variations and irregular superficial masonry textures. Regarding the foundation, a direct and shallow foundation was used (average of 0.3 m deep), see Fig. 9.4d. Nonetheless, some short stretches of wall showed a wider than the cross-section foundation (average of additional 0.10 m to road side).

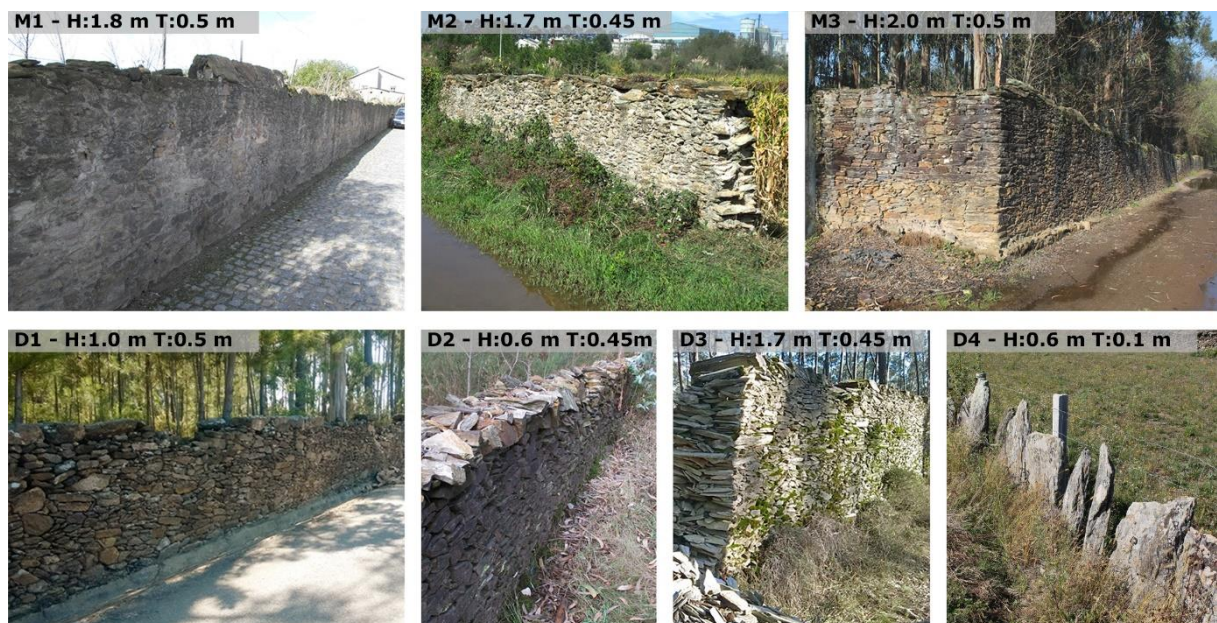
Fig. 9.5 – Examples of farm walls with mortar (group M) and dry joints (group D). Average height (H) and thickness (T) dimensions are presented in each image.

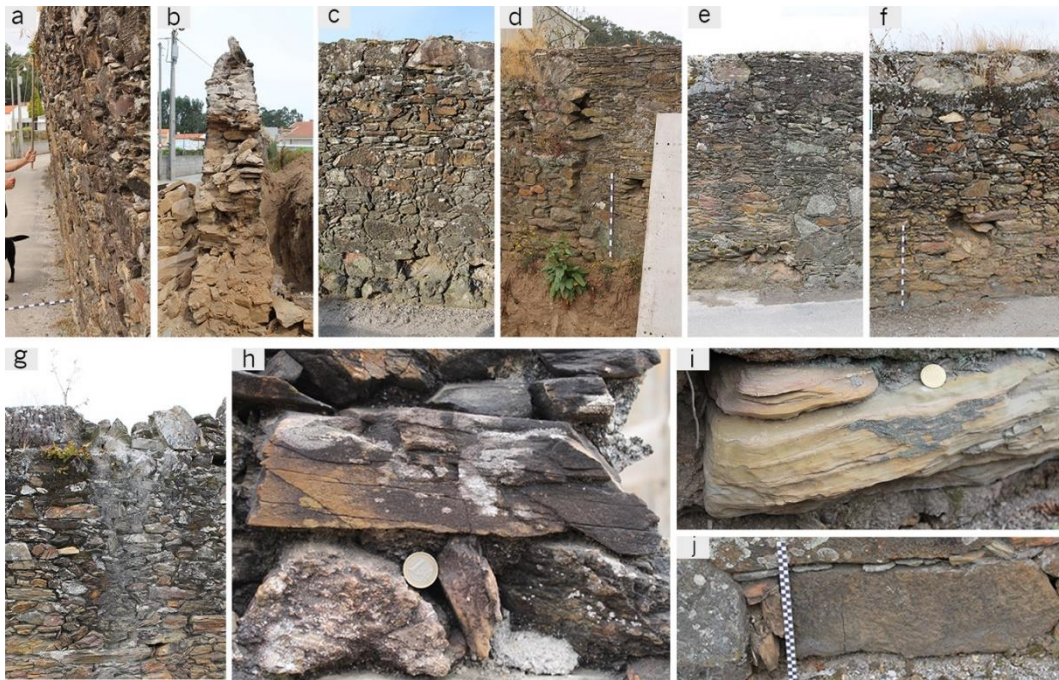
Fig. 9.10 – Examples of damage identified prior to reconstruction of the wall (see also Table 9.2).

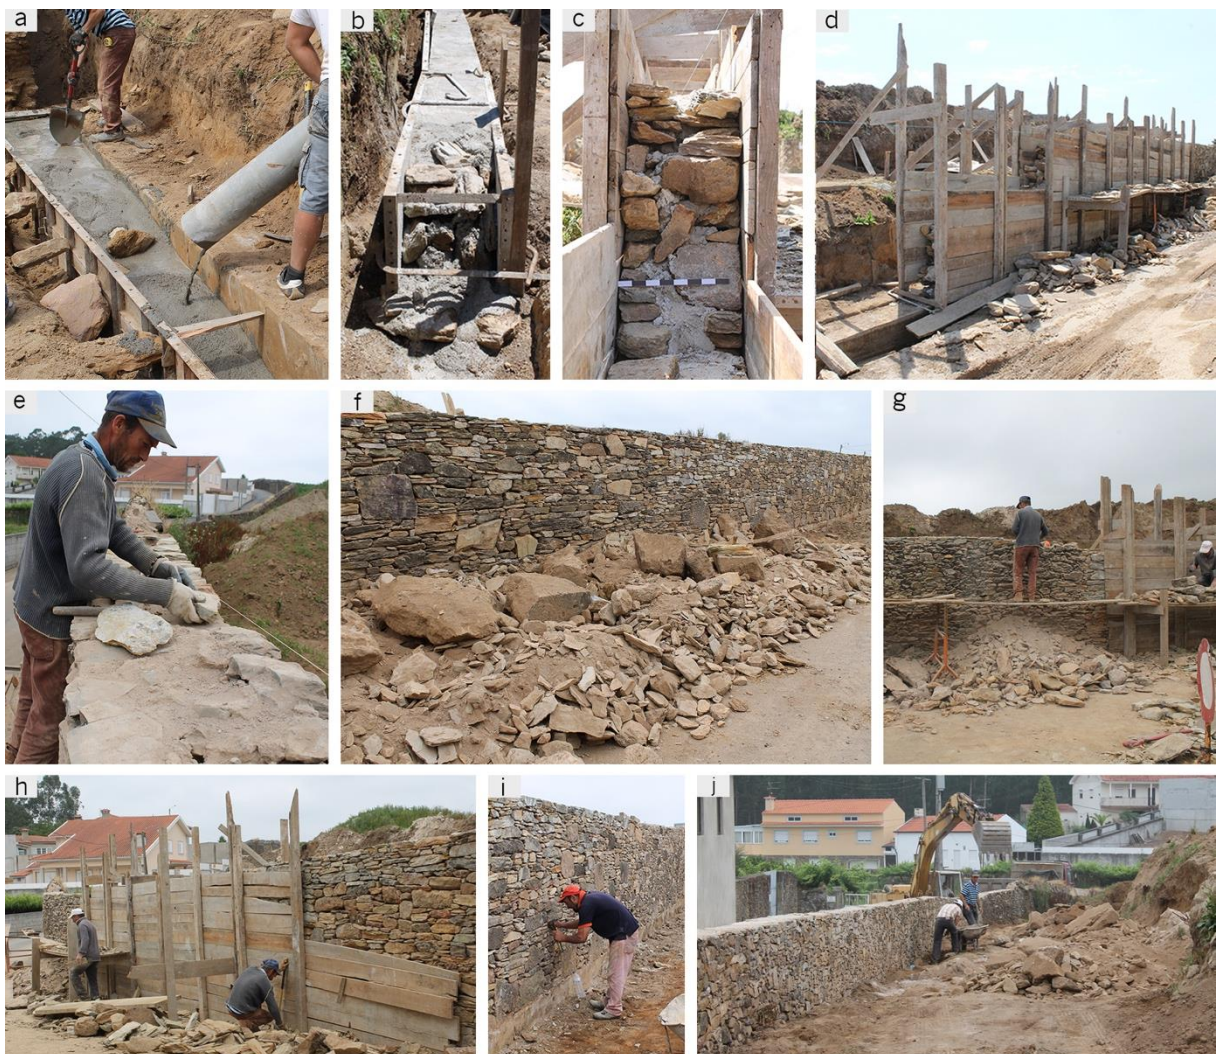
Fig. 9.12 – Different steps of the rebuilding of the farm wall: (a) and (b) shallow foundation construction; (c) cross-section of the double-leaf wall; (d) timber formwork and scaffolding; (e) bedding of a layer of stone blocks; (f) new wall and nearby materials from the demolished wall; (g) connecting of the new wall with the existent wall; (h) moving of the formwork; (i) pointing of the open joints with spalls; (j) correction of the terrain slope.

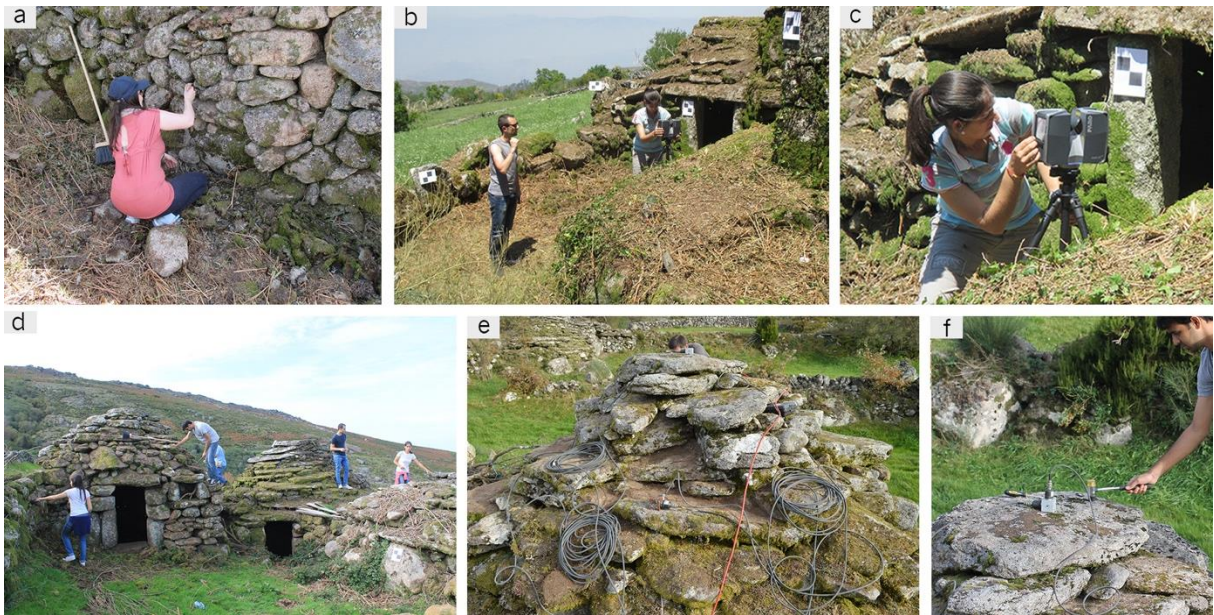
Fig. 9.24 – (a), (b) and (c) images from the laser scanning survey; (d) visual inspection and preparation for a laser scanning and dynamic identification surveys; (e) and (f) images from the dynamic identification survey.

On the second visit, see Fig. 9.23, with the support of the local partner and the Equipa de Sapadores Florestais do Gabinete Técnico Florestal do Município e da Associação Floresta Atlântica, the site was cleared from all large and medium-size vegetation that was blocking paths and access to buildings or conflicting with the laser scanner’s visual range. During the cleaning operation, a third large group of buildings was discovered, see Fig. 9.41c. The laser scanner surveys and visual inspections were performed on the third visit, see Fig. 9.24a to c. During a fourth and final visit, the buildings’ dynamic identification was performed, along with complementary laser scanner surveys, see Fig. 9.24e and f. Visual inspections and photographic surveys were performed on all visits.

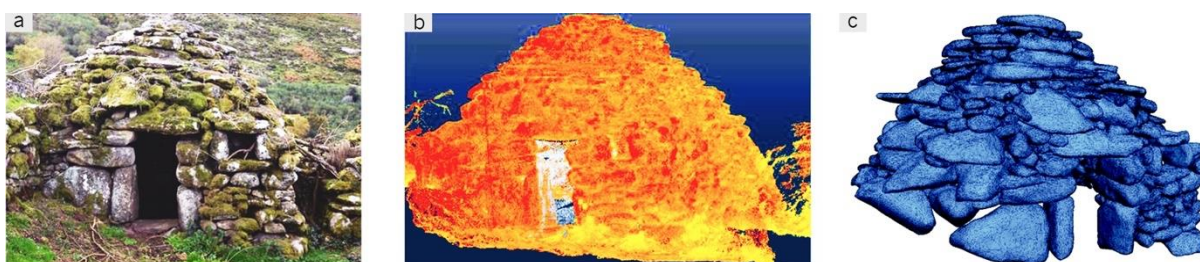
Fig. 9.27 – Sequence of task for the safety analysis: (a) inspection and dynamic identification of case study under analysis for structural safety; (b) point cloud created by laser scanning (author Dr. Belén Riveiro); (c) mathematical model based on the point cloud (author Dr. Belén Riveiro).

The first task consisted of performing the alignment of different scanner positions using the coordinates of the artificial targets measured in the field. Next, noisy points of non-desired objects such as vegetation were removed from the point cloud. The following step consisted of the segmentation of the point cloud into three main features: *i*) ground points (that are lately used to define the Digital Terrain Model (DTM)); *ii*) buildings; and *iii*) enclosing walls. To optimize the density of the point clouds and to remove redundant points, a spatial filtering was applied using octree structures. The parameter for this filter was the size of the minimum cube in the octree structure, which was set as 1 cm for the buildings and enclosing walls, and 25 cm for the ground (that define the DTM). Once the point cloud of each individual building was segmented, cross-sections of three orthogonal reference planes were extracted to perform the building's dimensional analysis, see Fig. 9.30. As for the images processing software, *RiscanPro®* and *CloudCompare®* were both used to create the final images of the point clouds, see Fig. 9.28 and Fig. 9.29. Also, as shown in Fig. 9.27, from the point clouds data, mathematical models will be developed to be used for the future structural safety analysis.

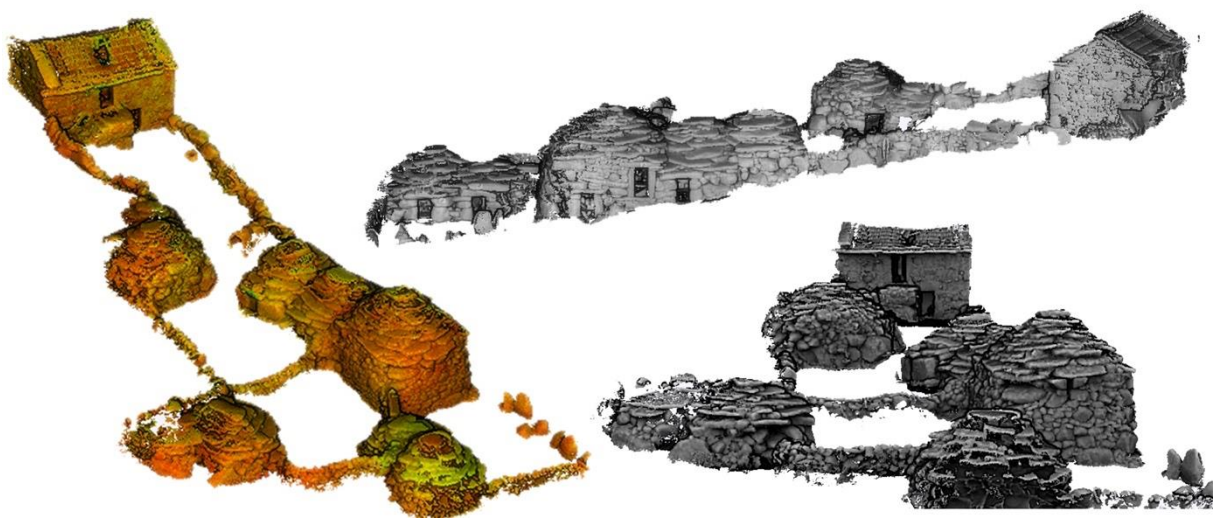
Fig. 9.29 – Examples of images (perspective and axonometric views) from Group A buildings created using *CloudCompare*® software.

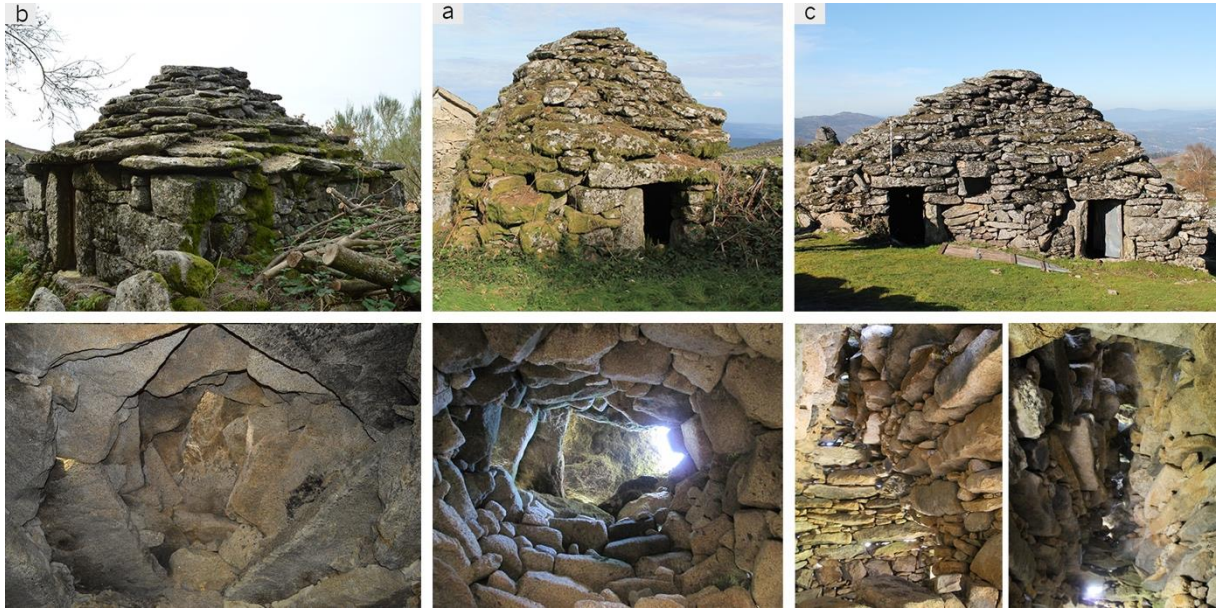
Fig. 9.33 – External (above) and internal (below) view of examples of different corbelled domes identified during the field survey: (a) taller dome built with parallelepiped and irregular shaped stone blocks (“*branda*” of Gêmea); (b) lower dome built with large plate shaped stone blocks (“*branda*” of Gêmea); (c) corbelled vault building with double chamber (“*branda*” of Alhal).

- iv) By comparison with other observed corbelled dome buildings, it became clear that stone blocks horizontal/vertical proportion influenced decisively corbelled domes height and number of built rows (F_{cu}). Therefore, stone blocks with higher horizontal area allowed lower structures with less rows, see Fig. 9.33a, whereas stone blocks with a parallelepiped shape resulted in taller and heavier structures, with more rows, as shown in Fig. 9.33b. Exceptional cases of megalithic domes, built with just a very large stone block were observed in other temporary mountain range settlements. As for alternative corbelling solutions, a very singular corbelled vault building was found at the "*branda*" of Alhal, see Fig. 9.33c;
