Universidade do Minho
Escola de Engenharia

The rural vernacular construction of the
Entre-Douro-e-Minho

Tese de Doutoramento
Engenharia Civil

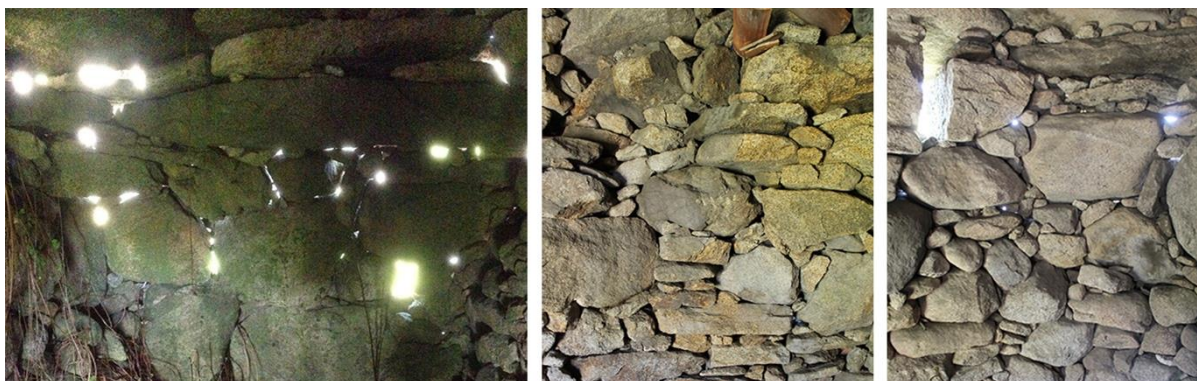
Fig. 9.34 – Examples of masonry walls' superficial textures, seen by the inside of buildings.

- i) The construction of masonry walls followed local dry stack tradition (see Chapter 6), built without or with a direct foundation, generally with two-leaves cross-section and presenting a very irregular superficial masonry texture with high percentage of voids, see examples in Fig. 9.34. Smaller buildings, due to the average size of the commonly used stone blocks, were frequently built in single-leaf cross-sections. Openings and corners were reinforced with larger stone blocks;

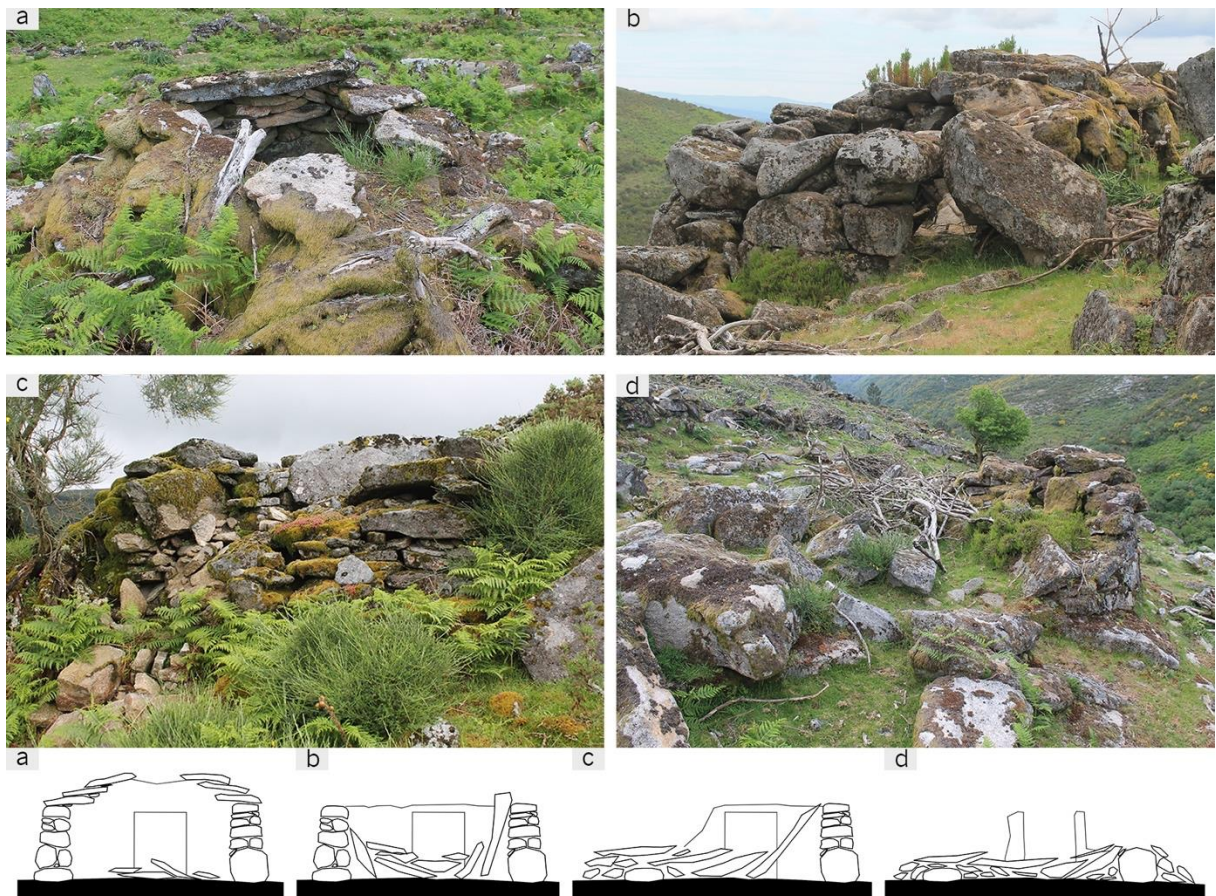
Fig. 9.35 - Examples of ruined small-size livestock shelters (*“branda”* of Rio Covo, Sistelo): (a) domes' partial collapse due to masonry unit's rupture; (b) building's corbelled dome in complete ruin (collapsed inward), but showing masonry walls in good condition; (c) masonry walls' partial collapse due to dome's inwards collapse; (d) building in complete ruin (partial reuse of stone).

Although corbelled domes and masonry walls are part of the same structure and fully built with the same type of materials, both show some specific types of structural damages. Being fully supported over the masonry load-bearing walls, corbelled domes structural safety depends of walls’ structural performance. Taking into consideration the previously described structural behaviour and its nature of assembled work [186], corbelled domes are highly sensitive to masonry walls’ structural instability. It is noteworthy that the observed examples of buildings with larger and heavier corbelled domes showed improved durability and were the best-preserved structures identified. However, as shown in Fig. 9.35, among buildings with smaller corbelled domes, thus lighter structures, several cases of buildings in ruins due to the collapse of domes were identified. Although was not the case on the “*branda*” of Gêmea, it was a common circumstance on other “*brandas*” visited during the exploratory visits. Therefore, corbelled domes collapses were identified during the fieldwork survey as the most representative cause for buildings’ ruin, being two types of structural failures observed. As for the most representative case, corbelled domes lose their structural equilibrium and typically collapse inward of buildings, see Fig. 9.35a. In the most severe cases, dome’s collapse causes masonry walls to disaggregate and collapse

outwards (push-over effect), see Fig. 9.35b. On the second case, the domes' collapse is a consequence of masonry walls severe rupture and collapse, see Fig. 9.35c. By losing their support, the corbelled dome collapse is immediate. On a few cases of buildings showing total ruin, and except for megalithic corbelled domes, it was not clear which of the structural elements collapsed first, see Fig. 9.35d. In less severe cases, such as partial corbelled domes rupture or when not causing severe damage to walls, buildings would become deactivated, but if masonry walls were still stable or could be repaired, the dome could be rebuilt. On cases where buildings became irrecoverable, by observing several ruins with a considerable amount of missing stone blocks, it became clear that the reuse of stone blocks was a widespread practice. Cases of structural damage with lower risk level are generally related to deformations caused by damage and/or instability of the walls or caused by over time structural instability related to stone blocks dislocations or failure. Due to very irregular interfaces and extensive use of wedges, the large stone blocks of the domes showed a higher exposure to flexural behaviours, therefore to tensile rupture [173]. On the surveyed area, the plate shape of granite stone blocks made them prone to such type of tensile mechanical failure.

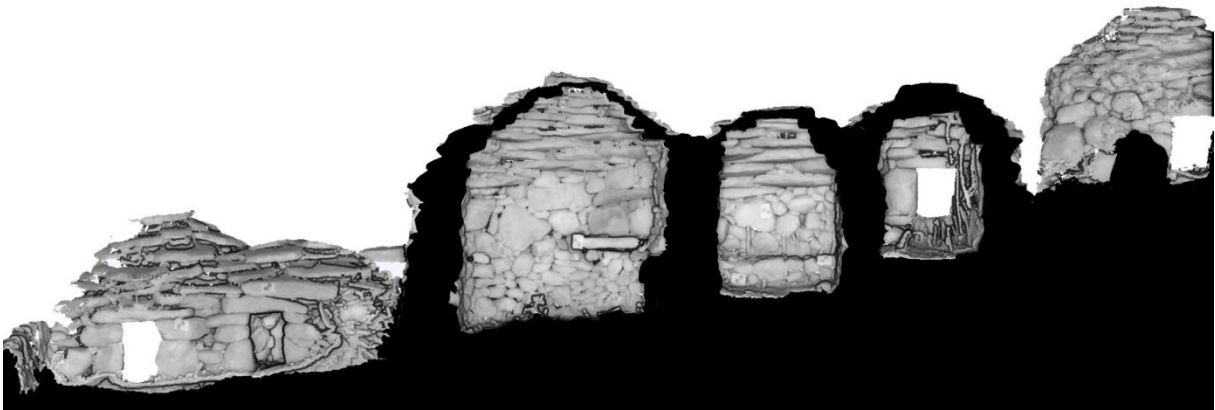
Fig. 9.37 – Laser scanner generated cross-section, showing deformed masonry walls due to overlapping corbelled domes (from left to right).

Regarding walls' damage caused by excessive vertical loads, these were either an outcome of corbelled domes structural behaviour changes and/or foundation soil's settlements. Excessive horizontal loads were mainly related to terrain's horizontal loads over walls simultaneously used for terrain retaining purposes. Similar damage caused by vertical and horizontal excessive loads were also seen on groups of buildings to which a new building was added, or cases were a new corbelled dome was constructed over existing structures, by overlapping them, as confirmed by the 3D model, see Fig. 9.37.

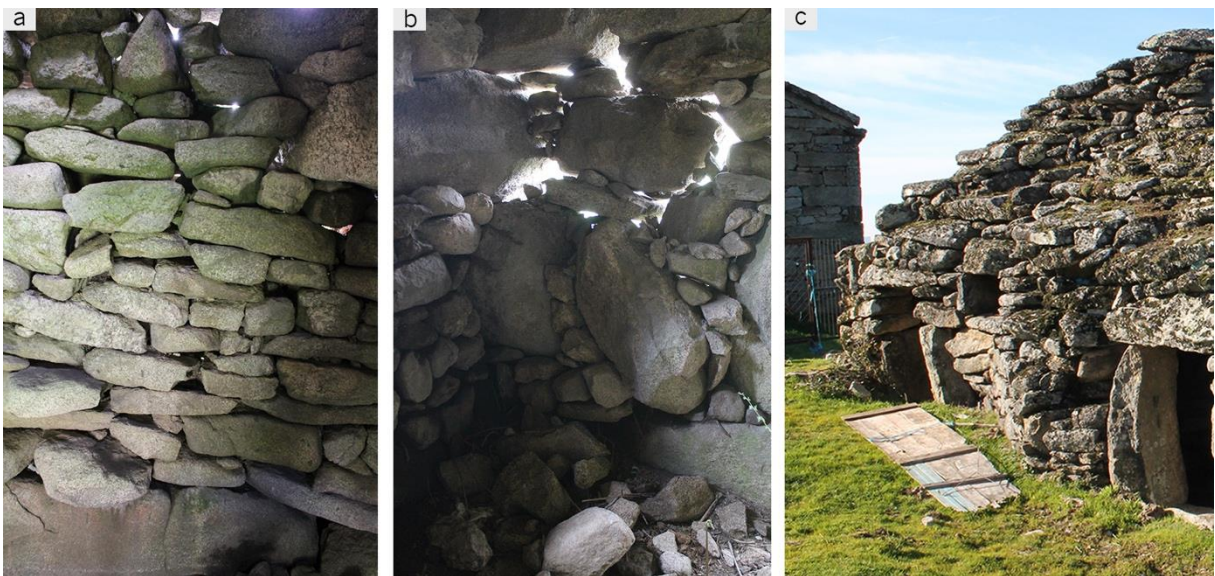
Fig. 9.38 – Masonry walls' examples of structural damage: (a) vertical cracks (opening of joints and fracture of masonry units); (b) disaggregated and partially ruptured masonry wall; (c) large masonry wall deformation.

Smaller buildings with less massive walls, frequently presented visible damage resulting from construction's poor quality or mistakes, generally related to: *i*) a very high percentage of voids; *ii*) high superficial masonry textures irregularities due to irregular stone blocks; *iii*) very poor interlocking. In these type of buildings, masonry walls' deformations and partial disaggregation was very common [172]. Fig. 9.38 illustrates some examples of typical structural damage on masonry walls.

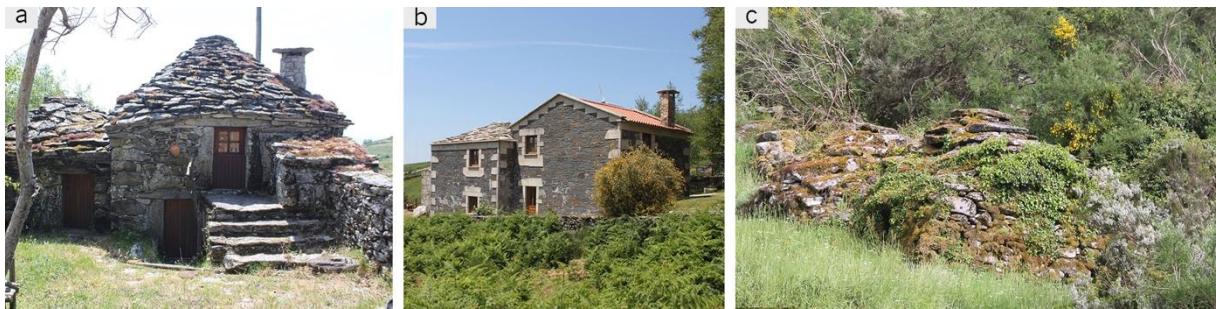
Fig. 9.41 – Examples of human caused damage: (a) and (b) severe and full loss of authenticity of both buildings and site caused by poor interventions (“branda” of Santo António of Vale de Poldros, Monção); (c) group of corbelled dome buildings discovered in “branda” of Gêmea during the cleaning operation.

severe character losses caused by human interventions on building are a still a non-existent phenomenon. Examples of the above-mentioned human caused damage are shown in Fig. 9.41.
