## Investigation Techniques Carried out on the Qutb Minar, New Delhi, India

**ABSTRACT:** In the framework of the Eu-India Economic Cross Cultural Programme “Improving the Seismic Resistance of Cultural Heritage Buildings”, aimed at the preservation of ancient masonry structures with regard to the seismic risk, different NDT were applied to the Qutb Minar, New Delhi, India, in September 2005. The paper describes the different investigation techniques applied (Ambient Vibration and Pulse Sonic Velocity Tests), intended to define the dynamic response of the tower and to qualitatively define the masonry conditions. For the dynamic modal identification analysis different test equipments were used, in order to compare the data and to have more reliable results. The dynamic parameters resulted from the acquisition campaigns will be used to estimate the mechanical properties of the masonry walls and the boundary conditions of the structure, to be considered in successive seismic nonlinear analyses of the Qutb Minar, aimed at the assessment of the safety level of the construction.

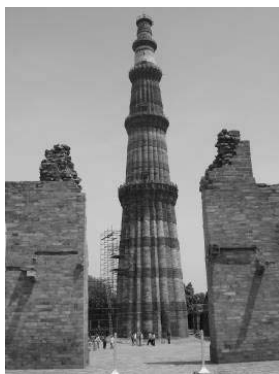
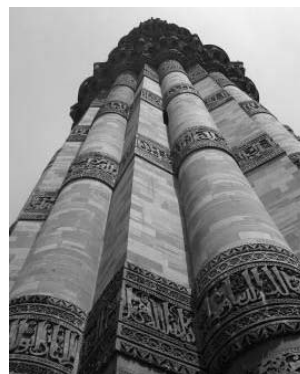
Figure 1 : (a) General view of the Qutb Minar; (b) detail of the Koran's inscriptions carved in the stone.
