Recycled Steel Fiber Reinforced Concrete  
for Structural elements subjected to chloride  
attack: Mechanical and Durability  
performance

Universidade do Minho  
Escola de Engenharia

Doctoral thesis  
Civil Engineering

October, 2019

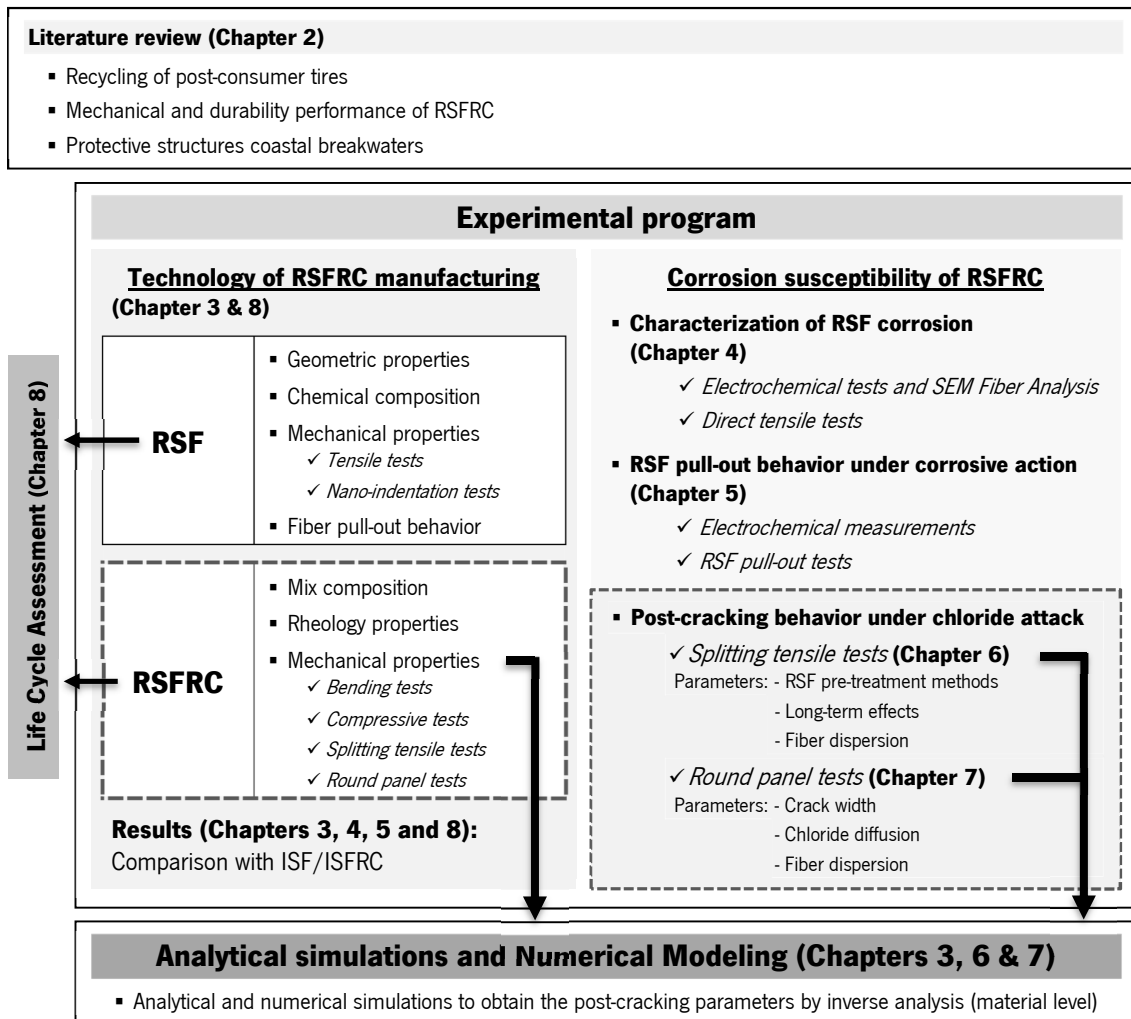
Figure 1.1 – Research methodology

According to the above-mentioned objectives, the present thesis intends to increase the current knowledge on the durability and long-term behavior of RSFRC under corrosive environments, which may contribute for future guidelines and design tools for RSFRC, whose lack currently limits the use of RSF in concrete construction. To accomplish the objectives listed above, the research methodology that was followed is schematically depicted in Figure 1.1.

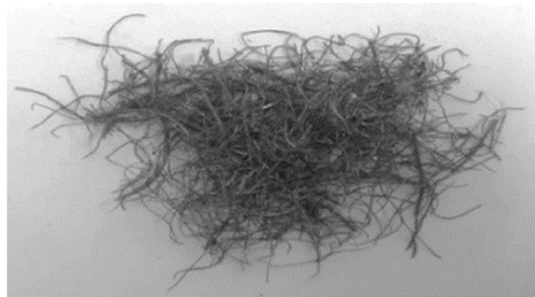
Figure 2.6 - RSF obtained from cryogenic process (Zamanzadeh *et al.*, 2015)

The resulting steel fibers obtained from this process are characterized by different diameters, lengths and shapes, and present irregular wrinkles (Figure 2.6).

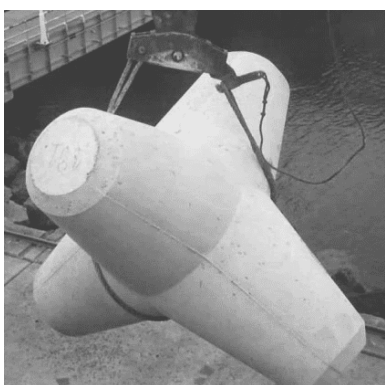
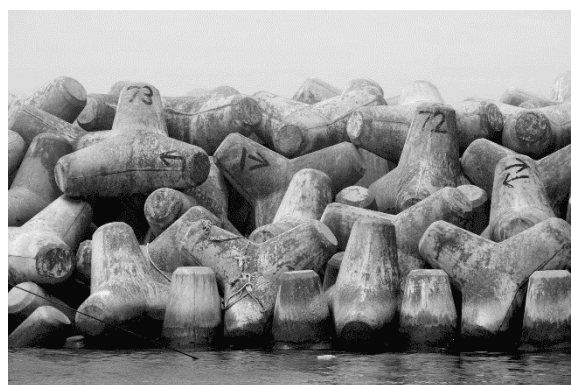
Figure 2.35 – (a) General view of a tetrapod unit; (b) Tetrapod armor layers for breakwaters

Tetrapods were the first interlocking armor units, and their main advantages were a slightly improved interlocking as compared to a Cube, and a larger void porosity of the armor layer, which increases wave energy dissipation and reduces the wave run-up (Bakker *et al.*, 2003). Tetrapods have four legs that irradiate from a central point, with leg diameters up to 2m and total tetrapod height over 4m (SOTRAMER, 1978) (Figure 2.35a). The average hydraulic stability and resistance of the Tetrapod are large. However, the structural stability is low, with a large risk of progressive failure (Bakker *et al.*, 2003). The cracking risk of this element is mainly relevant at the surface regions, during the initial setting and hydration of concrete (Azenha *et al.*, 2011). According with Van der Meer (1999), a Tetrapod armor layer has a void ratio of 48%. Tetrapods have been applied for breakwaters, seawalls, beach erosion control, as well as scour and bank protection (SOTRAMER, 1978) (Figure 2.35b).

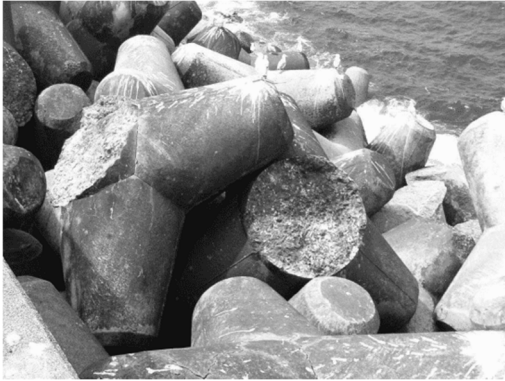
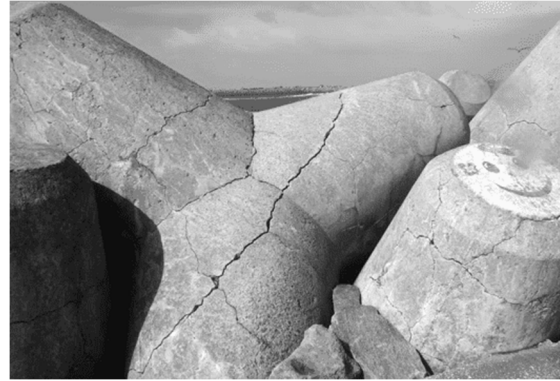
Figure 2.36 – (a) Rupture of tetrapod legs (b) Cracking of tetrapods

During their lifetime, the tetrapods are known to have severe degradation (mainly cracking) and premature rupture of their legs, when located in highly aggressive environments subjected to extreme wave action (as identified in the breakwaters located in the North of Portugal) (Figure 2.36).

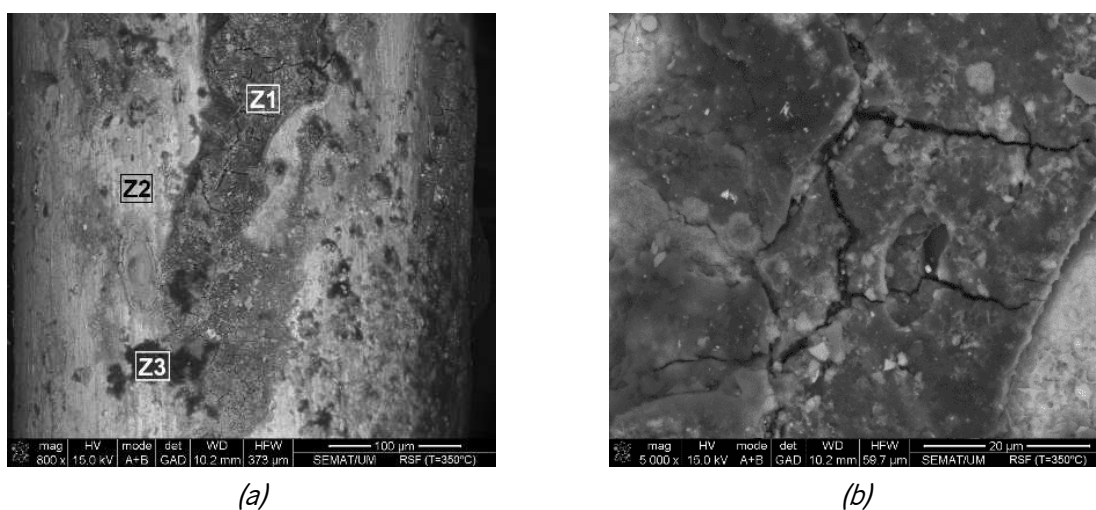
Figure 3.14 - SEM micrographs of the surface of a single RSF submitted to 350°C  
Magnification: (a) 1000x; (b) 5000x

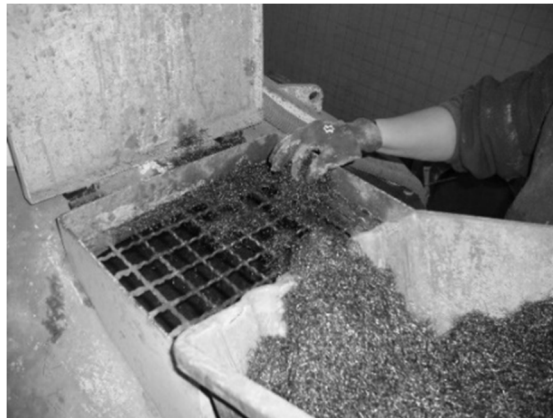
Figure 3.24 – Introduction of RSF into the concrete mixer

Planetary mixer of vertical axis was used to manufacture the RSFRC mixtures, with a volumetric capacity adequate to the quantity of concrete needed to produce the specimens. For every mixture, cement, fly ash, limestone filler, fine and coarse river sand, crushed granite, water, superplasticizer and RSF were weighed separately. The aggregates were first introduced into the mixer from the highest to the lowest aggregate dimension, i.e. first the crushed granites were added, then the coarse river sand and the fine river sand. After mixing for one minute, the necessary quantity of water was added to saturate the aggregate one more minute. The cement and fly ash/limestone filler were added, and later the remaining water. The superplasticizer was dissolved in the mixing water. Finally, without stopping the mixer, the RSF were gradually added to the mix by a metal grid where they were separated by hand, as can be seen in Figure 3.24. This process of RSF addition was crucial to assure a suitable distribution of RSF into the concrete matrix. After all the fibers have been added, the concrete was mixed during about five minutes, until it started to exhibit good homogeneity.

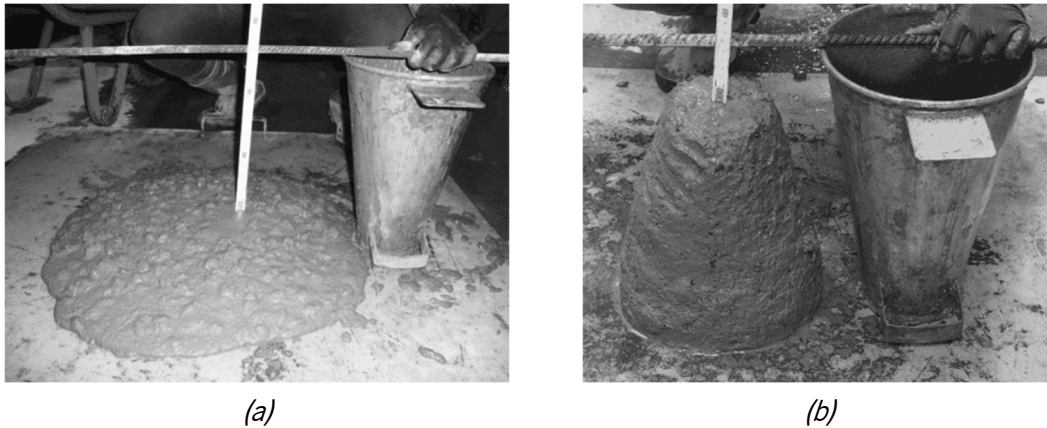
Figure 3.25 – Slump tests for a concrete reinforced with  $76 \text{ kg/m}^3$  of RSF  
 (a) Before and (b) After the addition of the RSF

After concrete producing and before casting the specimens, the workability of fresh fluid concretes (RSFRC0.8%) was determined by the slump-flow test, according to EN 12350-8:2010 while the workability of the remaining fresh concretes was determined by the slump test according to EN 12350-2:2009. Figure 3.25 depicts the final state of performed slump tests for a fresh mixture of RSFRC1%, before and after the addition of RSF, where an average flow reduction of 165 mm was observed after the addition of the fibers. The average slump-flow and slump values obtained for each produced RSFRC are presented in Table 3.20.

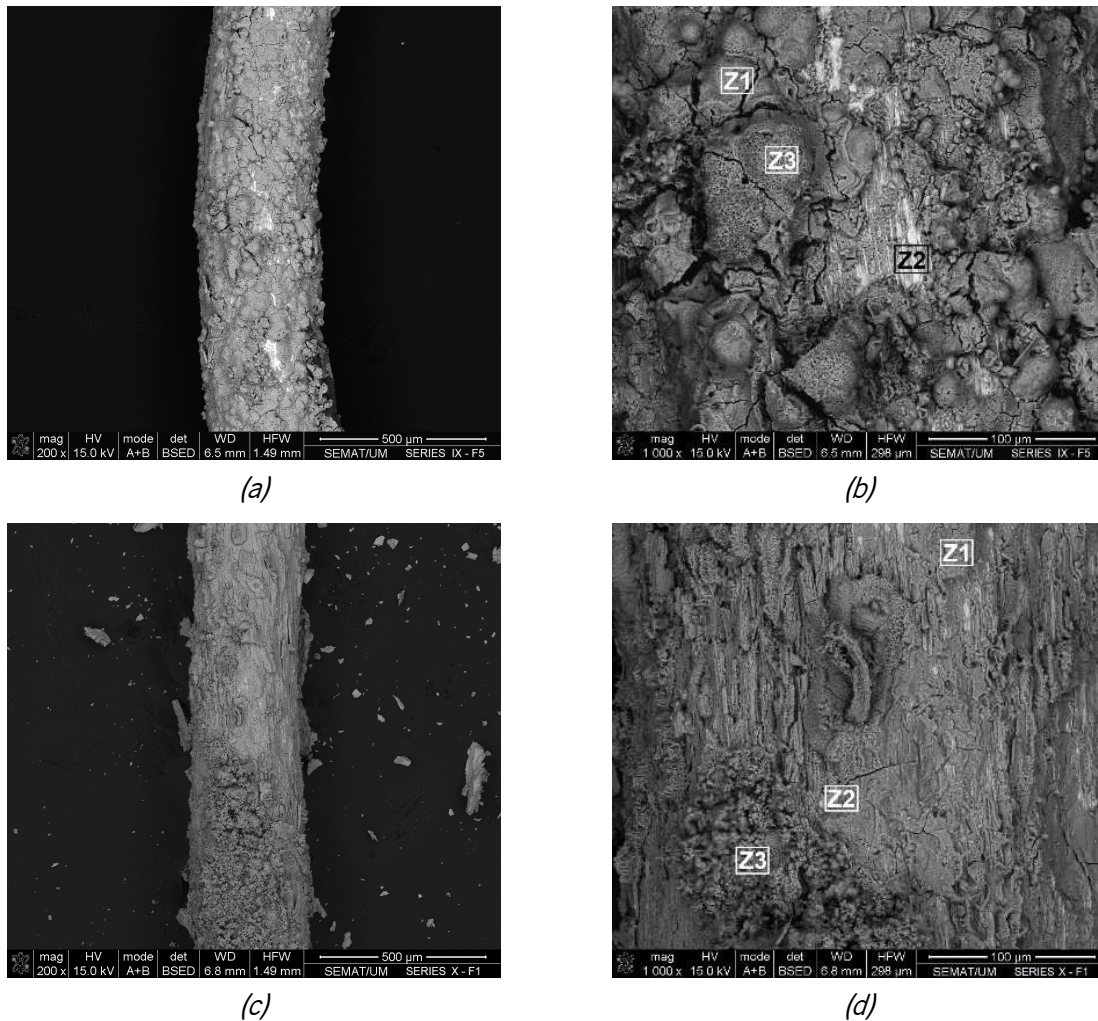
Figure 4.12 – SEM micrographs of the surface of one corroded polished RSF after:  
 Linear polarization (Series IX): Magnification: (a) 200x (b) 1000x  
 Linear polarization (Series X): Magnification: (c) 200x (d) 1000x

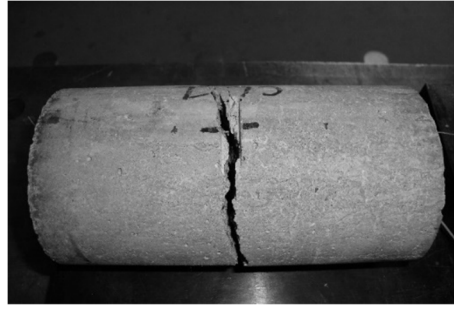
Figure 5.7 – Specimen of Series IV after four-point load bending test

The uncracked SCC specimens previously submitted to corrosion action (Series IV) were also subjected to four-point load bending test, according to the test configuration presented in Figure 5.4. Since these specimens were not cracked, a small notch with 5 mm of depth was implemented in the bottom part of the specimen (mid-length) in order to induce the crack surface crossing the embedded RSF (Fig. 5.7).

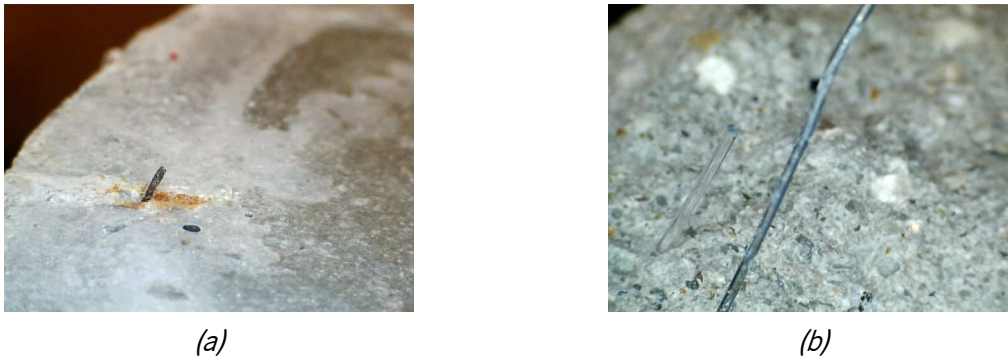
Figure 5.9 – Aspect of RSF after fiber pull-out test of: (a) SP1 (Series I); (b) SP11 (Series IV)

After performing all RSF pull-out tests in SCC specimens previously subjected to chloride immersion, corrosion products of RSF were visually observed at cracked surfaces, as shown in Figure 5.9a. On the other hand, no significant signs of corrosion were detected at RSF surface in uncracked specimens 10 and 11 (Figure 5.9b).

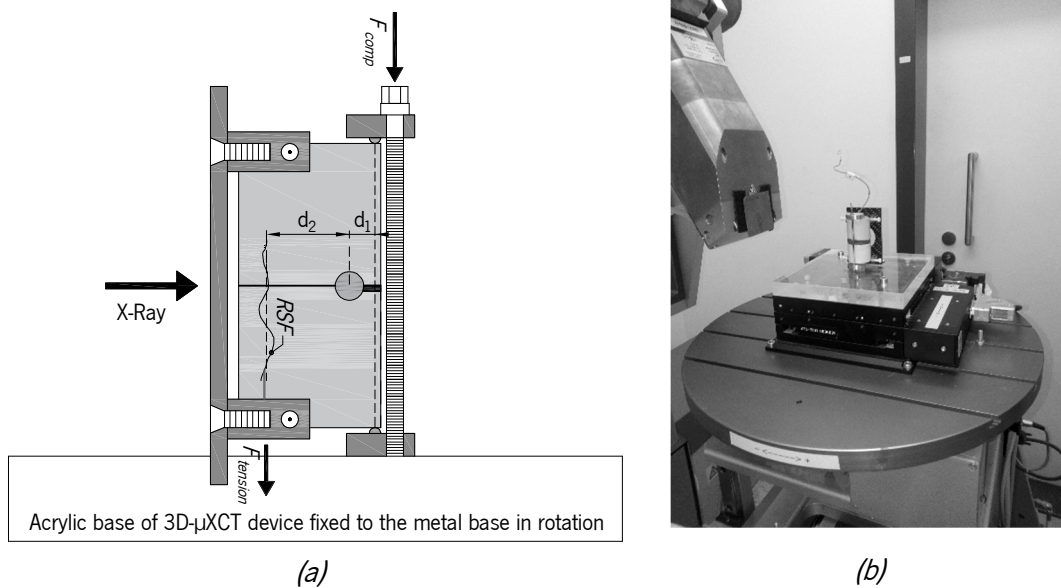
Figure 5.15 – (a) Fiber pull-out test setup defined to employ 3D- $\mu$ XCT; (b) Positioning of the mortar specimen for fiber pull-out test on the 3D- $\mu$ XCT device to be examine with X-ray imaging

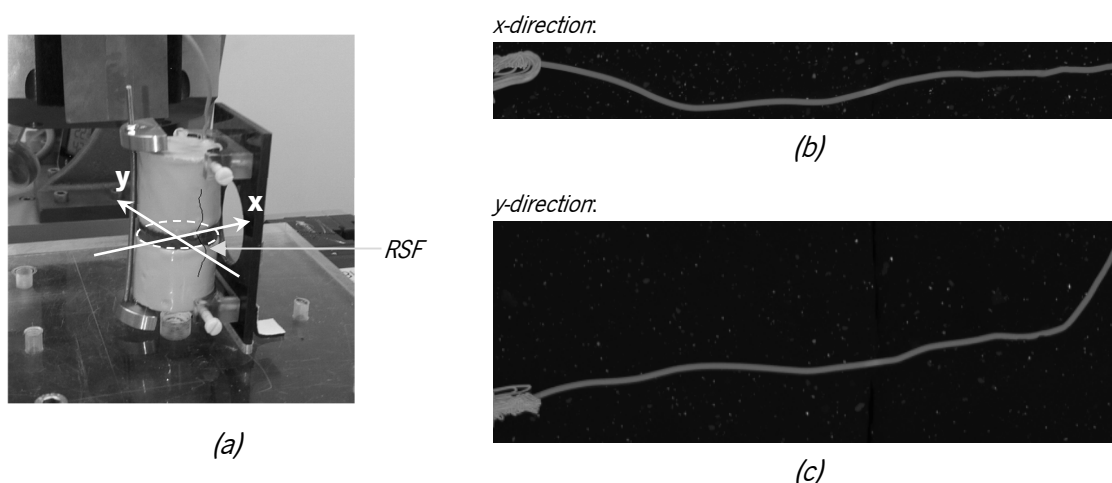
Figure 5.16 – (a) Identification of x- and y- direction defined for 2D-projection of the specimens; (b) 2D-Projection of RSF in x-direction; (c) 2D-Projection of RSF in y-direction

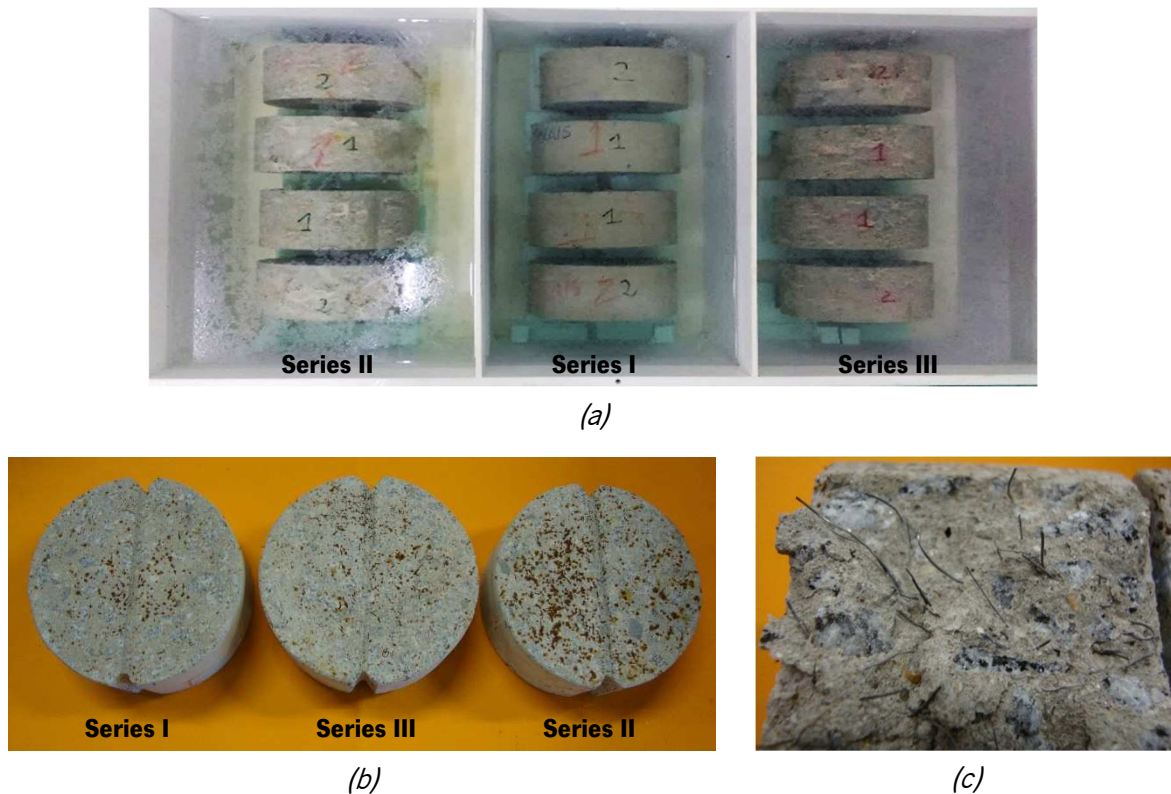
Figure 6.4 – Specimens subjected to 10 days of chloride immersion (Series I, II and III):  
 (a) Aspect of 3.5% NaCl solution; (b) Corrosion spots at exposed faces of the specimens (cut surfaces);  
 (c) RSF at crack surface of a specimen after DEWST with no visible signs of corrosion

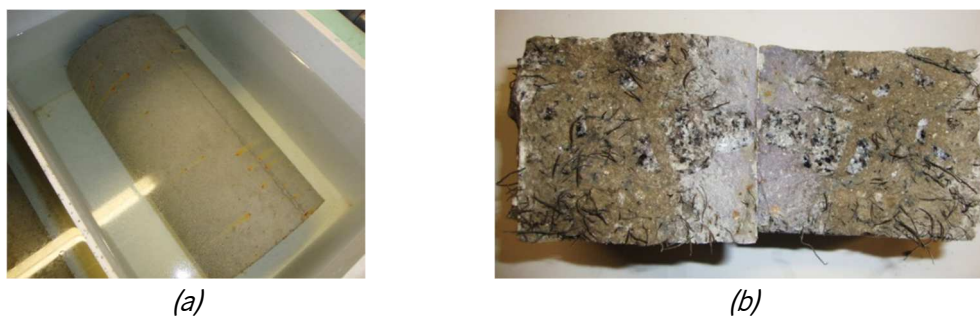
Figure 6.14 – Specimens after 3 months of chloride immersion (Series V): (a) Aspect of 3.5% NaCl solution and corrosion spots at exposed faces (b) Chloride penetration depth

After 3 months of chloride immersion, no significant increase was observed in terms of corroded material in the 3.5 wt% NaCl solution and corrosion spots at the exposed surfaces of  $\phi 150 \times 300$  mm cylinders (Figure 6.14a). An average internal depth of chloride penetration of 19.5 mm was measured by spraying with silver nitrate solution, which corresponds to 9.5 mm at crack surface, as observed in Figure 6.14b.

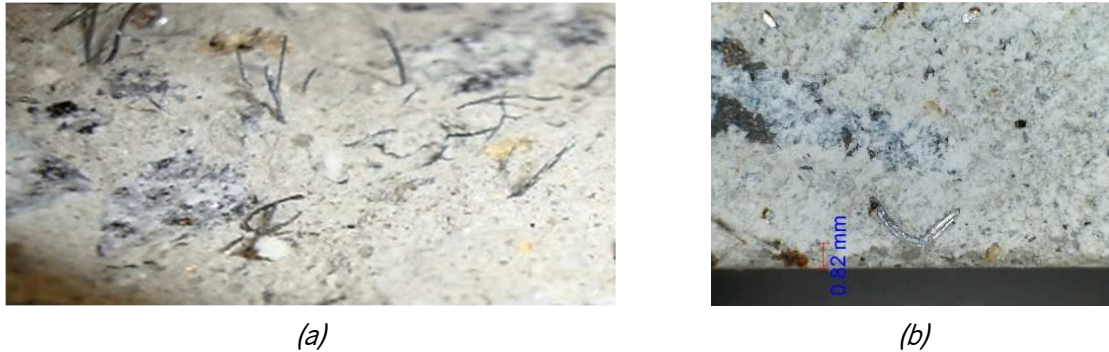
Figure 6.15 – Crack surface of specimens after 3 months of chloride immersion (Series V):  
 (a) General aspect of RSF (b) Corrosion sign on RSF near the exposed surface

Similar to Series IV, there were no significant signs of corrosion in the RSF at crack surface (Fig. 6.15a) and only few fibers near the exposed surface appeared to be corroded, as detected by microscopic analysis (Fig. 6.15b).

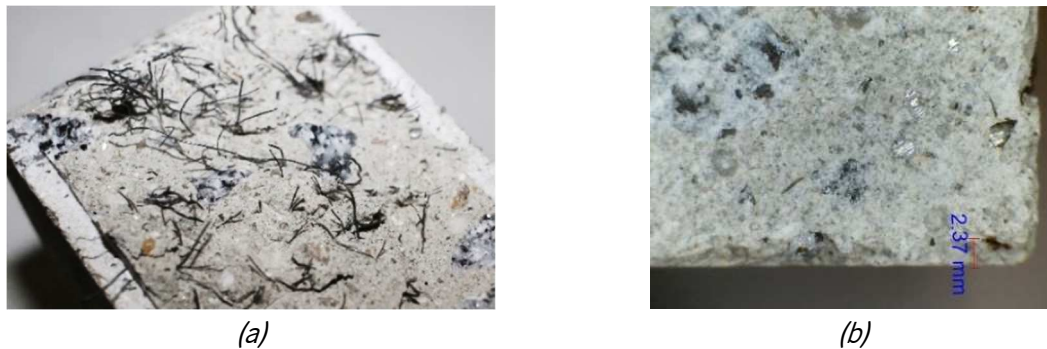
Figure 6.19 – Crack surface of specimens after 6 months of chloride immersion (Series VI):  
 (a) General aspect of RSF; (b) Corrosion sign on RSF near the exposed surface

No significant signs of corrosion in the RSF at crack surface were detected (Fig. 6.19a), and similar to Series IV and V, only a few fibers near the exposed surface appeared to be corroded (Fig. 6.19b).

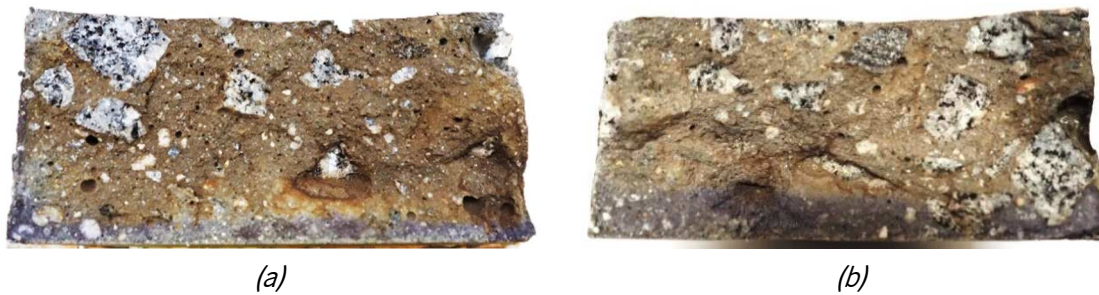
Figure 7.9 – Split section of PC cylindrical specimens:  
(a) after 10 days of immersion (b) after 3 months of immersion

The aging coefficients of the RSFRC1% and PC were determined considering the chloride diffusion coefficients calculated by the colorimetric method, in order to avoid making the most rigorous and difficult method of chloride profiles. Two cylindrical specimens ( $\phi 100 \times 50$  mm) of both RSFRC1% (RSFRC1%\_2 casting) and the corresponding plain concrete (PC) were submitted to chloride immersion in a 3.5 wt% NaCl solution. For these tests, it was used the same immersion container of the cubic specimens shown in Figure 7.8a. The lateral and upper (end) faces of each cylindrical specimen were waterproofed with a single layer coating, in order to restrict the penetration of chlorides from the bottom surface (sawn face). One specimen of RSFRC and one of PC were submitted to 10 days of continuous immersion and the remaining two specimens (one of RSFRC and one of PC) were subjected to 3 months of continuous immersion. After these exposure periods, the specimens were axially split, and a silver nitrate ( $\text{AgNO}_3$ ) solution was sprayed on to one of the freshly split sections (Figure 7.9).

The chloride penetration depth was measured from the visible white silver chloride precipitation (Fig. 7.9), where free chlorides have penetrated into concrete. The values of the chloride diffusion coefficient,  $D_c$ , were determined according to the assumptions indicated by Yang *et al.* (2014), considering the following equation:

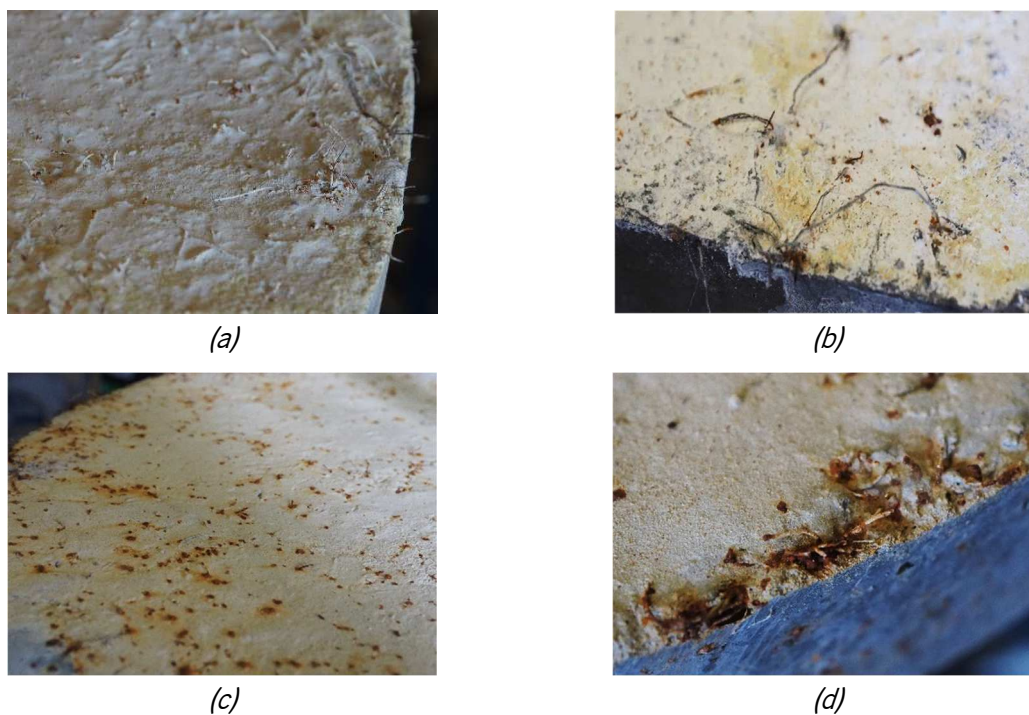
Figure 7.15 – Corrosion spots at exposed surfaces of RSFRC Panels:  
 (a) and (b) After 10 days of chloride immersion;  
 (c) and (d) After 3 months of dry-wet cycles in chloride solution

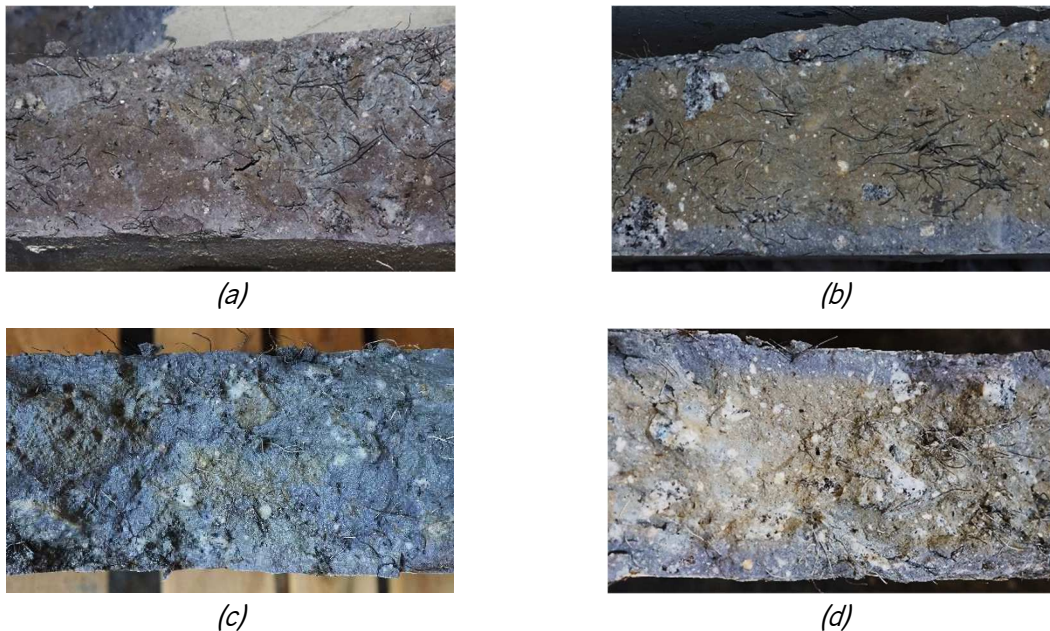
(a) (b)  
(c) (d)  
Figure 7.17 – Chloride penetration depth at cracked surfaces:  
After 10 days of chloride immersion: (a) Pre-cracked panels; (b) Non-cracked panels  
After 3 months of dry-wet cycles in chloride solution: (c) Pre-cracked panels; (d) Non-cracked panels

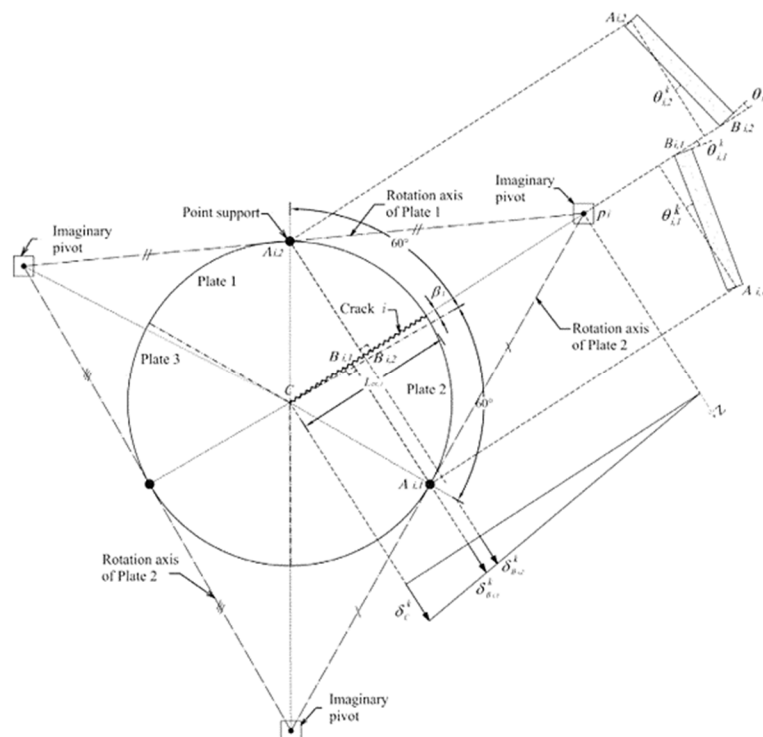
Figure 7.37 – Crack rotation analysis in RPT-3ps (symmetric crack propagation) (Salehian *et al.*, 2014)

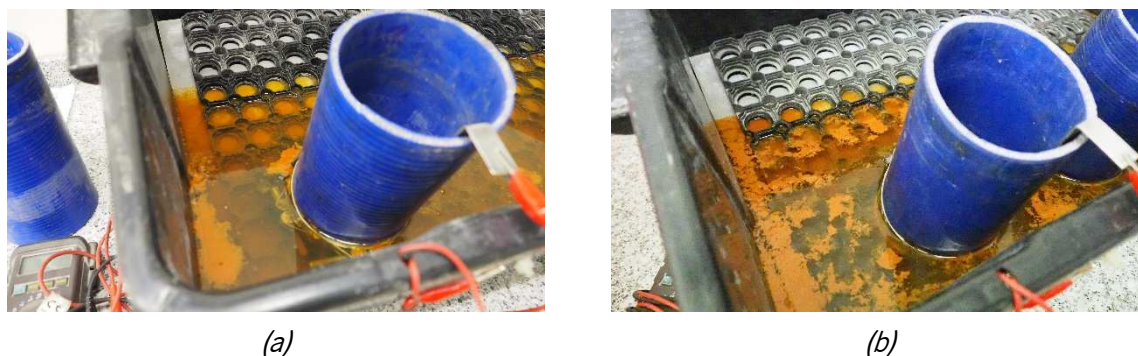
Figure 7.45 – Chloride migration tests carried out with specimens made with:  
 (a) The RSFRC1%\_2 casting and (b) The RSFRC1%\_4 casting

During the chloride migration tests described in Section 7.2.4.1, an increased formation of corroded material could be observed in the cathodic solution used to test RSFRC specimens, as shown in Figure 7.45. This fact happened due to the corrosion of fibers located on the specimen surface (cut surface) directly exposed to the chloride (catholyte) solution.

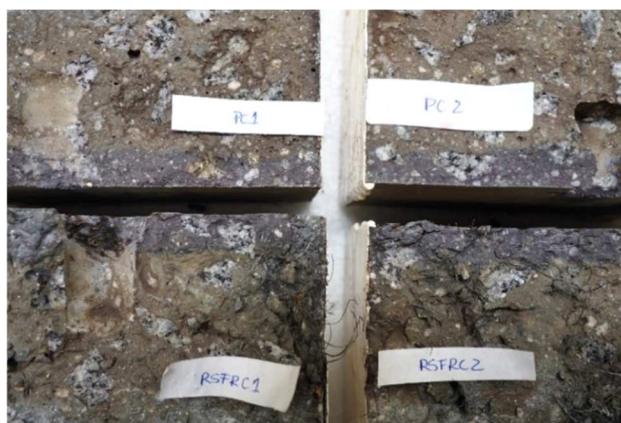
Figure 7.47 – Chloride penetration depth in RSFRC and PC cubes after 3 months of immersion

This simple colorimetric method was also used for measuring the chloride penetration depth into the 4 cubic specimens of RSFRC and PC used in the tests described in Section 7.2.4.2. After the determination of chloride profiles (Fig. 7.47), the 4 cubic specimens were axially split, and the 0.1 N AgNO<sub>3</sub> solution was sprayed on to one freshly split section (Figure 7.47).

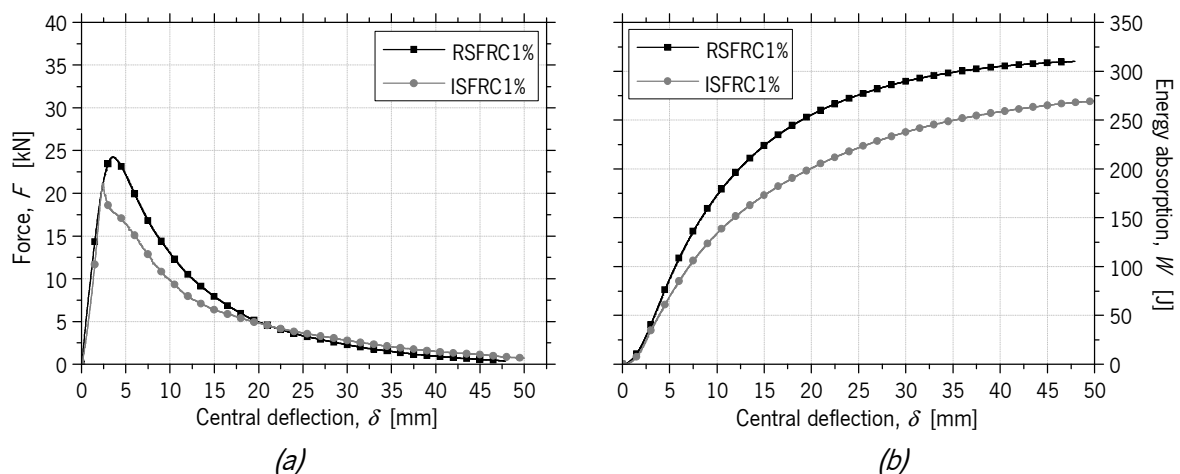
Figure 8.2 – (a) Average force versus central deflection, and (b) Average energy absorption versus central deflection of RSFRC1% and ISFRC1% panels

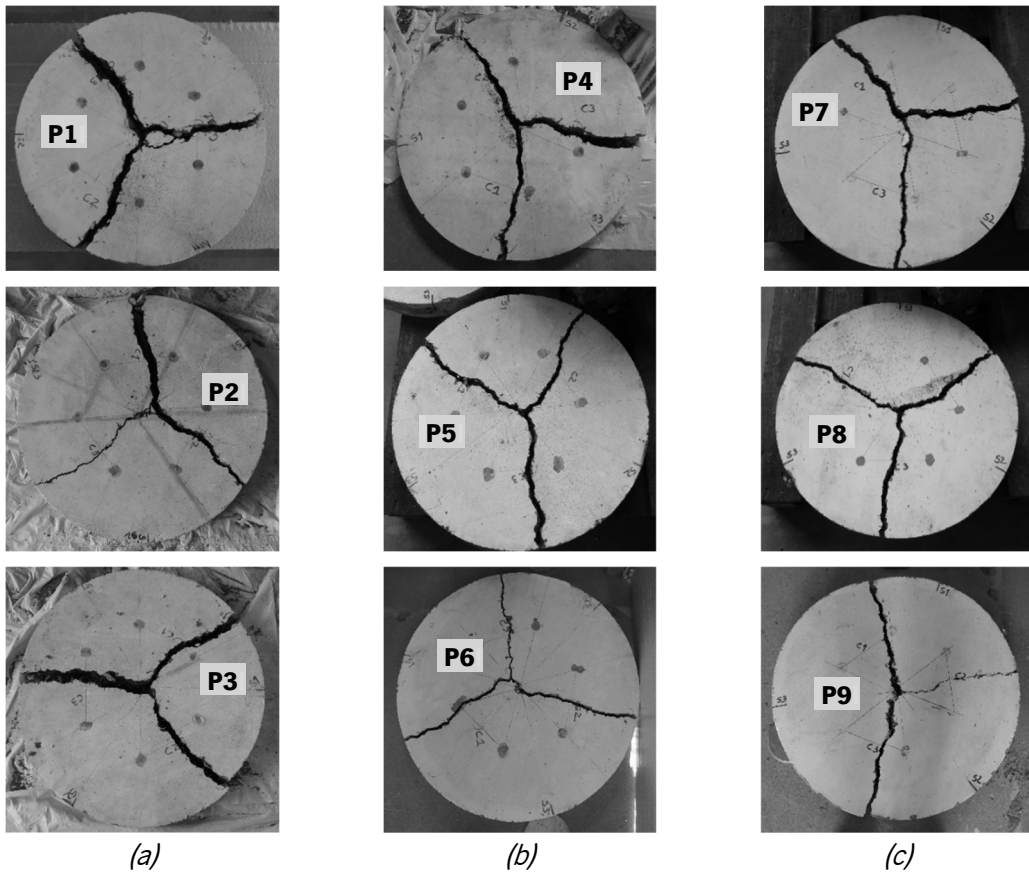
Figure D.1 – Crack patterns of the round panels of: (a) Series I\_CI; (b) Series II\_CI; (c) Series III\_CI

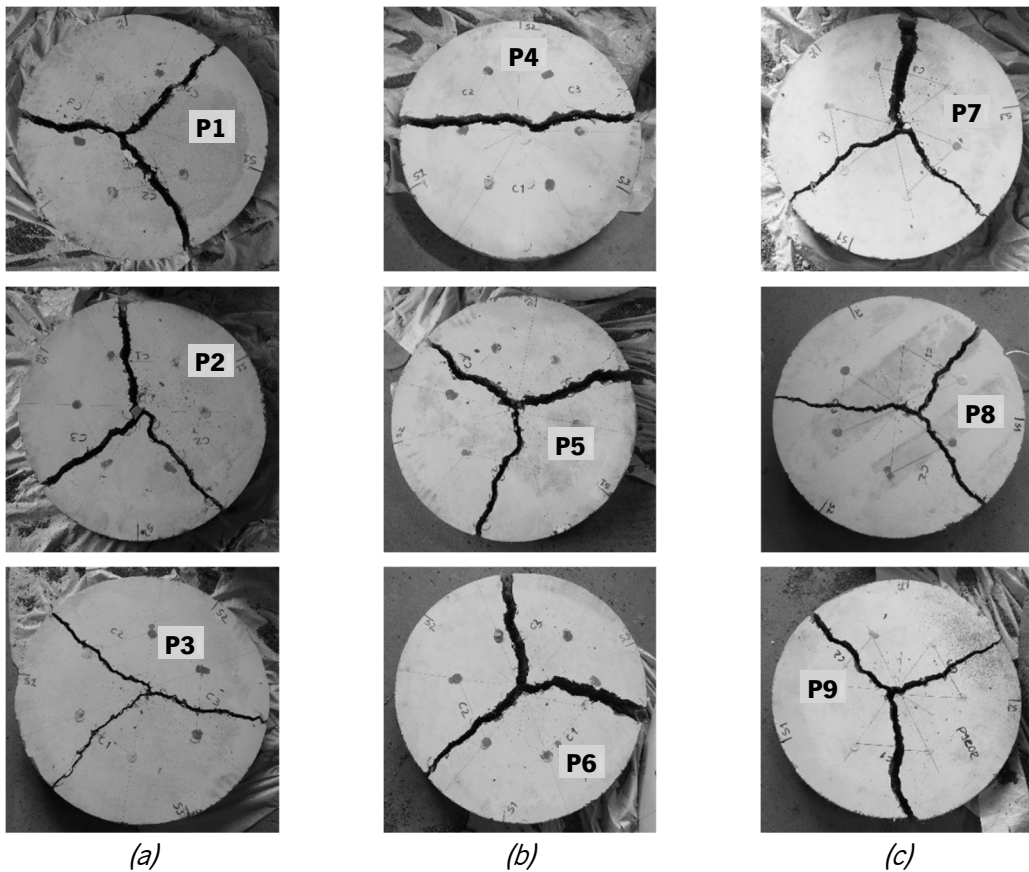
Figure D.2 – Crack patterns of the round panels of: (a) Series I\_REF; (b) Series II\_REF; (c) Series III\_REF

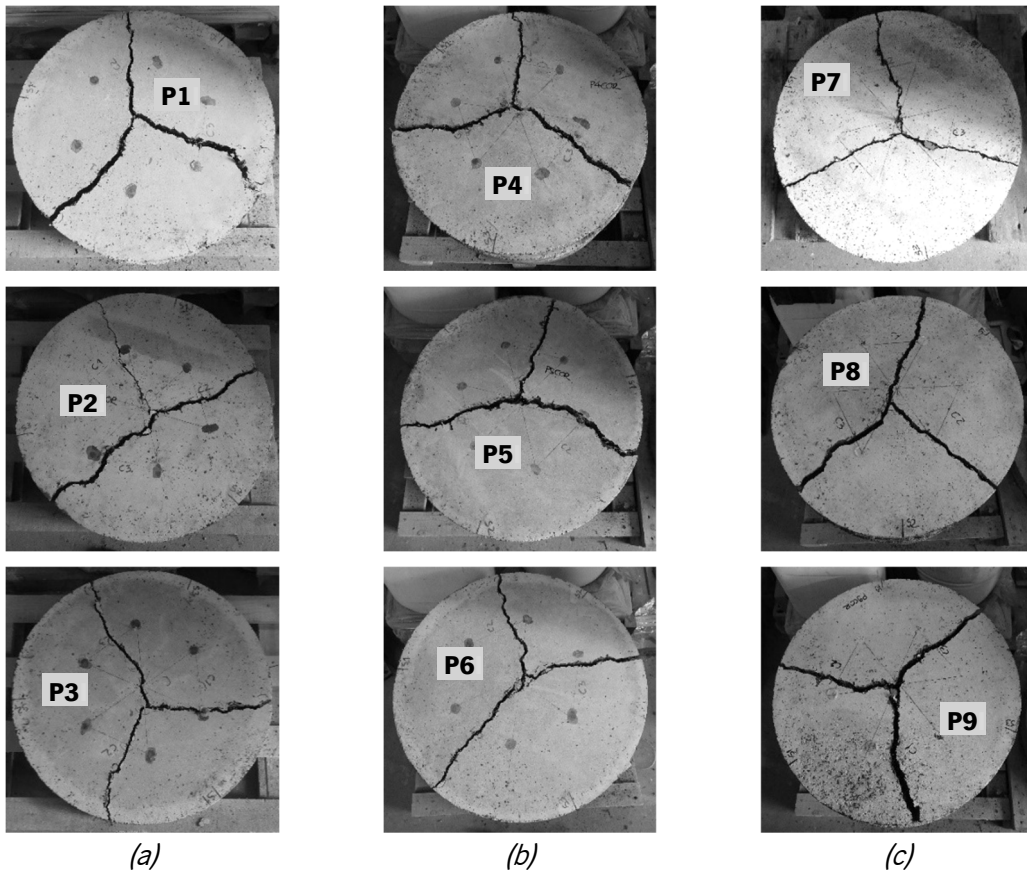
Figure D.3 – Crack patterns of the round panels of: (a) Series IV\_CI; (b) Series V\_CI; (c) Series VI\_CI

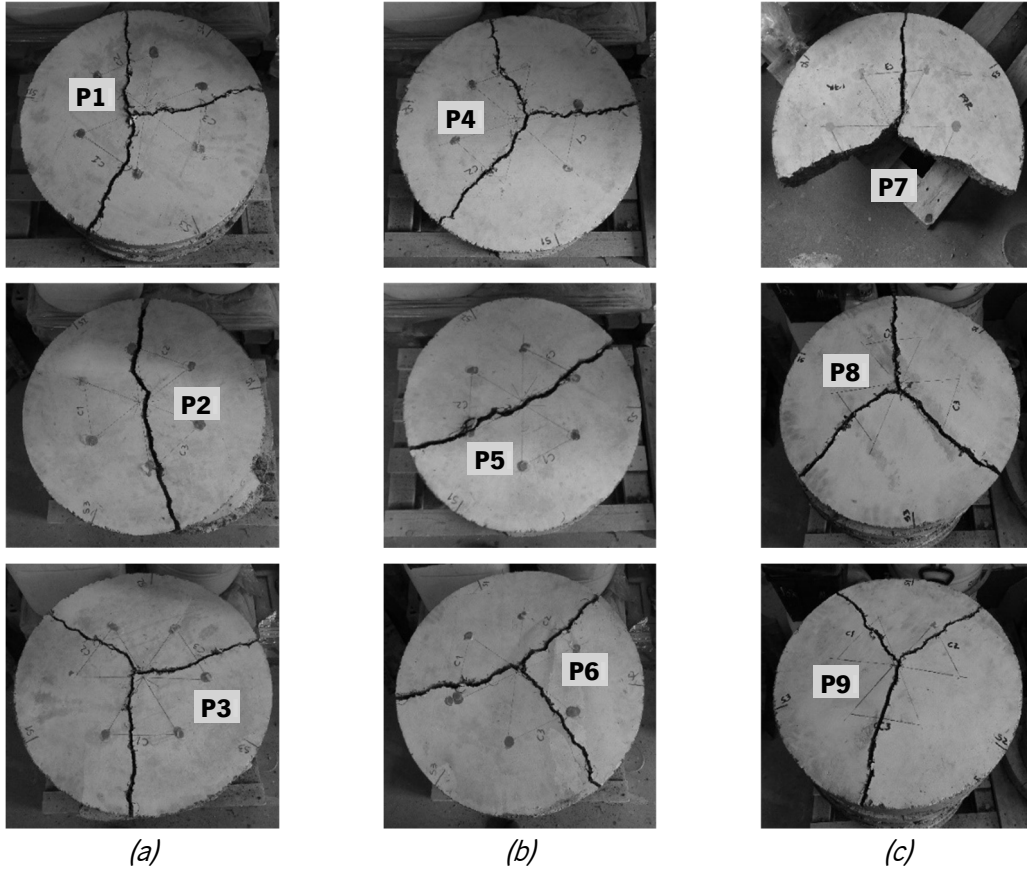
Figure D.4 – Crack patterns of the panels of: (a) Series IV\_REF; (b) Series V\_REF; (c) Series VI\_REF
