Experimental characterization of the deterioration of masonry materials due to wet and dry and salt crystallization cycles

Abstract. Considering that by 2050 the effects of climate change around the world will cause extreme conditions for the built environment, particularly for historic masonry constructions, it is important to understand in more detail the effect of different environmental conditions on the durability of masonry of stone. In this work, an experimental characterization of the deterioration process of the stone masonry submitted to wet and dry and salt crystallization cycles is presented and the results are discussed. For this, the effect of these conditions on the mechanical behavior under compression of stone masonry was evaluated. For the tests, samples composed of two and three units respectively were adopted. The experimental campaign was divided into two phases: (1) water absorption cycles by capillarity (clean water and water with a concentration of 3% and 10% sodium chloride) and drying cycles in samples at 60°C. Sodium chloride was selected because it is often found in old buildings subject to cycles of humidity. For this, a special setup was designed to p

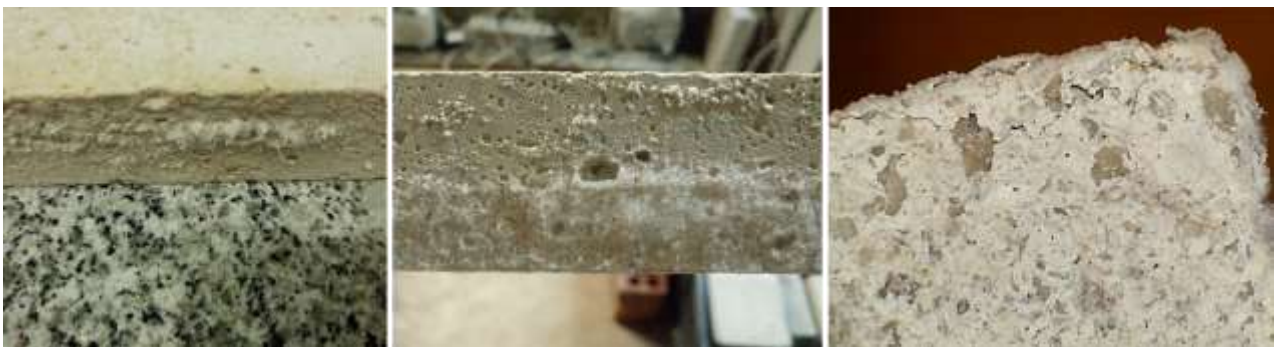
Figure 1. Lime mortar specimen subjected to 6 cycles in water with 10% NaCl concentration

The samples of lime mortar after wet and drying cycles present a change in hue, ranging from a light cream color to a darker and yellowish color for all three concentrations studied. For the samples placed in 3% and 10% NaCl solutions, the efflorescence was visible from the third cycle as a thin and discontinuous layer of white particles, which evolved throughout the six cycles to become settlements with appearance of "fluff" without compaction, fragile to the touch, see Figure 2. This characteristic shape grows from an almost dry surface, which receives the solution in a punctual manner through the substrate forming very thin and elongated acicular crystals called "whiskers" [11].

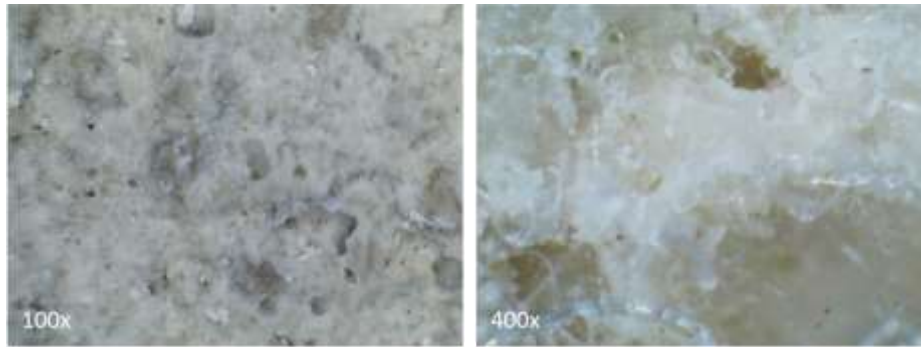
Figure 2. Amplified images of the interior of the lime mortar subjected to 6 cycles in water with 10% NaCl concentration

Another important consequence is the presence of micro cracks. In reference to the subflorescence, Figure 3 shows a comparison at two different scales under the lens of the microscope, the inside of the mortar specimens affected by the solution of higher salt concentration (10% NaCl) after the 6 cycles. The image amplified by 100x shows traces of salt crystals nested in the pores with greater dimension, and the image amplified by 400x shows the existence of internal "whiskers" on a layer of smooth and crystalline appearance.

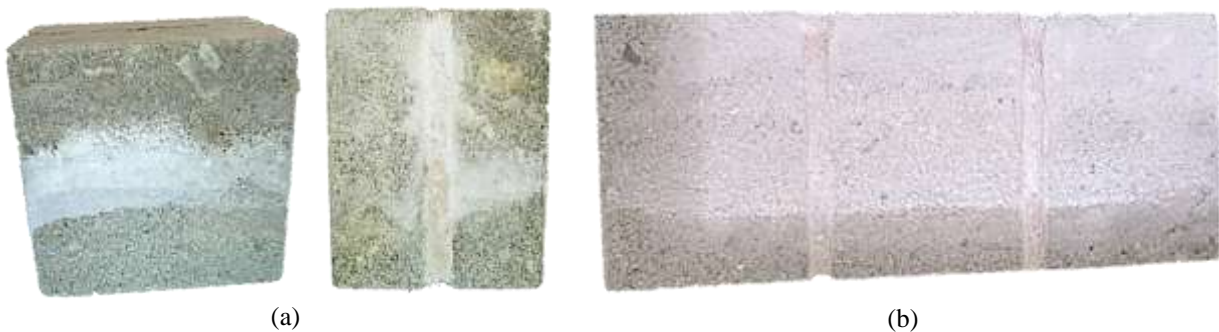
Figure 3. Visual aspect of masonry after the crystallization cycles on 10% NaCl water concentration; (a) duplet specimens; (b) triplet specimens

The masonry specimens placed in the solution with 3% NaCl showed a slow advance of precipitations evident from the third cycle, as spots existing in the upper two thirds of the block. Regarding the specimens placed in 10% NaCl water concentration, the first evidences of efflorescence were seen at the end of the first cycle (46 hours). Their evolution on the specimen shows the consolidation in several layers of the efflorescence located in greater concentration in the center of the specimen between 7 and 10 cm in height in the ascending direction. In addition, a concentration of precipitations was recorded in the mortar-block interface and a slight wear of it, as shown in Figure 4.

As for the triplets of $200 \times 150 \times 480 \text{ mm}^3$, the efflorescence was present in the 3% NaCl samples at the end of the fourth cycle, while in the 10% NaCl samples a slight layer of salt was observed finishing the second cycle. Figure 5 shows that at the end of the sixth cycle in the samples at 10% NaCl, a less dense but homogeneous layer was formed on the top of the specimens, probably due to the size of the sample as it increased the distance to the front of precipitation.

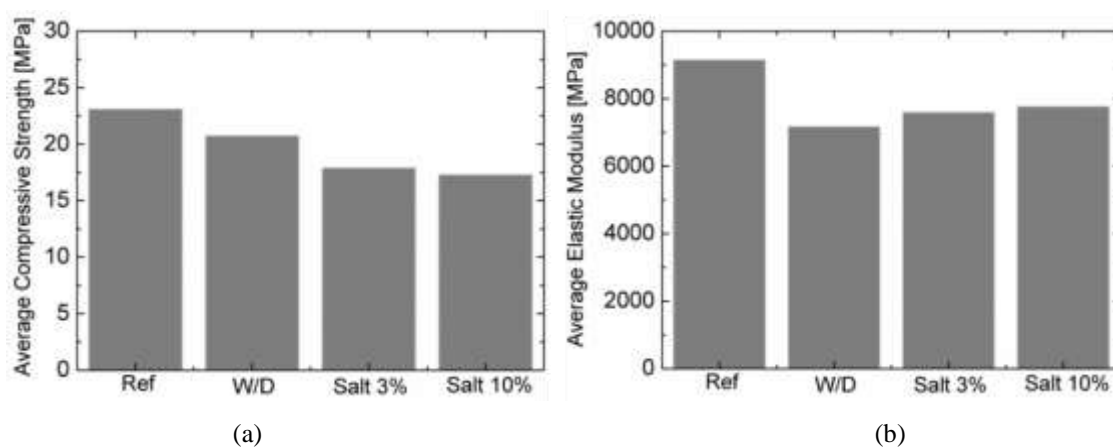
Figure 4. Comparison of mean values of the mechanical characteristics of the masonry prism before and after cycles
(a) Compressive strength (b) Elastic Modulus

The masonry prisms tested in uniaxial compression [8] show a reduction in the mechanical properties, namely compressive strength and modulus of elasticity with respect to the reference specimens. The data shown in Figure 5a shows a decrease on the compressive strength in masonry prims for increasing salt concentration. A reduction of about 25% was recorded in the masonry specimens placed in the 10%NaCl concentration solution. Regarding the variation of the mean values of the modulus of elasticity (Figure 5b), it is seen that a general decrease is observed for the three groups of test pieces compared to the reference module of between 15 to 20%. It is observed that the test pieces subjected to wet and dry cycles in 0% NaCl showed a significant decrease on the elastic modulus when compared to the reference masonry prisms. The masonry prims subjected to wet and dry cycles in salty concentration exhibit also a reduction on the elastic modulus but slightly lower when compared to the previous specimens. The salt concentration appears also not to have a significant influence on the modulus of elasticity.
