Experimental investigation of the behaviour of injection anchors in rubble stone masonry

Maria Pia Ciocci^{a,b}, Serena van Nimwegen^a, Arash Askari^a, Francesco Vanin^c, Paulo B. Lourenço^b, Katrin Beyer^{a,*}

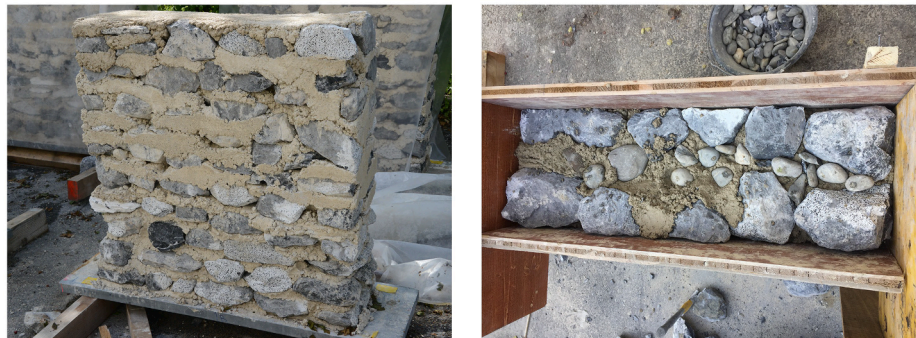
Fig. 2. Construction of the masonry walls.

Each wall was constructed on a 35-mm-thick steel plate. To increase the friction between the plate and wall base, the surface of the plate was roughened by a thin layer of sand and epoxy, and a timber formwork was used to maintain the correct dimensions and verticality during their construction (Fig. 2). For PAT specimens, the timber joist was positioned when the wall was built to 500 mm and then was surrounded by mortar

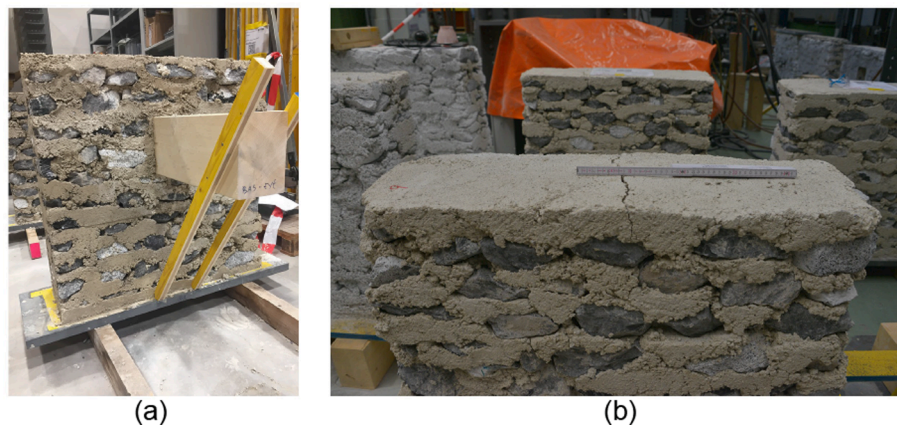
Fig. 3. PAT specimens: (a) construction; (b) existing crack (back view of the wall).

specimens were supported to prevent any rotation due to their weight (Fig. 3a). However, damage was still observed in these specimens before testing, possibly due to shrinkage and expansion of the masonry walls and timber joists. For all PAT specimens, a well-defined crack occurred from the top of the joist pocket up to the top face of the wall where the crack then crossed the entire wall thickness, with a maximum width of about 5 mm (Fig. 3b). Barring the first specimen, the existing cracks in the PAT specimens were repaired via grout injection before performing pull-out tests.

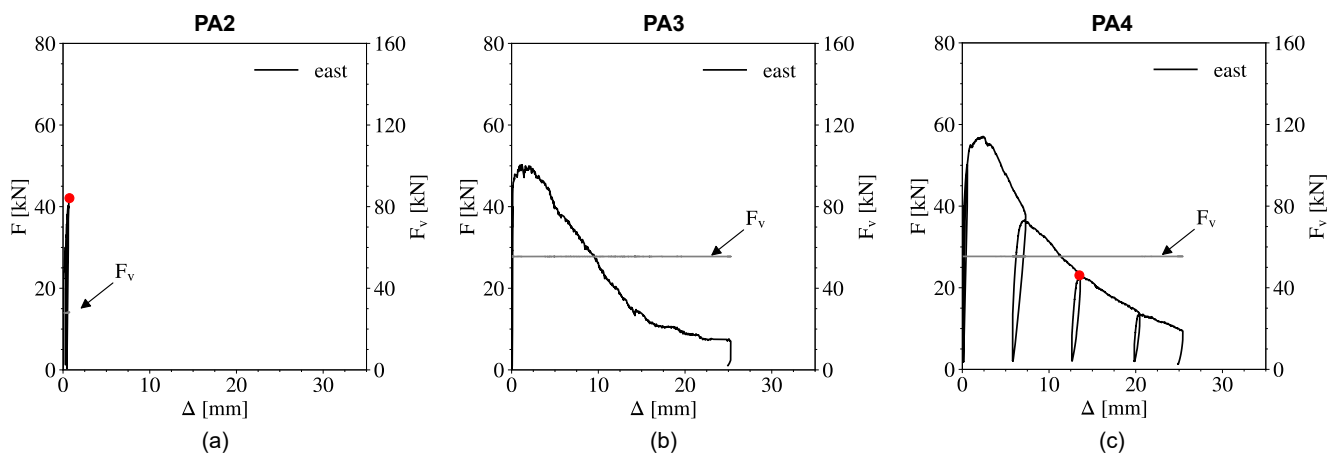
Fig. 7. Force-displacement curves obtained for PA specimens: (a) PA2; (b) PA3; (c) PA4. The red circles mark the step for which the DIC results are plotted in Fig. 8. (For interpretation of the references to colour in this figure legend, the reader is referred to the web version of this article.)

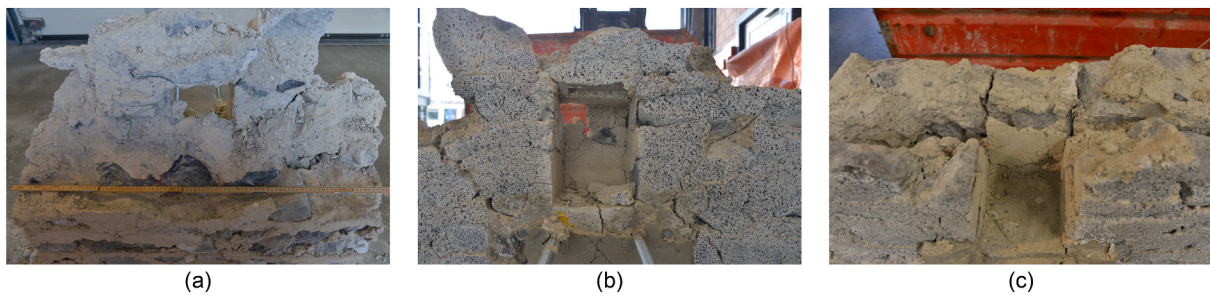
Fig. 16. Common features observed for PAT specimens: (a) top view of the breakout failure (PAT2); (b) damage at the joist pocket (PAT2); (c) cracks behind the joist pocket (PAT4).

For all PAT specimens, breakout failure occurred, and the masonry blocks that formed around each anchor overlapped. Notably, the failure in these specimens involved the masonry portion surrounding the joist pocket (Fig. 16a), and significant damage occurred at the back face of the pocket, especially at the top (Fig. 16b). Behind the joist pocket, cracks were also found in the masonry leave at the back of the walls, as shown in Fig. 16c. As a result, the breakout failure block had a rather complex shape for these specimens. Regarding the timber beam embedded in the masonry, no damage was observed.

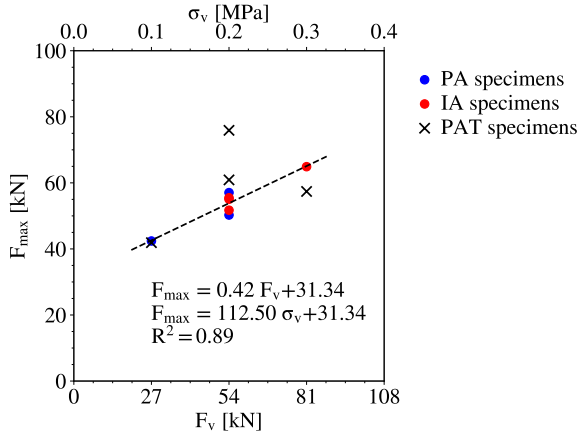
Fig. 17. Peak pull-out force values obtained for the adopted testing configurations under different vertical loading values. Note that the equations and the R^2 value were calculated considering only PA and IA specimens. In the reported equations, F_v must be given in kN, σ_v must be given in N/mm² or MPa and F_{max} is obtained in kN.

clearly observed for the PA and IA specimens, as shown in Fig. 17. For these tests, the value of F_{max} increased linearly with an increasing overburden stress in this study ($R^2 = 0.89$). This trend was also observed in the post-peak behaviour of IA4. Notably, the 10 kN drop in F that occurred when the F_v value was decreased from 81 kN to 54 kN is similar to the increase in value of F_{max} that was obtained for this specimen when compared to IA specimens tested under $F_v = 54$ kN (Fig. 10). The increase in pull-out load capacity with increasing vertical loading was also confirmed by the results obtained for the PAT specimens except PAT4. Besides the possible presence of pre-test damage, this might also be related to the fact that the free end of the west anchor of this specimen was embedded in mortar rather than stone (see Section 3.3.2), resulting in a lower pull-out load resistance value.

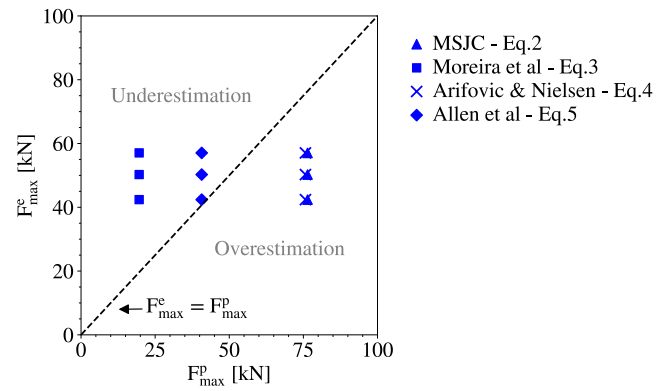
Fig. 19. Comparison between the experimental (F_{max}^e) and predicted (F_{max}^p) values for PA specimens using Eqs. (2)–(5).

selected equations (F_{max}^p) and the experimental results (F_{max}^e). To weigh the effectiveness of each formulation, the mean absolute error (MAE) and the mean absolute percentage error (MAPE) are reported in Table 7. The formulas provided by the MSJC [28] and Arifovic and Nielsen [20] predict very similar values for the pull-out load capacity, both overestimating the experimental results. Conversely, Eq. (3) proposed by Moreira et al. [33] significantly underestimates the experimental values. A good correlation could be obtained by adopting a value of $\kappa_1 = 0.22$. Though this κ_1 value is in the proposed range, it is noted that it does not satisfy the relationship between the compressive and tensile strengths of masonry using the results from characterisation tests as proposed by Moreira et al. [33], i.e. $f_t \neq \kappa_1 \sqrt{f_m}$ (refer to Section 4.1.1). Equation (5) proposed by Allen et al. [43] correlates better with the experimental results, though the experimental results are still underestimated. This is reflected in Table 7, where this formula reaches the smallest prediction errors. Fig. 19 shows the values obtained for each of the PA specimens when applying Eq. (5). It is noted that Eq. (5) yields the best prediction for PA2, which is the specimen that was subjected to lowest vertical load (0.1 MPa). The reason for the good correspondence might lie in the fact that Eq. (5) does not account for the effect of the vertical load on the pull-out capacity. Neglecting the effect of the vertical load might therefore lead to larger errors for PA3 and PA4, which were subjected to higher vertical loads.

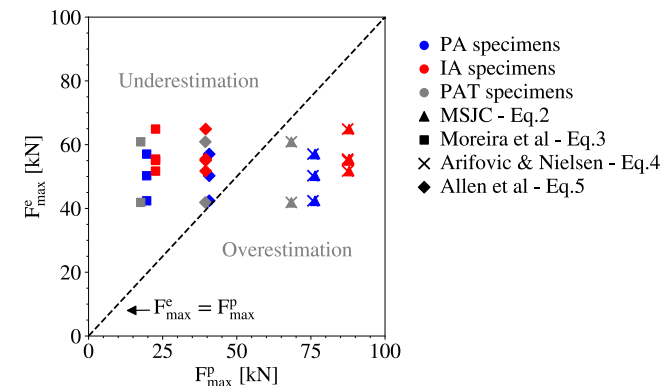
Fig. 20. Comparison between the experimental (F_{max}^e) and predicted (F_{max}^p) values for all testing series using Eqs. (2)–(5).

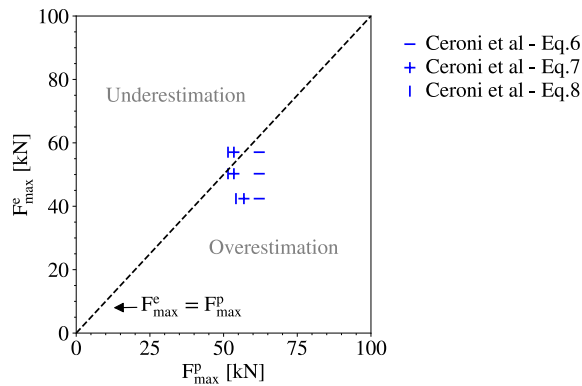
Fig. 21. Comparison between the experimental (F_{\max}^e) and predicted (F_{\max}^p) values for PA specimens using Eqs. (6)–(8).

The results obtained by comparing the values predicted by Eqs. (6)–(8) with the experimental results are presented in Fig. 21 and Table 9. Accounting also for the influence of overburden stress, Eqs. (7) and (8) are better at predicting the experimental values. When compared to Eq. (7), Eq. (8) shows lower values of MAE and MAPE (6.2 kN and 0.13, respectively), possibly as it was calibrated on a larger set of experimental results. However, it is to be noted that when applying Eqs. (7) and (8), the predicted value obtained for $\sigma_v = 0.20$ MPa is lower than the value calculated for $\sigma_v = 0.10$ MPa (Fig. 21), which is in contradiction to the trends observed in experimental results. This might be due to the fact that, as a result of the lack of experimental data in literature, the adopted database included a limited number of tests which failed for masonry breakout and where the overburden stress was varied.
