Application of radar techniques to the verification of design plans and the detection of defects in concrete bridges

Paulo J.S. Cruz^{a*}, Lukasz Topczewski^a, Francisco M. Fernandes^a, Christiane Trela^b and Paulo B. Lourenço^a

^aDepartment of Civil Engineering, University of Minho, Guimarães, Portugal; ^bFederal Institute for Materials Research and Testing (BAM), Berlin, Germany

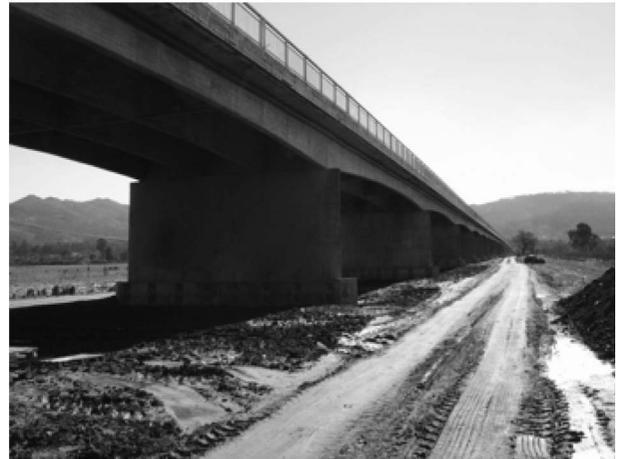
Figure 4. Lanheses Bridge.

The Lanheses Bridge is illustrated in Figure 4. It is a cantilever bridge with a total length of 1218 m between abutments and the width of the bridge deck is 11.5 m. The superstructure, in reinforced and prestressed concrete, consists of four longitudinal beams with variable inertia, connected superiorly by the deck's slab and transversally by beams located over the columns and at thirds of the spans. The bridge presents, along its length, typical spans of 30.0 m, with the exception of the approach spans, which have a length of 24.0 m.

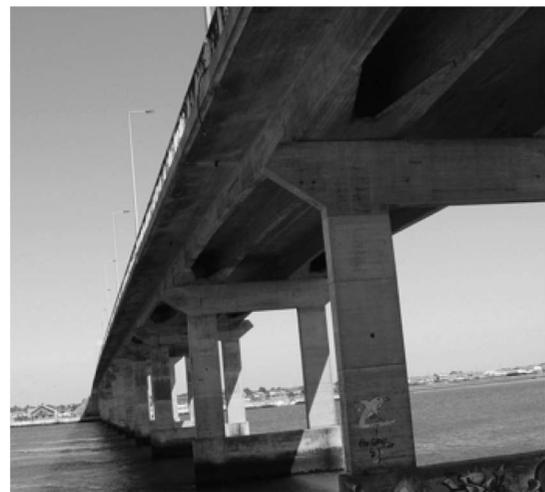
Figure 5. Barra Bridge.

The Barra Bridge, which crosses the delta of the Vouga River ('Ria de Aveiro'), in Ílhavo, was also designed by Edgar Cardoso in 1972 and was built in 1978. Currently, this bridge suffers from significant deterioration caused by contact with seawater, an aggressive environment and nearly 30 years of service-life. Figure 5 illustrates a general view of the structure. The total length of the bridge is about 620 m between the abutments, and the width of the bridge deck is 15.9 m. The bridge deck is composed of reinforced concrete that is supported by four longitudinal beams of variable inertia and box-girders over the bridge

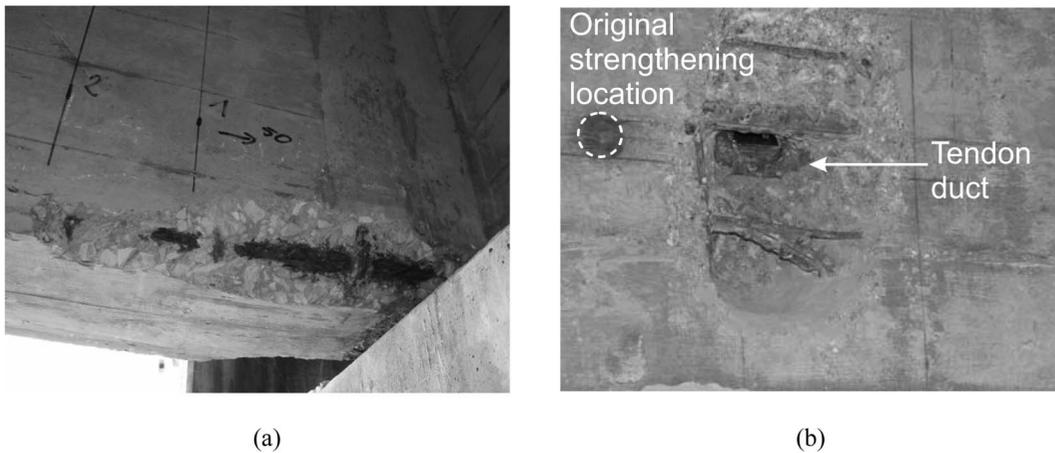
Figure 6. Example of: (a) corrosion of the reinforcement in the Barra Bridge, and (b) window opened in a longitudinal beam for the detection of tendon ducts in the Lanheses Bridge.
