## **Seismic strengthening of beam-column joints with multi-directional CFRP laminates**

Mário Coelho, Pedro Fernandes, José Sena Cruz, Joaquim Barros

Technical Report 11-DEC/E-13

Technical report developed under the scope of project  
*PTDC/ECM/74337/2006.*

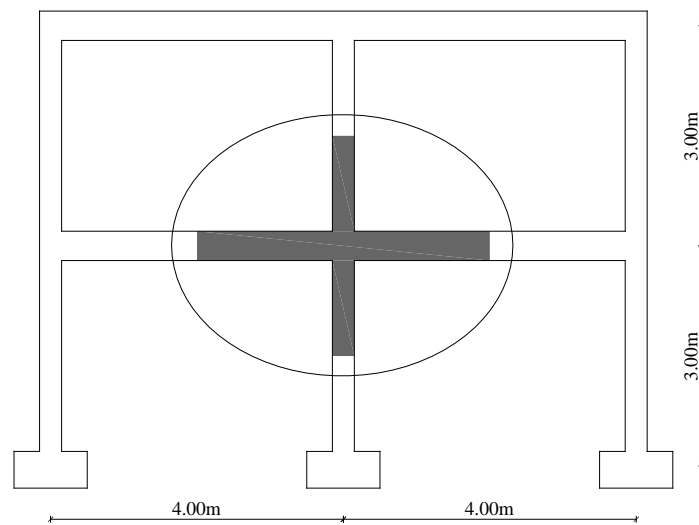
Figure 1 – Type of joint studied.

In this work, three interior joints like the one shown in Figure 1 were selected. Those were intended to simulate the connection of two beams with  $0.30 \times 0.40 \text{ m}^2$  cross section and 4 m span length and two columns with  $0.30 \times 0.30 \text{ m}^2$  cross section and 3 m length.

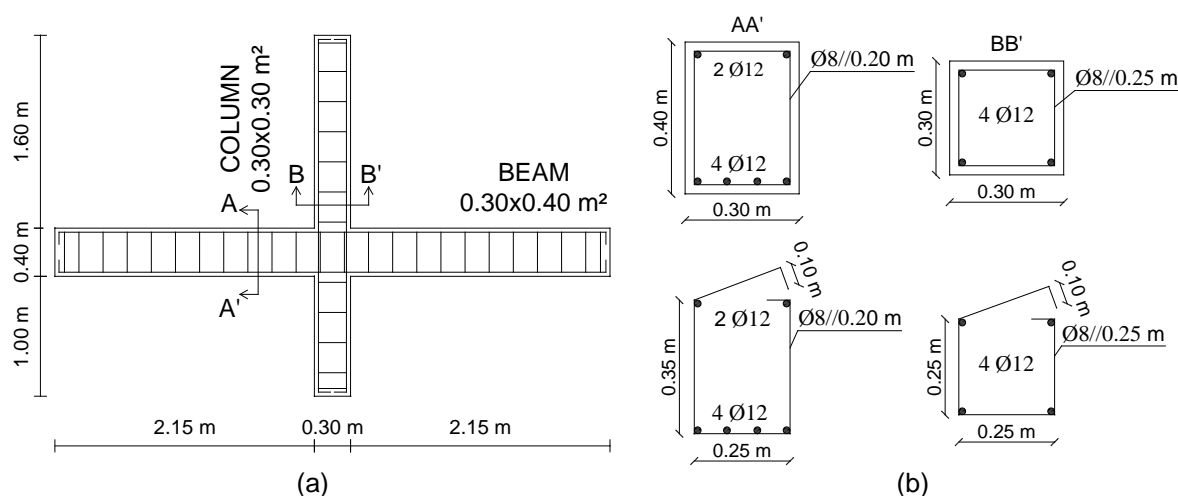
Figure 2 – Specimens (beam-column joints): a) global geometry; b) cross sections and reinforcing steel detail.

Figure 2 presents the global geometry and the cross sections of the nodes. All the specimens have the same amount and detail of reinforcement steel. The anchorage of the longitudinal bars was carried out by a standard bend with a length of 0.10 m (Figure 2a). The beam longitudinal reinforcement was composed of 2 steel bars of 12 mm of diameter ( $2\text{Ø}12$ ) at the top and  $4\text{Ø}12$  at the bottom. The transverse reinforcement consisted in 8 mm stirrups spaced 0.20 m. In the columns, the longitudinal reinforcement was composed of 4 steel rebars of 12 mm diameter (one on each corner) and the transverse reinforcement was composed of 8 mm stirrups spaced 0.25 m between them. The anchorage of the transverse reinforcement was done like in the longitudinal reinforcement (see Figure 2b). The concrete cover was 2 cm thick for all the elements (beam and column).

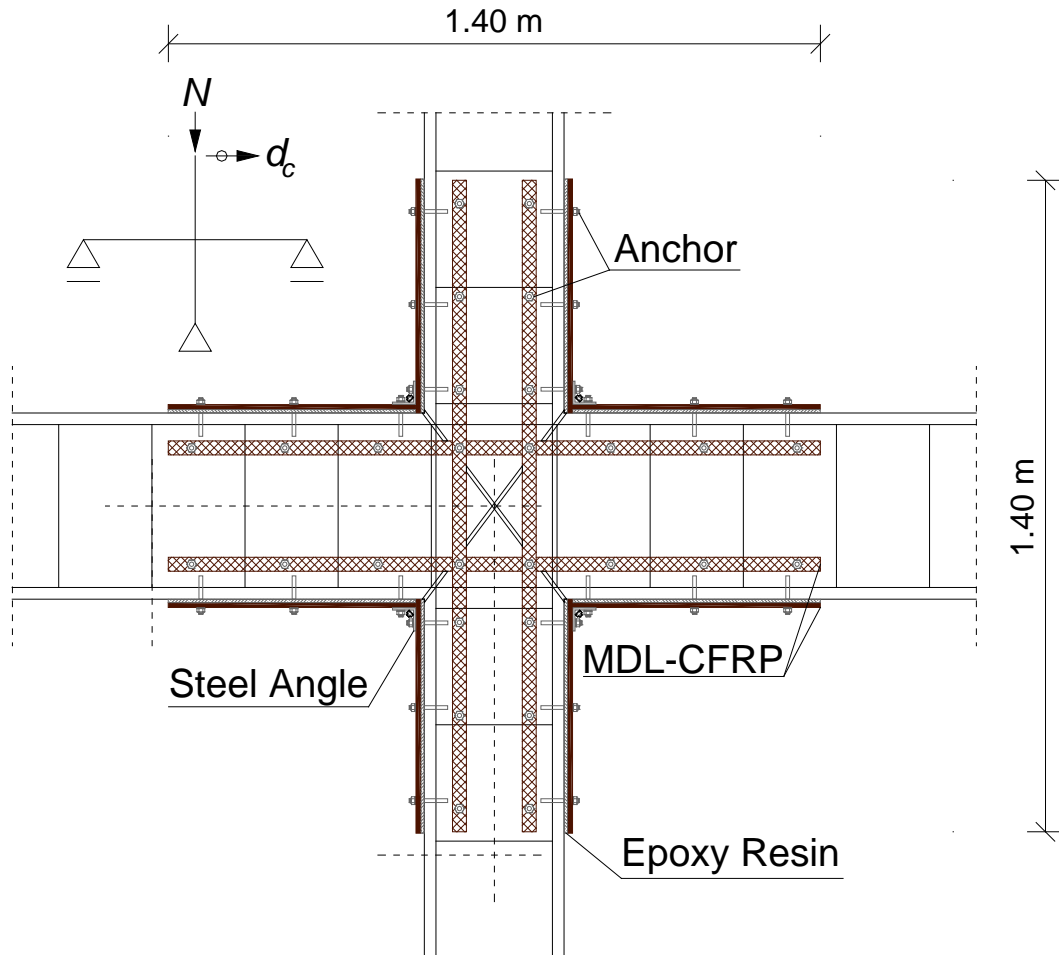
Figure 4 – Strengthening solution with MDL-CFRP.

Figure 4 shows the global appearance of the complete solution (direct strengthening).

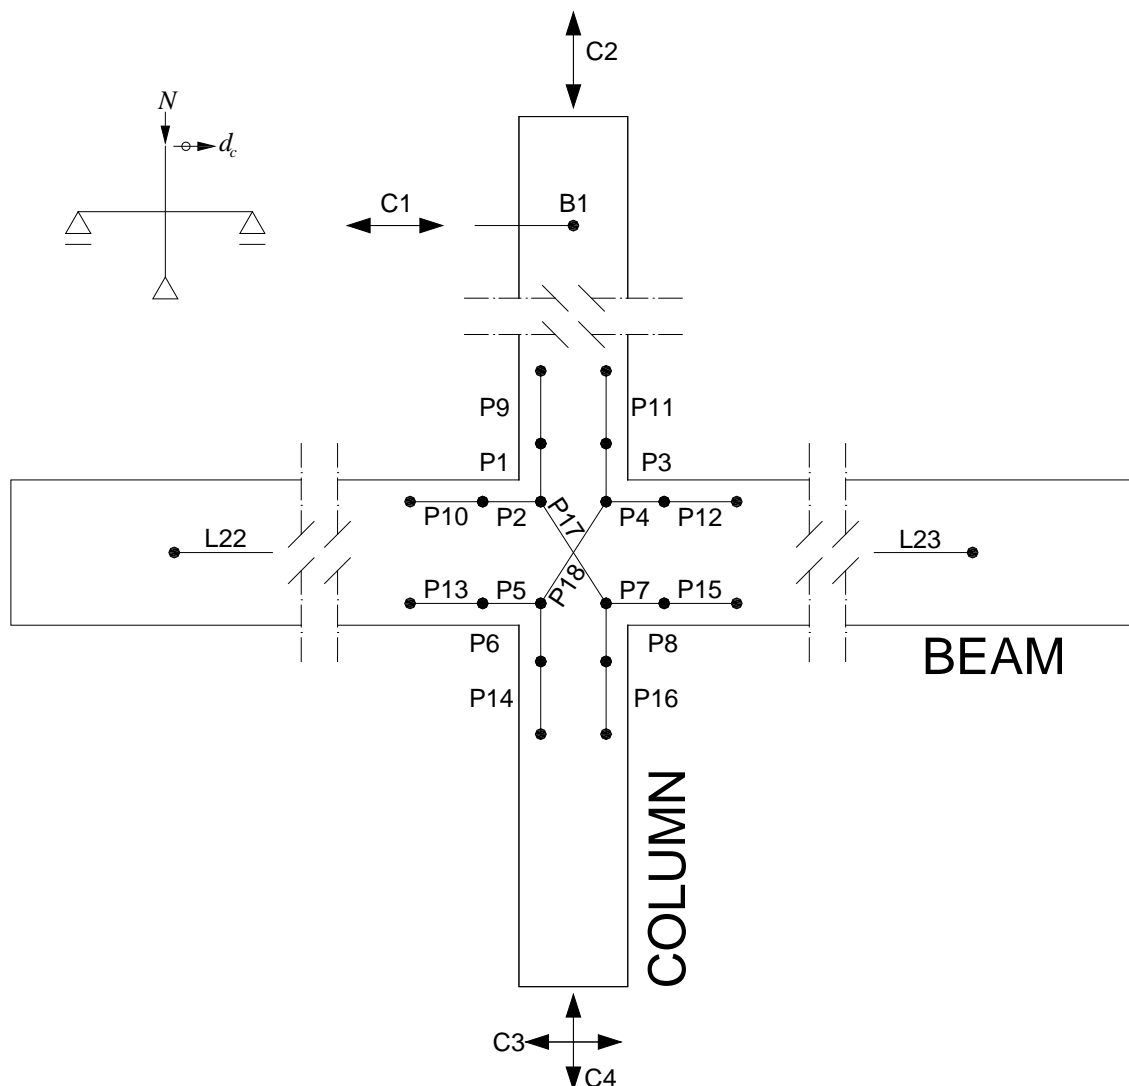
Figure 5 – Location of the external instrumentation used for monitoring the tests.

In both phases all the tests were carried out under displacement control according to the load laws mentioned above. The load at the column top and the axial force on this were applied by two hydraulic servo-controlled actuators equipped with load cells of 200 kN (C1 in Figure 5) and 500 kN (C2 in Figure 5) capacity, respectively. Additionally two load cells were used. One with 300 kN of capacity to register the horizontal reaction at the base of the column (C3 in Figure 5) and other with 100 kN of capacity to register the vertical reaction at the same point (C4 in Figure 5).

All the tests were monitored internal and externally. Figure 5 presents the location of the external instruments used. To register the behaviour of the specimens in the zones where the damage was expected to appear, eighteen potentiometers (P1-P18) were used. These register the approach or departure between the black spots where they were fixed. The horizontal displacements that were allowed in the beams supports were registered by two linear variable differential transducers (LVDT - L22 and L23). The displacement imposed at the top of the column was registered with more accuracy by the inductive linear position sensor (B1).

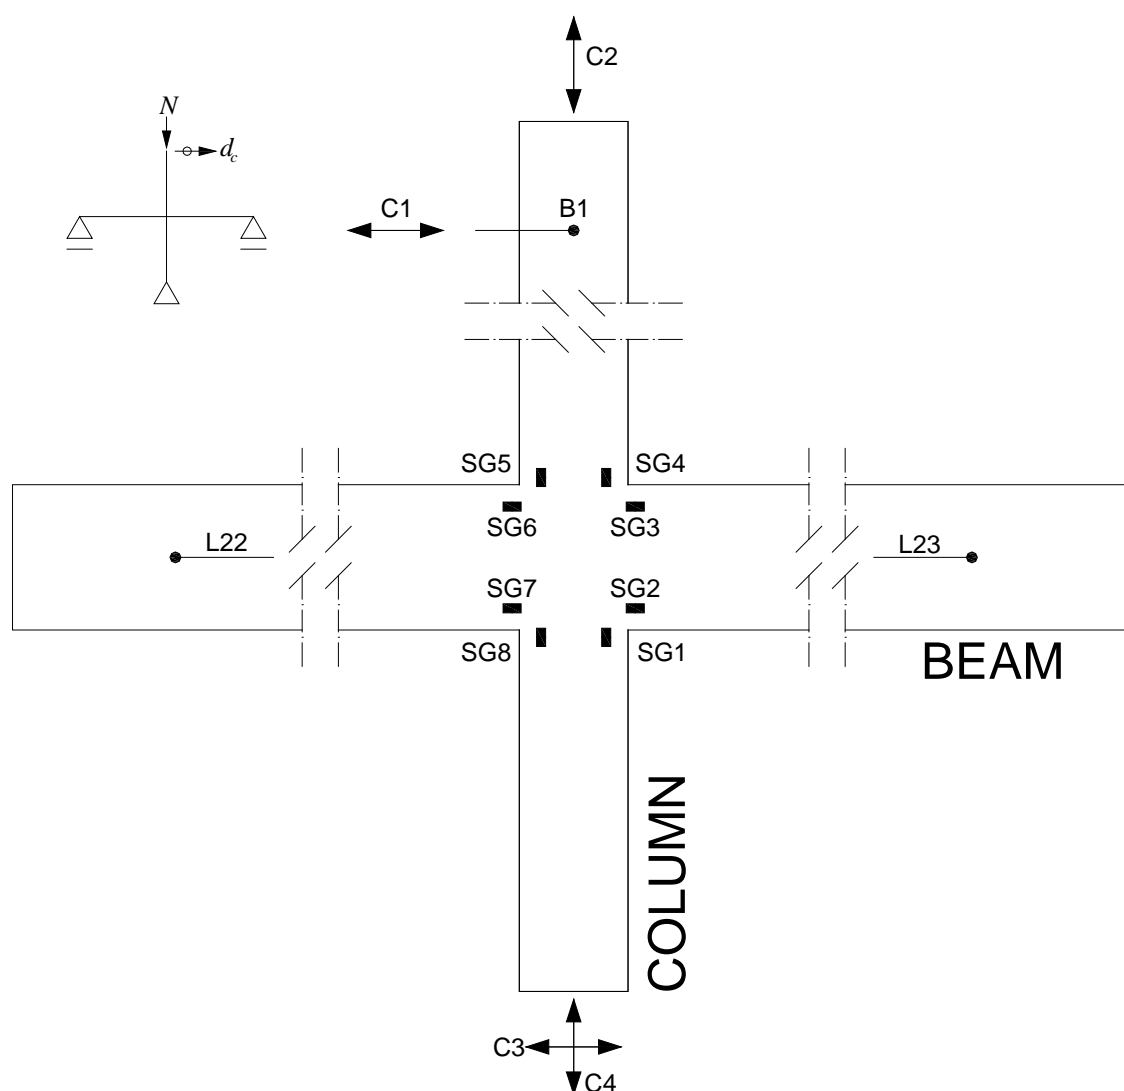
Figure 6 – Location of the strain gauges.

Figure 6 presents the location of the strain gauges (SG1-SG8) that were used only in the second phase of this work (strengthened specimens). These were located on the surface of the upper bar of each element (beam or column) at the indicated places.

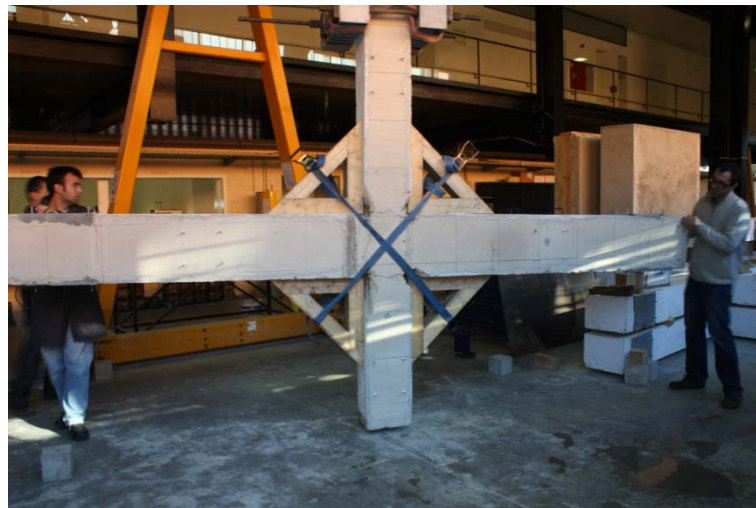
Figure 7 – Joint rotation.

Before initiating the preparation of the joints, they were turned so the retrofit work began by the inferior face and, after this face has been treated, the joint was again turned to the initial position to be tested. The rotation of the joints was performed with the aid of solid wood squares placed in order to minimize the opening of the cracks, before and after sealing them. Figure 7 shows an informative picture of the joints rotation.

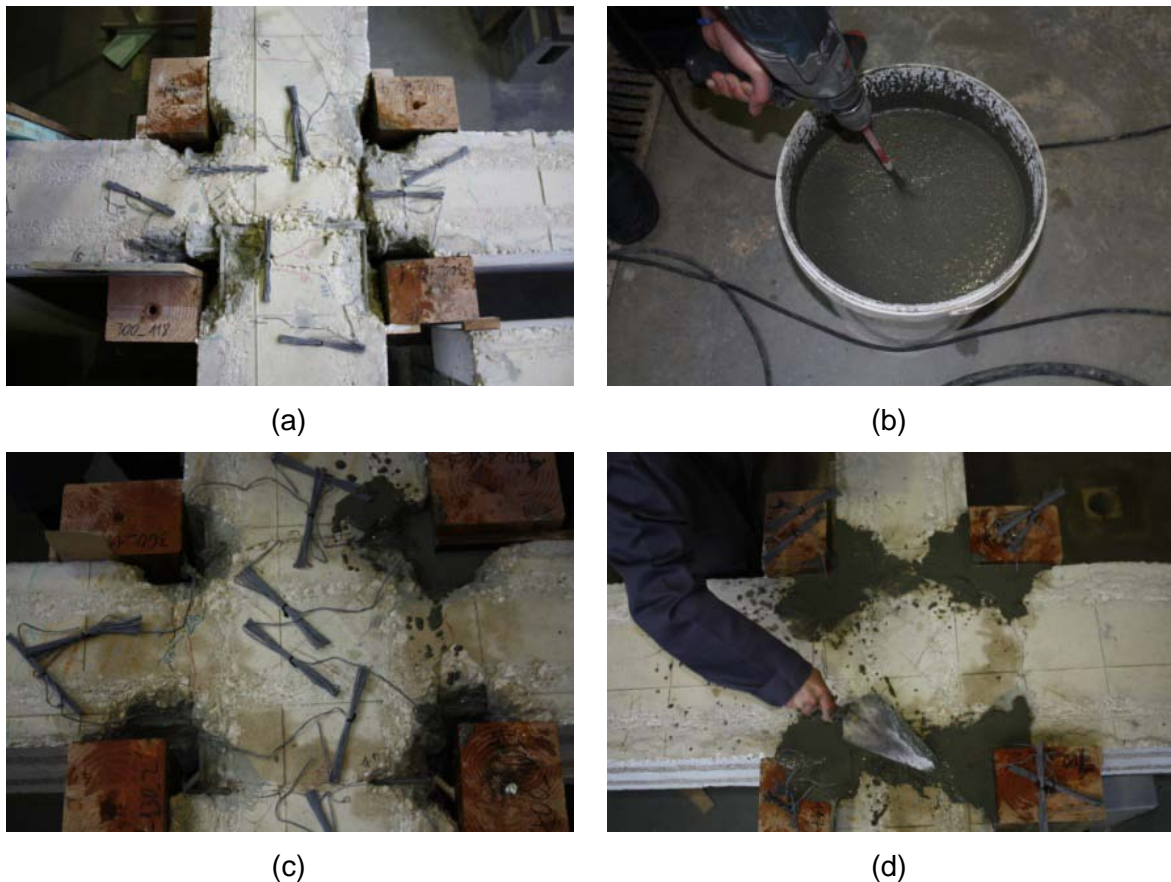
Figure 8 – Joint reconstruction: (a) formwork; (b) grout preparation; (c) filling the formwork with grout; (d) surface regularization.

- a) Removal of deteriorated concrete in the corners area of the node and then cleaning with compressed air;
- b) Application of the formwork (Figure 8a);
- c) Preparation of the grout used in the reconstruction (Figure 8b);
- d) Filling the formwork with grout (Figure 8c);
- e) Surface regularization (Figure 8d).

As can be seen in Figure 8c, referring to JPA-1R joint, 12 mm diameter tubes were placed in this joint at its diagonals. The purpose of these tubes was to act as a negative for the threaded 8 mm diameter rods that would connect the corner metal elements which were later put in this joint in order to give continuity to the MDL-CFRP placed on the sides of this joint.

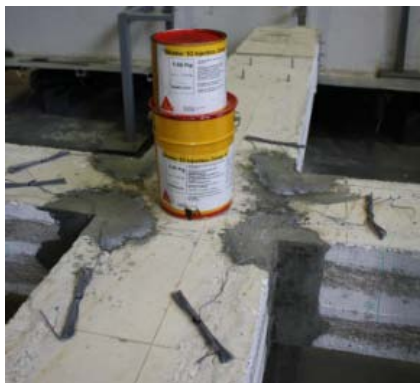
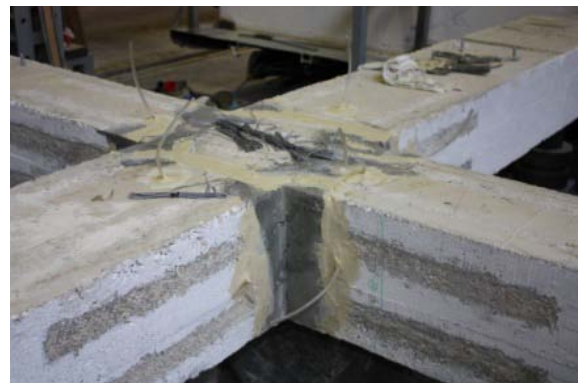
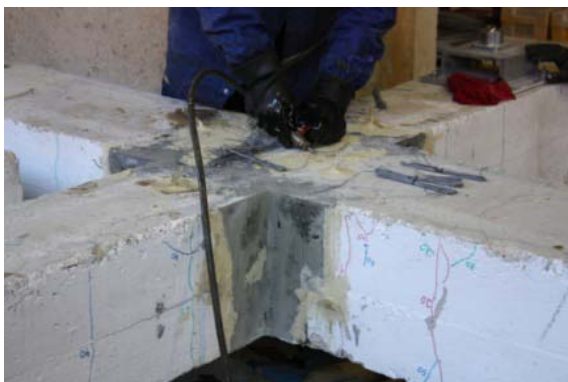
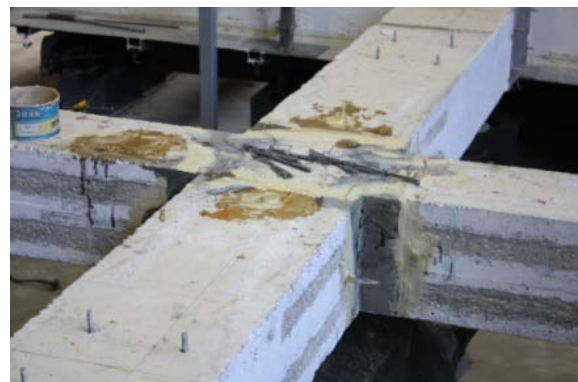
Figure 9 – Sealing the cracks: (a) formwork removal; (b) cracks sealing, with iron mass and purges application; (c) injection of the sealing resin; (d) final appearance of the joint after sealing the cracks.

Even though the reconstruction of the joint has replaced the material that was lost during the first phase tests it was not able to close the micro cracks that existed in the concrete. That was accomplished in another step that can be called cracks sealing. The cracks sealing had essentially two goals, on one hand to bond the old concrete in the slit area and, on the other, to bond the old concrete to the new grout in the reconstructed areas. That step involved the following main tasks:

- a) Removal of the formwork after the grout being cured (Figure 9a);
- b) Drilling of boreholes in the area of the cracks (through them) to place purges in all the faces of each element (beam or column), except on the underside. These purges were materialized by small transparent hoses;
- c) Sealing the areas of the cracks and around the purges with iron mass to prevent the resin to escape (Figure 9b);
- d) Injection of the resin through the purges (Figure 9c). This process began by side purges of each element and finished when the superior purge of that element started to lose resin, meaning that it had already filled the entire slit. The resin used for this purpose was the one showed in Figure 9a.

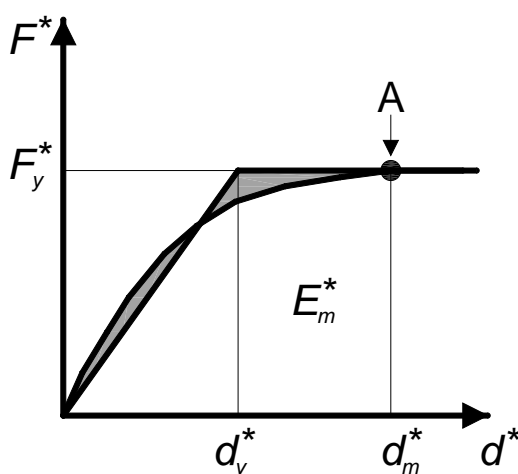
Figure 12 – Determination of the idealized elasto-perfectly plastic force versus displacement relationship (adapted from EN 1998-1:2004 (E)).

In order to have a comparison rule between the results of all the tests, the envelopes presented in Figure 11 were used to estimate an idealized elasto-perfectly plastic force–displacement relationship. The determination of this relationship was performed according to the methodology prescribed in the Annex B of EN 1998-1:2004(E). Figure 12 presents a graphical view of the type of approximation methodology referred. Transposing for the present study case, point A coincides with the maximum force point in each cycle, being  $(d_m^*, F_y^*)$  its coordinates. The parameter  $E_m^*$  is the actual deformation energy up to point A. The only unknown point is the yield displacement of the idealized curve. This point can be calculated by the following equation:

$$d_y^* = 2 \left( d_m^* - \frac{E_m^*}{F_y^*} \right) \quad (1)$$

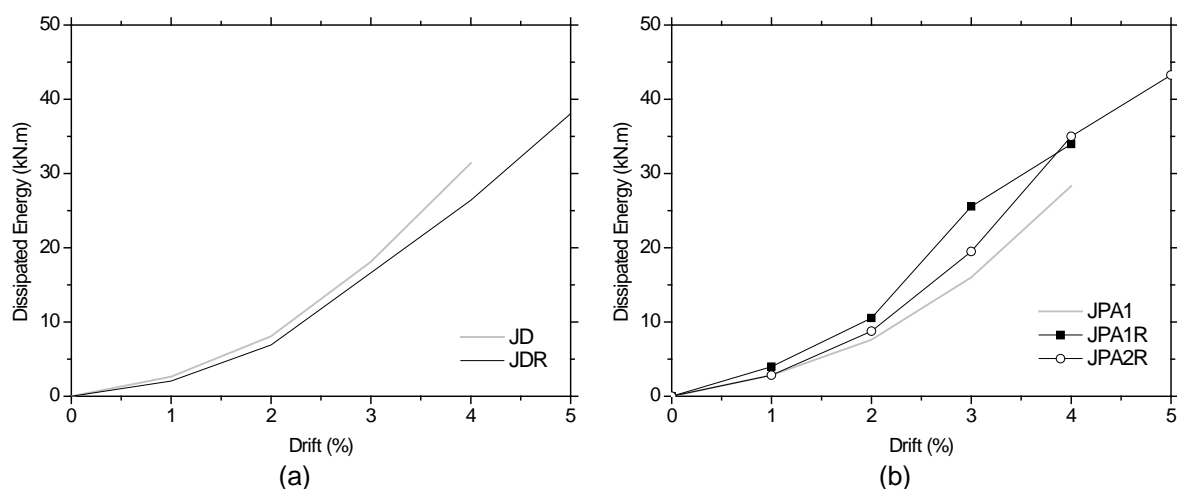
Figure 14 – Dissipated energy: (a) JD/JDR; (b) JPA-1/JPA-1R/JPA-2R.

Figure 14 shows the evolution of the dissipated energy along the drift levels of the tests. In this case, because the columns had 3 m length, 1% of drift corresponds to a displacement level of  $\pm 30$  mm. The dissipated energy was calculated using the trapezium rule to estimate the area under the curves presented in Figure 11 (not the envelopes).

Until the drift level of 4%, corresponding to the step  $\pm 120$  mm, JD as dissipated more energy than JDR.

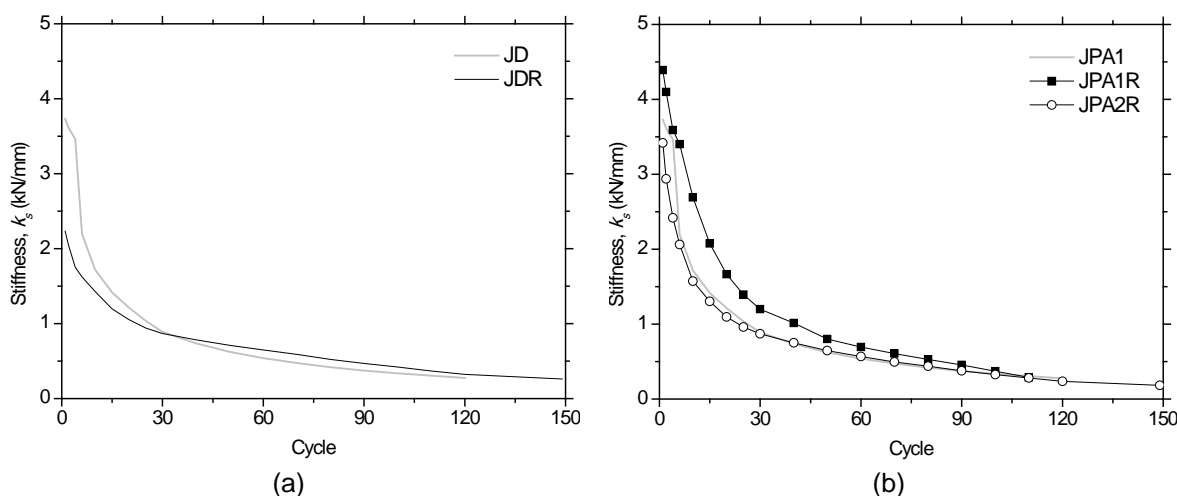
Figure 15 - Stiffness degradation: (a) JD/JDR; (b) JPA-1/JPA-1R/JPA-2R.

Figure 15 presents the stiffness degradation of the specimens along the cycles. This stiffness was assumed to be secant stiffness and was calculated as the slope of the line that can be drawn between the maximum positive and negative force point in each half cycle of the curves presented in Figure 11 (not the envelopes). It's an approximation but it gives a qualitative measure to compare the stiffness degradation between the specimens.

Specimen JD presents higher initial secant stiffness ( $k_{s,0} = 3.33$  kN/mm) than JDR ( $k_{s,0} = 2.23$  kN/mm). Regarding to the plain rebars specimens, JPA-1 has higher initial secant stiffness ( $k_{s,0} = 3.73$  kN/mm) than JPA-2R ( $k_{s,0} = 3.42$  kN/mm) but lower than JPA-1R ( $k_{s,0} = 4.39$  kN/mm).

In terms of stiffness degradation, JDR and JPA-2R presented similar values than the respective unreinforced specimens while JPA-1R presented higher values along the entire test than JPA-1.

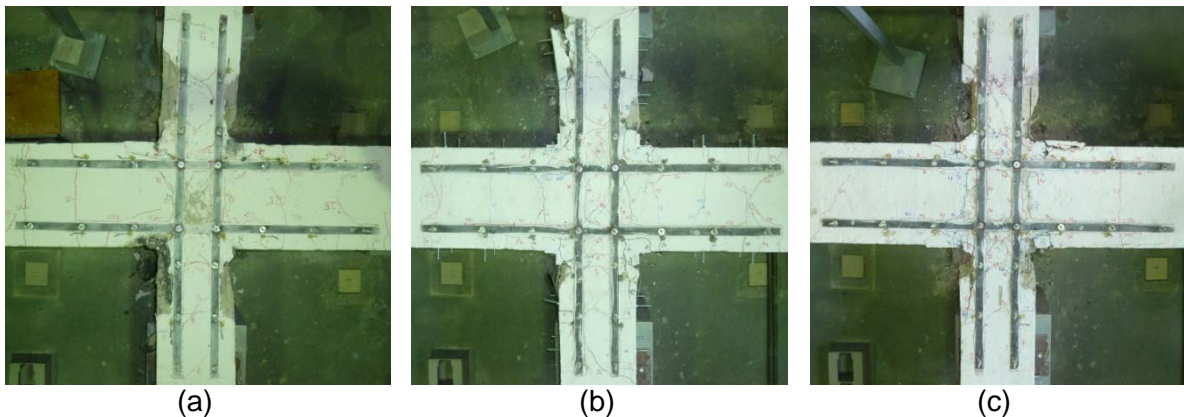
Figure 17 – Damage in the joints after the tests: (a) JDR; (b) JPA-1R; (c) JPA-2R.

Figure 17 shows the damage in the strengthened specimens at the end of the corresponding test. As can be seen, the damage was higher in JDR specimen and lower in JPA-1R. The steel corners existent in this last one have actually helped a lot to this as they prevented the concrete detachment to be so pronounced as the one seen in JDR and JPA-2R specimens.

JDR crack initiation occurred at level  $\pm 6$  mm and  $\pm 15$  mm in the beams and columns, respectively, while crack initiation occurred at level  $\pm 10$  mm and  $\pm 4$  mm in the beams of JPA-1R and JPA-2R specimens, respectively. In the columns, crack initiation occurred at level  $\pm 10$  mm for both specimens.

The explanation to that fact could be associated to a bad joint reconstruction, especially at the crack sealing phase, or just to an inadequate or insufficient reconstruction work compared to the initial damage of the specimen.
