SEISMIC ASSESSMENT OF ST JAMES CHURCH BY MEANS OF PUSHOVER ANALYSIS – BEFORE AND AFTER THE NEW ZEALAND EARTHQUAKE

Ana S. Araújo¹, Paulo B. Lourenço², Daniel V. Oliveira³, João Leite⁴

Abstract

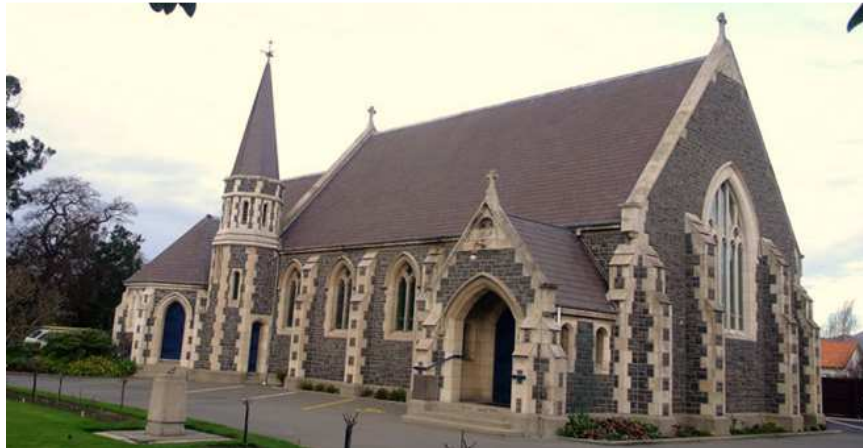
Figure 1 - General view of St. James Church.

The Church building was started in 1923 to provide a permanent centre for Anglican worship. The architects were the brothers Alfred and Sidney Luttrell who together designed a number of notable New Zealand buildings. For St James Church, they adopted a simple early English Gothic style (see Figure 1). On the right hand side of the nave a memorial headed “Pro Patria” lists the names of the men of Riccarton, a suburb of Christchurch, who died in the 1914-1918 war. In the 1940's the Church grounds were redesigned. The hedge fronting Riccarton Road was removed and a curved driveway lined with roses and centring on another war memorial (this time to the soldiers of World War II) was put down. Thus the original concept of a memorial Church was continued.

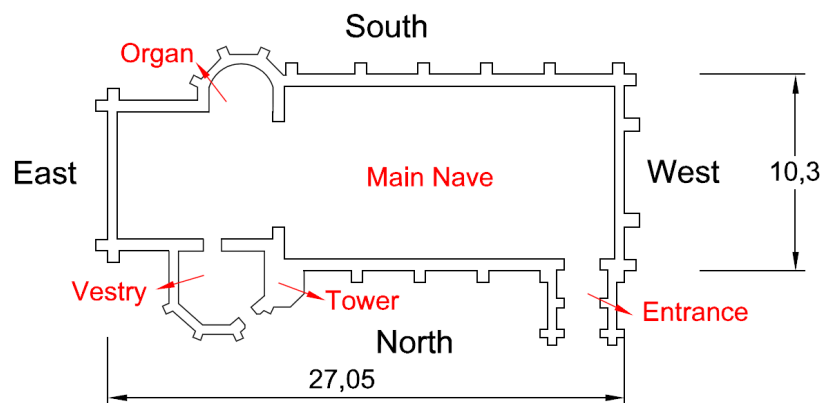
Figure 2 – Plant of the Church with the areas that compose the building and the main dimensions, in meters.

The Church has rectangular shape with a long nave that constitutes the main body of the building with 27.0 m long and 10.3 m wide. There are other secondary compartments that define the exterior shape of the building, as the entrance, the vestry, the tower, and a sort of side chapel where the organ is located (see plan of the Church in Figure 2). The building has a large number of buttresses in all façades and corners, which seems to indicate a clear earthquake concern. The two naves that compose the Church have different heights, with a height of 10.5 m for the main nave and a height of 9 m for the altar nave. The tower is the tallest element of the Church with a height of 15 m. The roof consists of a series of wooden trusses, spaced every 3 m and aligned with the external buttresses position (see Figure 3).

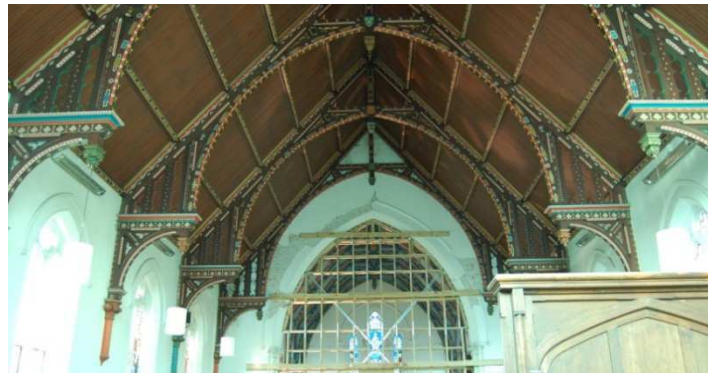
Figure 3 – Roof structure.

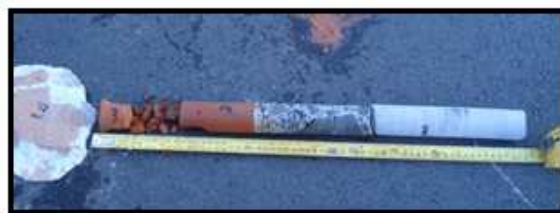
Figure 4 – Specimens of the walls.

During the in situ inspection, specimens were taken from the walls in order to know their constitution (Figure 4). The Church is usually referred to as an unreinforced masonry structure, coated with Halswell stone, with facings of cream Oamaru stone and plastered brick on the inside [20]. In fact, the wall specimens indicate that three layers of materials are present, brick on the inside of the wall, weak concrete in the inner core and stone in the outside façade.

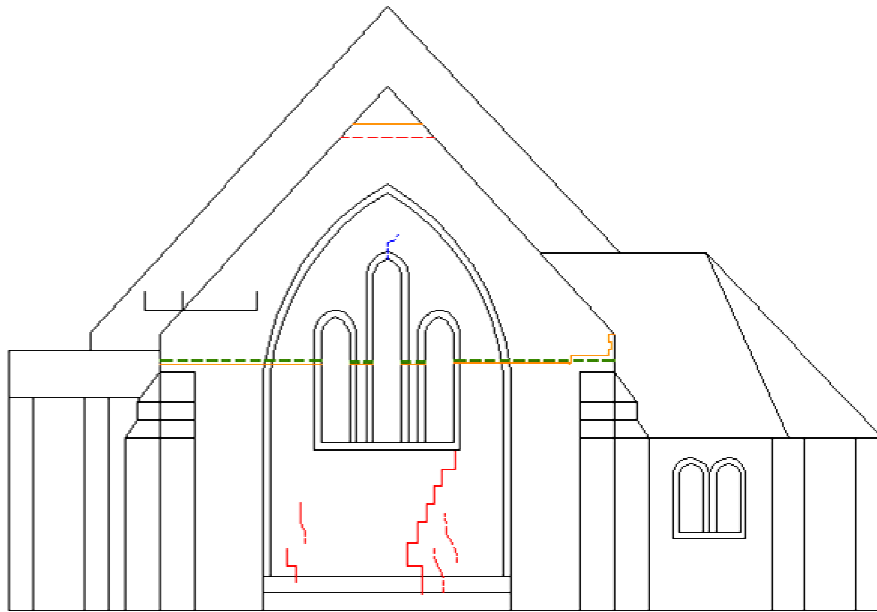
Figure 5 – Crack pattern; a) East wall, b) West wall, c) South wall, d) North wall, e) Triumphal arch f) Crack legend.

triumphal arch located in the middle of the two naves. Several cracks developed on the east wall both in the outer façade and inside of the Church (see Figure 5 a). It can be observed that the areas with more damage are aligned with the height at which the buttresses end, which indicates therefore an inadequate design with a strong geometrical discontinuity. Some thin cracks with a width smaller than 1 mm have developed between the window and the base of the wall. However, there is a large horizontal crack, about 5 mm wide, above the alignment of the buttresses, both in the façade and inside the building. Some stone blocks have moved at this level. In conclusion, damage is present and is mostly due to out-of-plane movements, even if some diagonal cracks due to in-plane movements are also observed.

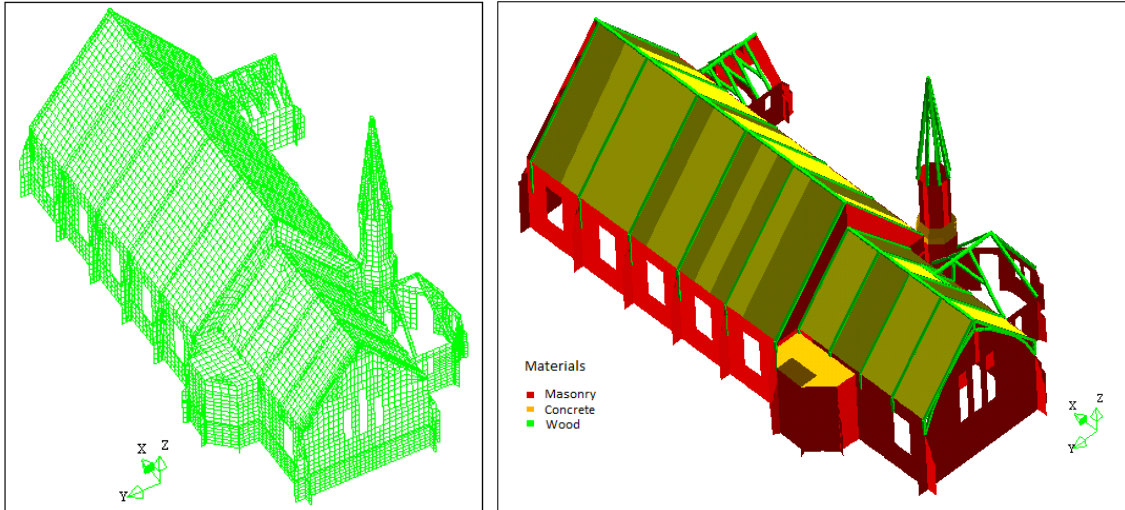
Figure 6 – Numerical model; a) Mesh b) Materials

The numerical model was prepared using the DIANA [22] software using the geometrical information gathered from historical documents and in situ survey. The church geometry was prepared using a 3D model with the two main naves, the three secondary compartments and the tower. The walls were simulated as shell elements and the timber trusses of the roof were simulated as beams elements. The roof sheeting and transverse beams between the timber trusses were also simulated with shell elements. The model aims also at reproducing the structural damage present. Due to the extensive damage observed in the triumphal arch and gable walls, one can assume that the roof structures are not rigidly connected with all transversal walls. The mesh was automatically generated by DIANA and then manipulated and controlled in order to obtain a good quality mesh. The areas with shell elements are discretized in both quadrilateral 8 nodes (CQ40S) and triangular 6 nodes elements (CT30S) depending on the geometry. With respect to the beam trusses, these are discretized using 3 nodes beam elements (CL18B). The generated mesh resulted in 29,648 nodes and 10,588 elements, see Figure 6 a). Concerning the materials, these can be divided into four in the numerical model: “masonry” in almost all of the walls (in fact, the material is made of three different layers), concrete in two slabs (one of the secondary compartments and another in the tower) and wood in the roof structure, see Figure 6 b).

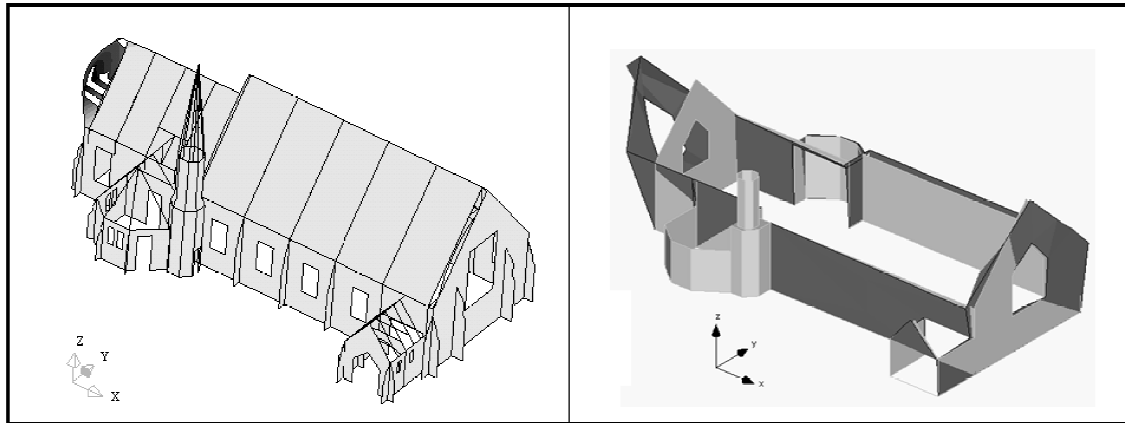
Figure 7 - Comparison between the 1st vibration mode of the numerical and the experimental

A visual comparison in terms of mode shapes can now be performed. The first vibration mode is mainly the out-of-plane displacement of the east wall and Figure 7 presents the comparison between the experimental and the numerical shapes, which show excellent agreement as also given by the MAC value close to the unit value. The second vibration mode is related mainly with the west wall, also with an out-of-plane displacement, and both experimental and numerical results are shown in Figure 8. Again, very good agreement is found, with a slightly lower MAC value. Finally, the third vibration mode concerns predominantly the west wall with double curvature, as shown in Figure 9. The agreement between the numerical and experimental shape is reasonable, even if the movement in the east wall is not replicated by the numerical model.

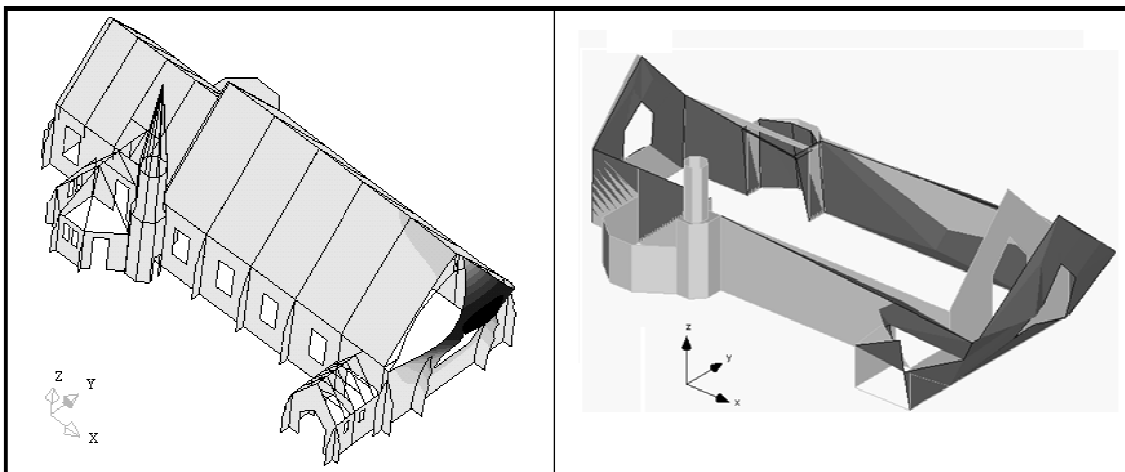
Figure 8 - Comparison between the 2nd vibration mode of the numerical and the experimental

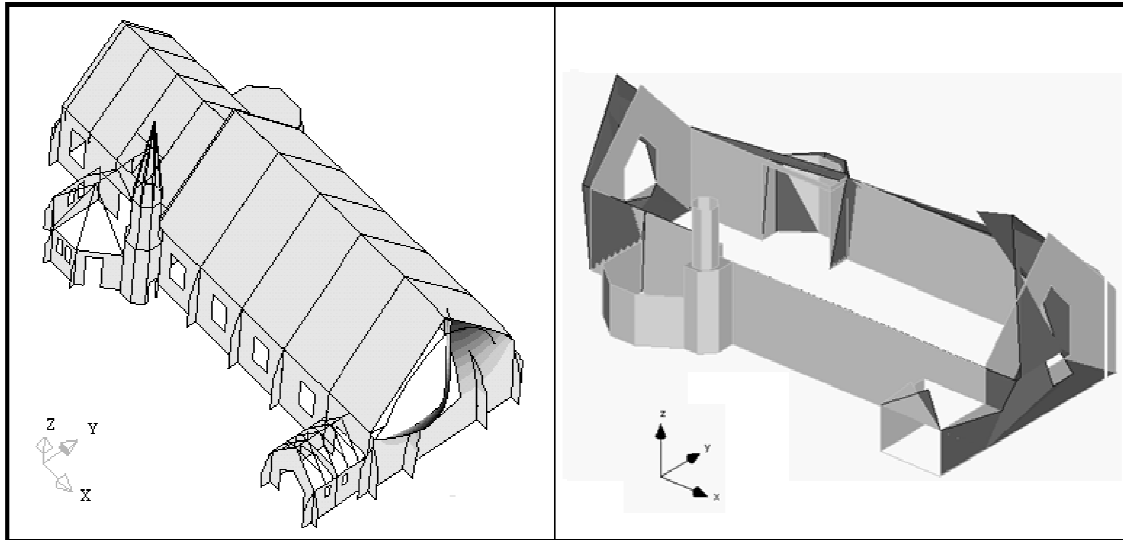
Figure 9 - Comparison between the 3st vibration mode of the numerical and the experimental

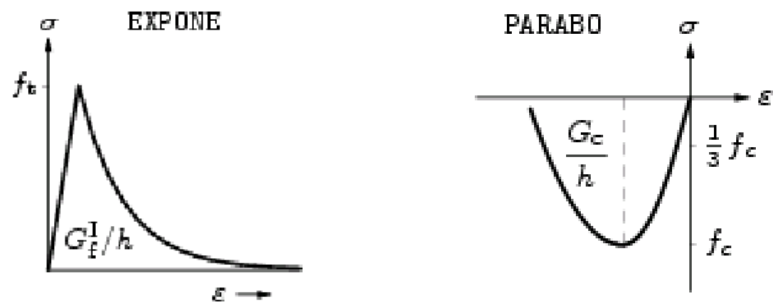
Figure 10 – Stress-strain diagrams for the non-linear behaviour of masonry, tension and compression [22]

As recommended in [4], a uniform or mass proportional pushover approach is carried out in the main axis directions (X and Y), one for positive and one for the negative direction. As most of the non-linearities are expected to concentrate in the masonry, only this material is considered with non-linear behaviour. The non-linear behavior of the masonry is modeled by the adoption of a constitutive model based on total strain, the Total Strain Fixed Crack model. This model describes the tensile and compressive behavior of the masonry with one stress-strain relationship [22] and has been used successfully in many applications to complex masonry structures, e.g. [29] and [30]. The inelastic stress-strain diagrams selected were an exponential relationship for tension and a parabolic relationship compression (see Figure 10). The nonlinear properties for the masonry constitutive model were calculated based on recommendations from Lourenço [31], according to the elastic modulus previously calibrated (see Table 3). Here f_c is the

masonry compressive strength, G_c is the fracture energy in compression, f_t is the masonry tensile strength, G_t is the tensile fracture energy and β is the shear retention factor. The solution procedures used the regular Newton-Raphson method and an energy convergence criterion, with a tolerance of 0.001.

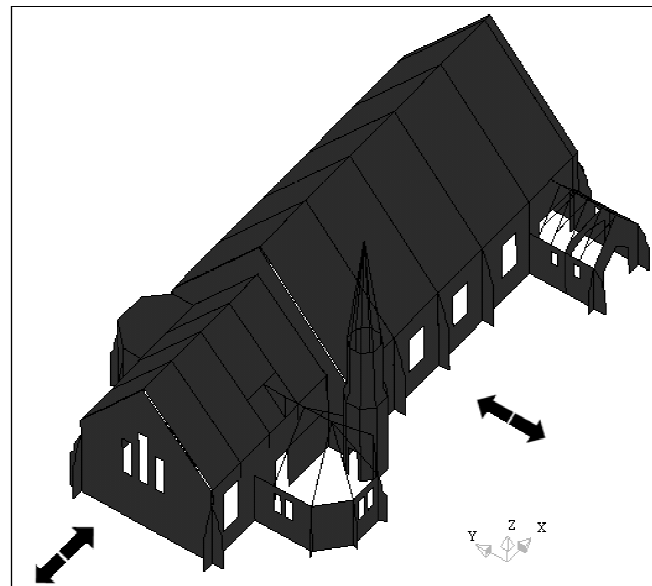
Figure 11 - Applied load direction in the principal axes directions

The first pushover analyses were performed in the numerical model that simulates the damaged church after the earthquake. Four analysis were carried out in the principal directions of the building (+X, -X, +Y and -Y), as shown in Figure 11. In a first stage the self-weight of the structure was applied and then the horizontal load was increased monotonically until full collapse.

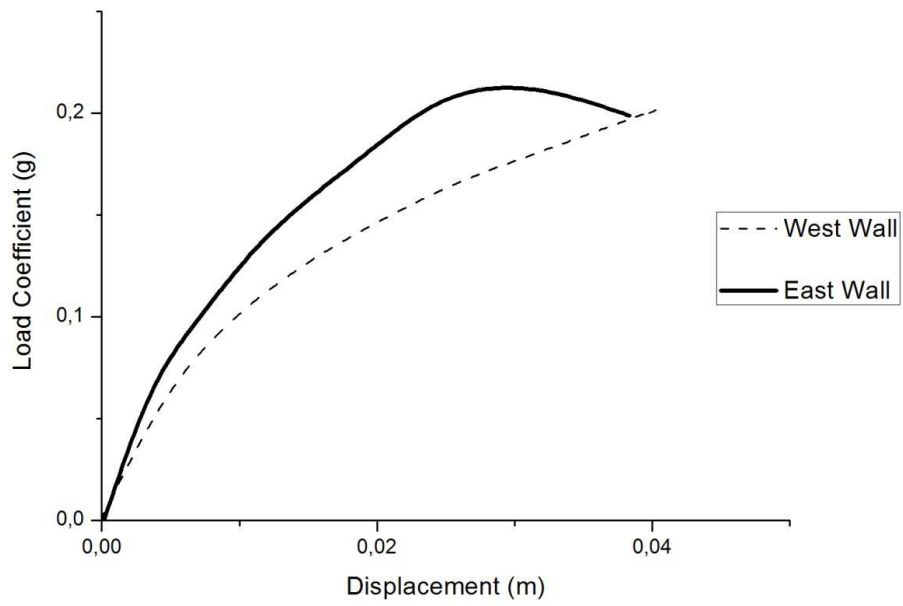
Figure 12 - Capacity curve of pushover analysis in +X direction

Figure 12 depicts the capacity curves for the gable walls, with a maximum load coefficient of 0.21g in +X direction, with loss of the capacity of the east wall. As addressed before, the east wall has a very severe crack pattern and the west wall has more stiffness due to its configuration: the thickness is larger than the east wall and it has two more buttresses near the window. For a better understanding of the non-linear behaviour of the structure, the principal tensile strains are plotted as an indicator of damage (Figure 13). The concentrations of strains occur on the top of the tympanum. The pushover analysis in the -X direction provides similar results in terms of capacity and damage pattern. A possible interpretation of the collapse mechanism of the wall, as observed in true earthquakes, is shown in Figure 14. The presented failure mode occurs with the detachment of the top of the tympanum of the east wall which can then lead to the out-of-plane collapse of the whole tympanum due to the pre-existent horizontal crack.

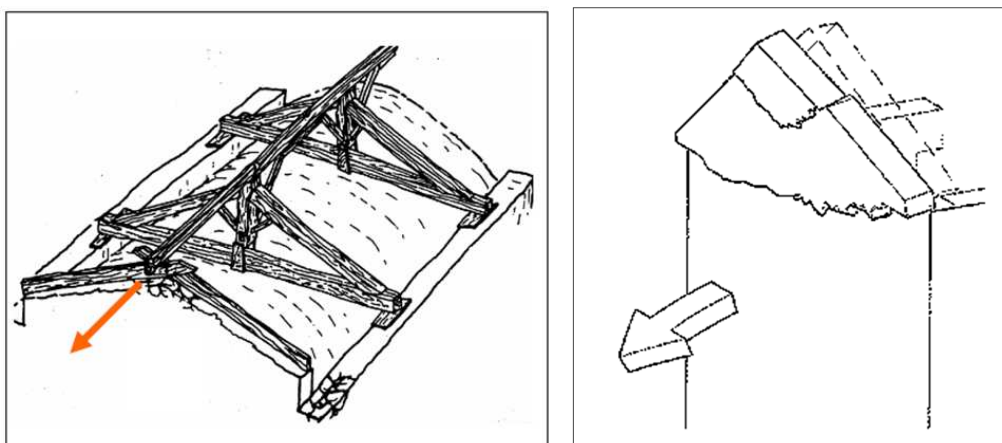
Figure 14 - Collapse mechanism in the tympanum of the east wall (+X and -X direction)

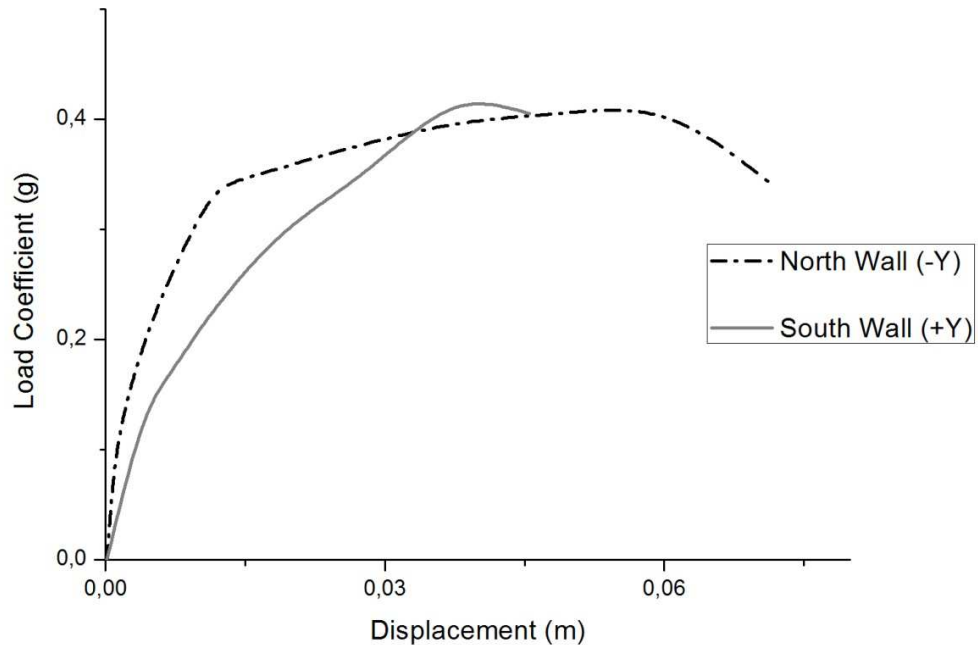
Figure 15 - Capacity curve of pushover analysis in Y direction

The pushover analyses carried out in the other principal direction, Y, prove that when the horizontal load is applied perpendicular to the longitudinal walls (north and south), the structure capacity increases, being able to reach a PGA of about 0.4g (Figure 15) significantly higher than the one attained by the X analyses. For the two loading signs, the results are similar, with a deformation mode involving the entire structure, see Figure 16 a). The maximum displacement occurs on the tower and in the region close to it, reaching a displacement about 0.15 m for the peak load. The principal strains at the maximum applied load are plotted in Figure 16 b), where two main damaged areas are clearly shown. One of the cracks is located on the east façade, near the buttress and opposite to the loading sign, while the other is visible in the triumphal arch. This last crack is possibly due to the large stiffness and stress differences between the nave and the tower. In fact, the formation of the crack along the connection allows the tower's independent movement and rotation. No significant damage is visible in the other walls.

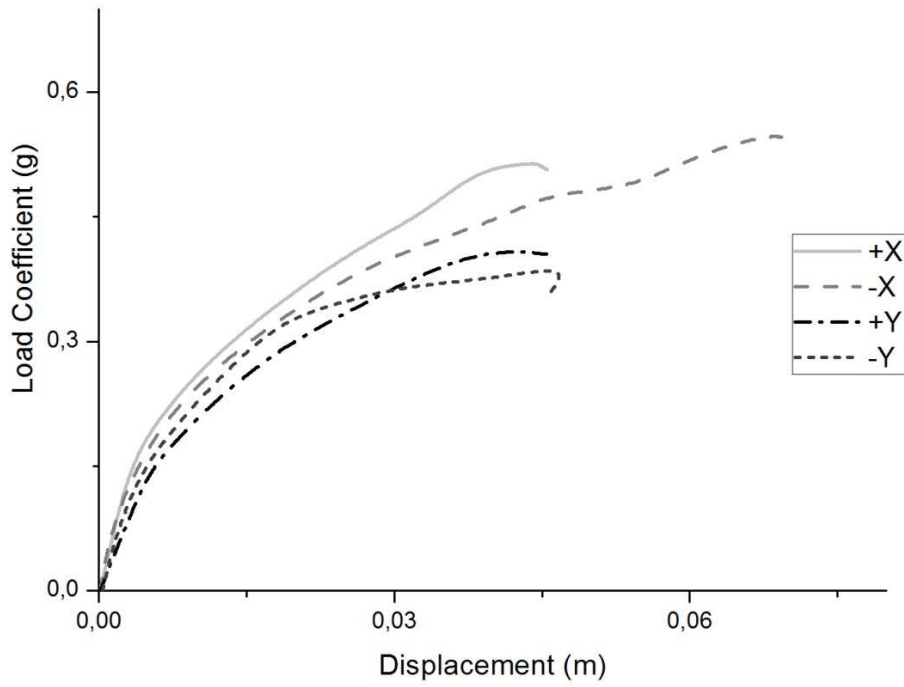
Figure 17 – Capacity curves for undamaged structure

The new capacity curves are shown in Figure 17, where it is shown now that the capacity in the X direction increased significantly, to values higher than 0.5g, while the capacity in the Y direction is kept about the same, meaning that the weakest capacity occurs for the Y direction. Concerning the pushover in +X direction the areas subjected to most relevant cracking are the buttresses and facades in the east and west ends, due to out-of-plane rotation, and the longitudinal walls, on the north and south façades, due to in-plane shear around the openings and the entrance, see Figure 18. The analysis in the opposite loading sign (-X) leads to concentration of damage in the east wall, see Figure 19. In the Y pushover, damage is mostly induced by in-plane shear, with some concentration around the tower, as explained above, see also Figures 20 and 21. Damage occurs in transverse walls and the triumphal arch.

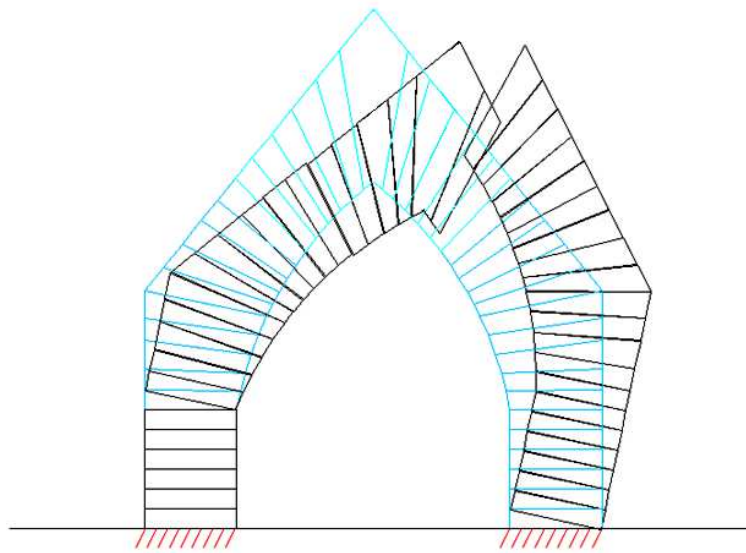
Figure 23 – In-plane collapse mechanism of the triumphal arch [35]

The last collapse mechanism defined is an in-plane failure in the triumphal arch with the formation of plastic hinges. The triumphal arch is a recurrent structural element in Churches and has special importance in its seismic behaviour [36], [39]. In this study the limit analysis approach was applied using the software Block developed by Orduna [35] and the obtained mechanism is presented in Figure 23 with the formation of three plastic hinges. The obtained load coefficient was 0.229. Thus, considering the four studied collapse mechanism, the lowest load coefficient was obtained for the out of plane overturning of the east facade tympanum, with 0.141. These results are compatible with the numerical ones in the way that the east wall is the one limiting the structural capacity of the Church, which was also verified in the pushover analysis after the earthquake damage. The simplification of the wall tympanum to a rigid block for the limit analysis is comparable in terms of load coefficient to the case in which there is no connection between the roof structure and the walls. With regards to the triumphal arch results, the limit analysis results are also in agreement with the numerical ones. Firstly, the plastic hinge formation is quite near the main crack development. Secondly, the formation of the plastic hinge on the base leads to the rotation of the rigid block which can create stress concentrations in the connection with other elements, which is visible on the numerical results (Figure 16 b)).
