# Seismic Assessment of a Typical Masonry Residential Building in Bosnia and Herzegovina

**15 WCEE**  
LISBOA 2012

## **SUMMARY:**

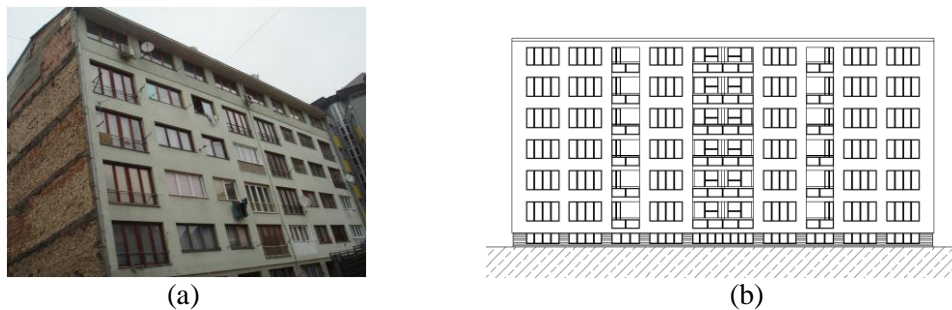
**Figure 1.** Considered building, built in the year of 1957: (a) real structure; (b) East façade.

The typical masonry building, see Figure 1 (a) and (b), is located in Sarajevo, in the part of the city called Grbavica. It is a seven level (basement + ground floor + 5 storeys) building. The plan view illustrated in Figure 2 shows the layout of the structure with load bearing walls in Y direction only. The structure has been design and built in 1957. During its time life there have been no changes regarding its layout and usage.

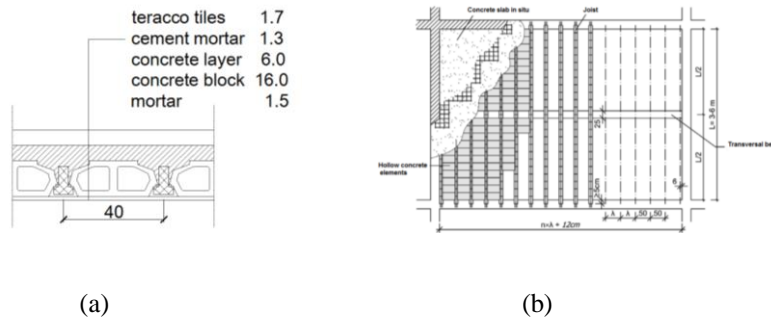
**Figure 3.** Constructive details: (a) Semi-prefabricated concrete elements; (b) Floor (Peulić, 2002).

In the plan, the structure is of dimensions 38.0m by 13.0m with 7 levels. The structure is composed of load bearing walls only in the transverse direction (y direction, see also Figure 2) with slabs made of semi-prefabricated elements. The longitudinal walls are not considered as load-resisting elements as they have been made weak by many openings as shown in Figure 1 (b). The transversal bearing walls are brick masonry walls of 0.25m thick and a non-bearing façade wall made of hollow bricks of 0.125m thick, while the inner bearing walls are solid brick walls of 0.25m thick. Bricks are of standard dimensions 25x12x6.5cm, connected by cement mortar. The slabs are made out of "Herbst" concrete hollow elements as shown in Figure 3(a). The roof is of the same construction as the floors, providing continuity of the construction, and later on the possibility for additional storeys to be added. Construction of these blocks was regulated by Yugoslavian standards B.D1.030-1965 (Peulić, 2002). The basement walls are made out of concrete. Inner perpendicular walls are 0.38m thick, while the outer (longitudinal) walls are 0.30m thick, and two inner walls are 0.25m thick. As the span is larger than 3.0m it was foreseen, as per above mentioned standards at that time, to construct a transversal beam of 0.25m width with the same height as the slab, see Figure 3(b). Visual inspection revealed that there were no major damages on the structure.

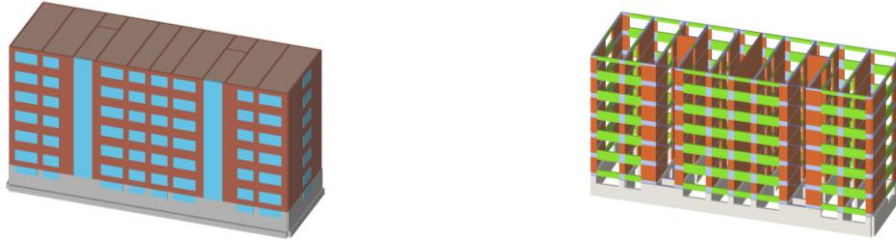
**Figure 6.** View of the structure and its elements in 3MURI.

The structure was modeled in 3MURI having the same material and geometrical characteristics as defined before. The model consists of 7 levels, 218 - 3D nodes, 34 - 2D nodes, and 506 elements. The view of the structure and elements is presented in Figure 6.

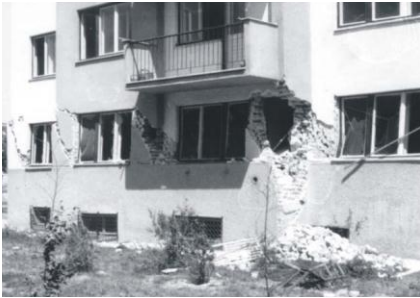
**Figure 10.** Concentrated damage at the ground floor (Petrovski, 2003).

This kind of damage was observed on a structure of a similar type after the earthquake that struck Skopje in 1963, as shown in Figure 10. The concentration of damage is located on the ground floor with diagonal cracks between the openings probably caused by shear. Falling of the masonry in one of the corners is evident.

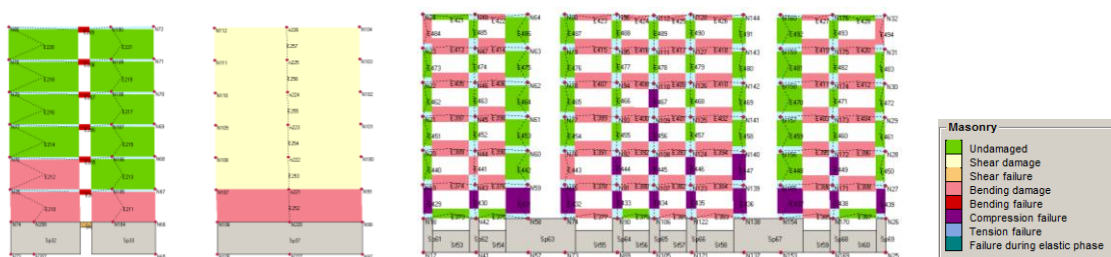
**Figure 13.** Damage in the walls in "+Y" direction at the failure stage: (a) W-Y4; (b) W-Y6; (c) W-X1; (d) legend.

The capacity curve of the structure while exposed to the load patten proportional to the mass in "+Y" direction is shown Figure 12. As it can be seen from Figure 13 (see also Figure 16(c)) bending damage is located at the spandrels above the doors and windows, and even in some of the walls bending failure is observed. Shear damage is seen on all the perpendicular walls (Y direction) and especially on the wall W-Y6. The basement which is made out of concrete remains undamaged during the application of the load.
