**Manuscript Title: Pushover Analysis and Failure Pattern of a Typical Masonry Residential Building in Bosnia and Herzegovina**

Author line: Naida Ademovic<sup>1</sup>, Mustafa Hrasnica<sup>2</sup>, Daniel V. Oliveira<sup>3</sup>

**Abstract** — The paper discusses the behavior of a typical masonry building in Bosnia and Herzegovina built in the 50's without any seismic guidelines. A global numerical model of the building has been built and masonry material has been simulated as nonlinear. Additionally, calculations done with a "less" sophisticated model are in a good correlation with the finite element method (FEM) calculations. It was able to "grasp" the damage pattern; not as detailed as in the FEM calculations, but still quite good. On the basis of this it may be concluded that in this case calculation with Frame by Macro Elements (FME) program could be recommended for future analysis of this type of structures, having quite good results with a less computation time. However, in the need for more precise results FEM should be utilized.

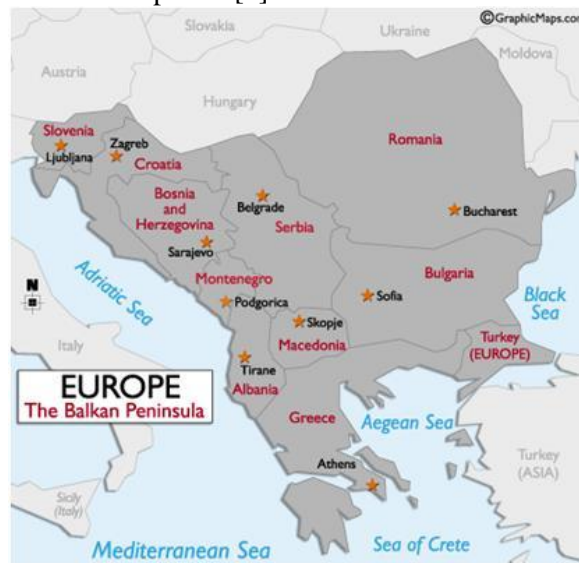
Figure 1.1 - Balkan Peninsula [2]

The region of South-East Europe, see Figure 1.1, has one on the most complex tectonics in Europe, as it is also stated in the newsletter of Gisdevelopment [1].

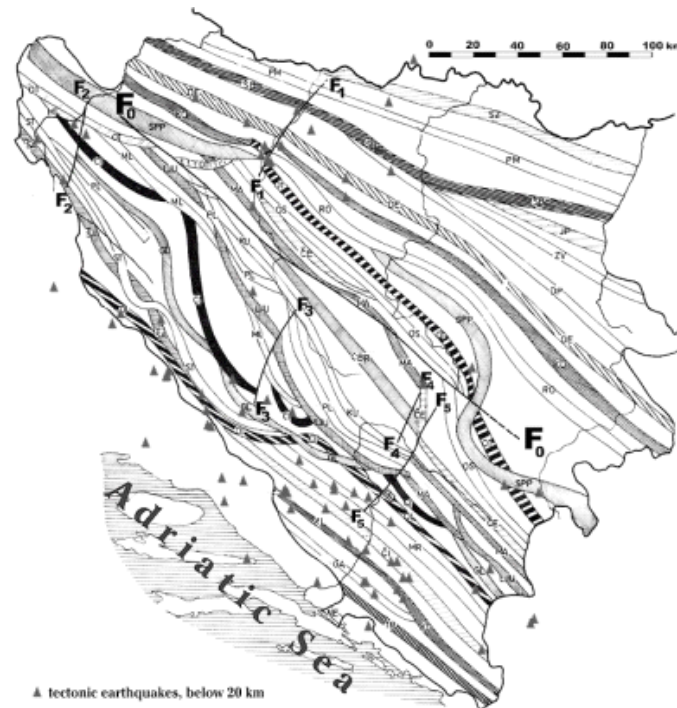
Figure 1.3 - Main deep thrusts (to 25 km): Sarajevo fault (F0F0), Gradiška fault (F1F1), Bihać fault (F2F2), Livno fault (F3F3), Jablanica fault (F4F4) and Mostar fault (F5F5) [8]

Until present, the most complete picture of the tectonic structure in B&H was done by [8] who has identified deep faults passing through B&H as well as 30 tectonic units. This is shown in Figure 1.3.

The longest is the Sarajevo Fault spreading in the direction NW-SE in the length of 300km, meaning across the entire B&H. The second longest is the Banja Luka Fault, and the third Konjic Fault [8]. All transversal faults are under-passing the Sarajevo Fault. High seismic activity is evident along the transversal deep faults, while low to moderate seismicity along the Sarajevo Fault is noted. According to Papeš [8] Sarajevo and Gradiška Faults may experience series earthquakes of magnitude M6 by Richter's scale or even higher.

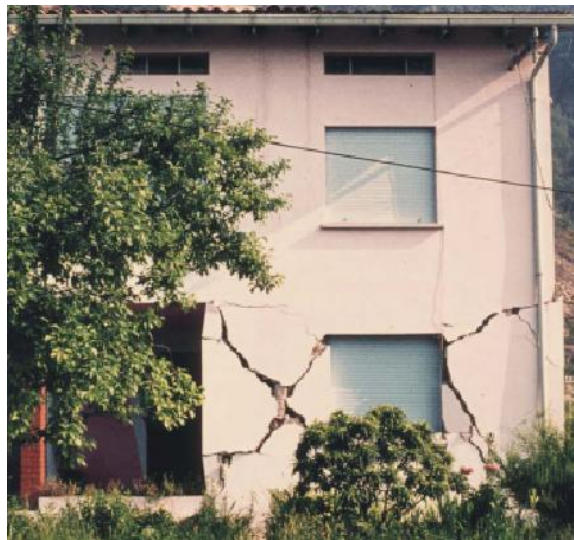
*Figure 2.1 - Diagonal crack in masonry walls and loss of corner wall URM masonry' R.C. floors [14]*

Common damage in masonry buildings caused by earthquakes are diagonal cracks in the walls, see Figure 2.1. This type of damage in masonry structures was observed after many earthquakes, from minor cracks after less severe ground motion to larger cracks due to strong earthquakes, as illustrated on the figure below. This can lead to the out-of plane failure of the damaged wall and collapse of the whole building. The reasons for the diagonal cracks in the masonry walls are in their small resistance in tension. Due to the high level of the horizontal forces induced by an earthquake a sort of truss resistance mechanism is formed in the masonry walls or piers. The truss chords are floor structures, which in the case of R.C. floors can transmit the horizontal forces in efficient way, while the diagonals are formed in the masonry wall itself and fall in tension. The most of the existing masonry buildings in southeast Europe belong to the unreinforced masonry structures and this tradition is preserved. The improvement is made by almost regular built in of the vertical reinforced concrete confining elements, which improve the overall structural ductility significantly [11].

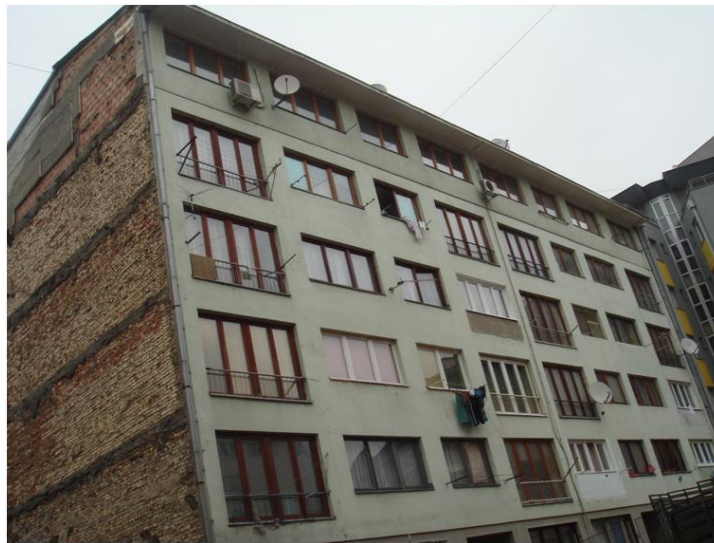
*Figure 4.1 - Considered Building, built in the year of 1957 - perspective*

The typical masonry building under analysis is presented in Figure 4.1, located in Sarajevo, in the part of the city called Grbavica. The structure has been design without any seismic guidelines and built in 1957. During its life there have been no changes regarding its layout and usage. It is a seven level (basement +

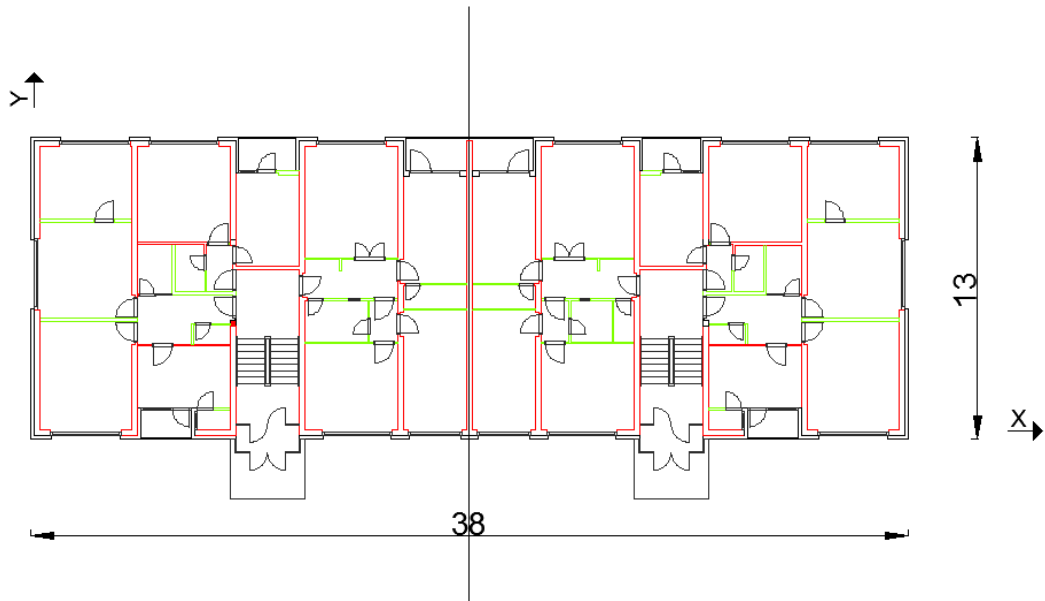
Figure 4.2 - Sketch - Plan view of the typical floor and adopted axes system

ground floor + 5 storeys) building with a basement underneath the entire structure. The plan view is illustrated in Figure 4.2 showing the layout of the structure. The visual inspection carried out revealed that there were no major damages on the structure.

The structure has 38.0m long by 13.0m width, with 7 levels, totally 19.6m high. The structure is composed of load bearing walls mainly in the transverse direction (Y direction), as seen in Figure 4.2, with slabs made of semi-prefabricated elements. The longitudinal walls have their load capacity much affected by the many openings, as shown in Figure 4.3.

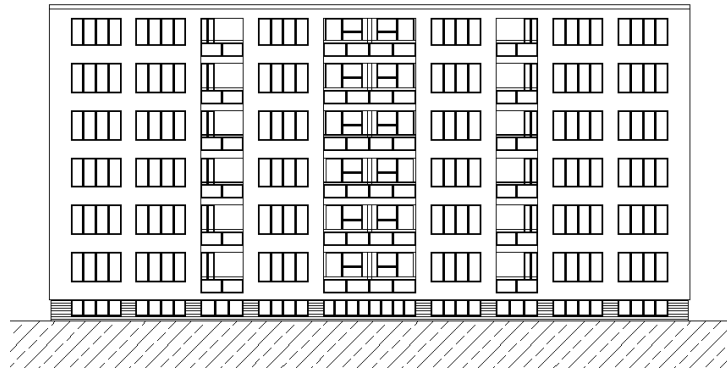
Figure 4.3 - East façade

The walls are transversal are composed of solid brick masonry walls 0.25m thick, representing the load bearing part of the structure and façade part made of hollow bricks 0.125m thick. The inner bearing walls are made of solid brick, of 0.25m thickness. Bricks are of standard dimensions 250x120x65mm, connected by cement mortar. The slabs are constructed as semi-prefabricated, made out of "Herbst" concrete hollow elements, joists and concrete slab as shown in Figure 4.4. The roof is of the same construction as the floor, proving continuity of the structure, and later on a possibility for additional storeys to be added. Construction of these blocks was regulated by ex-Yugoslavian standards B.D1.030-1965 [27]. The basement walls are made out of reinforced concrete. Inner perpendicular walls are 0.38m thick, while the outer (longitudinal) walls are 0.30m thick, and two inner walls are 0.25m thick. As the span is larger than 3.0m it was foreseen, as per above mentioned standards at that time, to construct a transversal beam of 25cm width with the same height as the slab see Figure 4.4. Large openings of a regular sequence are found on both west and east façades of the building, as indicated in Figure 4.3.

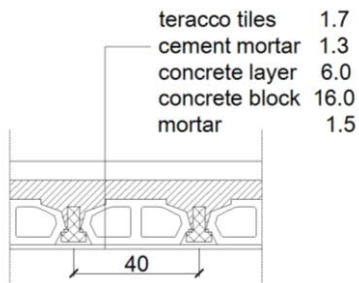
Figure 4.4 - Semi-prefabricated concrete elements

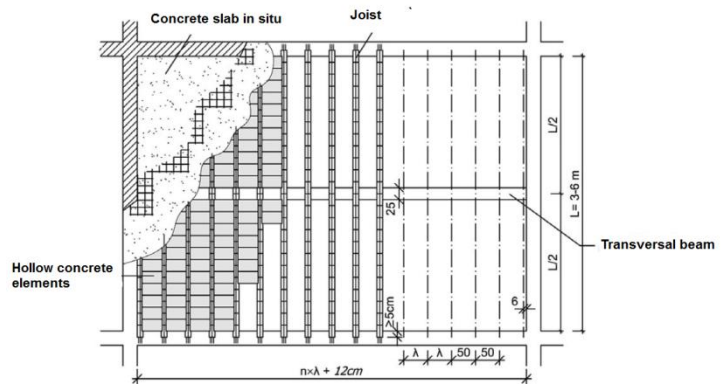
Figure 4.5 - Floor [27]

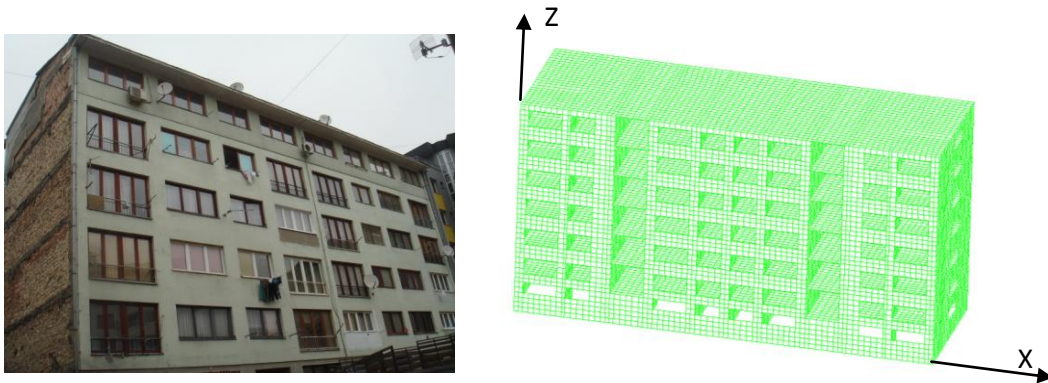
Figure 5.1 - (a) General view of the building and (b) numerical model performed in DIANA

The geometrical data obtained from the original design conducted in 1957 was cross checked by laser measurements on the site, and taking into account some simplifications, the numerical model was completed in DIANA 9.4 [29], as shown in Figure 5.1.

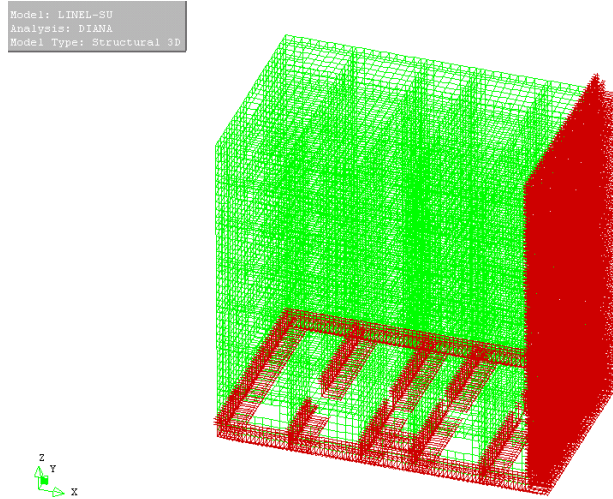
Figure 5.2 - Constrains for half of the model

Due to the size of the building and limited time, only half of the structure was modeled and analyzed, using 45443 nodes and 15759 CQ40S elements. This was enabled by the fact that the structure is symmetric. Adequate boundary conditions were used as shown in Figure 5.2.

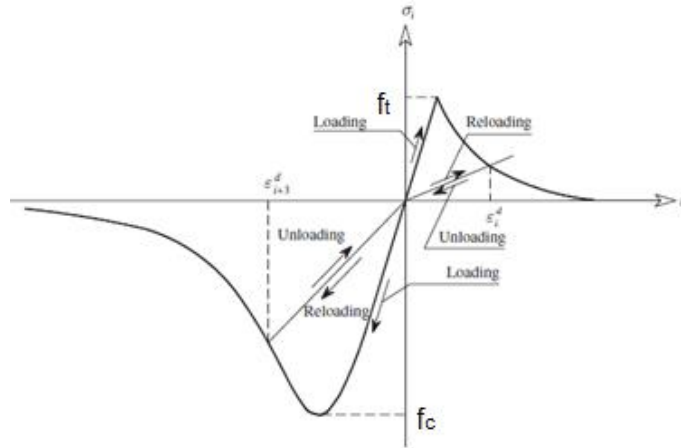
Figure 5.3 - Hysteretic Behavior of Masonry [32]

For hysteretic behavior of masonry parabolic stress-strain relation for compression, based on Hill-type yield criterion, was chosen with no lateral confinement and no lateral crack reduction, as indicated in Figure 5.3. A compressive strength of  $f_c=4.07$  N/mm<sup>2</sup> and a compressive fracture energy of  $G_{fc}=6.51$  N/mm were adopted. If lateral confinement had been chosen, then the compressive strength of the masonry would have increased because masonry elements within the section would be strengthened by the added compression of the masonry elements around them. No lateral confinement is a more realistic assumption for masonry because it is easy for the masonry elements to separate at mortar joints and provide no added confinement strength to other elements. Lateral crack reduction refers to the reduction in strength of the material when it has cracked in tension and then been reloaded in compression. Since there are no cyclical loads in the Pushover analysis, there is no need to make the model more complex by considering lateral crack reduction.

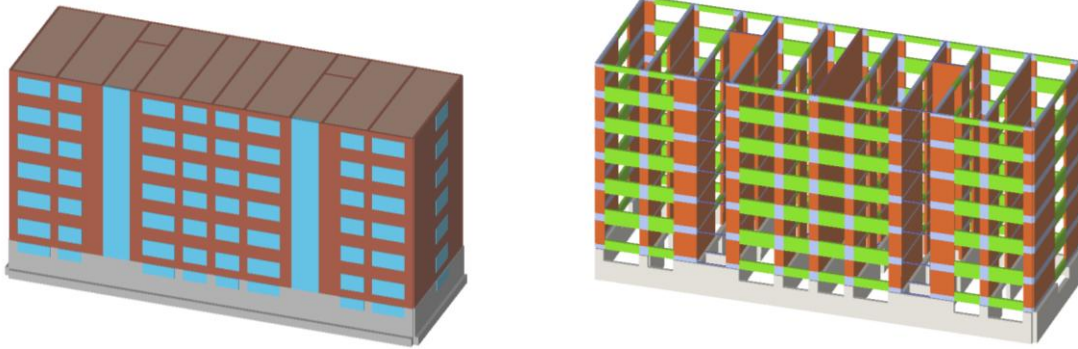
Figure 5.4 - View of the structure and its elements in 3MURI

Here, as the modeling procedure is much simpler and quicker and the calculation time much shorter the entire structure was modeled. The structure was modeled in 3MURI [30] having the same material and geometrical characteristics as defined before. The model consists of 7 levels, 218 - 3D nodes, 34 - 2D nodes, and 506 elements. The view of the structure and elements is presented in Figure 5.4.

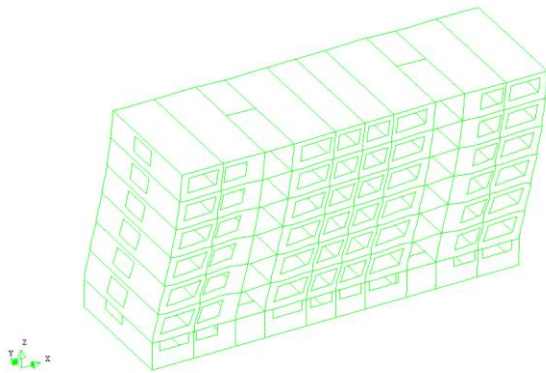
Figure 6.1 - Mode 1 (2.19 Hz)-translation in X direction

The relevant eigen-modes and eigen-frequencies obtained by the FEM calculations are presented in Figure 6.1, Figure 6.1 and Figure 6.3. Whereas, the results obtained by 3MURI are shown in Figure 6.4, Figure 6.4, and Figure 6.6. The mode shapes obtained by both models are very similar as it can be seen from the following figures Figure 6.1 to Figure 6.6. The maximum difference for the first three modes is 19.2% while for effective modal mass is 9.2%, as shown in Table 6.1. It can be concluded that a good correlation between the dynamic properties of two structural models has been obtained, which will further allow a comparison of results.

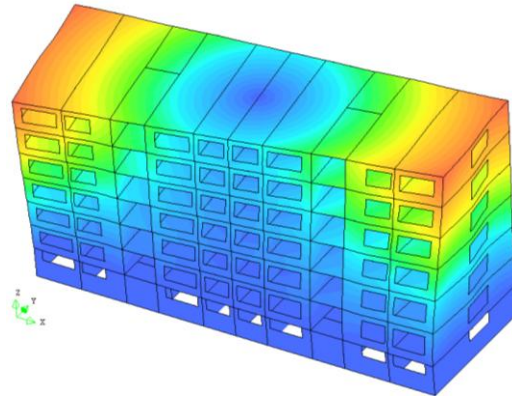
Figure 6.2 - Mode 2 (3.85 Hz)-torsion along Z direction

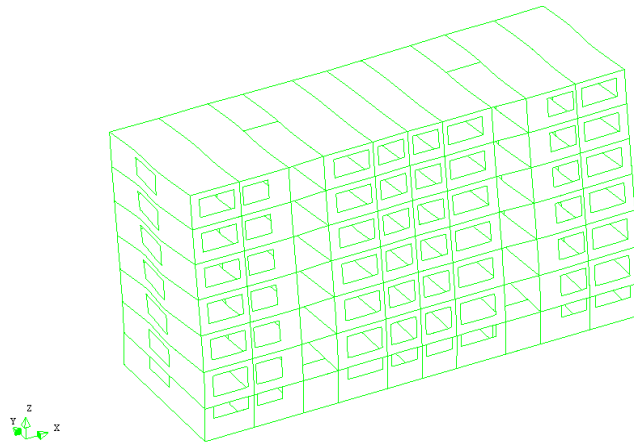
Figure 6.3 - Mode 3 (4.00 Hz) - translation in Y direction

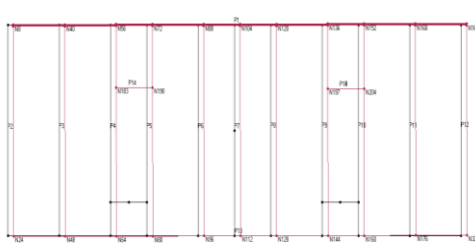
Figure 6.4 - Mode 1 (1.96 Hz) - translation in X direction

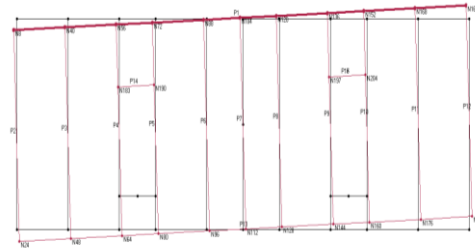
Figure 6.5 - Mode 2 (3.23 Hz) - torsion along Z direction

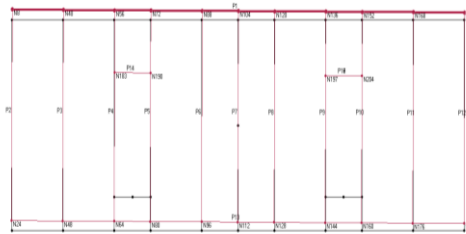
Figure 6.6 - Mode 3 (3.57 Hz) - translation in Y direction

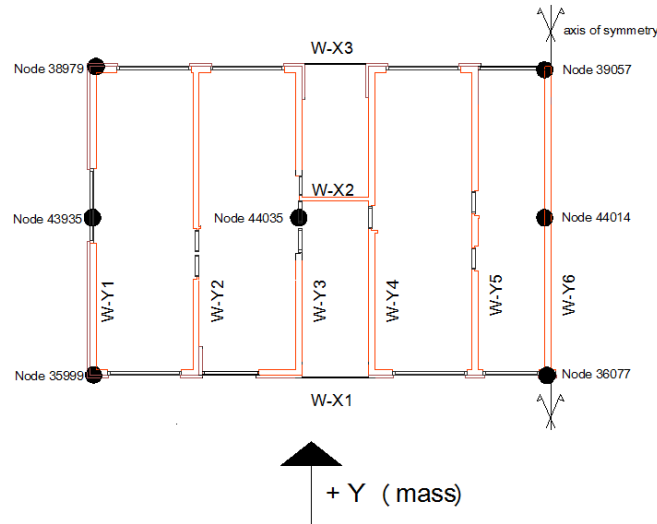
Figure 7.1 - Location of the nodes; wall labeling; and direction of the horizontal force

The analysis of the seismic behavior has been conducted by the application of a non-linear static analysis (pushover), a performance-based methodology, based on an incremental increase of the horizontal force distribution on a structure and constant gravity loads. The structure was exposed only to horizontal acceleration in the "+ Y" directions, as shown in Figure 7.1, as the building would not be able to resist earthquakes with the ground motion applied in the weak direction of the building. The horizontal load was applied in a stepwise fashion proportional to the mass of the structure. The node no. 44014, in the line of symmetry at the roof level, was chosen as the control node, as shown in Figure 7.1.

In order to verify the behavior of the slab, two additional nodes aligned nodes were selected (node 44035 and 43935), see also Figure 7.1. The coincident values of the movement of the three nodes at the top of the structure prove the validity of the rigid floor assumption, as shown in Figure 7.6.

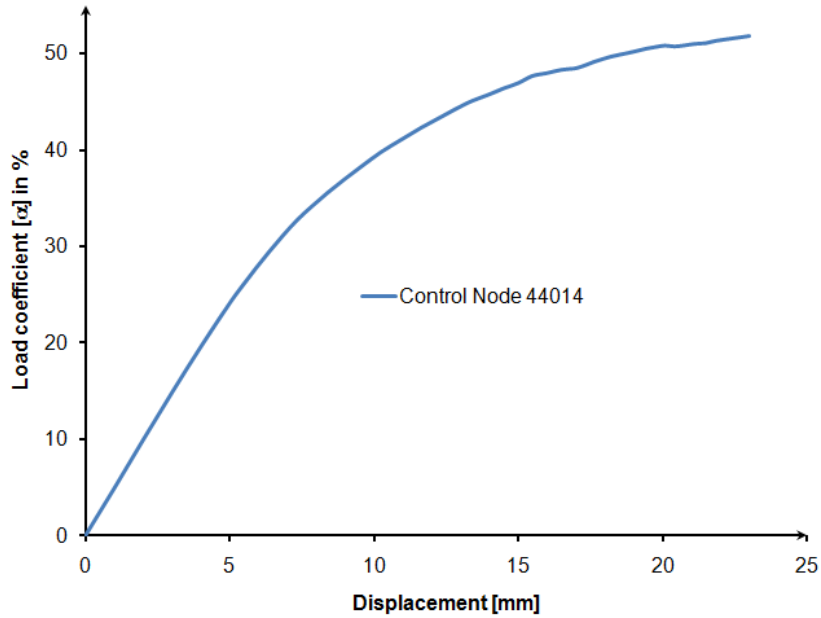
Figure 7.2 - Capacity Curve for Pushover Analysis in "+Y" direction

The capacity curve for "+Y" direction is shown in Figure 7.2. The nonlinear behavior of the structure starts very early and the maximum load coefficient of  $\alpha=0.518$  was reached.

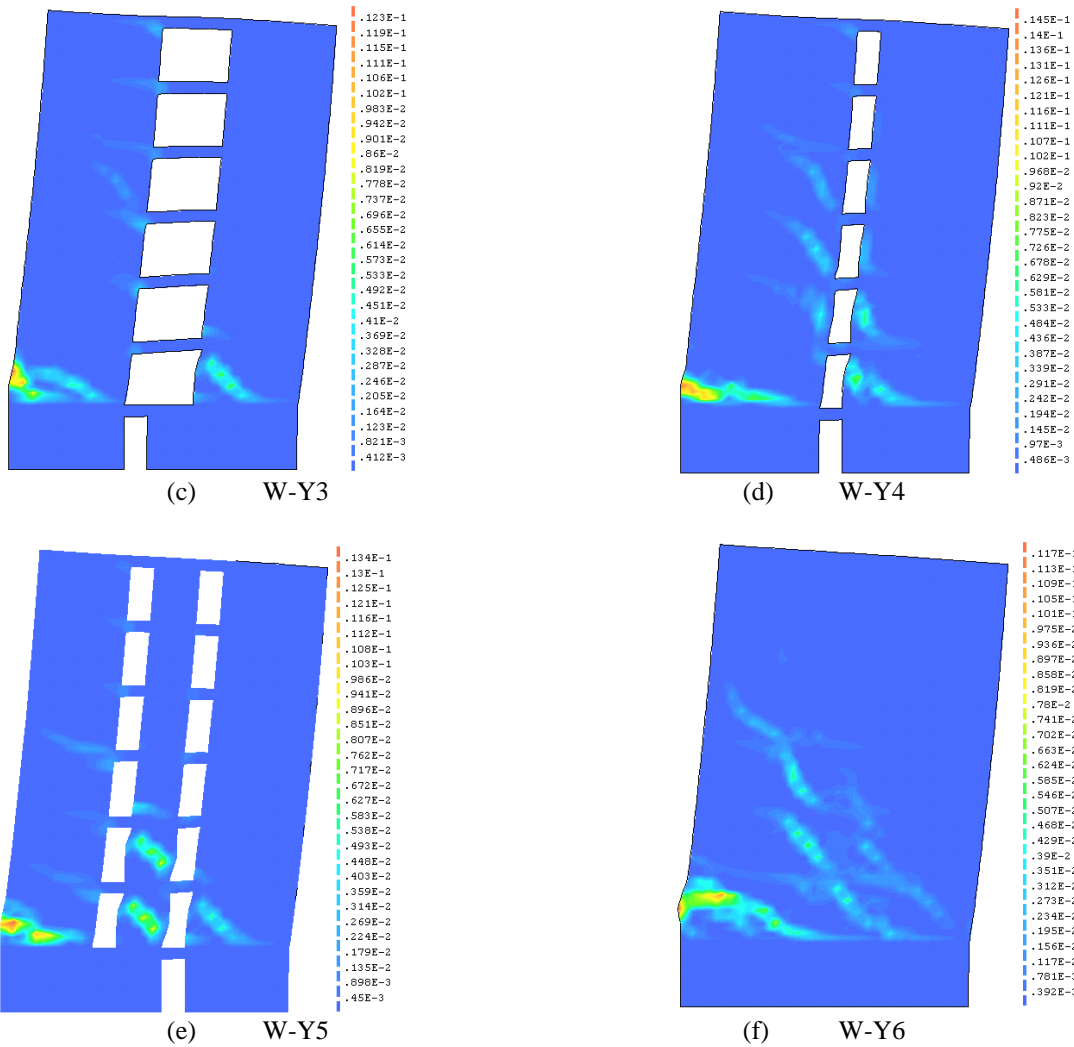
Figure 7.3 - Principal tensile strains ( $\alpha=0.518$ ) depicted on the incremental deformed meshes for load bearing walls: (a) W-Y1; (b) W-Y2; (c) W-Y3; (d) W-Y4; (e) W-Y5; (f) W-Y6

The appearance of the cracks at the last step equivalent to 51.8% of the force is shown in Figure 7.3. The largest amount of cracks is located at the walls W-Y6 and W-Y5 caused by shear, followed by the wall W-Y4, while the walls W-Y1, W-Y2 and W-Y3 had almost the same and the smallest amount of strains at this stage. Shear damage of transversal walls (parallel to the Y direction) is evident, which would further on lead to shear failure. Additionally, due to bending above the openings, bending damage and maybe later on even failure is to be expected in these locations. Evidently this has implications on the development of the cracks on the facade wall W-X1 and W-X3, see Figure 7.4, but to a smaller extent, where evident compression (seen from the principal compressive stresses, not presented here) damage and even failure at the ground level is noticed, with most probably later on local falling out of masonry.

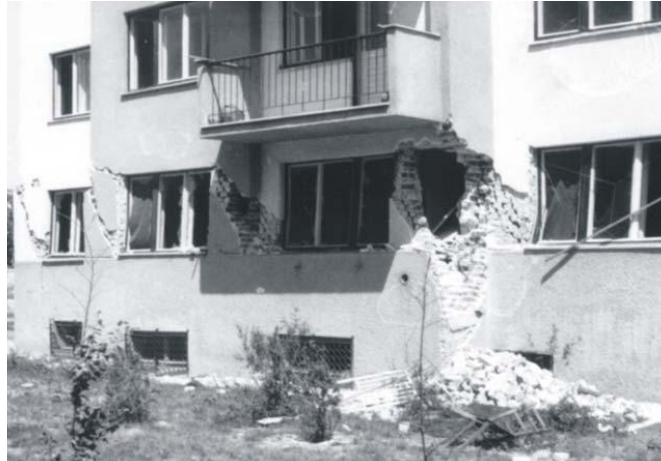
Figure 7.5 - Concentrated damage at the ground floor [39]

This type of damage has been observed on a similar structure type affected by the Skopje earthquake in 1963, as shown in Figure 7.5. The concentration of damage is located on the ground floor with diagonal cracks between the openings, probably caused by shear and in one of the corners, falling of the masonry is evident.

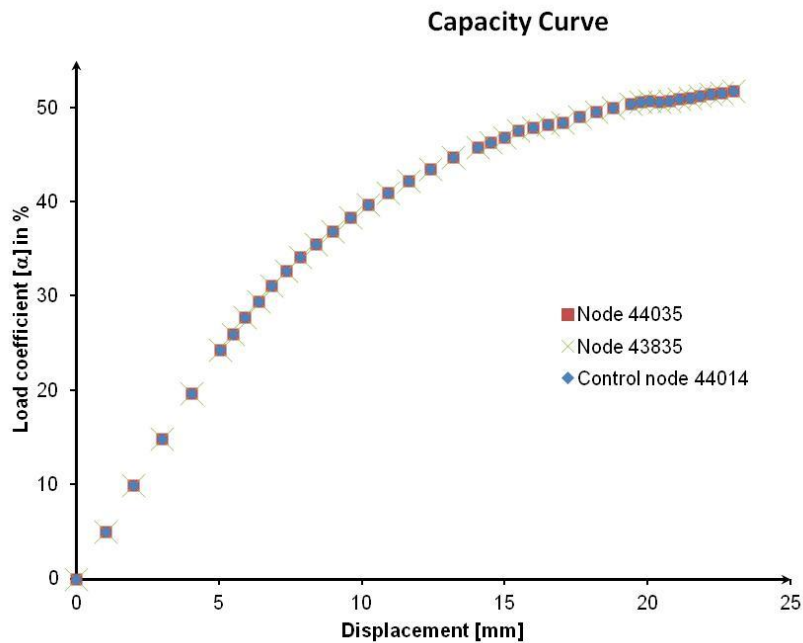
Figure 7.6 - Capacity Curves for Nodes 44014, 44055 and 43935

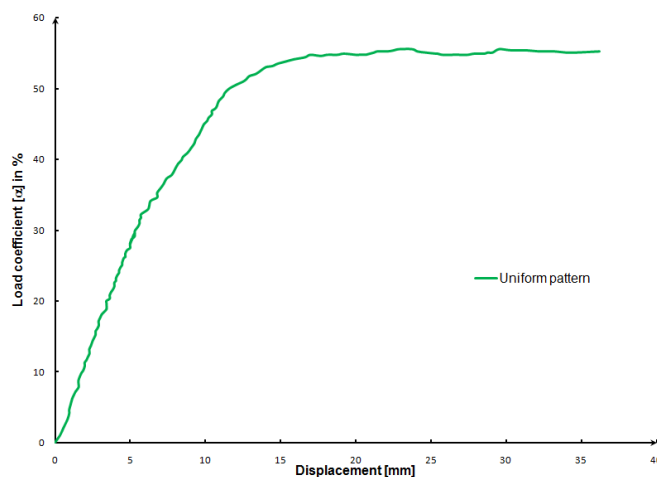
Figure 7.7 - Capacity curve for "+Y" direction

The capacity curve of the structure exposed to a load pattern proportional to the mass in "+Y" direction is shown Figure 7.7.

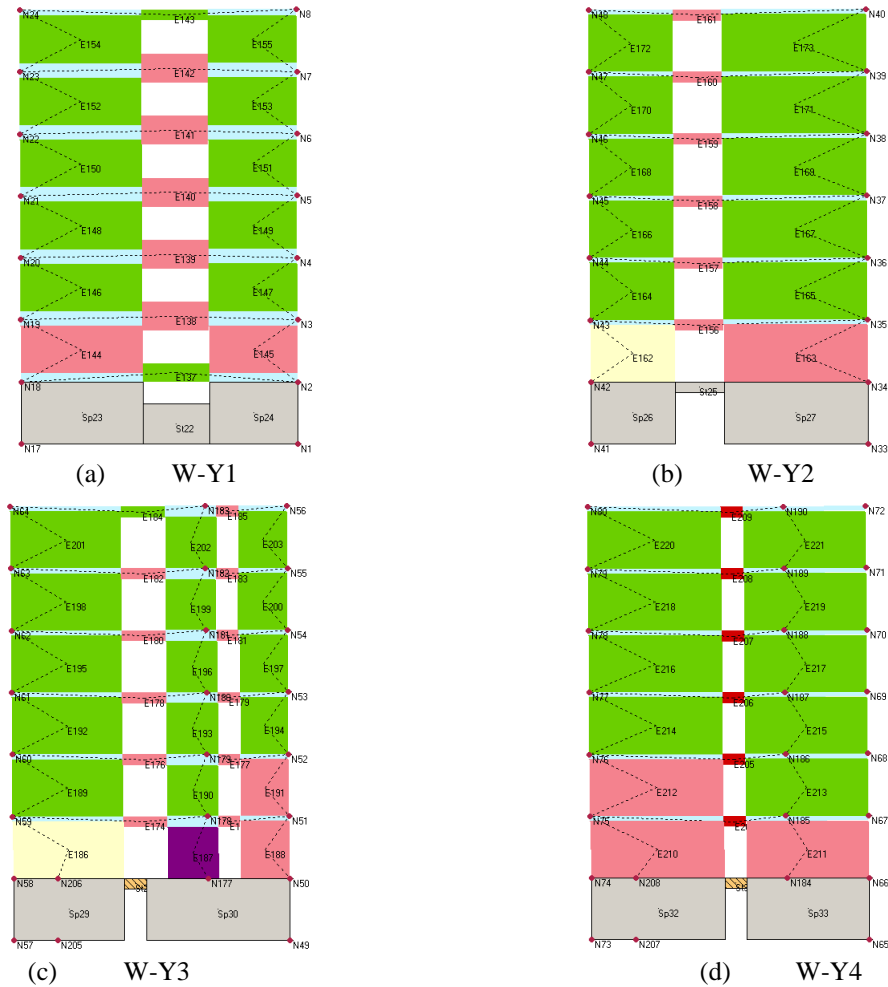
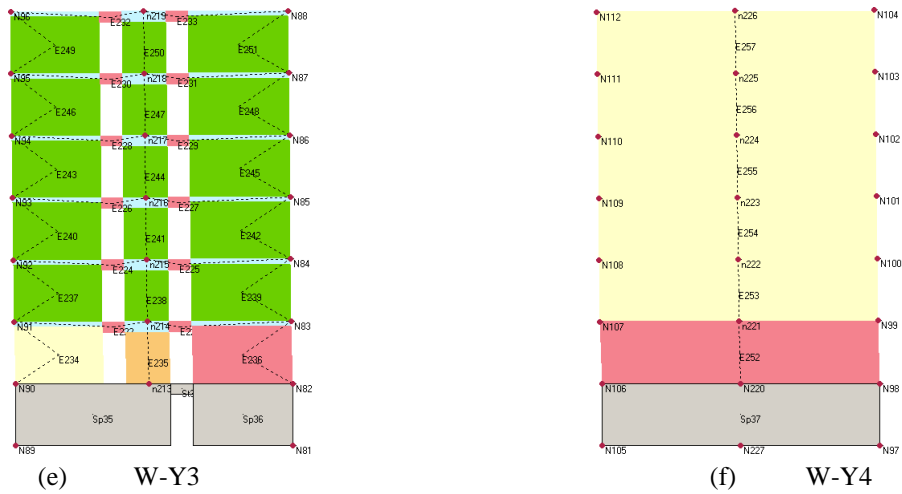
Figure 7.9 - Damage state at failure for load bearing walls: (a) W-Y1; (b) W-Y2; (c) W-Y3; (d) W-Y4; (e) W-Y5; (f) W-Y6

The damage state of the individual walls have been elaborated at the final stage (failure of wall W-X1) and explained using the legend as shown in Figure 7.8. Bending damage is located at the spandrels above the doors and windows, and even bending failure is observed in some of the walls, as illustrated in Figure 7.9. Shear damage is seen on all the perpendicular walls (Y direction) and especially on the wall W-Y6. The basement which is made out of reinforced concrete remains undamaged during the application of the load.

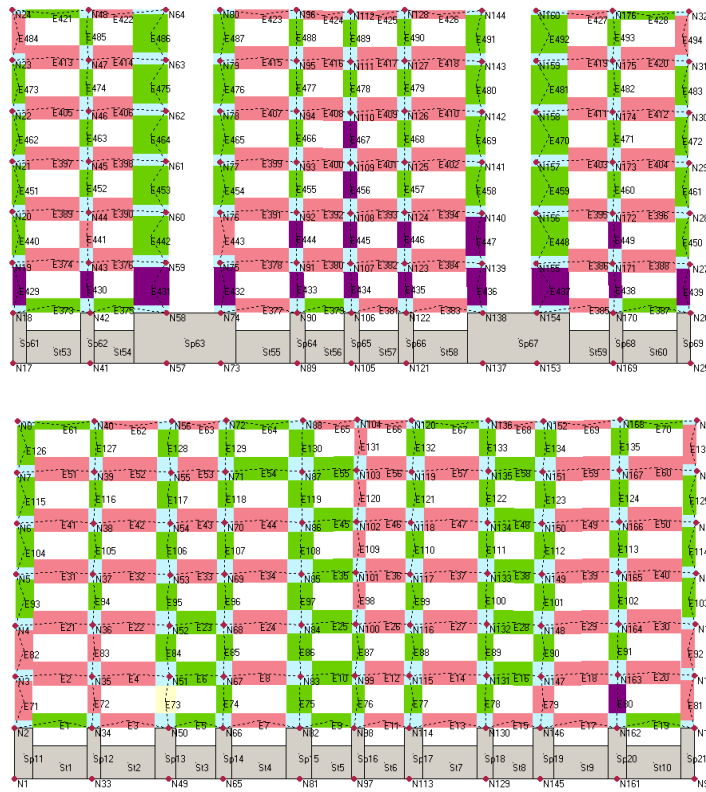
Figure 7.10 - Damage state at failure for façade walls: (a) W-X1; (b) W-X3

The compression failure is concentrated on the ground level of the façade wall W-X1, and it propagates in the direction of the upper floors, as seen in Figure 7.10. At the line of symmetry damage slowly propagates until the fourth level. Evident bending damages are observed around the openings.

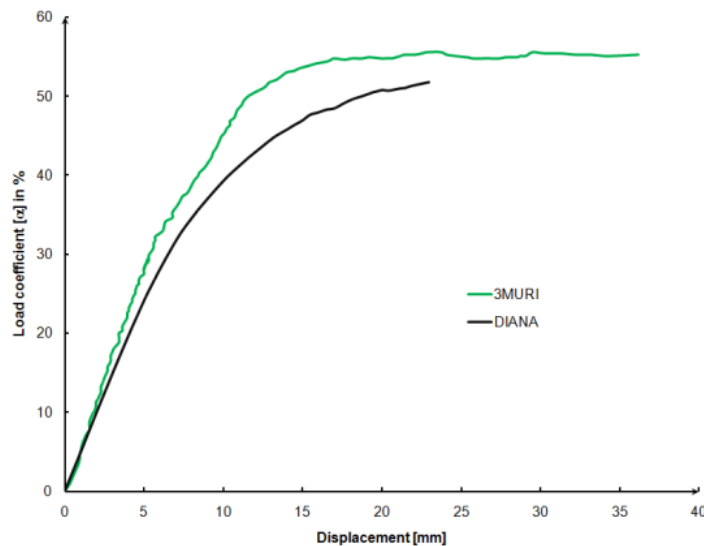
Figure 7.11 - Capacity curves from DIANA and 3MURI softwares for the "+Y" direction

The capacity curves for the "+Y" direction obtained by FEM and FME are compared in Figure 7.11. The capacity curve achieved by FEM, once the maximum strength was obtained, stopped due to convergence issues. The capacity curve obtained by the FME after reaching the strength continues on with a horizontal plateau and then reduction of strength is evidently seen. The difference in the stiffness can be attributed to rigid connection between the spandrel and the pier elements in the FME. The difference regarding the load coefficient is in the range from 6.39 % to 6.94%, which can be declared as acceptable.
