Carlos Andrés Arce Campos The São Francisco portal in Almeida: modelling, analysis and conservation

Portugal | 2016

# Master's Thesis

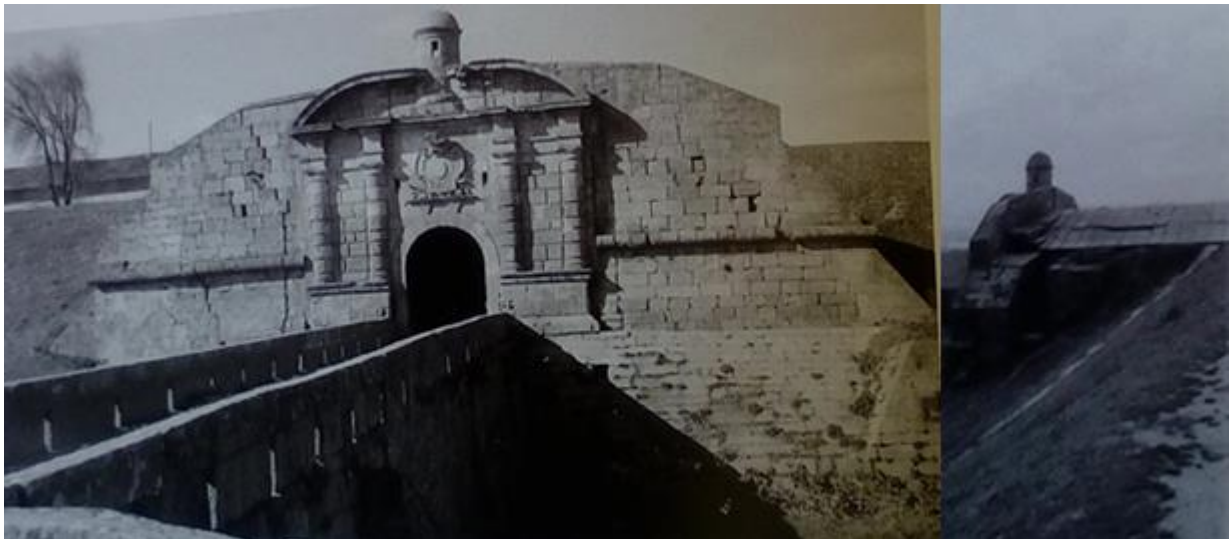
**Figure 9. State of damage in the Gate of San Francisco year 1962**

Restoration works in the San Francisco Gate began in this period: earth covering the longitudinal steps of the cover was removed.

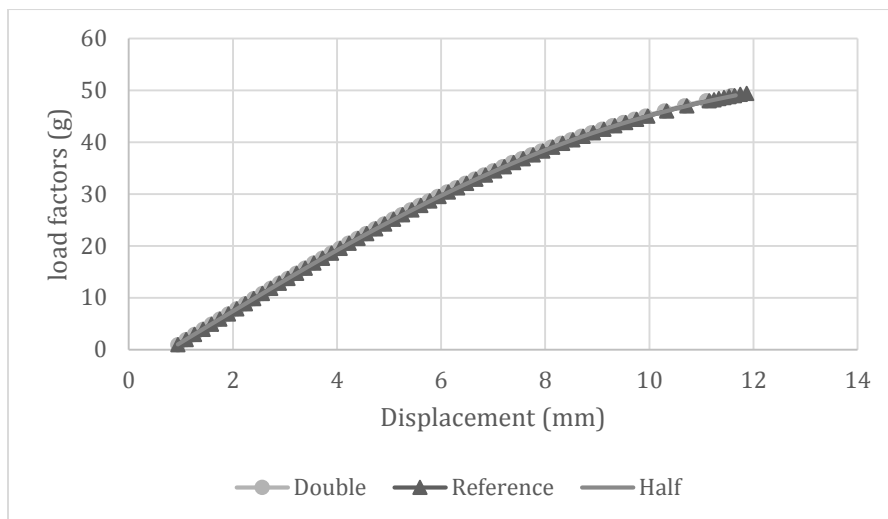
**Figure 26. Sensitivity of results to variation of Tensile characteristics for incremental of live load**

Variation of the tensile strength of the material does not show any relevant effect in the failure history of the material as shown in Figure 26. For the reference properties the first crack appears at load factor of 11.8, while it develops much earlier at load factor 2.97 for half the tensile strength. When using twice the tensile strength value results in a later apparition of cracks, at load factor 29.6. Even though the comparison of history of crack apparition shows that the tensile strength does have a high influence in the formation of cracks, this effect is not reflected in the load history of the whole structure. This result can be interpreted as that the damage in tension is highly smaller than the one in compression. Therefore the structure failure is mainly governed by crushing of the material in compression.

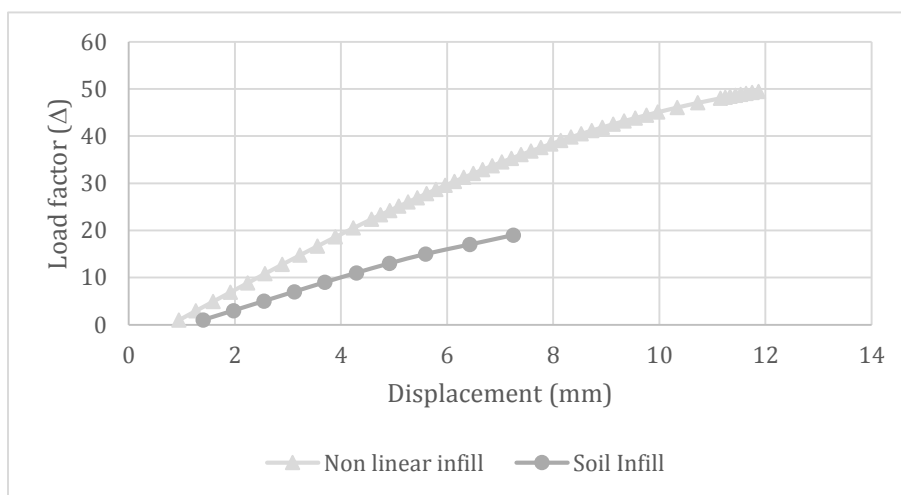
Figure 31. Comparison of load vs. displacement for a soil infill

Another model was created with a soil material. For this model, the load factor varies greatly and the influence of the soil properties show a high importance. Figure 31 shows a comparison of the structure’s behavior as a result of a change in the infill model. The nonlinear infill modeled with a total strain crack model results in a general higher stiffness for the structure and a higher load factor. A value of 49 compared to a value of 18.1.

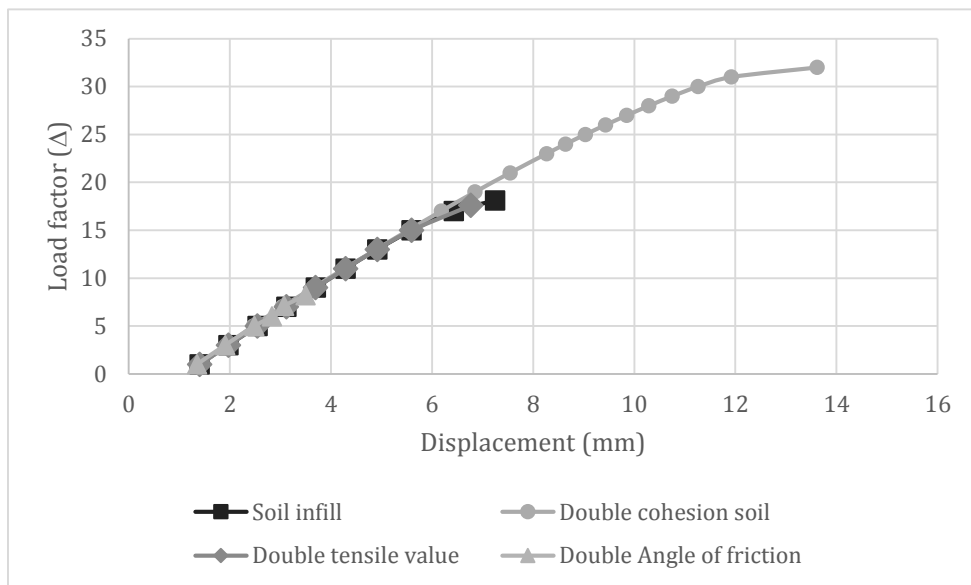
Figure 32. Sensitivity of properties for the soil infill

structure's response, while the variability of the angle of friction has a huge impact, making the model reach failure much faster, with a load factor of 8.2.

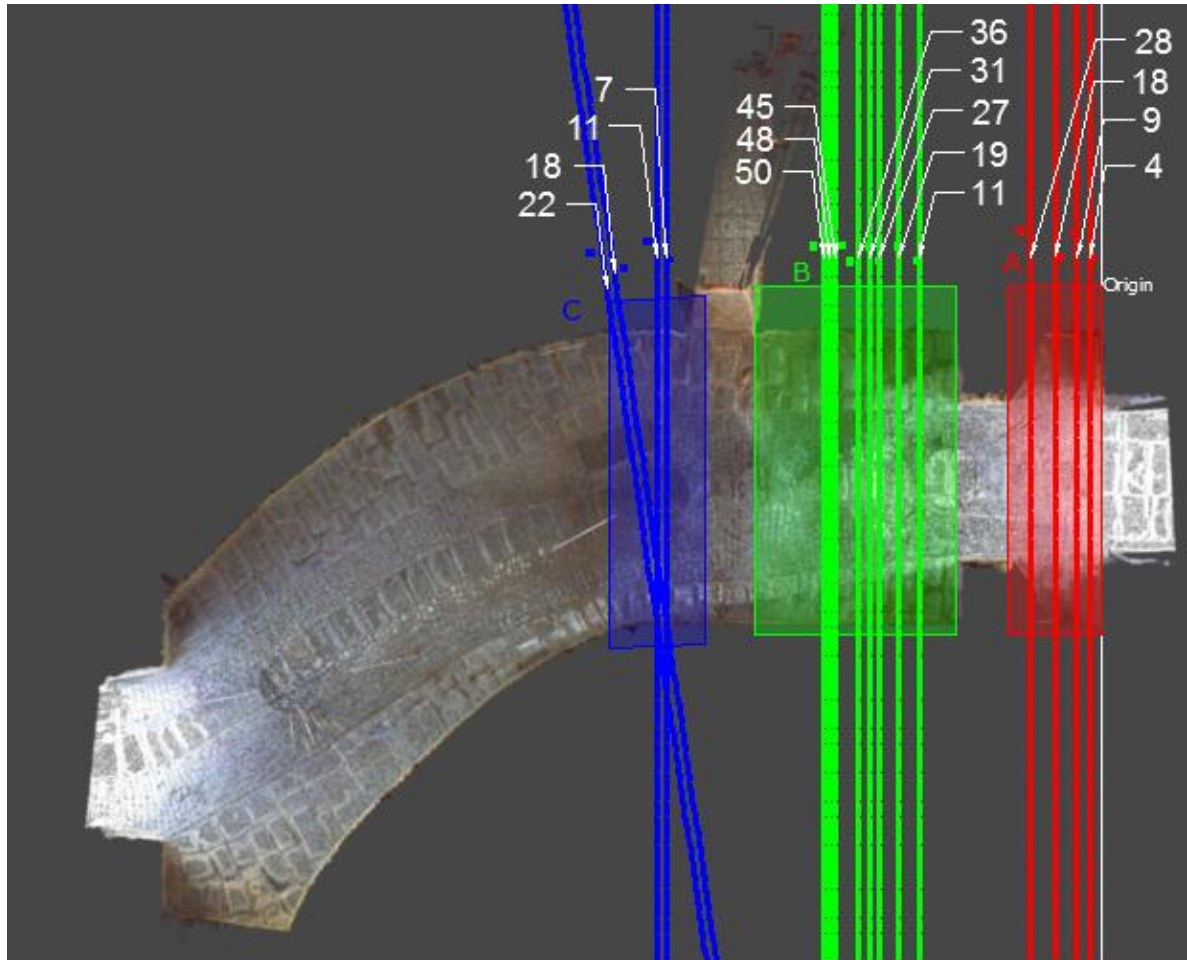
**Figure 34. Laser scanning testing zones A (Red), B (Green), C (Blue)**

Three main damage zones were identified and studied (see Figure 34), the one that shows the worse state is the area closest to the exterior side of the fortress.

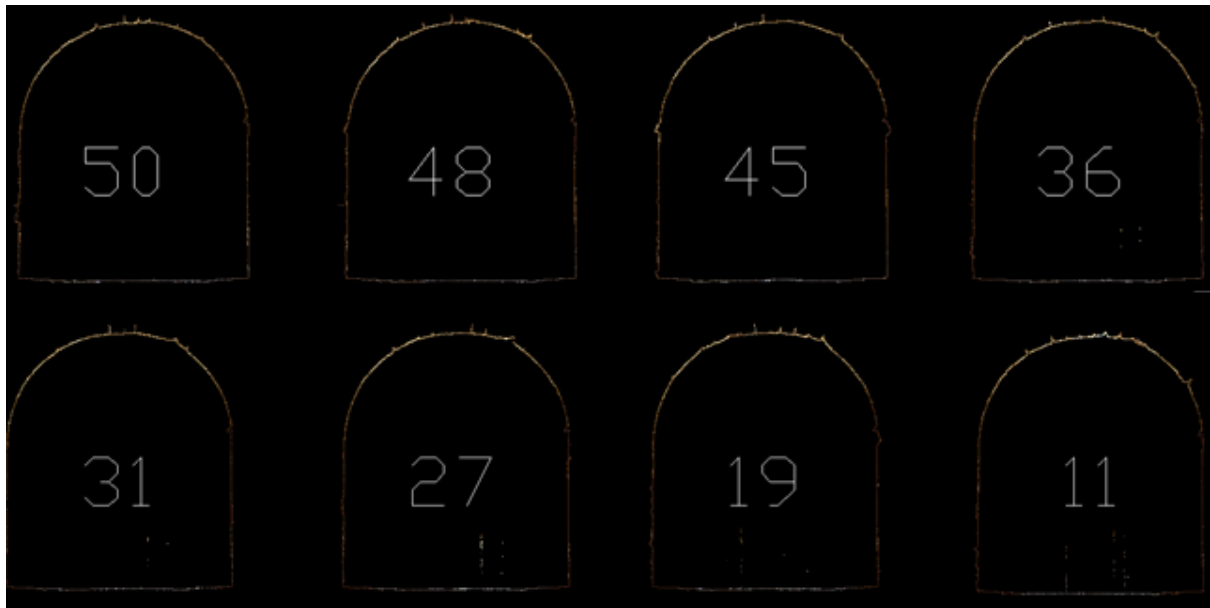
**Figure 36. Damage profiles from clouds of points for Zone B**

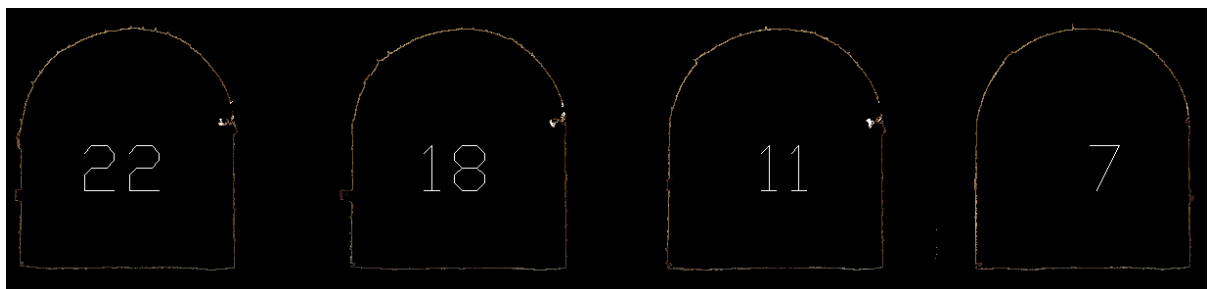
**Figure 37. Damage profiles from clouds of points for Zone C**

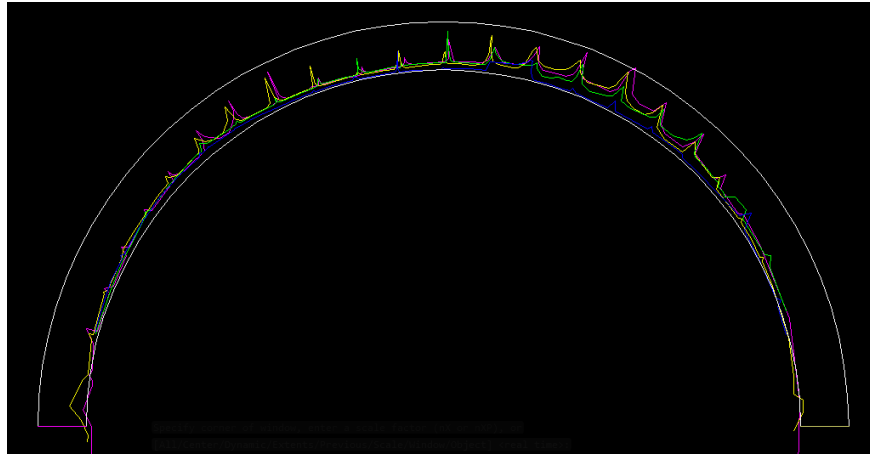
**Figure 38. Superposition of damage profiles in Zone A**

Figure 38 shows a superposition of the damage profiles in zone A, damage is not only deeper in this section of the tunnel but also the location of joints are approximately aligned which results in a higher risk of failure for the structure.

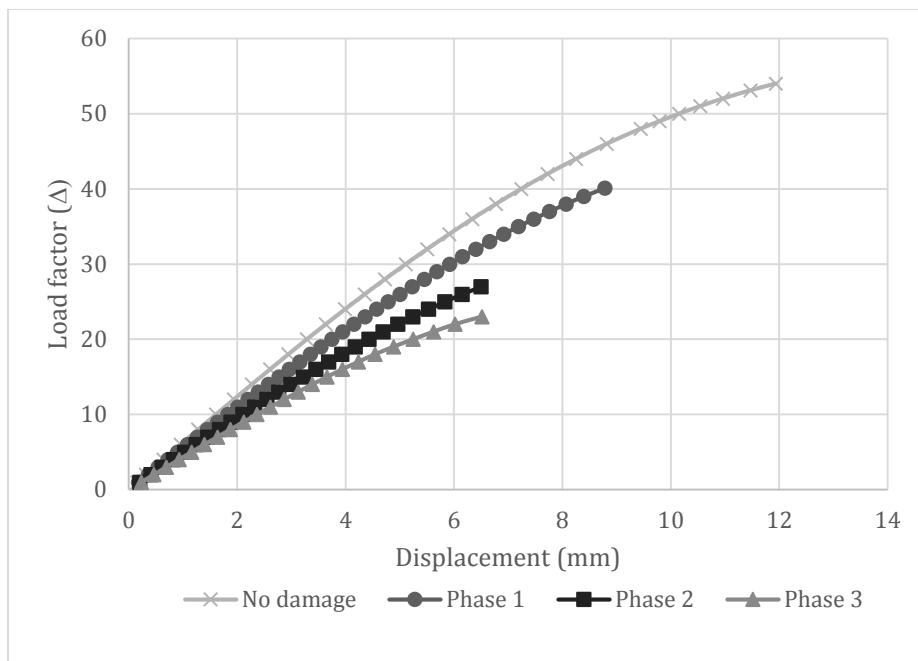
**Figure 55. Safety analysis for symmetrical live load**

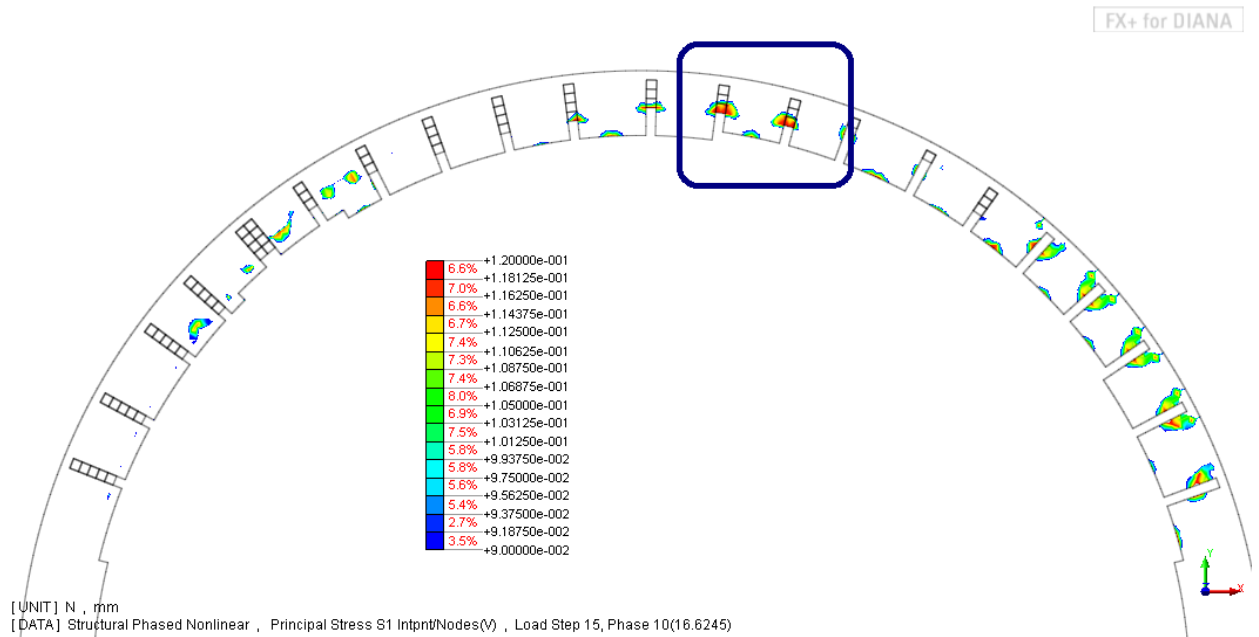
Figure 74. Principal stress S1 for live load and a prediction of damage on the right
