Pushover Analysis of Historical Elti Hatun Mosque

L. Mangia¹, B. Ghisaasi², E. Sayın³, O. Onat⁴, P. B. Lourenço⁵

Keywords: historical heritage; mosque; pushover analysis; finite element method; seismic performance.

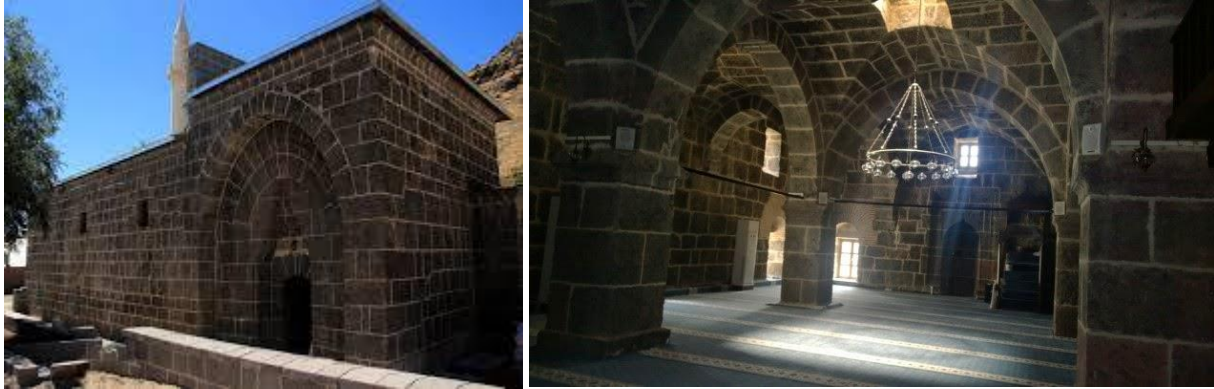
Figure 2: Outside and inside of the Elti Hatun Mosque

was composed of many vaults and arch systems. During the construction phase of the mosque, Horasan mortar was used. Horasan mortar is composed of lime and brick powder. The mosque was restored in the end of July in 2014. Figure 2 shows the views of Elti Hatun Mosque after restoration.

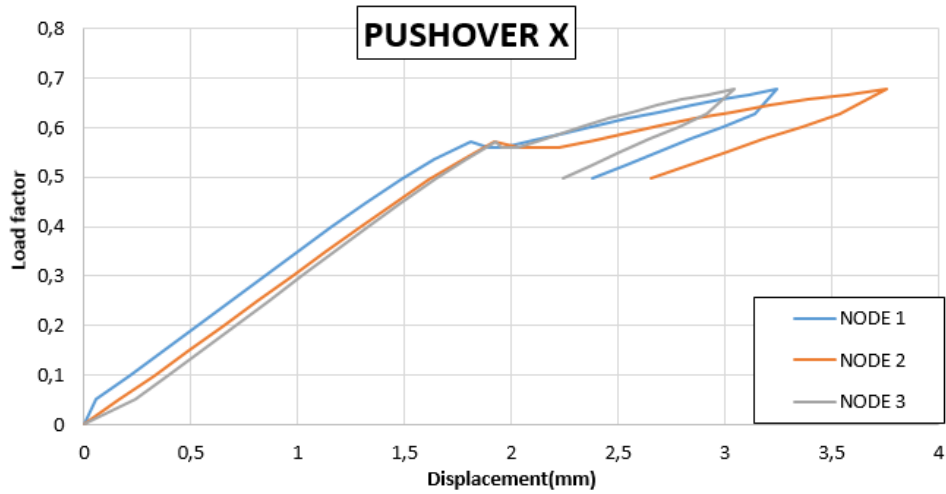
Figure 7. Force – Displacement curve in longitudinal direction

The obtained force-displacement curves of the structure are presented in Figure 7 and Figure 8 respectively. It can be observed that, in longitudinal (x-direction) direction, the displacements were nearly the same at the center of the vault and at the corner of structure. But, the roof displacement belong to top of the main entrance of the structure is more than that. The reason for this is vault and arch system that belong to the main pray room showed superior behavior due to the existence of four pillars and the thick wall system. The main gate of the mosque works as a support system for grand pray room of the mosque. This support mechanism shows resistivity against longitudinal lateral pushover loading. Vault and arch system showed weaker behavior during the pushover analysis due to the larger displacements than node 2 and node 3. For this reason, transversal displacement of the node 1 is nearly 2.5 times bigger than node 2 and node 3 as seen in Figure 8. Deformation of the model at peak displacement can be seen in Figure 9 for both directions. The structure shows a safety factor of 0.65 and 0.32 in longitudinal and transversal directions, respectively.

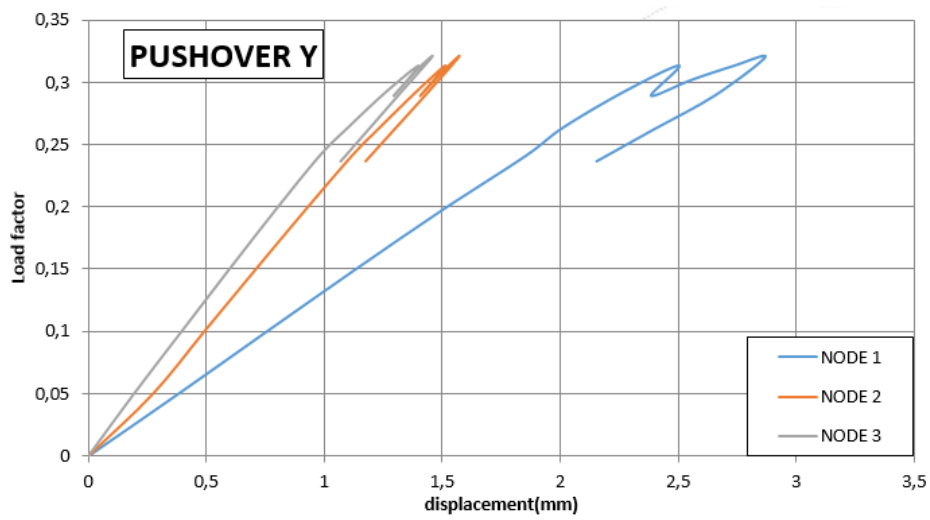
Figure 8. Force – Displacement curve in transversal direction

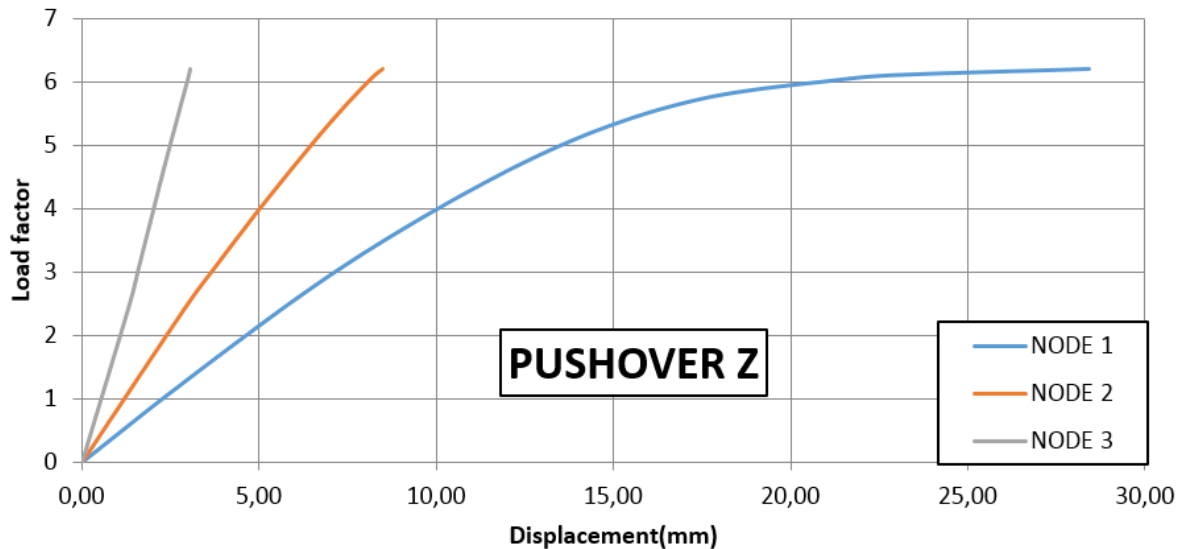
Figure 10. Force – Displacement curve in transversal direction

The nonlinear analysis under the self-weight of the structure is performed to investigate its safety factor under vertical loads. The obtained pushover curves are presented in Figure 10.

As seen from Figure 10, the failure under vertical loads occur at the central point of the arches (node 1). Except for node 1, the pushover curves remain elastic due to existence of perimeter thick rigid walls. The structure is sensitive to vertical loads at node 1 due to a missing column at the center of the main pray room. Stress distribution can be seen in Figure 11. The safety factor of the structure under its self-weight is around 6.0 which is a relatively high value and in acceptable range.
