STRUCTURAL ANALYSIS OF HISTORICAL CONSTRUCTIONS

Possibilities of numerical
and experimental techniques

D.V. Oliveira and P.B. Lourenço

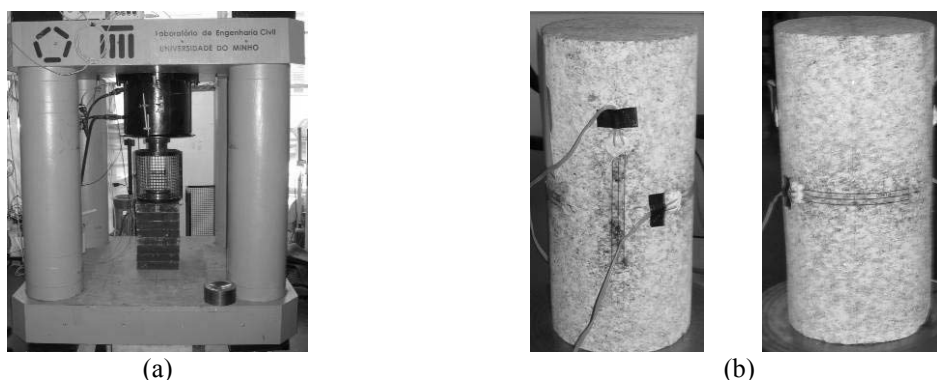
Figure 1 : Testing setup: (a) testing equipment; (b) strain gauges arrangement.

The major part of ancient buildings located in the North of Portugal is made of granite. Therefore, in order to assure an effective representativeness, a granitic stone, locally available, was used in all tests concerning the behaviour of three-leaf walls. Aiming at characterizing its mechanical behaviour, six cylindrical stone specimens of $\varnothing 100 \times 200 \text{ mm}^2$ were tested. A monotonic compressive load was applied under displacement control in a static fashion until the complete loss of strength capacity was attained, see Fig. 1a. In order to assess the Young's modulus and Poisson's ratio, four strain gauges attached to each specimen, equally spaced around the perimeter and placed at mid-height, were used, see Fig. 1b.

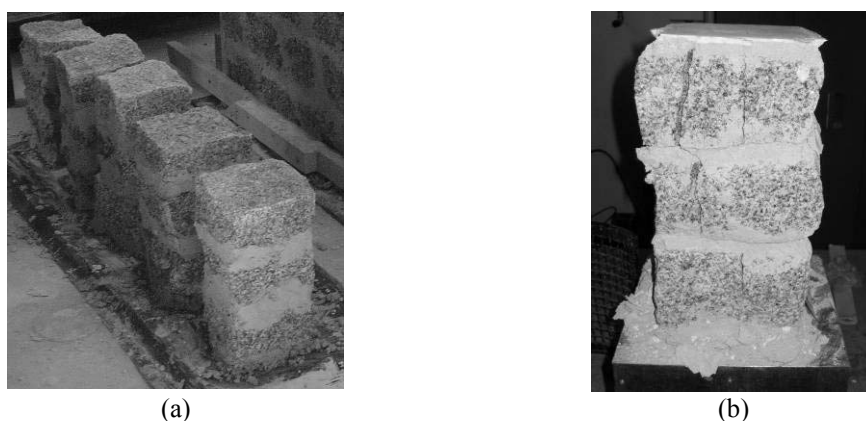
Figure 2 : Prisms representative of the external leaf: (a) prisms prior testing; (b) typical failure pattern.

In order to obtain a good insight into the structural behaviour of each one of the leaves, a set of prisms representing both the external and internal layers were built. The stone masonry prisms were composed of three stones and two masonry joints, built carefully in order to simulate as much as possible the external leaves. During the construction of the walls, in both series a total of nine prisms with average dimensions of $150 \times 150 \times 320 \text{ mm}^3$ (height/width ratio of 2.1) were built and tested under uniaxial compressive loading and at a displacement control rate of $10 \mu\text{m/s}$, see Fig. 2a. The prisms were tested after about 60 days of curing.

An average compressive strength of 7.7 MPa and a coefficient of variation of 28% were computed. As reported in the literature, see Oliveira et al. (2006b) and others, the use of several stone pieces assembled in one prism is likely to originate lower maximum strength values in comparison to the monolithic stone specimens. Here, a reduction of 85% was observed when shifting from stone specimens to stone masonry prisms. However, the high coefficient of variation found, caused by different average values rising from the two series, seems to indicate that such a reduction is also due to the workmanship effect and that more research is needed in order to assess the effect of mortar joints. The typical failure pattern observed is dominated by the formation of vertical cracks that progressed through the entire prism, see Fig. 2b.
