## 7 **Assessment and Mitigation of Seismic Risk at the Urban Scale: An Application to the** 8 **Historic City Center of Leiria, Portugal**

30 **Keywords:** Risk Management, Seismic Vulnerability Assessment, Historic Centers, Masonry  
31 Buildings, Retrofitting Strategies.

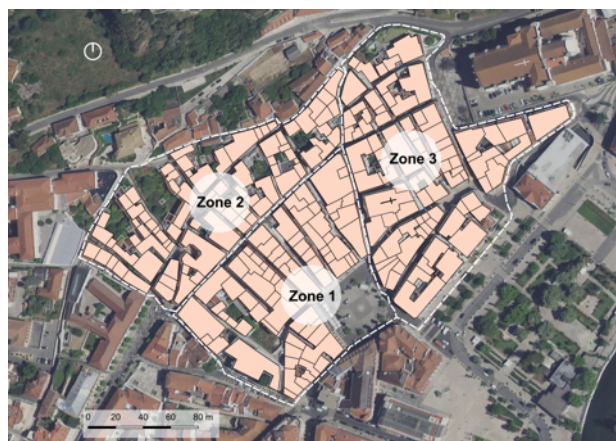
75  
76 Figure 1. Case study zones, adapted from Anglade et al. (2020)

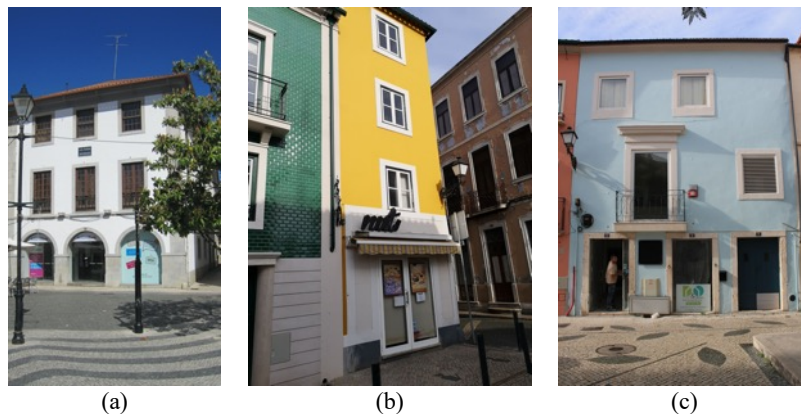
Figure 2. Regular big openings facing of a building facing the cathedral's square (a), a minor square (b) and irregular size and layout openings of a secondary street (c)

88 The study area is composed of a fairly homogeneous building stock with common features that were  
89 easily identifiable during fieldwork. The buildings are generally part of an aggregate, and they tend to  
90 be of 3-4 stories and regular in both plan configuration and height. The façade layout characterization  
91 is also notable, as it has a great influence on the shear resistance and in-plane response of the façade  
92 walls. The façade openings were found to be of notable size and fairly regular in layout for façades  
93 facing the main streets and squares, see Figure 2 (a) and (b), while in secondary streets they present a less  
94 regular configuration and are smaller in size, Figure 2 (c). In some cases, sources of irregularity both in  
95 plan and elevation were introduced by later interventions carried out on the buildings, such as additions,  
96 super elevations, creation of larger openings at the ground floors, floor slab replacements, etc.

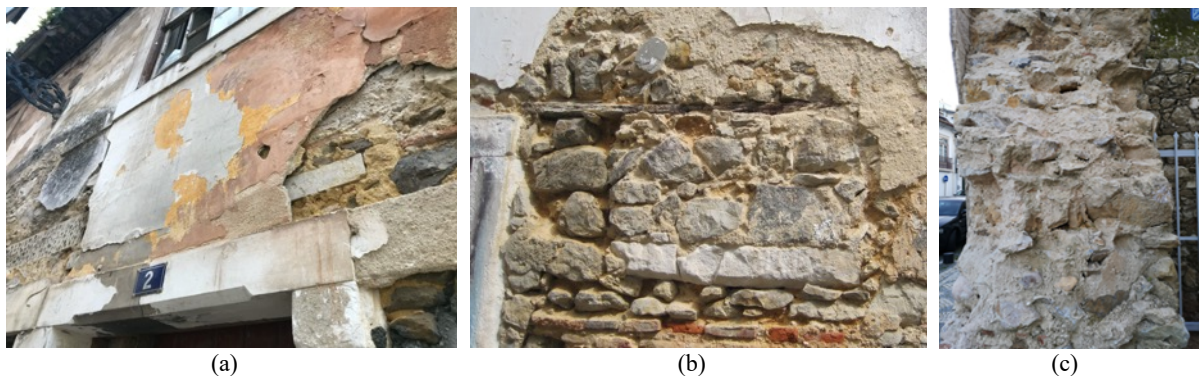
Figure 3. Rubble stone masonry with other material units: sub-horizontal arrangement (a, b) and cross section (c) of some masonry walls in Leiria

98 External inspections were used to evaluate the quality of masonry because deterioration of the external  
99 renders allowed for direct observation of the material underneath. The external walls of the buildings  
100 are mainly composed of stone masonry, usually limestone units of different sizes sometimes mixed with  
101 units of other materials, e.g. clay bricks, marlstones, etc. The units' arrangement has sub-horizontal  
102 mortar joints, but the alignment of the vertical joints does not indicate a good quality masonry (Borri et  
103 al. 2015). In addition, there is large variability in the size and shape of the units, Figure 3. The walls'  
104 thicknesses range from 0.4 m to 1.0 m with an average of 0.7 m and are a three-leaf arrangement with  
105 weak inner filling and lack of connections. The mechanical properties of the masonry were identified

106 according to the “*Masonry of roughhewed stones*” category defined in the Italian Codes (Circolare 21  
107 gennaio 2019 n. 7 C.S.LL.PP. 2019) and confirmed by flat jack tests performed by Pinheiro et al. (2017).

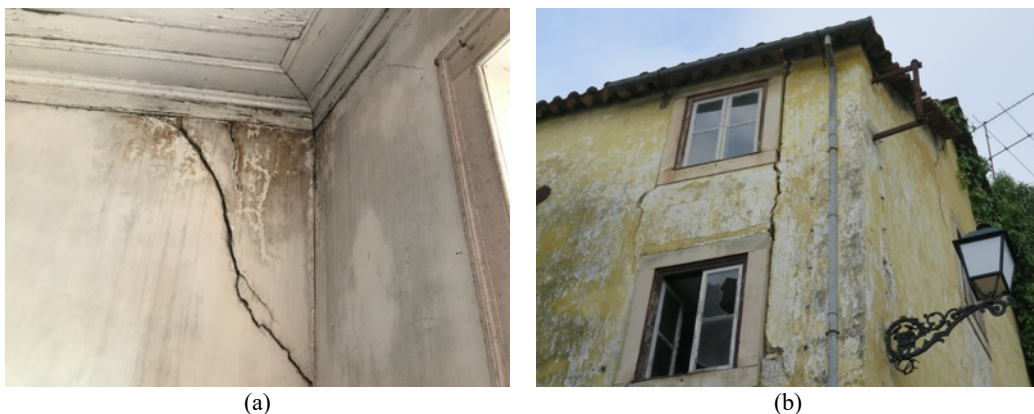
Figure 4. Bad quality connections between orthogonal walls evidenced by diagonal cracks on internal walls (a)  
and by detachment cracks on the corners (b)

108 Good wall-to-wall connection was often evidenced by the presence of large stones in the façade corners,  
109 Figure 4 (a). Thus, when this feature was detected, good quality of the wall-to-wall connection was  
110 assumed for the building. If this was not observed, a bad quality connection and improper interlocking  
111 was assumed. This assumption was supported by observations of large vertical and diagonal cracks, an  
112 indication of a poor connection between the internal and external walls that allows for independent  
113 behavior and rotation of the façade walls, Figure 4 (b) and (c).

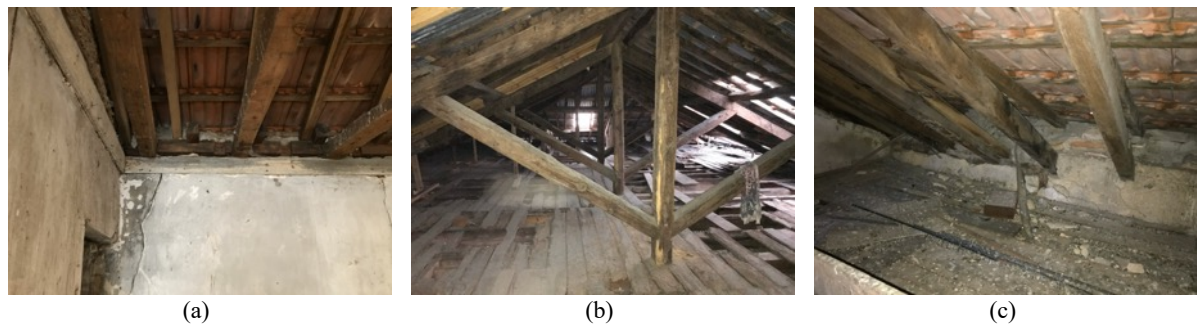
Figure 5. Example of a two-order timber floor with connection to the perimeter wall (a), timber king post truss of a roof (b), mixed masonry-timber perimeter ribbon of the roof (c)

117 Three floor types were observed in the study area: concrete slabs, metallic structures, and timber floors.  
118 The first two typologies were observed in just a few cases in buildings that were recently restored, while  
119 the third type was found in the majority of buildings. The timber floors are composed of pine beams  
120 directly supported by the bearing wall or by a primary order of timber beams, Figure 5 (a). No tie rods  
121 or metallic elements were observed to improve connections between the floor and walls. Thus, a  
122 conservative assumption was made when information about the floor was not available: the presence of  
123 a flexible timber floor with weak connections to the walls and no presence of tie rods was assumed.

124 Few roofing systems were accessible during the fieldwork. However, all of the roofs inspected consisted  
125 of timber truss elements. In some cases, half trusses were observed, but in most cases king post trusses  
126 or simple trusses were used, Figure 5 (b). Additionally, in all the inspected roofs, the truss structure was  
127 connected to the walls through a dormant beam extending all along the perimeter with load distribution  
128 and tying function, Figure 5 (c). This beam is a mixed masonry-timber element that indicates that the

129 roof weight and thrust are properly distributed to the perimeter walls and a good connection between  
130 walls and roof is assured. It was assumed that inaccessible roofs are similar to the ones inspected. These  
131 assumptions, namely the non-impulsive nature of the roof and the presence of a perimeter ribbon, might  
132 lead to an underestimation of the vulnerability of the buildings to the roofing system interaction.  
133 However, the assumptions made are supported by observations made in the field inspections and by the  
134 knowledge of the traditional construction techniques of the area. For these reasons the assumptions made  
135 are considered sufficiently cautious.

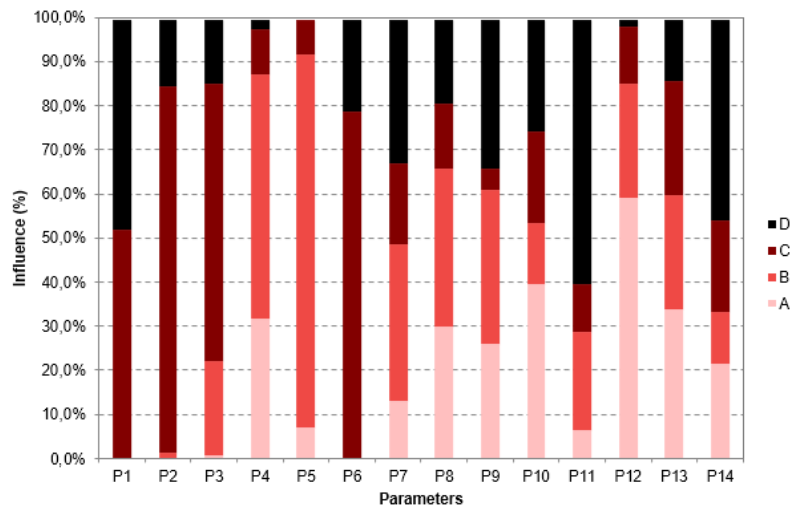
Figure 7. Vulnerability class distribution of each parameter

199 The compilation of the database and analysis of the parameters yields the parameter class distribution  
 200 shown in Figure 7. Of these, P1, P2, P7, and P12 were found to be the most influential and given a  
 201 weight of 1.5 or greater (Table 2). Parameters P3, P11, and P13 are also notable with weights of 1.0; P1,  
 202 P2, P3, P11, P12, and P13 are the target of the retrofitting strategies presented in Section 6. The position  
 203 of a building within its aggregate (P7) is fixed and thus unaffected by retrofitting.

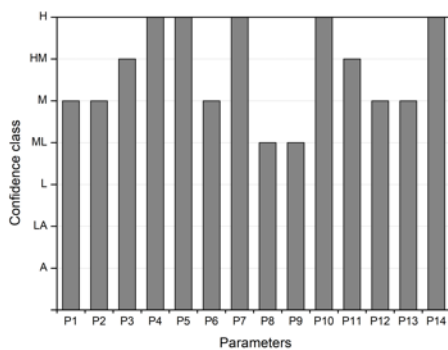
Figure 8. Bar chart distribution of the average confidence class for each parameter

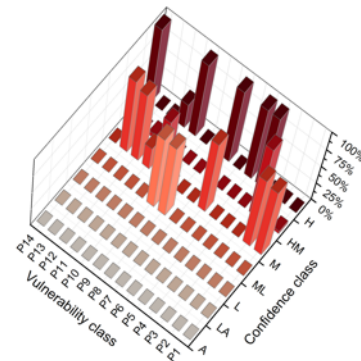
Figure 9. Matrix distribution of the confidence class for each parameter

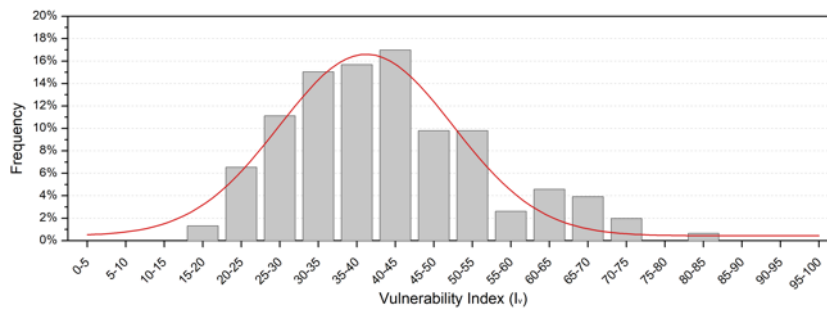
Figure 10. Vulnerability Index distribution of the building stock: histogram and best-fit normal distribution curve

234 The vulnerability assessment described in Section 4 was applied to 153 buildings and yielded a mean  
235 seismic vulnerability index value,  $I_{v,mean}$ , of 41.57. The minimum value of the vulnerability index was  
236 16.83 and the maximum was 82.67. The associated standard deviation,  $\sigma_{I_v}$ , is 12.93. The Kolmogorov-  
237 Smirnov normality test (Frank J. Massey Jr. 1951) confirmed that at the 0.05 significance level, the data  
238 was significantly drawn from a normally distributed population with a p-value of 0.148. Figure 10 shows  
239 the histogram and the best-fit normal distribution curve resulting from the assessment. The buildings'  
240 conservation status ranges from good condition to ruin, and a good distribution of the  $I_v$  values can be  
241 observed in the plots in Figure 11 (a). This distribution was mapped in GIS software to show the spatial  
242 relationship of the vulnerability index values in the study area (Figure 11).

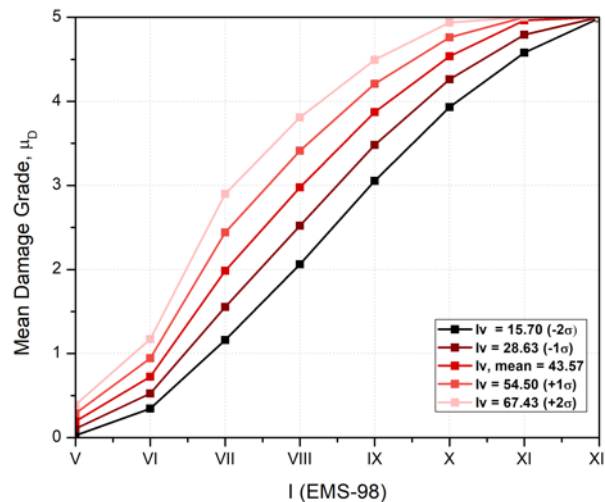
Figure 12. Mean damage grade curves for characteristic values of the vulnerability index

273 Vulnerability curves are plotted in Figure 12 that show the expected mean damage grade for events with  
 274 a range of macroseismic intensities given the mean value of the vulnerability index ( $I_{v,mean}$ ) and upper  
 275 and lower bound ranges ( $I_{v,mean} \pm 1\sigma_v$ ,  $I_{v,mean} \pm 2\sigma_v$ ) found for Leiria.

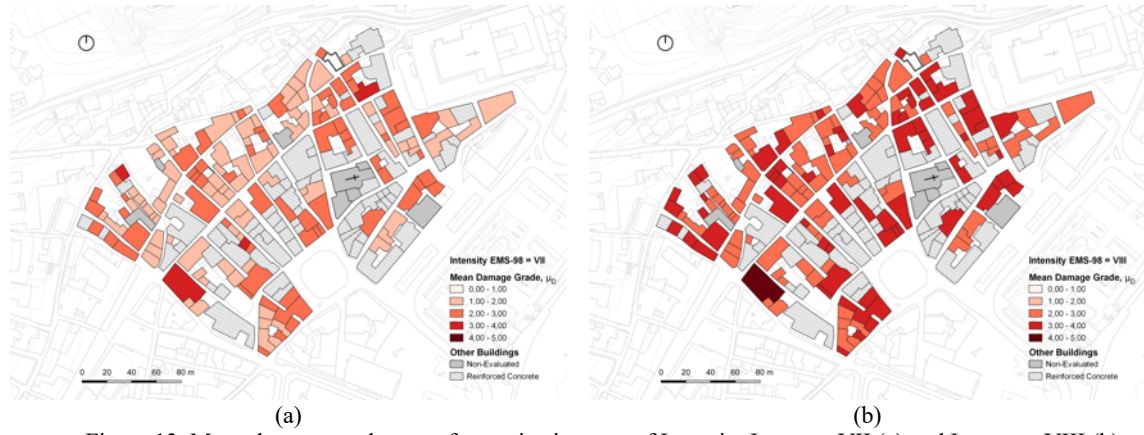
281 Figure 13. Mean damage grade maps for a seismic event of Intensity  $I_{EMS-98} = VII$  (a) and  $I_{EMS-98} = VIII$  (b)

279 visualized in their actual location on the map. Figure 13 shows the distribution of the mean damage  
 280 grades across the study area given macroseismic intensities of VII and VIII.

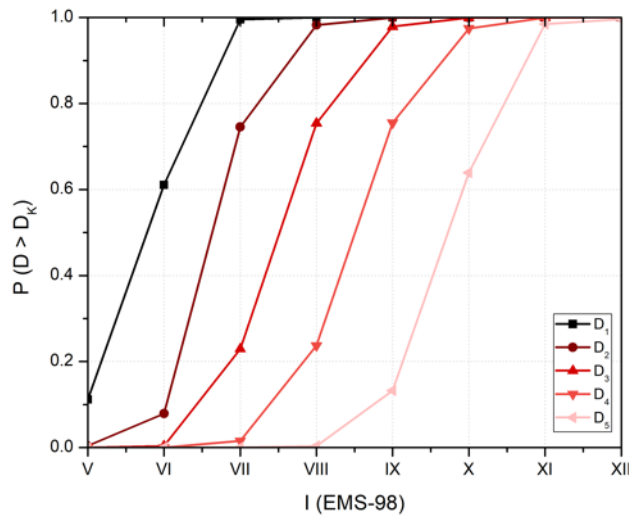
Figure 14. Fragility curve depicting the probability of reaching or exceeding discrete damage grades  $D_1$ -  $D_5$

304 Figure 14 shows the fragility curves plotted as continuous probability functions for the mean  
 305 vulnerability index value ( $I_{v,mean} = 41.57$ ).

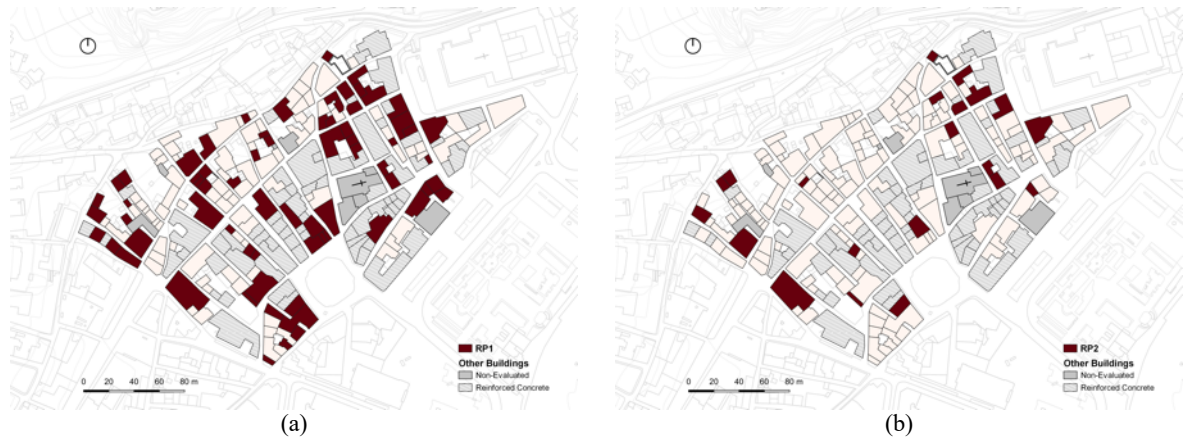
Figure 16. Location of the building intervened with the RP1 (a) and the RP2 (b)

357 a result, 69 constructions (45%) were subjected to RP1, Figure 16 (a). The updated mean damage grade  
 358 was still higher than 3 after the RP1 interventions for 21 buildings (13.7%) out of the original 69. RP2  
 359 was therefore applied to these 21 buildings to further reduce their mean damage grades, Figure 16 (b).  
 360 Finally, the total cost for the application of RP1 was computed as € 862,330.70 and the total cost for the  
 361 application of RP2 was found to be € 1,215,111.00. Bearing in mind that the given amounts are  
 362 representative and do not correspond to the real expenses that incurred by application, these results are  
 363 useful to evaluate the cost-benefit balance that will be discussed in the following sections.

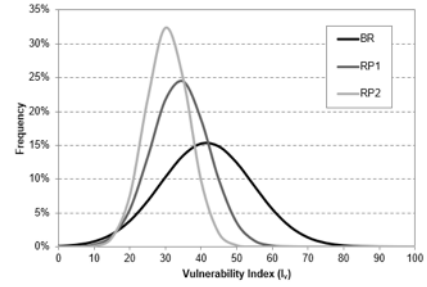
Figure 18. Best-fit normal distribution curve of  $I_v$  before and after retrofitting

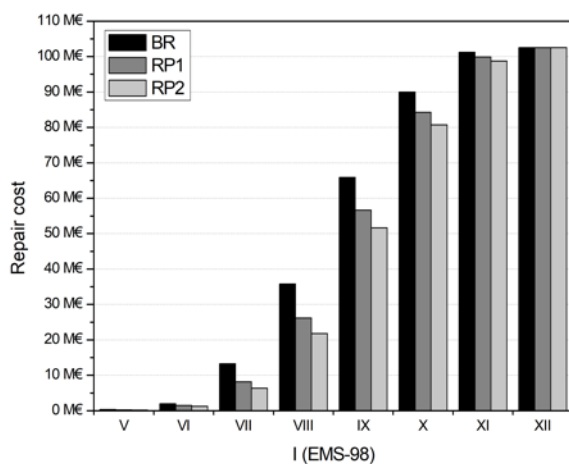
Figure 24. Evaluation of the reparation costs for the different conditions analyzed

473 The application of the retrofitting strategy decreases the estimated economic losses for low intensity  
474 earthquakes ( $I_{EMS-98} = VII$ ) from 13.27 M€ to 8.15 M€ for RP1 (reduction about 39%) and to 6.36 M€  
475 for RP2 (reduction about 52%), see Figure 24. For higher intensities the repair costs of the retrofitted  
476 scenarios are equivalent to the initial repair costs of the BR situation, because these are unlikely  
477 situations, and total destruction is expected.

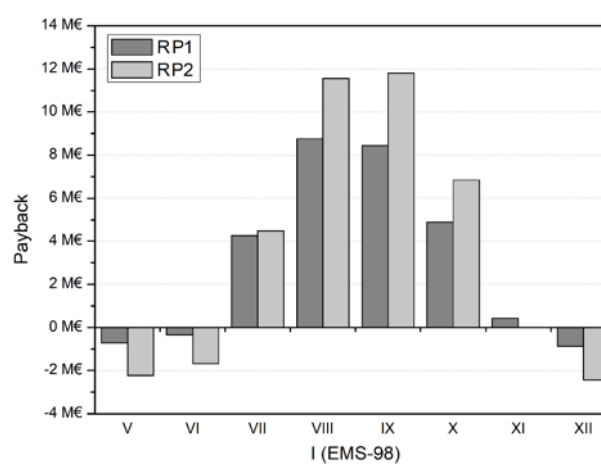
Figure 25. Evaluation of the payback amounts for the retrofitting packages applied

478 Considering the repair costs and the total cost of each retrofitting package, the seismic intensity range  
479 for which the application of the indicated retrofitting strategies is effective can be identified, Figure 25.

480 For low intensity earthquakes (V and VI), the initial retrofitting cost is not justified. The effectiveness  
481 range of the two intervention types are between intensities VII and X for RP1 with a payback maximum  
482 at intensity VIII of 8.75 M€ (ten times the initial investment), and for RP2 with a payback maximum at  
483 intensity IX of 11.81 € (5 times the initial investment). Beyond seismic intensity IX, the retrofitting  
484 applications start losing their effectiveness because the building stock, including the unreinforced  
485 buildings, start to suffer severe damage and collapse.
