Nonlinear Dynamic Analysis for Safety Assessment of Heritage Buildings: Church of Santa Maria de Belém

João Roque¹, Daniel V. Oliveira², Tiago Miguel Ferreira³, Paulo B. Lourenço⁴

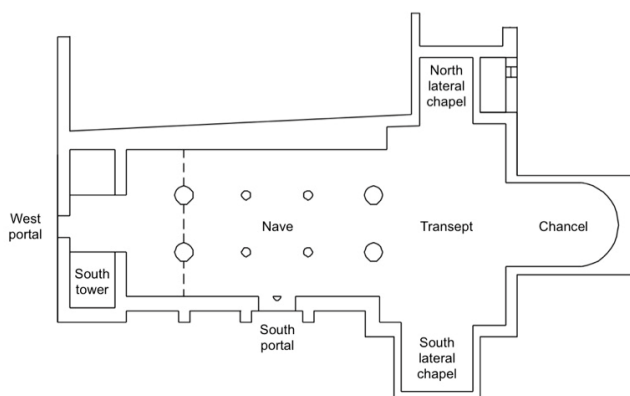
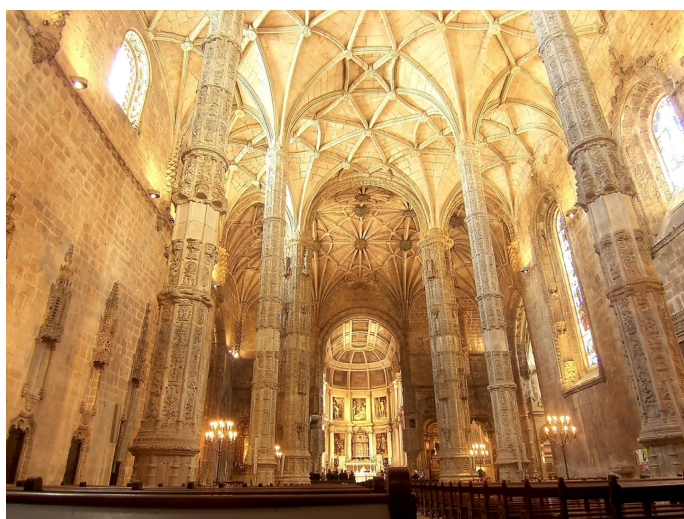
Figure 2: Monastery of Jerónimos complex: (a) plan of the two courts; (b) plan of Santa Maria de Belém church; (c) view to the ribbed vault.

The monastery stretches over an area of approximately 300 per 50 m² and develops around two courts, see Figure 2 (a). The larger court is bordered by a two-storey arcade, wherein the National Archaeology Museum, the Maritime Museum, and the Central Library are hosted. The smaller court, the cloister, is bordered by the sacristy, the chapter room, the refectory and the church of *Santa Maria de Belém*, object of this research. In geometrical terms, the church is 70 m long, 23 m wide (40 m in the transept), and 24 m high. As can be observed in Figure 2 (b), geometrically the church presents a cruciform layout with a single nave crossed by a transept with two lateral chapels and a chancel. The roof is composed of a single rib-vaulted ceiling of 30 m span, see Figure 2 (c), supported by six columns with circular base. A single bell tower of 50 m height rises from the corner between south and west façades.

The church is made of large blocks of a white fossiliferous limestone, called "*calcário de lioz*", which were quarried close by. The naves are covered with a slightly curved barred vault provided with stone ribs according to a spider web pattern. Two rows of octagonal columns, with a free height of 16 m and a radius ranging from 1.04 m (in the nave columns) to 1.88 m (in the nave-transept columns), divide almost imperceptibly the longitudinal naves, creating almost a single nave. The columns are connected to the vault by means of large fan capitals that reduce the free span of the nave.

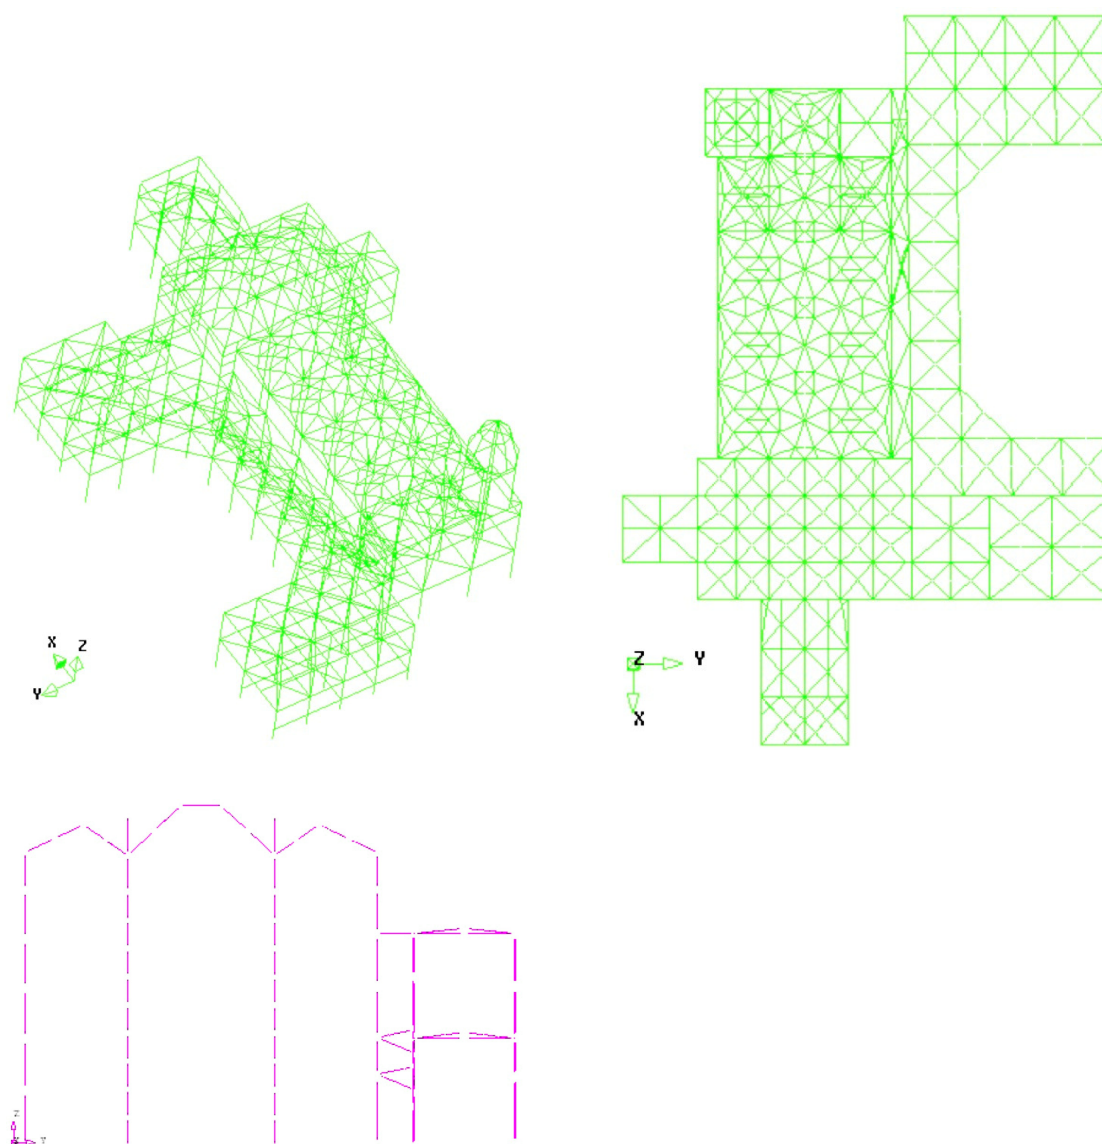
Figure 3: Finite element model: (a) 3D view; (b) plan view; (c) central arcade of the nave in transversal direction, adapted from (Masciotta et al. 2016).

The full numerical model is composed of 2684 Timoshenko beam elements with quadratic interpolation and 4242 nodes, corresponding to a total of 25452 degrees of freedom (DoF), see Figure 3. The supports were fully restrained, being rotations possible given the non-linear material behaviour assumed.

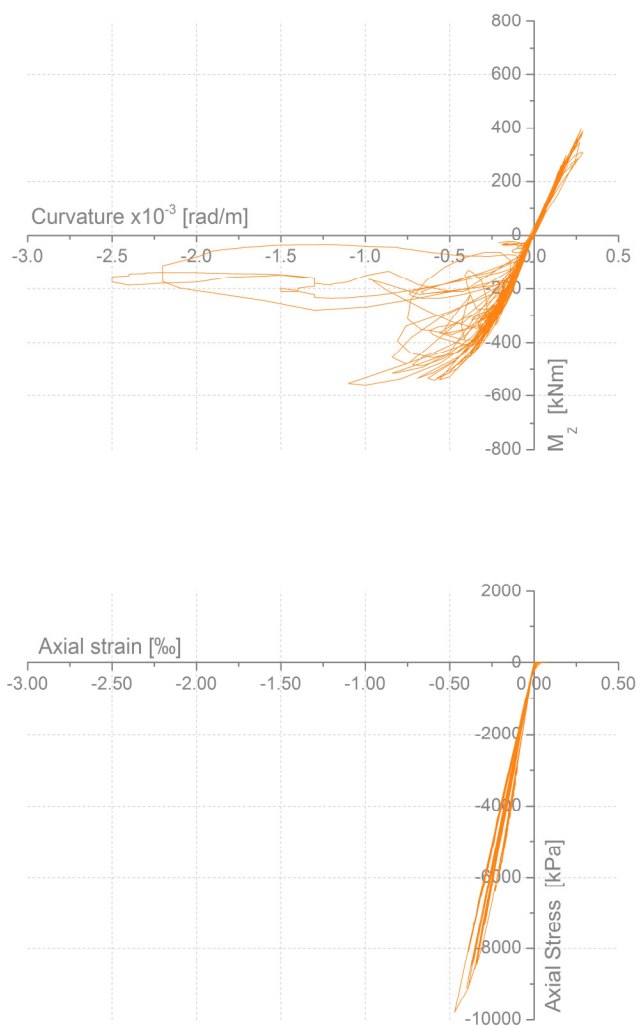
Figure 11: Response of the north column obtained from seismic input 5000_M82_2: (a) moment-curvature diagrams; (b) stress-strain curves of the most compressed fibres.

As the dynamic response of the church to the seismic excitation with 5000 years return period reveals the occurrence of potential collapse mechanisms involving the central arcade of the nave, the subsequent discussions will be focused at investigating damage on its structural elements (namely columns and walls). The response of the north column is presented in the form of bending moment-curvature diagrams and stress-strain curves (for the most compressed fibres), both at the bottom, middle and top sections. Moment-curvature diagrams presented in Figure 11(a) confirm the asymmetric behaviour of the column sections due to the seismic increase of the eccentric compression resulting from dead loads. A stiffness and flexural strength degradation of the sections is evident from the hysteretic behaviour associated with progressive damage, that culminates in total loss of strength at the bottom section. The stress-strain curves presented in Figure 11(b) also evidence the high damage under compression at the bottom and middle sections, as well as a significant level of cracking ($\epsilon_{axial} \gg \epsilon_{ck}$) present in all sections. Being the axial strains lower than 0.5‰ at the top section, no damage in compression is found.

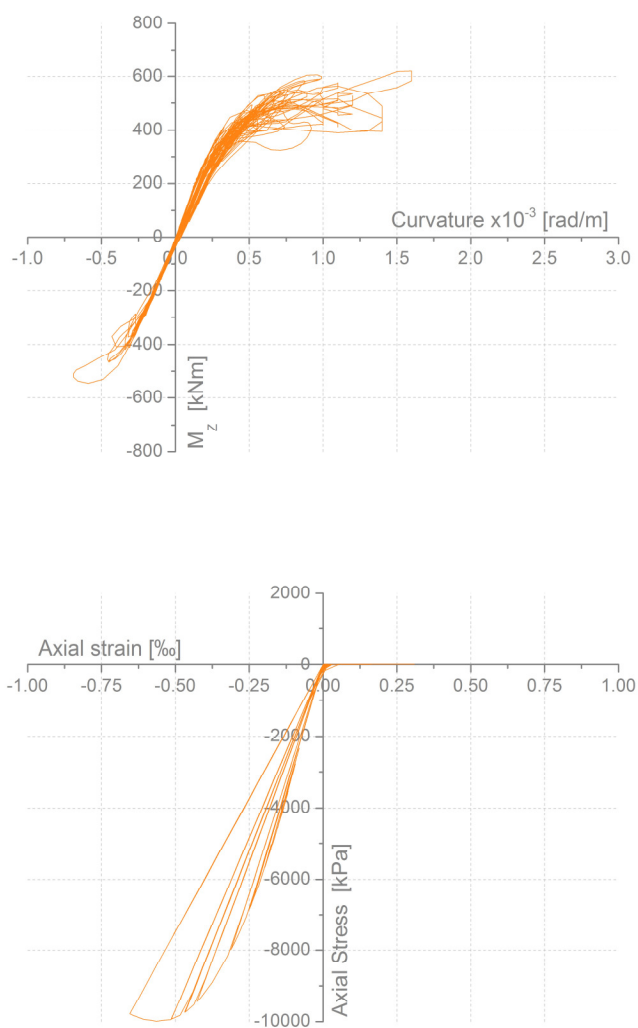
Figure 12: Response of the south column obtained from seismic input 5000_M82_2:
(a) moment-curvature diagrams; (b) stress-strain curves of the most compressed fibres.

From the analysis of the moment-curvature curves presented in Figure 12(a), it can be observed that non-significant hysteresis justifies that sections haven't lost its total flexural strength

capacity in the south column. However, in the bottom section, the failure of the most compressed fibres appears as eminent (post-peak instability), see Figure 12 (b).

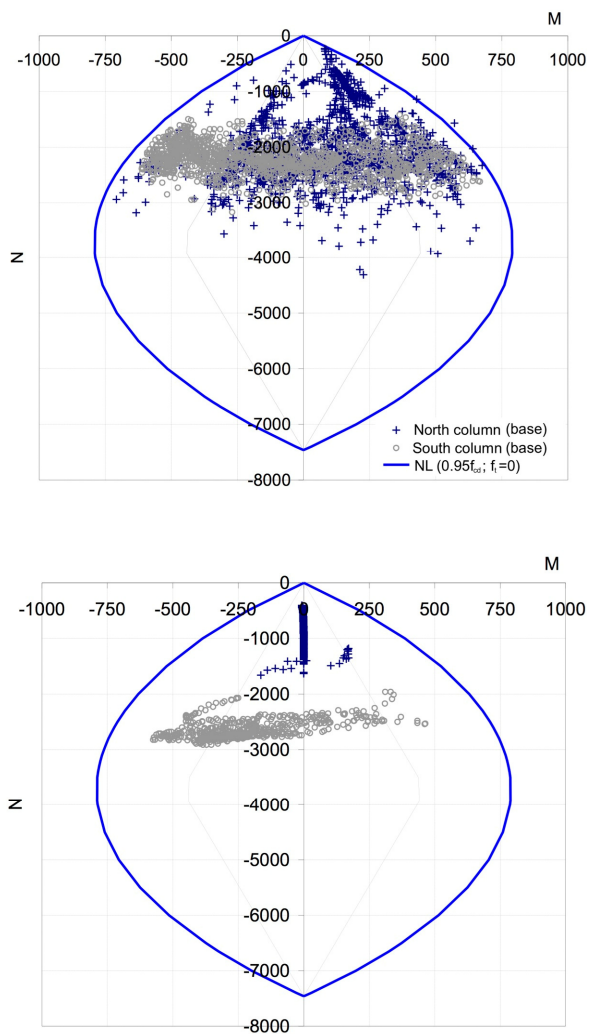
Figure 13: N-M interaction diagram at the base of the north and south columns: (a) before and (b) after the beginning of collapse (seismic input 5000_M82_2).

The asymmetric behavior of the nave columns, due to the asymmetry of the central arcade, is also apparent in the load interaction N-M diagram (axial load *versus* bending moment), presented in Figure 13, which reveals that the collapse of the central north column is conditioned by the combination of moderated axial compression loads ($\nu < 0.40$) with large bending moment values, resulting in high levels of eccentric compression in the section.

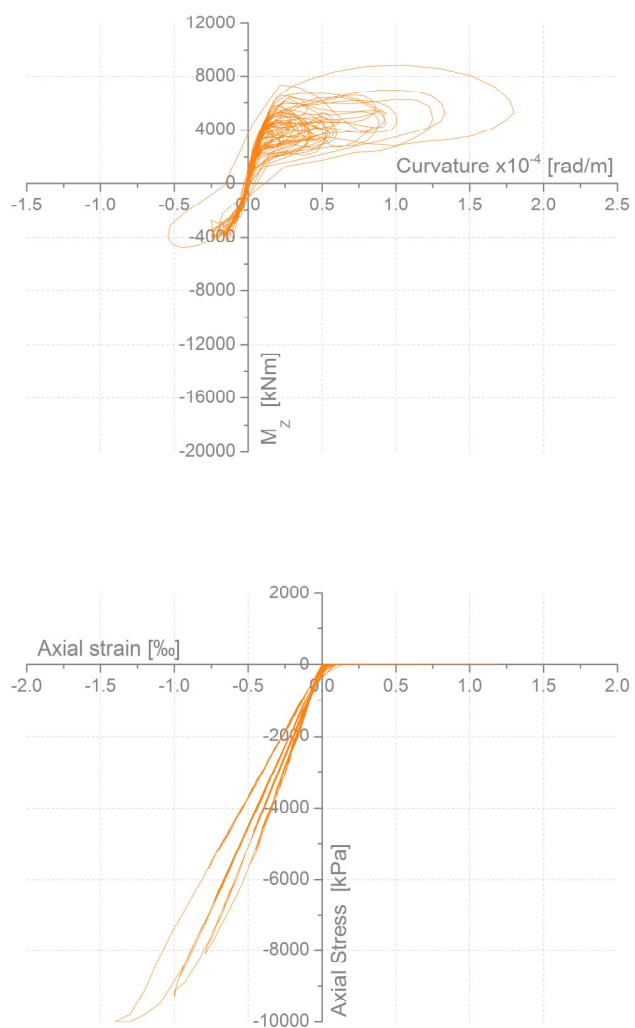
Figure 15: Response of the lateral walls, north and south, obtained with seismic input 5000_M82_2: (a) moment-curvature diagrams; (b) stress-strain curves for the most compressed fibres.

As for the lateral walls of the nave, the seismic damage was analysed in the critical section of the central buttresses by means of the moment-curvature and stress-strain curves presented in Figure 15. High levels of cracking on both walls, but low compressive damage, particularly noticeable in the north wall, were found.
