# Assessment of tunnels stability in the Maya archaeological area of Copán, Honduras

**Abstract.** Copan is an important heritage site known by its preserved Maya ruins and recognized by UNESCO as a World Heritage Property since 1980. To investigate and understand the site development, extensive archaeological tunnels were excavated in the earthen fills of the temples in the twentieth century. Archaeologists found a series of superimposed temples, built one upon another, in a very complex chronological sequence and spatial disposition. Even though the tunnels were initially excavated in the earthen fill without putting in place any supporting structure, masonry lining was applied in parts of the tunnels years after they were excavated, in areas that suffered local collapses. Thick walls were built, forming tunnels about 1.0 m wide and 2.0 to 3.0 m high. The excavated soil is unsaturated, and thus has a strength depending on its water content and suction. Since most of the observed collapses take place during raining events, the effect of the change of the saturation degree on tunnels stability was investigated with numerical analyses. As typical in numerical simulations, the posit

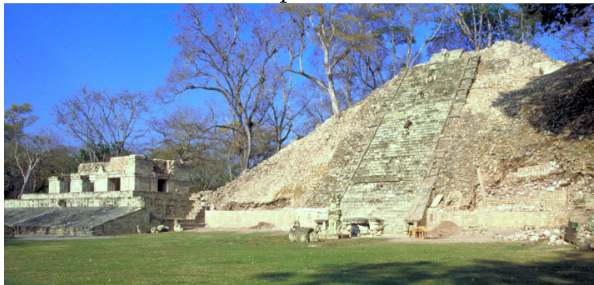
**Fig. 1.** Picture of the Hieroglyphic Stairway Court, with the temple at right and part of the Ball Court at left – photo by Linda Schele [7].

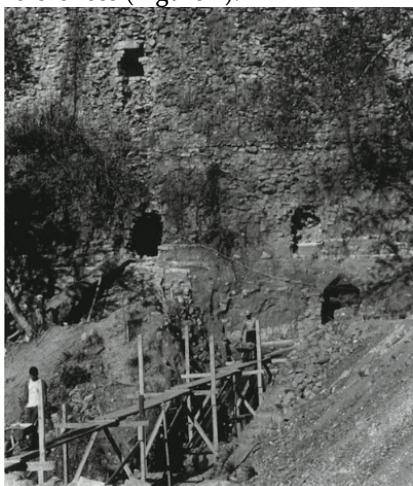
**Fig. 2.** A view of different entrances to tunnels in the Acropolis archaeological cut in 1989 [11].

The first tunnels under the Acropolis were excavated to permit the archaeological investigation in the 1930's. More complex tunnelling started in the 1980's from the “*corte*”, using the exposed layers as references (Figure 2).

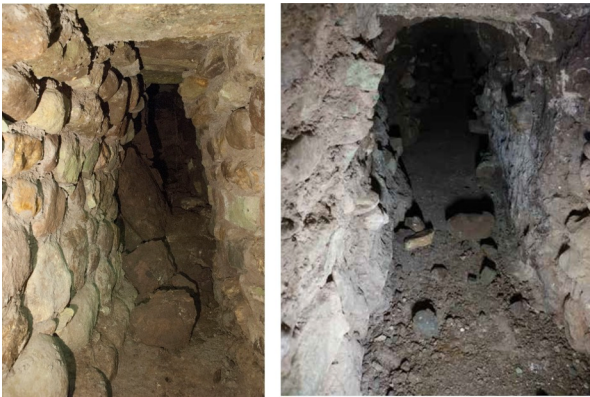
**Fig. 5.** Examples of local collapses at the interface between lined and unlined tunnels – left – and in an unlined tunnel – right [12].

Collapses often occurred at the interface between lined and unlined tunnels or in unlined tunnels, as shown in the photos of Figure 5.
