## CYCLIC BEHAVIOUR OF TRUSS TYPE REINFORCED CONCRETE MASONRY WALLS

### SUMMARY

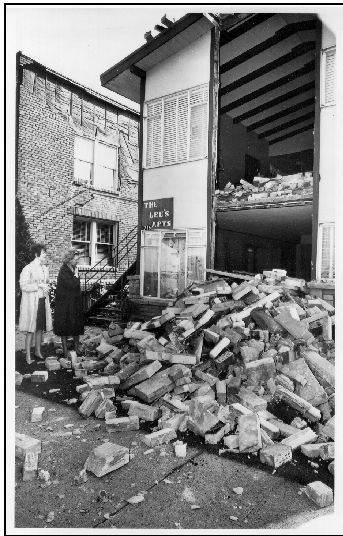
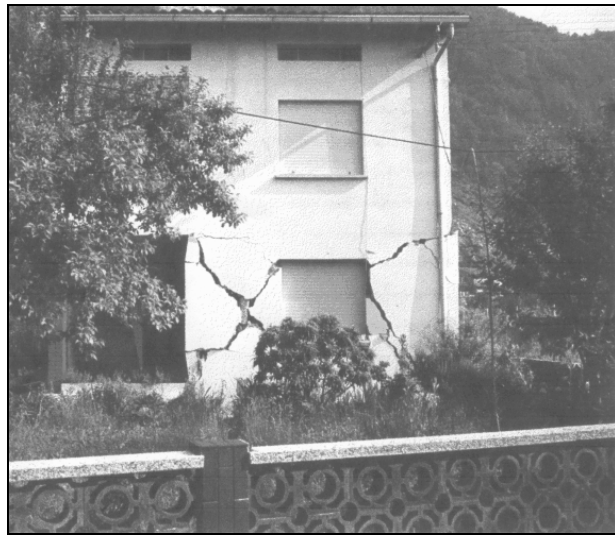
Figure 1: Damages caused by an earthquake in unreinforced masonry walls: (a) 1965 Seattle-Tacoma[5]; (b) 1976 Friuli in Italy [6]

Over the years considerable researches have been conducted on masonry structures. Masonry walls were mainly designed to resist gravity loads. However masonry walls have also an important role in improving seismic resistance and global stability of masonry buildings. Due to their role in the masonry buildings, masonry walls can afford significant horizontal loads, induced by earthquakes. Serious damages in masonry walls were observed in some past earthquakes such as the 1931 Hawke's Bay in New Zealand; 1976 Friuli in Italy; 1949 Olympia and 1965 Seattle-Tacoma earthquakes, see Figure 1. This led to the idea that unreinforced masonry walls behave badly under seismic loading, being not allowed in zones with moderate to high seismic hazard. The brittleness of the failure of unreinforced masonry shear walls, which is more remarkable with high axial loads, may be reduced by the use of steel reinforcement. This procedure ensures the increase of the ductility due to redistribution of lateral load, and provides better energy dissipation under seismic loading. The failure mode of a shear wall depends on the combination of applied loads, wall geometry, properties of the materials and as recently pointed out by [1], on the bond masonry. According to [2], when an unreinforced masonry shear wall is subjected to lateral loading a diagonal crack opens producing a severe deterioration in wall strength and a brittle collapse.

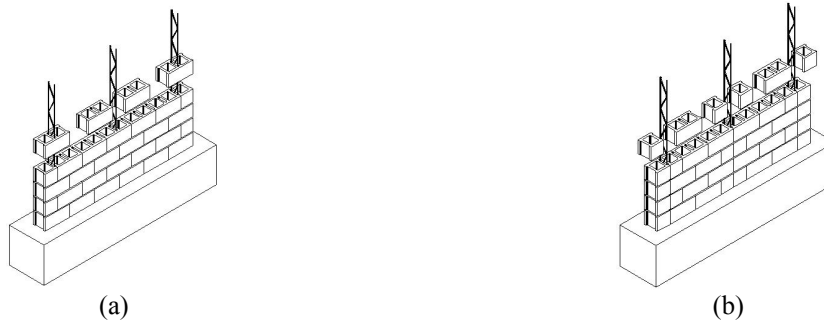
Figure 4: Masonry bonds: (a) running masonry bond, B1 (b) bond with continuous vertical joint, B2

Four reinforced masonry walls were built with two different masonry bonds (B1 and B2). B1 corresponds to running masonry bond (units were overlapped on consecutive courses) see Figure 4a. This masonry bond implies that vertical reinforcements are placed both in the bands of the three cell masonry units and in the internal hollow cell. In the second masonry bond (B2), the vertical reinforcements are placed only in the vertical core defined by the bands of the units, defining a continuous vertical joint, see Figure 4b. The latter masonry bond has advantages concerning the construction technology as the masonry units can be laid after the placing of the reinforcements without any change on the traditional constructive technique applied in the construction of unreinforced masonry walls.

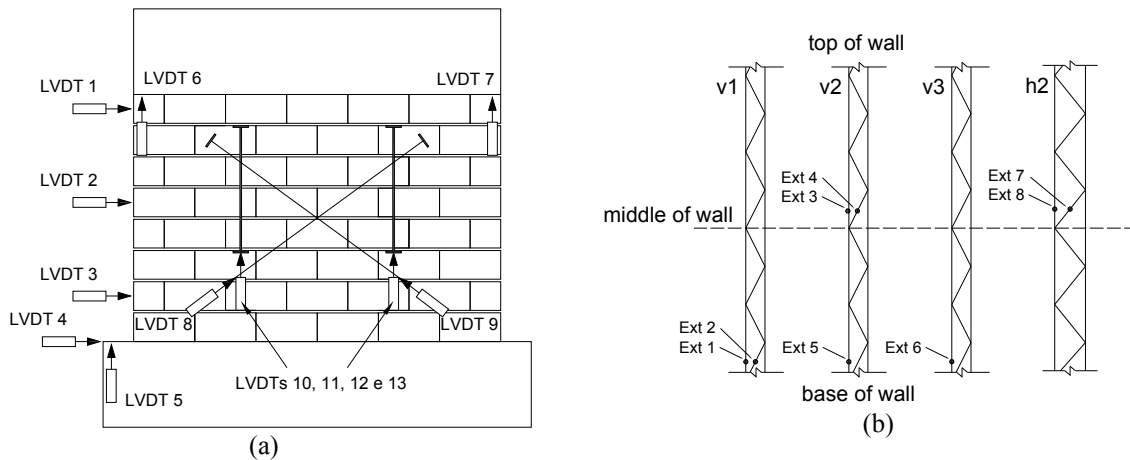
Figure 8: Instrumentation of the wall: (a) LVDTs to measure the displacements of the walls: (b) strain-gauges to measure the deformation of the reinforcements.

The displacements of the wall under cyclic loading were measured by means of a set of LVDTs as indicated in Figure 8a.

LVDTs 1,2 and 3 measured the lateral deformation of the wall. LVDTs 4 and 5 were placed to measure the slip and rotation of base of the wall, respectively. LVDTs 6 and 7 intend to measure the rotation of the top concrete beam. LVDTs 8 and 9 measured the diagonal crack openings of the wall indicating also possible movements of rigid body. The vertical LVDTs 10, 11, 12 and 13 were fixed to both sides of the wall in order to obtain the elastic modulus of the wall. Besides, strain-gauges were glued to reinforcements to evaluate their contribution to the response of the wall, see Figure 8b. In specimens N150-B1 and N150-B2, strain gauges were also glued in the top and bottom horizontal reinforcements at the same position as the one indicated in Figure 8b.

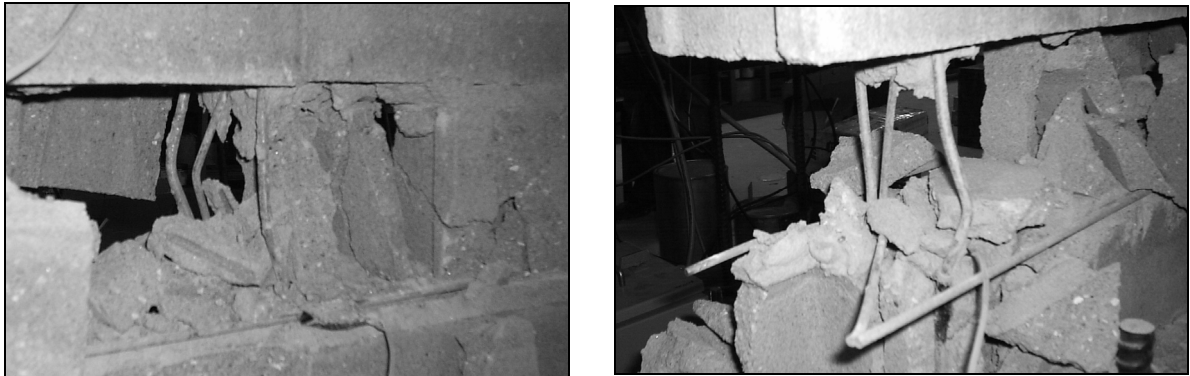
Figure 12: Buckling of the reinforcement because of the high compression stresses.
