Dynamic Identification and Monitoring of St. Torcato Church

RAMOS Luís F[1,a], ALABOZ Murat[2,b] and AGUILAR Rafael[3,c]

[1,2,3]Civil Engineering Department, University of Minho, Guimarães, Portugal

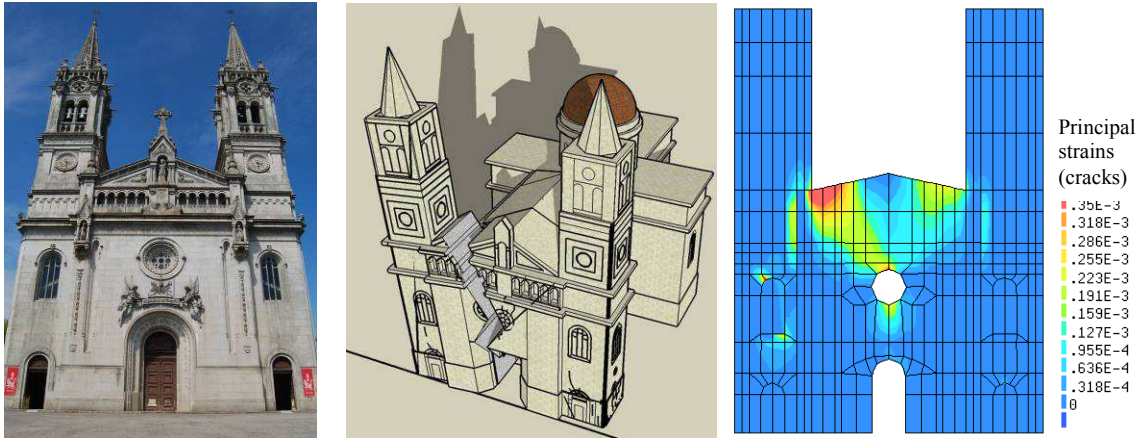
By simply looking to main façade a significant crack can be observed. Starting from the key stone of the entrance door arch, the crack goes through the rose window to the roof, splitting the façade in two macro blocks, as it is represented in Figure 1. The crack pattern seen on the façade is also observed inside.

The leaning of the towers reveals that they are moving in opposite directions due to soil settlement. The hair cracks seen at the bottom of the towers might be related with the compressive stress concentration caused by eccentric loads.

Figure 1 : Façade view, crack pattern representation, and numerical model with cracks
