Damage Identification in Masonry Structures with Vibration Measurements

L.F. Ramos & P.B. Lourenço

For the first phase of the proposed approach it is presented the case study of Mogadouro Clock Tower. The Mogadouro Clock Tower is located inside the castle perimeter of Mogadouro (see Figure 1), a small town in the Northeast of Portugal. It has a rectangular cross section of $4.7 \times 4.5 \text{ m}^2$ with an interior hole of $2.5 \times 2.3 \text{ m}^2$, and a height equal to 20.4 m. It was built in stone masonry with granite and shale, with dry joints at the corners and with mortar joints in the central part of the walls. The walls have, on average, 1 m of thickness and are composed by an irregular bond of stones.

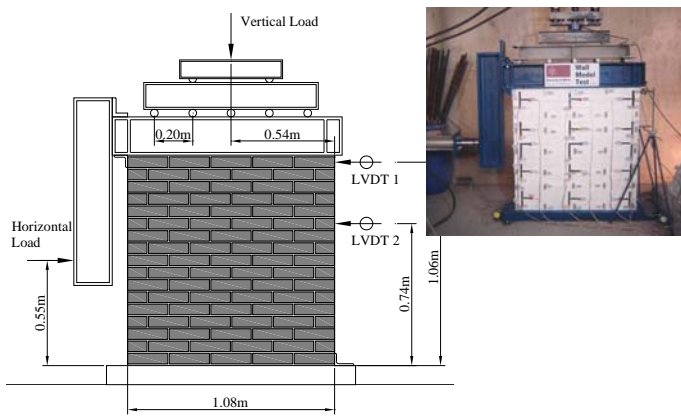
(a)

To achieve several controlled cracks, three series of static tests were carried out. Figure 8 presents for the last series (Series C) the test apparatus, the static response of the wall and the final crack pattern. From the static response is possible to observe the stiffness decrease, where the horizontal displacement indicated corresponds to the maximum or top value (LVDT 1).

The final crack pattern includes three cracks. One bending crack is at left bottom part, and another bending crack is at right top part of the wall, namely crack c_1 and c_2 , respectively. The third crack (c_3) is a shear crack in the diagonal direction of the wall.
