ASSESSMENT OF THE BÔCO HISTORICAL RC BRIDGE

José Sena-Cruz¹, José Carlos Araújo², Fernando Castro³, Marco Jorge⁴

Keywords: Concrete bridge, Hennebique system, Survey

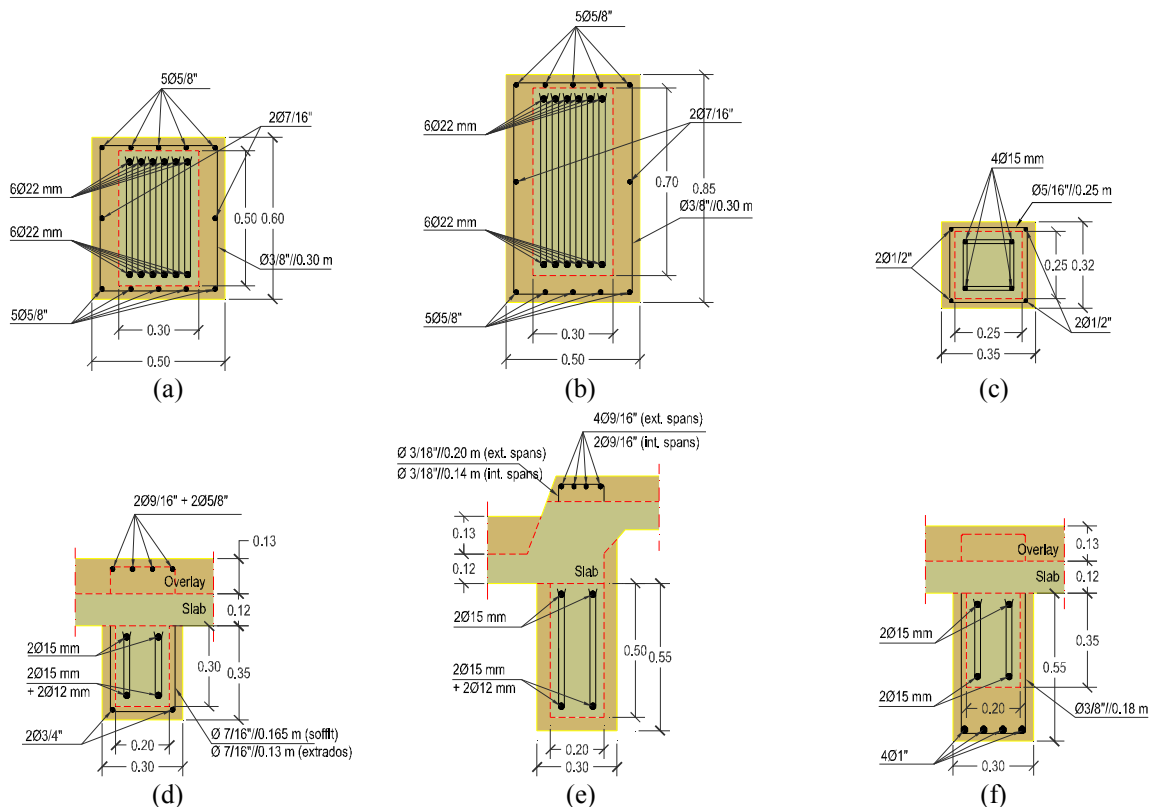
Fig. 4 Current cross-section geometry versus original one of different structural elements: (a) arches at the mid span; (b) arches at the abutments; (c) columns; (d) intermediate longitudinal girder; (e) lateral longitudinal girders; (f) transverse girders.

Fig. 4 and Fig. 5 include the current geometry of the bridge. The geometrical survey of the current state was performed by laser distance meter, tape measure, camera and ruler. The reinforcement detailing specified in Fig. 4 was based on the rehabilitation project.

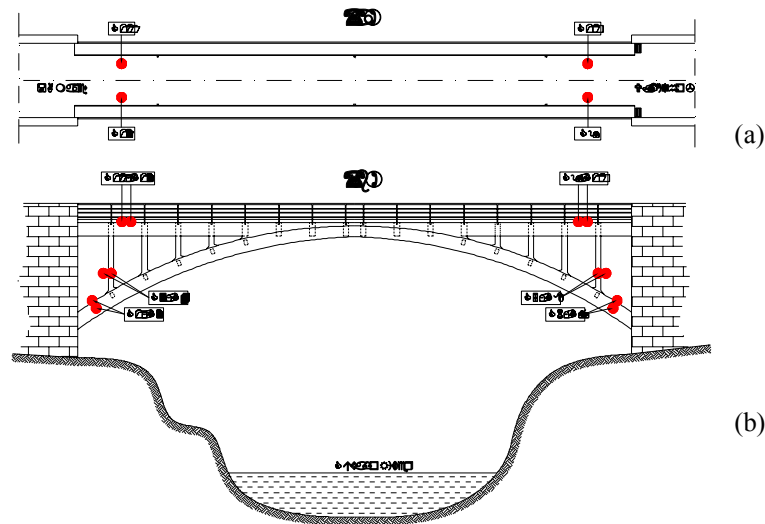
Fig. 5 Current geometry obtained from the geometrical survey: (a) top view; (b) downstream elevation

The concrete characterization included mix design, composition and physical properties, as well as mechanical performance. This characterization was based on 12 cylindrical core samples (see red circles in Fig. 5) taken from different types of structural elements of the bridge. The restrictions on access to site and level of degradation the bridge were the two main reasons for the limited number of samples taken. After cores have been drilled and before be sealed with a plastic film, remained during a few minutes in-situ environment in order to surface moisture be evaporated.

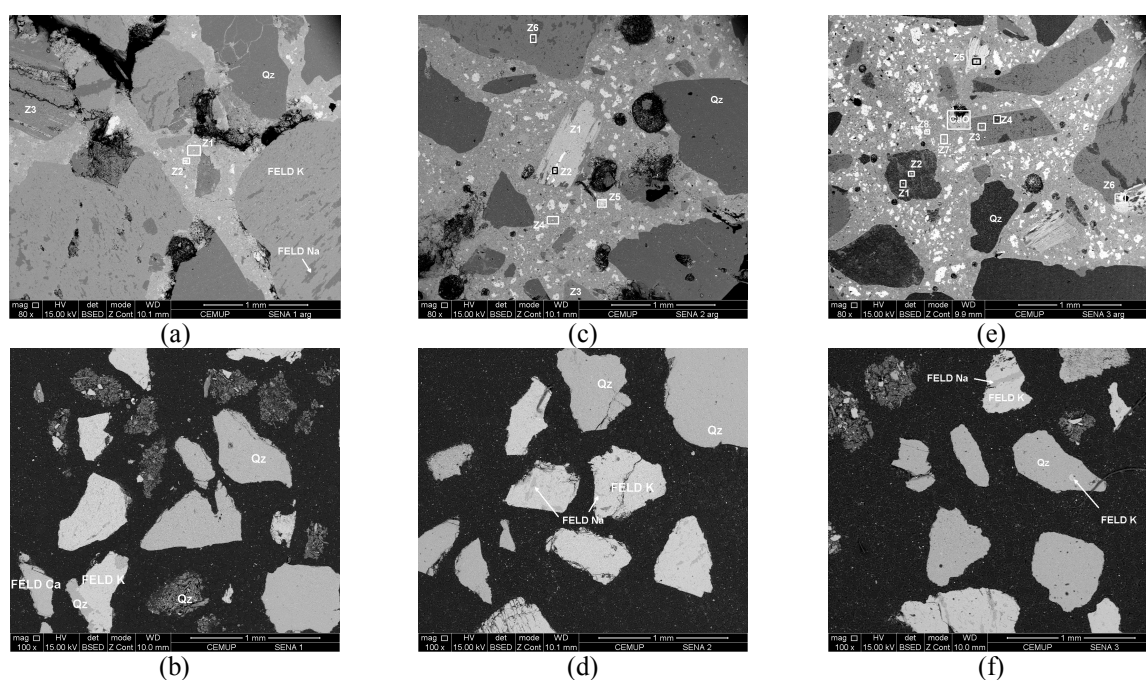
Fig. 7 (a) SEM images of sample 1 (a-b), sample 2 (c-d) and sample 3 (e-f)
