Inspection and Analysis of ancient Monastery of “São Romão de Neiva”, Portugal

Abstract. The monastery of São Romão de Neiva is an ancient building located in the north of Portugal, in the district of Viana do Castelo and it is considered to be of national interest by the Portuguese Institute of Monuments (DGPC). Due to its importance, an inspection to identify damages and their causes was performed on this building. The inspection and diagnosis included a historical, geometrical and defects survey, and mechanical and physical characterization of the masonry stone. Non-destructive tests on the structural elements such as GPR and sonic tests were also carried out to assess the internal morphology of the stone masonry walls and estimate the quality and modulus of elasticity, respectively. Qualitative assessment of masonry walls using the MQI (Masonry Quality index) was also carried out. Finally, by means of a visual inspection of the structure, the assessment of the damages and pathologies on the structural elements was performed. This **work focus on** the most important **experimental results** and some recommendations to apply them on a structural analysis.

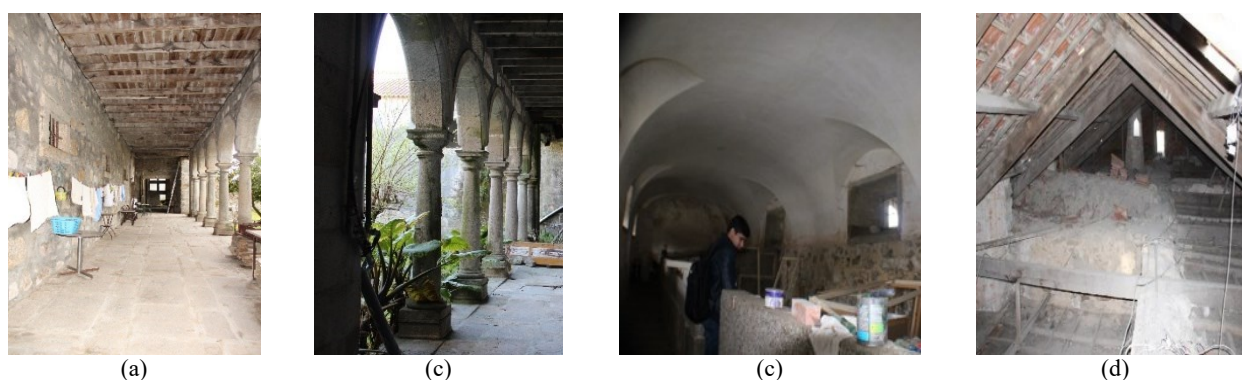
Figure 3: Structural typologies. a) Masonry walls and wooden floors. b) Granite stone pillars. c) Brick vaults. d) Wooden trusses.

The identification of the most important elements, the connections between the elements and the visual characterization of the material is shown in Figure 3. The system is formed by granite stone masonry bearing walls (Figure 3a), wooden beams bear a wooden boarding floor (Figure 3a). On the inner corridors granite arcade and stone pillars can be observed (Figure 3b). There are three vaults made of brick under the wooden floor (Figure 3c). While the roof was made of wooden trusses and ceramic tiles floor (Figure 3d).
