INSPECTION, DIAGNOSIS AND MODELLING OF AZURARA CHURCH IN THE NORTH OF PORTUGAL

Abstract. *Santa Maria de Azurara church is a XVI century church in Portugal, classified as a national monument since 1910. The building shows not only the influence of the Manueline architectural style (Portuguese late Gothic style), but also Baroque and Mannerism styles. Presently, the church presents some structural and non-structural problems, so an inspection and diagnosis of the main building pathologies was carried out. This process was assisted by non-destructive testing (NDT) techniques which included sonic tests, ground penetrating radar (GPR) and Schmidt hammer for masonry elements and Pilodyn and ultrasonic pulse velocity for the timber elements. In addition, scanning electron microscope and x-ray diffraction analysis were used for mortar and stone characterization. Furthermore, dynamic identification tests were performed. Numerical analysis was performed to assess the nonlinear behaviour of the structure under different load conditions. In order to create an accurate model, material properties were estimated from the non-destructive tests and the dynamic properties were used to calibrate th

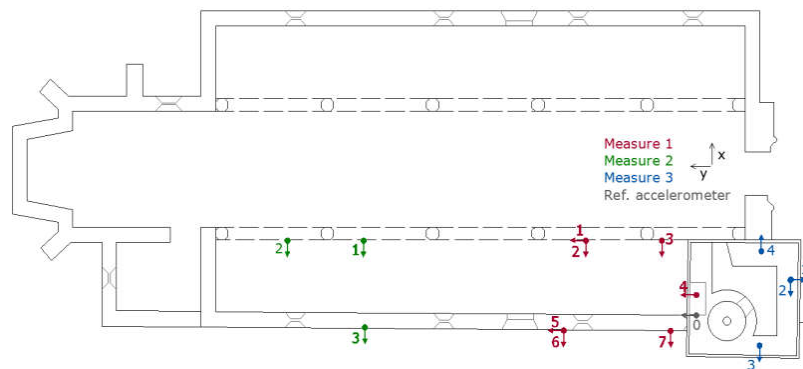
Figure 5: Accelerometer locations for OMA campaign

A representative part of the church was chosen for analysis; namely, the tower and the north walls connected to it. Twelve points of measurement were chosen: five in the bell tower, four in the clerestory wall and three in the external wall (Figure 5). The accelerometers measured the out-of-plane acceleration at every point and in-plane acceleration at one point of each structural element.

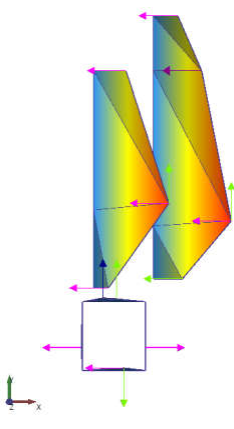
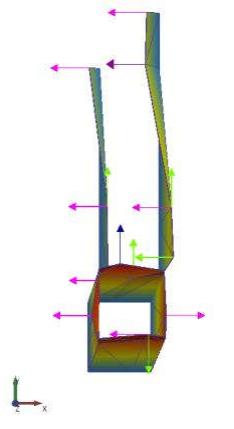
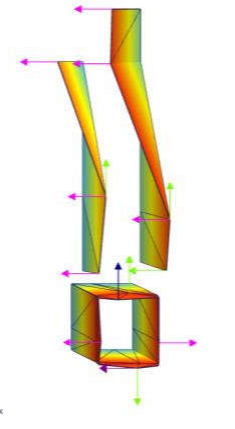
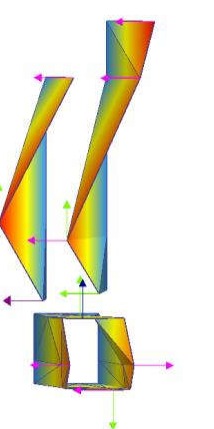
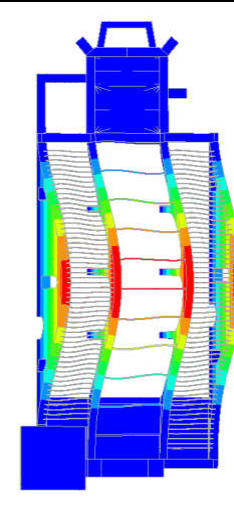
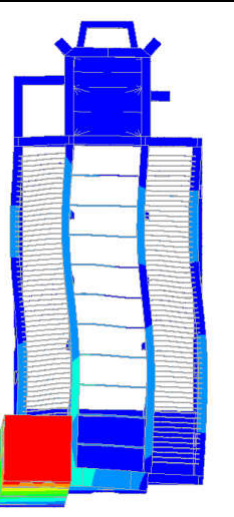
Table 3: Modal shapes and frequencies of the OMA (ARTeMIS) results and updated FEM

The elastic modulus of the masonry was modified in order to match the values of the frequencies and the modal shapes from the OMA campaign. Then, a MAC comparison was also used. The final properties are listed in Table 2 and the four selected mode shapes are provided in Table 3. Poisson ratio was taken as 0.2, tensile strength as 0.15 MPa, and tensile fracture energy 8 N/m.

OMA Mode 1: 1.73 Hz	OMA Mode 2: 2.68 Hz	OMA Mode 3: 2.83 Hz	OMA Mode 4: 3.18 Hz

FEM Mode 1: 1.73 Hz	FEM Mode 2: 2.68 Hz	FEM Mode 3: 2.89 Hz	FEM Mode 4: 3.04 Hz

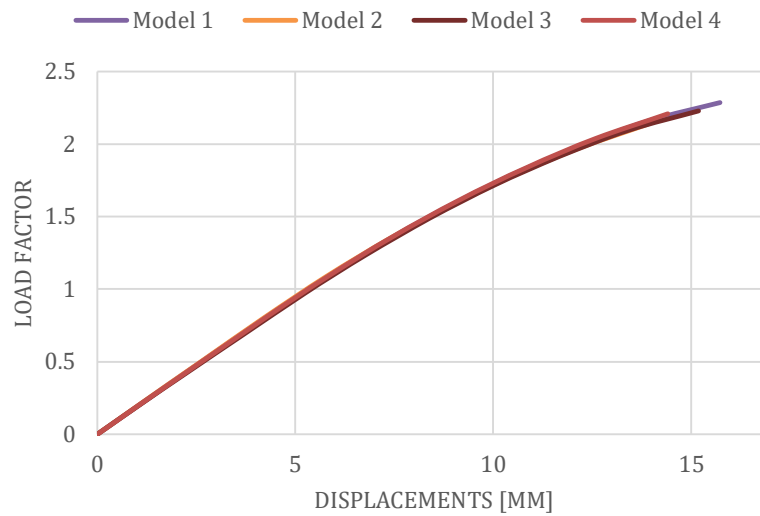
Figure 6: Capacity curve of the incremental vertical analysis

The first analysis was performed in the vertical direction in order to obtain the maximum load factor for the gravitational load that the structure can support. The capacity curve is shown in Figure 6. Different models were created with different values for the variables that define the nonlinear analysis. Three values for the tensile fracture energy were used, 8, 50 and 1000 N/m. A model without the slab of the choir was also analysed. Model 1 represents the original model whose material properties are defined in the previous section. For Model 2 the slab was removed. Model 3 and Model 4 present higher tensile fracture energy, 50 N/m and 1000 N/m respectively. The results are similar for all the cases, reaching a maximum value for the load factor of 2.3 for the original model. It can be observed that for the current state of loading, the

structure is in the linear range what means that no problems should appear in the structure related to the materials.

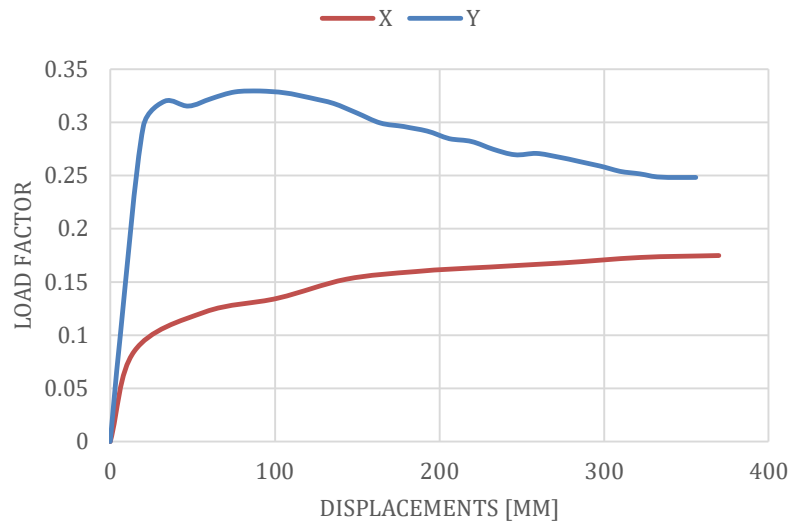
Figure 8: Capacity curves for horizontal pushover

For the horizontal pushover both the transversal and longitudinal axes were analyzed in one direction. In the case of the transversal direction (X) the church presents a load factor around 0.17 and the capacity curve presents hardening. As expected, in the longitudinal direction (Y) the structure presents higher capacity and the curve reaches a value of 0.3 with an elastic behavior. The nonlinear branch presents softening in this case.
