## Assessment Methodology for Conservation Planning of Concrete Buildings: Ocean Swimming Pool (1960–2021) by Álvaro Siza in Portugal

Teresa Cunha Ferreira, Nuno Mendes, Rui Fernandes Póvoas & Paulo B. Lourenço

The paper intends to provide a building assessment methodology for the conservation planning of concrete buildings, presenting the demonstrative case-study of the Ocean Swimming Pool (design 1960–1966; conservation 2018–2021) conceived by the Pritzker Prize Álvaro Siza, in Portugal. The building is a landmark of 20<sup>th</sup> century architecture in the national and international context, being listed as National Monument and included in the World Heritage Tentative List. The article will focus particularly on the building assessment methodology, supported by the cross-analysis of the ‘documentary evidence’ and ‘physical evidence’, allowing for an integrated approach for conservation planning. The paper includes documentation on the building chronology and construction, as well as on the inspection and diagnosis using both non-destructive and minor destructive testing. Moreover, the article presents a pilot demonstration of concrete repair supported on the building knowl

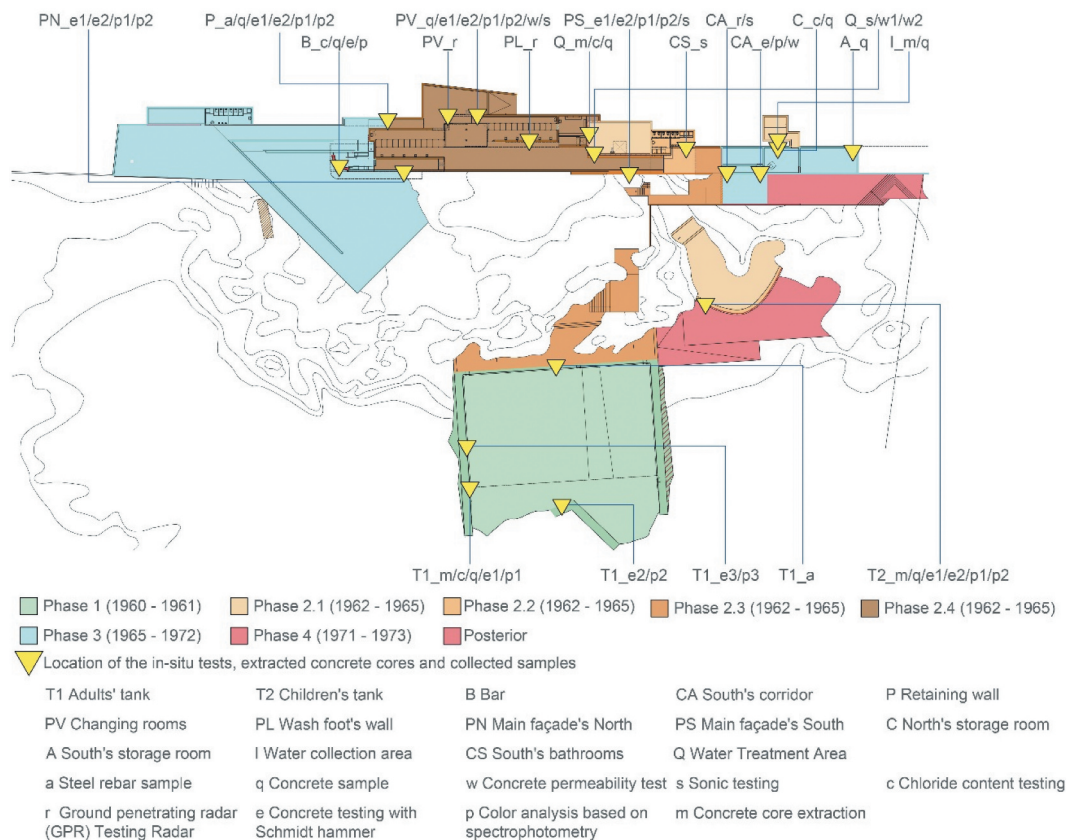
Figure 11. Locations of the in-situ tests and the extracted samples.

destructive and minor destructive tests and laboratory tests of samples extracted from the structure (concrete, cement paste, steel rebars and timber). The in-situ tests and the samples were done and collected, respectively, in parts of the structure built in different construction phases (Figure 11). Next, the main works and results of the inspection and diagnosis are presented.

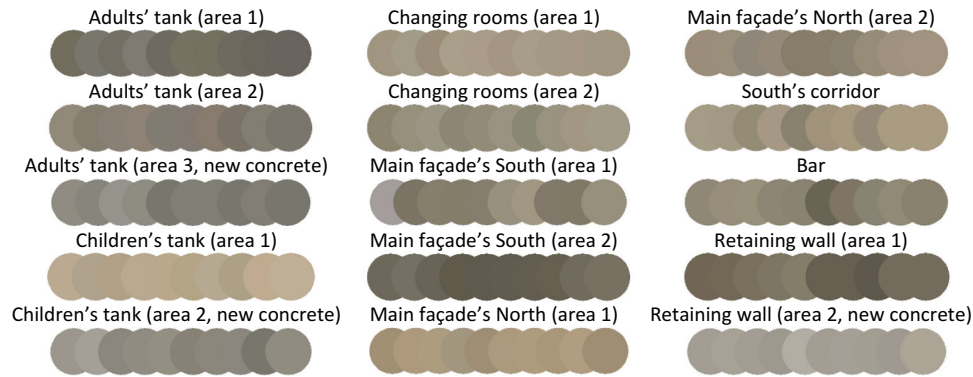
Figure 14. Results of the colour analysis.

The colour tests were carried out with a spectrophotometer at eight locations of the building, including original concrete and new concrete applied in the intervention. Moreover, ten test repetitions were considered in each location. The results were represented using the Adobe RGB 1998 (Figure 14). As expected, the results present a high dispersion, with the colour ranging from beige to dark grey. The lighter colours were detected in the children's tank and the main façade South's. The new concrete presents also different colour with respect to the original concrete.

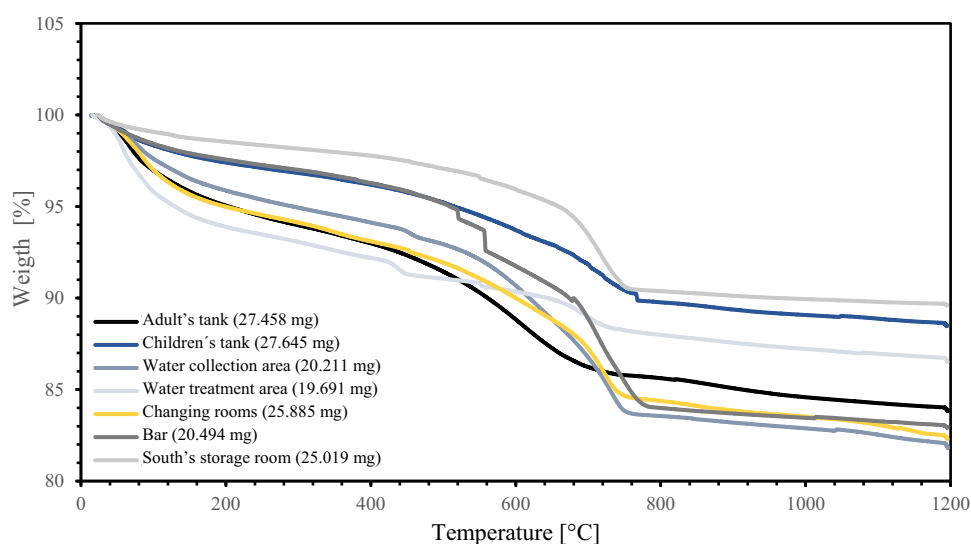
**Figure 15.** TGA thermal curves and initial mass of the samples.

The thermal gravimetric analysis (TGA) was performed in an SDT Q600 thermal analyser of the TA Instruments for a temperature range between 0°C and 1200°C. Seven cement paste samples were analysed. The initial mass of the samples ranges from 19.70 mg and 27.65 mg. The TGA thermal curves (Figure 15) show water release from 0°C to 200°C. Between 400°C and 450°C, the samples of the water treatment area and water collection area present calcium hydroxide

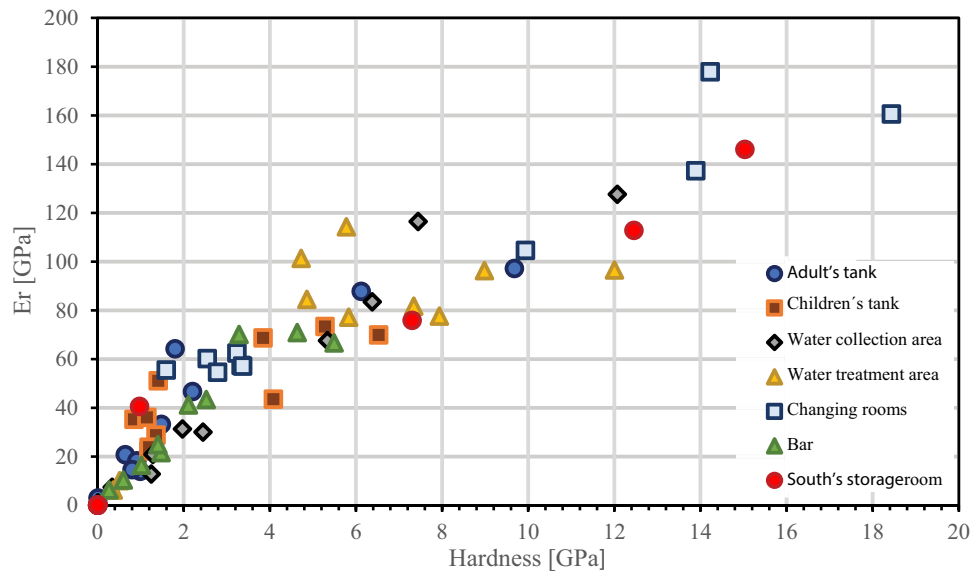
Figure 16. Results of the nanoindentation.

(effective) elastic modulus obtained from the unloading stiffness ( $E_r$ ). The sample of the Adult's tank (phase 1) presents a high dispersion in the results, with elastic modulus ranging from 2.98 to 97.16 GPa. Although this is a cement paste sample, the concrete core of the adult's tank presents a mean Young's modulus equal to 39.36 GPa (Table 1). The samples of the phase 2.1 of the children's tank and the water collection area present a similar mean elastic modulus, with exception of the sample of the water treatment area (interior surface of a closed area), which presents a higher value (74.56 GPa). The sample of the changing rooms (phase 2.4) presents a mean elastic modulus of 92.75 GPa and the highest value of all tests (177.87 GPa), which can be associated with the many aggregates presented in this sample. The sample of the bar and South's storage room (phase 3) present very similar mean elastic modulus, namely 37.14 GPa and 37.53 GPa, respectively.

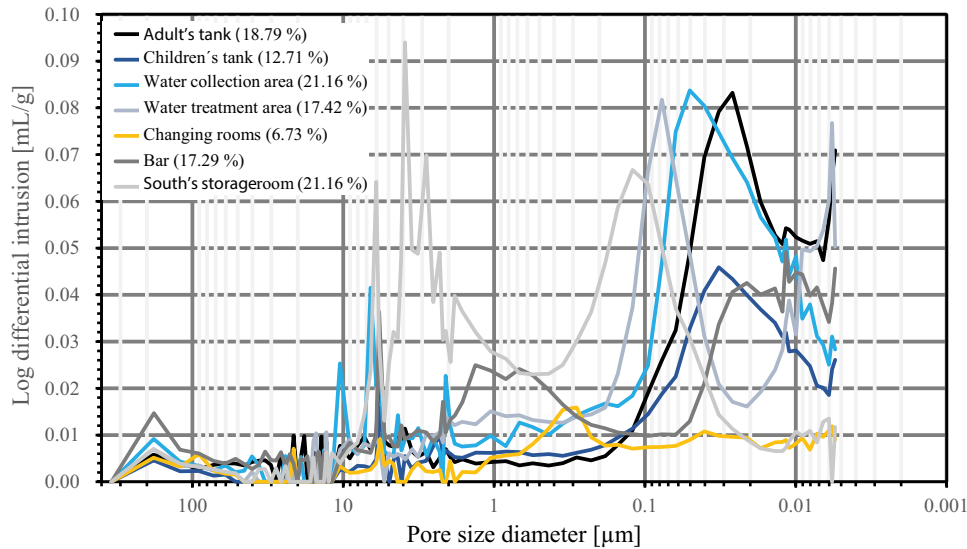
Figure 17. MIP results: logarithmic differential intrusion vs. pore size diameter and porosity.

The mercury intrusion porosimetry (MIP) tests were performed to evaluate the pore size distribution of the cement paste samples. The critical pore diameter ( $d_c$ ) is one of the most relevant parameters obtained from the MIP tests, which corresponds to the steepest slope of the cumulative porosity curve and can be determined from the highest point of the logarithmic differential intrusion curve. The logarithmic differential intrusion curves (Figure 17) show that the lowest  $d_c$  is equal to 0.026  $\mu\text{m}$  and is associated with the sample of the adult's tank (phase 1). The  $d_c$  of the samples of phase 2.2 ranges from 0.032  $\mu\text{m}$  (children's tank) to 0.077  $\mu\text{m}$  (water treatment area). It is noted that the sample of the water collection area (phase 2.1) presents also three relevant peaks for the 10.5114  $\mu\text{m}$ , 6.5834  $\mu\text{m}$  and 5.714  $\mu\text{m}$  pore size diameter. The sample of the changing rooms (phase 2.4) presents a  $d_c$  of 0.2840  $\mu\text{m}$  associated with the lowest porosity (6.73%), which agrees with the results of the water penetration tests (Section 3.2.1). The sample of the bar (phase 3) presents two relevant ranges of pore size diameter, namely 0.0263–0.0055  $\mu\text{m}$  and 1.3312–0.4341  $\mu\text{m}$ . Finally, the sample of the South's storage room (phase 3) presents the highest  $d_c$ , namely 3.8968  $\mu\text{m}$  (sample collected from a slab with carbonated concrete and corroded rebars).
