# Historic Mortars and RILEM TC 203-RHM Final Workshop HMC2010

## Causes of Decay of the Aveleiras House Decorative Plasters (in Torre de Moncorvo)

## 2 Study Case – plastered ceilings of Aveleiras House

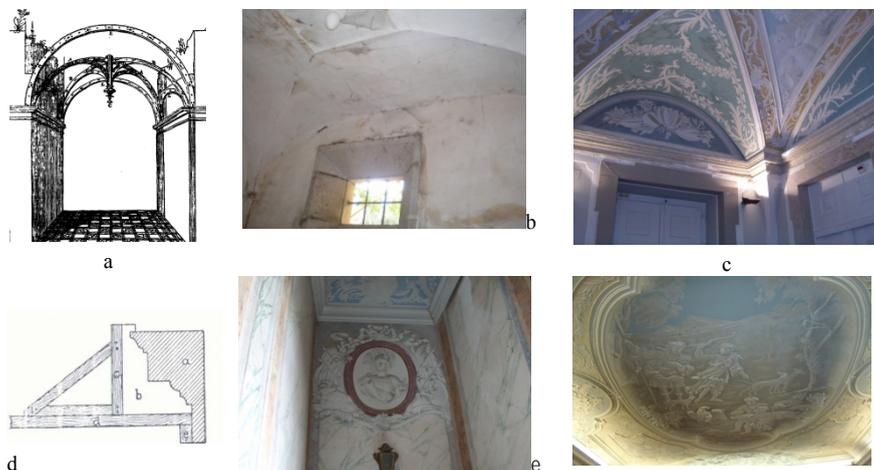
Fig. 1 a) Wooden vault structure of support of a plastered ceiling (De l'Orme, 1561); b) Ceiling of Chapel Sacristy, 16th c., Aveleiras House, Torre de Moncorvo (2008); c), e), f): Plasters of Pombal Palace, Oeiras, 18th c. d) Running mould for the execution of interior cornice (SEGURADO, J, 1949).
