An Inspection of Three of Famagusta's Churches

Paulo B. Lourenço and Luís F. Ramos

In Famagusta three churches were selected for advanced, non-destructive inspection, namely dynamic and sonic testing, and preliminary diagnosis. These were: St. George of the Latins, St. George of the Greeks and The Carmelite Church.

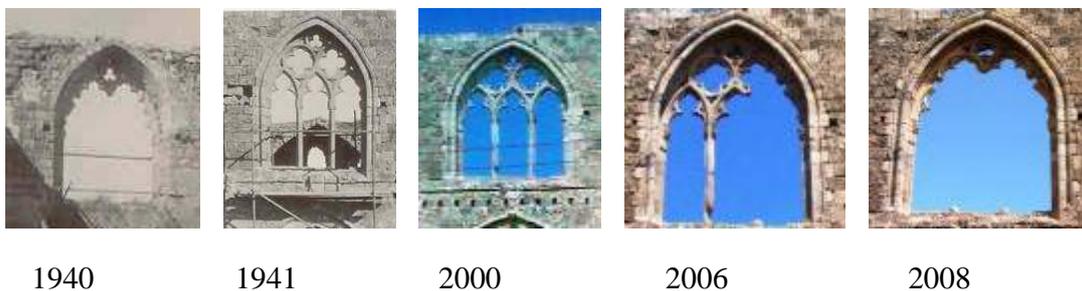
Figure 4: Window tracery above the main door.

Because the Carmelites originated from the Carmel Mountains of Syria, this area became known as the Syrian quarter of the city. It was built in the 14th century as the church of a monastery, and has a single nave of four bays and a three-sided apse. In the second bay, two small chapels were added. The roof had ribbed vaults, and the exterior walls were supported by buttresses. The tomb of Peter Thomas, who was the Pope's representative and the Patriarch of Constantinople, who died in 1366, was in this church. The walls of the church were covered in frescoes, and some of those are still (just) visible. Outside the west door, you can also see the remains of sculptures above the entrance. Recently, the tracery added by the British above the main door around 1940 collapsed (Figure 4). The present condition of the church seems not to differ significantly from the condition around 1940 according to a visual comparison made with the images in the Mogabgab Archive.

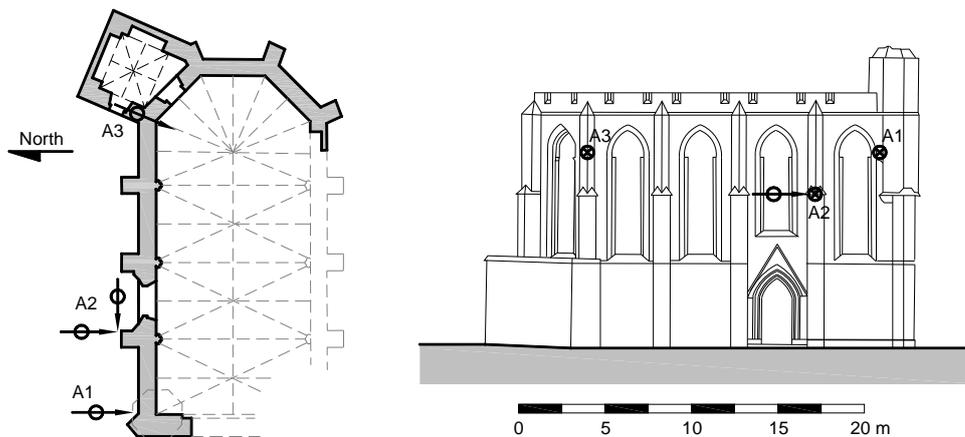
Figure 6: Test planning of St. George of the Latins church: top plan; and North façade.

The measurements were carried out in three points in the North façade, close to the top of three buttresses. The measuring points are indicated in the letter A (Fig 6). Images of the dynamic measurements can be seen (Fig 7 a-c) as can the stabilization diagram of the SSI method, where 17 stable columns can be observed, corresponding to 17 natural frequencies of the structure below 20 Hz (Fig 7 d). The standard deviation values for frequencies are very low, indicating

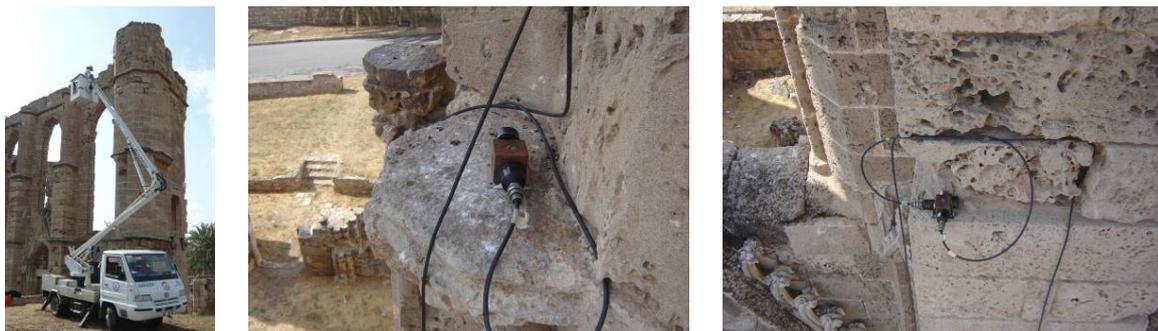
Figure 7: Dynamic Testing at St. George of the Latins

Dynamic testing at St. George of the Latins church: (a) lorry used to place the sensors in the structure; (b) accelerometers at position A1; (c) accelerometers at position A2; and (d) stabilization diagram.

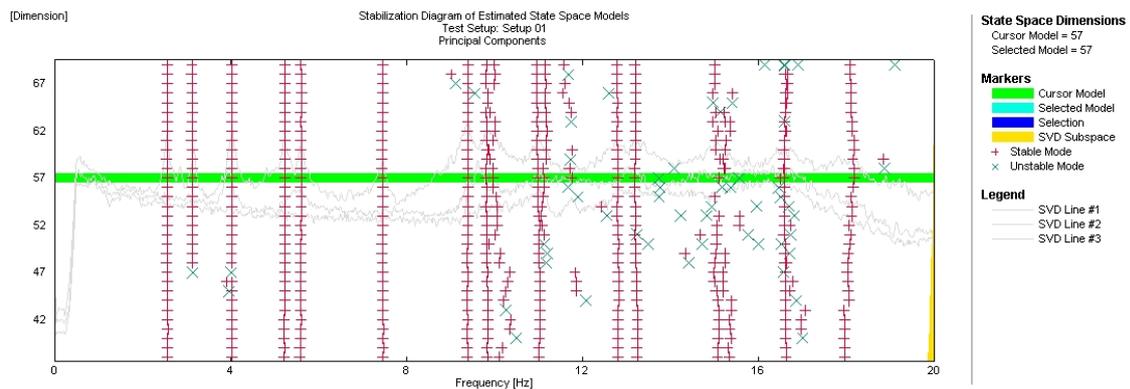
(d)

that the estimation is accurate. The mode configurations are mainly out-of-plane modes, as expected due to the unconstrained walls of the church ruins.
