# SAFETY ASSESSMENT OF THE SOUTH OCULUS, CANTERBURY CATHEDRAL (UK)

## ABSTRACT

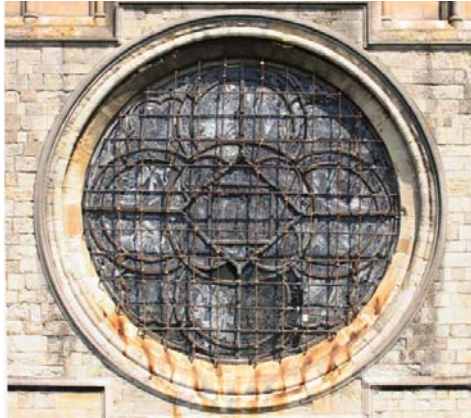
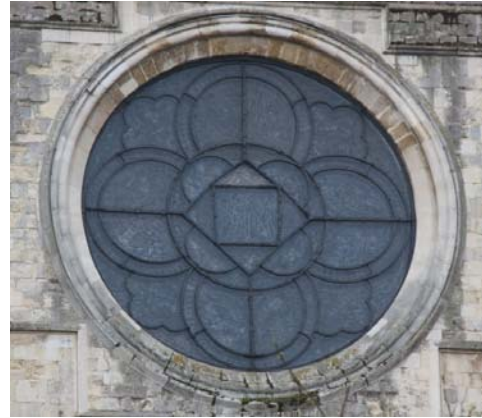
**Fig. 3** Images of the oculi: (a) South (before conservation); (b) North (after conservation)

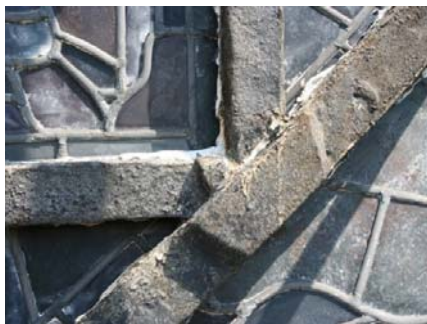
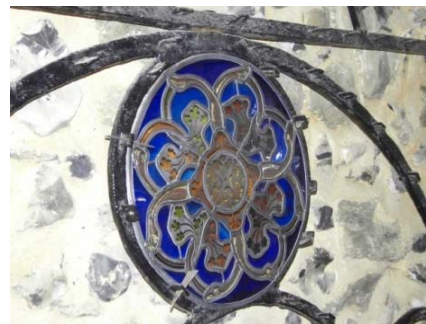
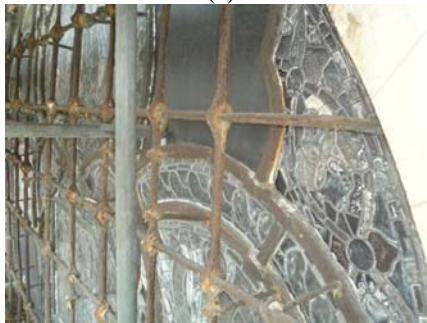
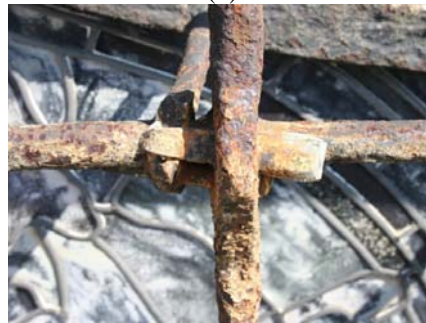
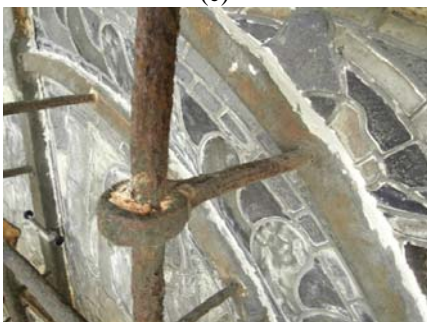
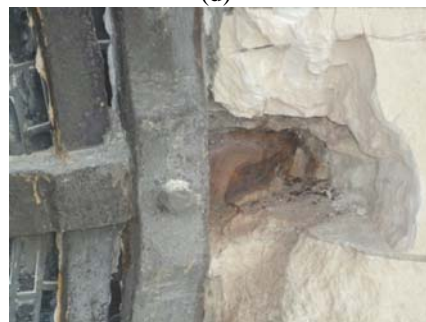
**Fig. 4** Details of the ironwork: (a) Joint detail of the armatures; (b) System for holding the stained glass on the armatures (another window is shown); (c) Iron grille with round bars; (d) Copper wedge in the connections of the grille; (e) Iron pin connecting the two layers, (f) Fixing of the space frame into the masonry

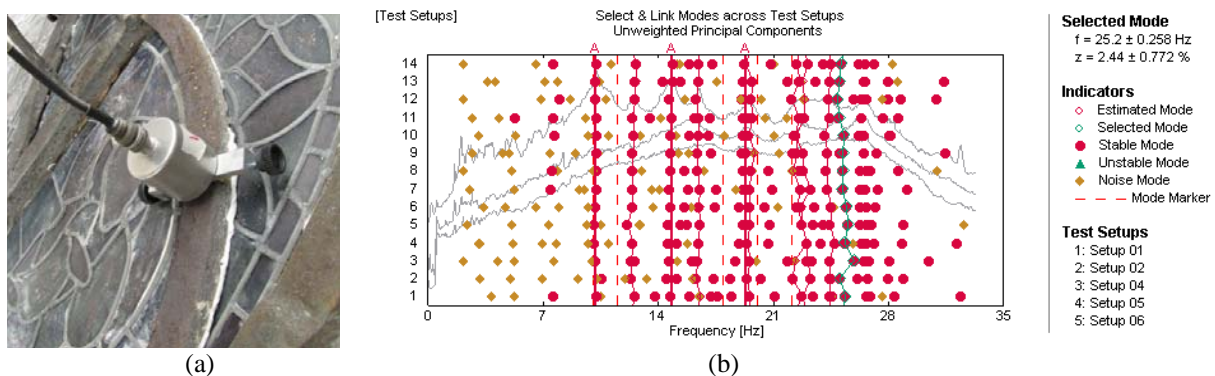
parameters. This technique operates in the time domain and is based on the Stochastic Sub-space Identification (SSI) method. The maximum amplitude of vibration was lower than 6 mg. Fig. 9b shows four stable modes in the frequency range under 17 Hz, while it is difficult to specify a stable mode over the frequency of 17 Hz. Still, overall, ten modes were estimated with experimental frequencies between 10 and 25 Hz [4]. The first six modes are global with a regular shape and have single or double curvature, while the shape of the higher modes is complex.

Fig. 9 Modal identification: (a) Accelerometer applied to the Ferramenta; (b) Frequencies measured

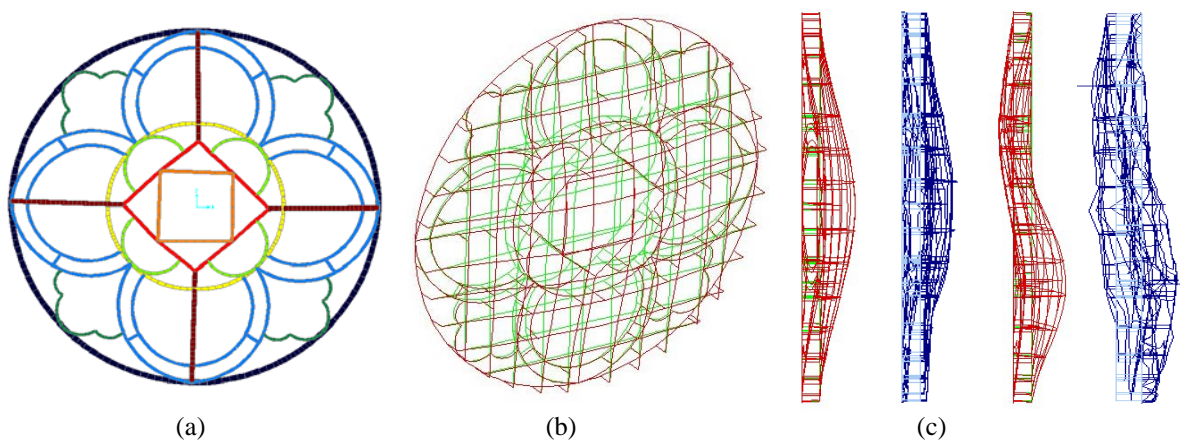
The finite element mesh contains 2278 nodes and 1648 elements of which 381 are the spring elements that connect the pins-Grille bars and the horizontal-vertical Grille bars. The finite element model has a range of the first ten frequencies from 9 Hz to 29 Hz, which is close to the experimental range. For the first three frequencies the average error is 12%, with a Modal Assurance Criteria (MAC) value of 0.94, 0.66 and 0.61, see also Fig. 10b,c.

**Fig. 10** Finite element model: (a) Different bar sections of Ferramenta; (b) First numerical mode; (c) First experimental vs. numerical modes, for single and double curvature
