# SHM of a Masonry Chimney after a Lightning Accident

L. F. RAMOS, M. G. MASCIOTTA, P. B. LOURENÇO and M. VASTA

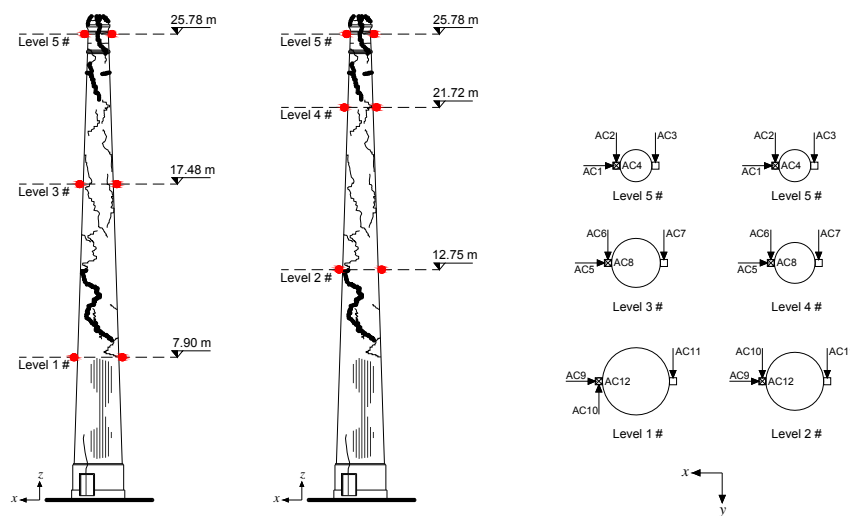
The dynamic acquisition system was composed by 12 uniaxial piezoelectric accelerometers and the 4 channels DAQ system was connected to a laptop by an USB cable. To record the accelerations in 12 measurements points, 2 test setups, 3 levels for each setup and 4 accelerometers for each level were used, keeping the ones on the top of the chimney as reference (see Figure 3).

Figure 3. Test setups and measuring points: front view and top view schemes.

During the structural consolidation works the chimney was monitored by four acceleration transducers placed at the top, namely at Level 5# (see Figure 3). The aim was to follow the evolution of the natural frequencies while the reconstructions works were carried out. Especially attention was paid during reconstruction of masonry panels in the areas where the lightning explosion occurred to seek if the reconstruction would change significantly the dynamic response.
