Safety Analysis of Modern Heritage Masonry Buildings: Box-buildings in Recife, Brazil.

Short Title: Safety Analysis of Box-buildings in Recife

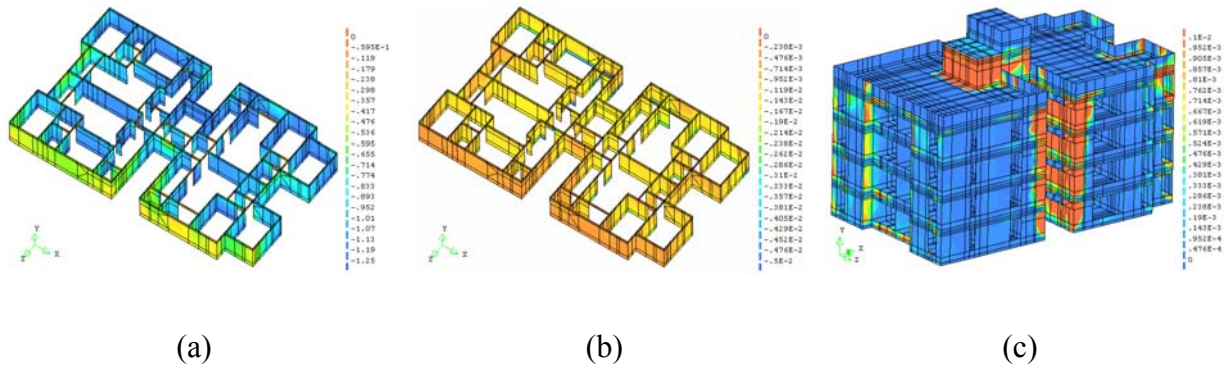
FIGURE 12 Results of safety analysis at the peak stage: (a) minimum principal stress at the foundations; (b) minimum principal strains at the foundations; and (c) maximum principal strains above ground.

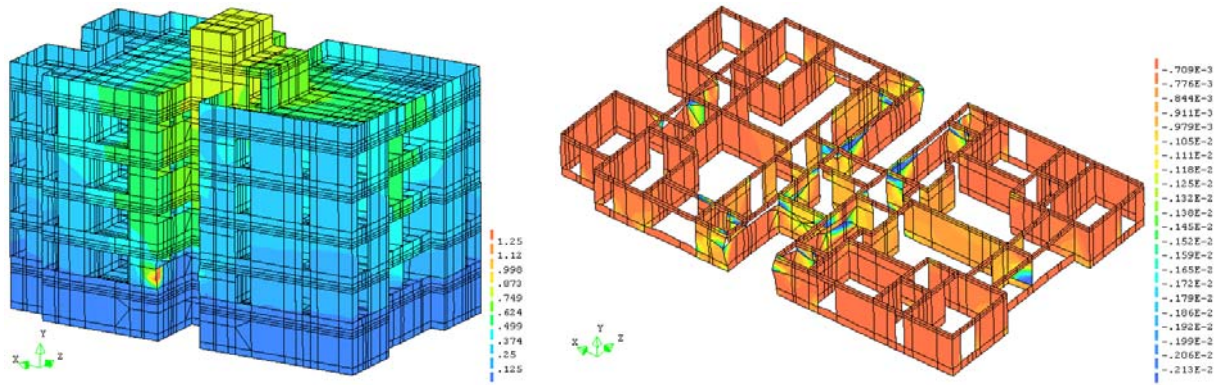
FIGURE 14 Results of safety analysis at failure: (left) incremental displacements depicted on deformed mesh, note that collapse occurs at confined areas surrounding an opening; (right) minimum principal strains at the ground floor walls, where the damage is maximum.

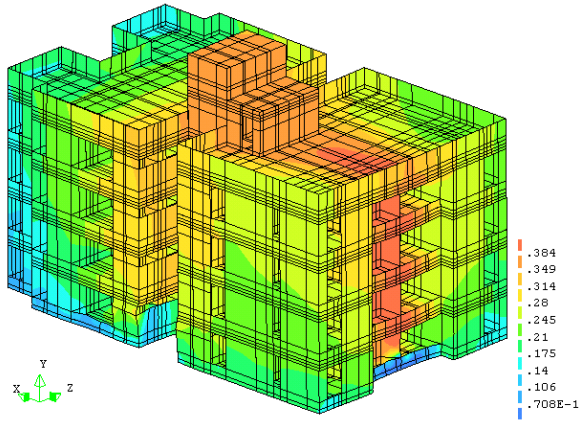
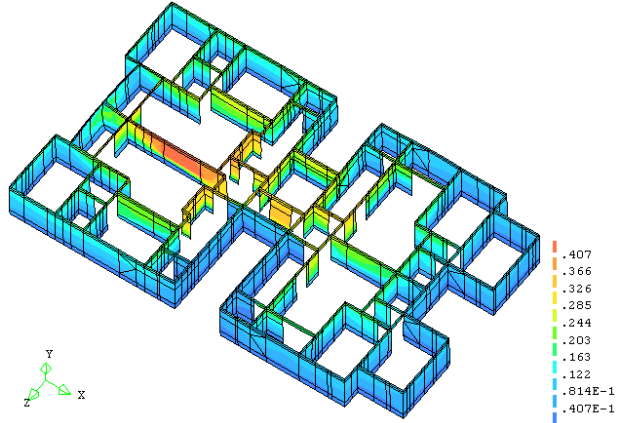
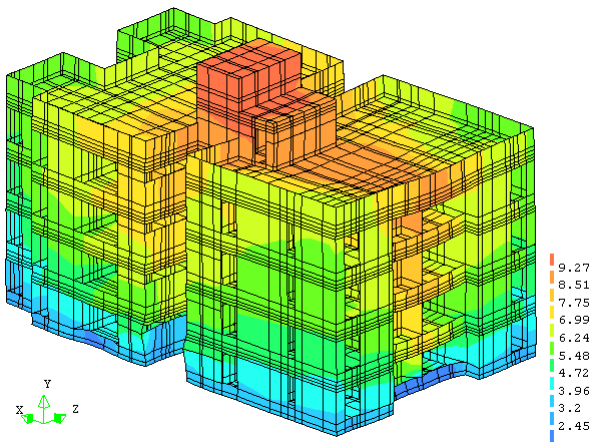
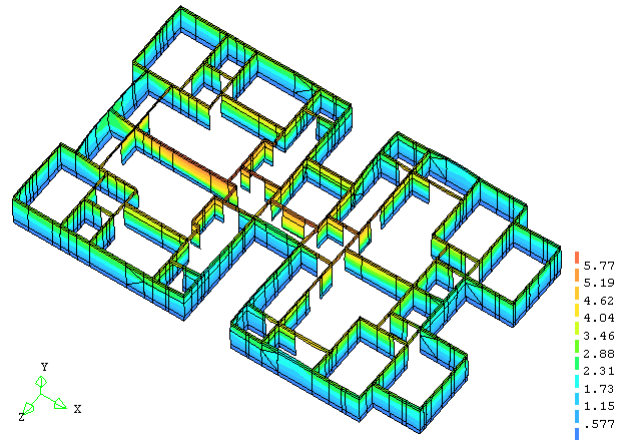
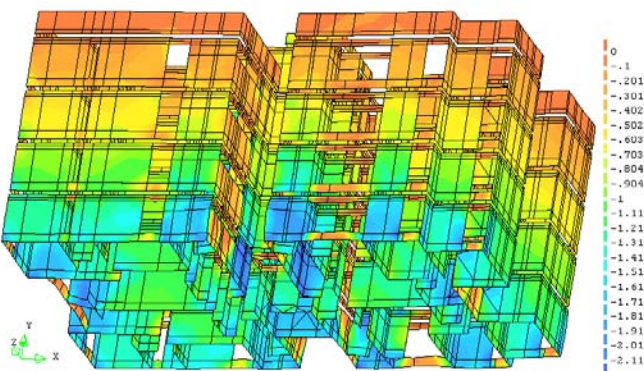
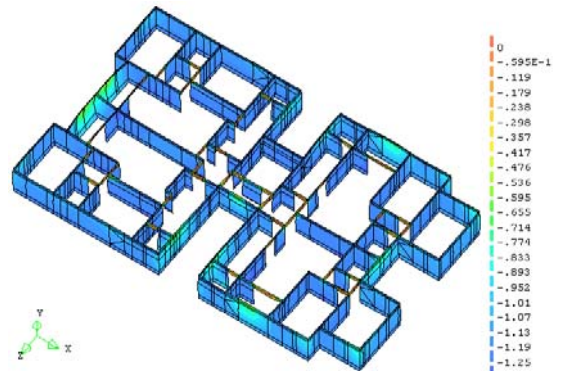
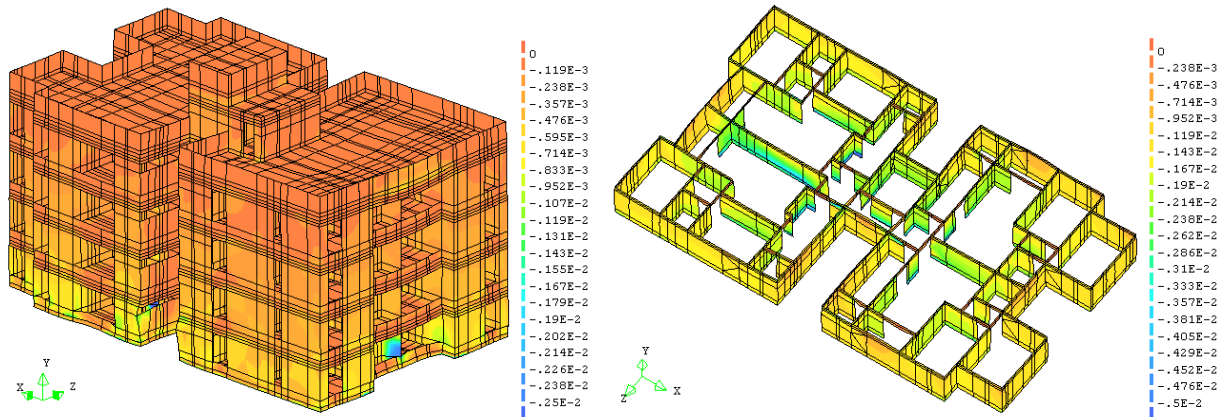
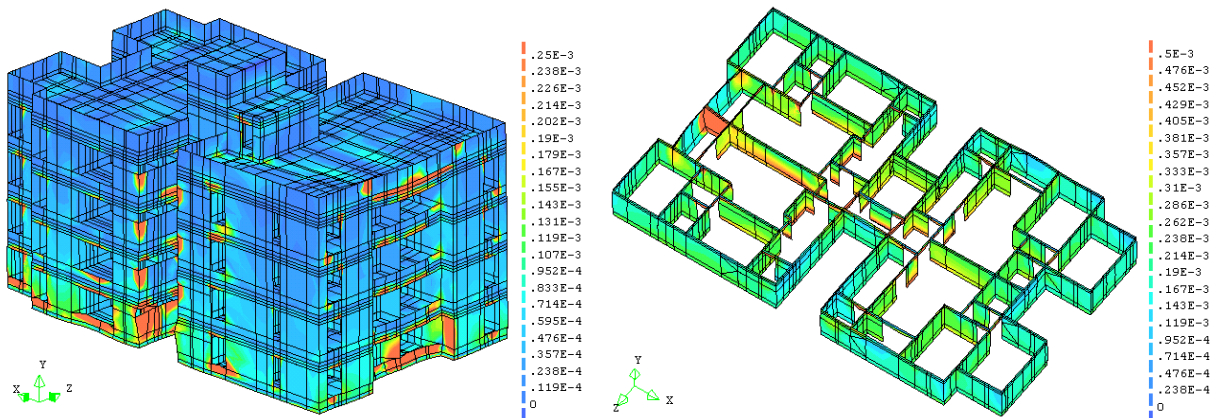
FIGURE 18 Results of the reference analysis. The building above ground is depicted on the left side of the figure and the foundations on the right side. All the results refer to the peak load: (a) incremental displacements depicted on incremental deformed mesh; (b) total displacements depicted on total deformed mesh; (c) minimum principal stress depicted on total deformed mesh (results in MPa); (d) minimum principal strains depicted on total deformed mesh; and (e) maximum principal strains depicted on total deformed mesh.

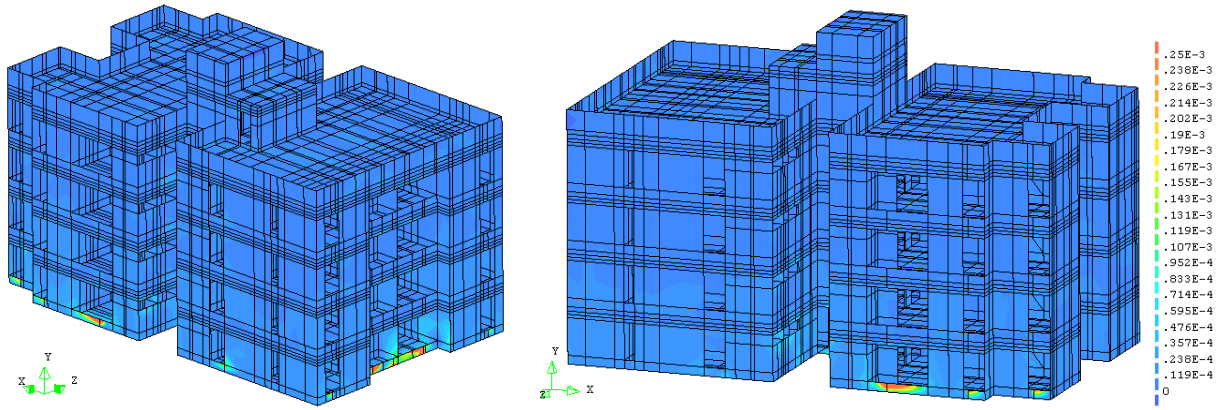
FIGURE 20 Maximum principal strains above ground (cracking) at peak load.

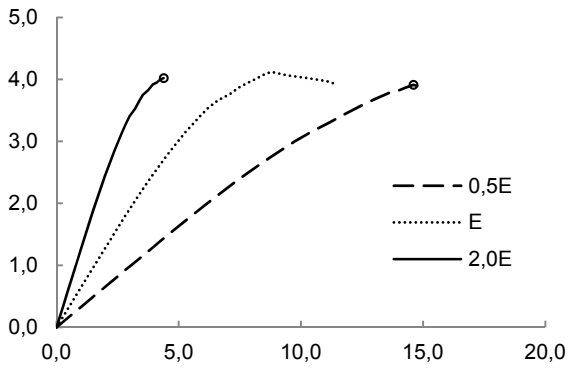
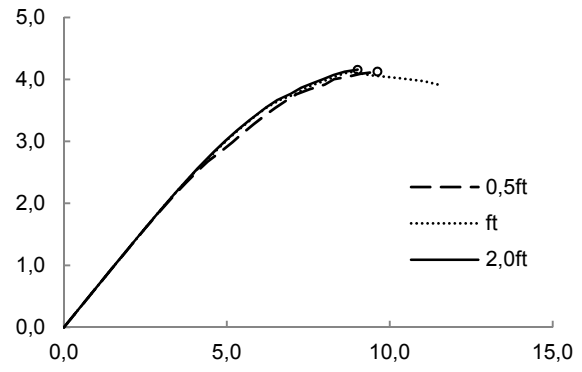
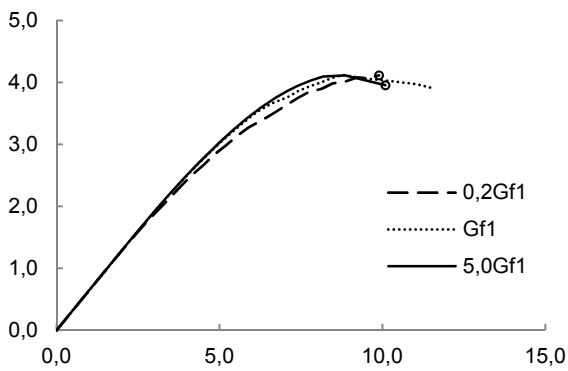
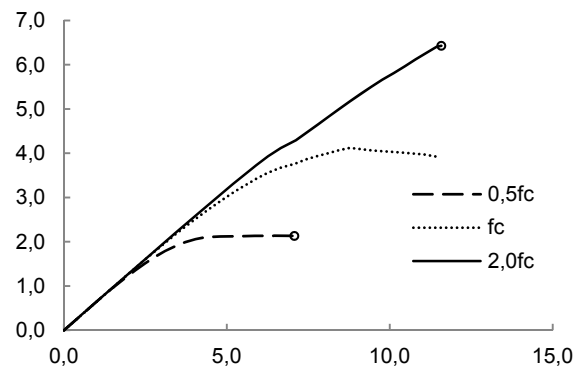
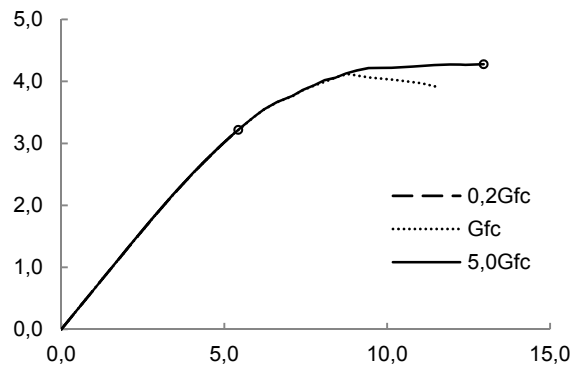
From the load-displacement diagram illustrated in Figure 21a, it can be observed that the influence of the elasticity modulus on the structural response of the building affects primarily the elastic stiffness and thus, the deformation is much increased or decreased according to the variation of this parameter. As the response of the structure is fundamentally linear until very high load factor values, the structure is very sensitive to the variation of this parameter in terms of deformation. However, the results are only very slightly sensitive in terms of peak loads, the difference to the reference value is around 5%, and the failure mode remains the same. The variation of the tensile strength and mode I fracture energy, have almost no influence on the results, as it could be expected, given the compressive dominated failure, see Figure 21b and Figure 21c. The differences to the peak load are smaller than 1% and the failure mode did not vary.

On the other hand, results are very much sensitive to the variation of the compressive strength and the compressive fracture energy. Figure 21d confirms that the structural response of the building is mostly dependent of the compressive strength of the masonry. The differences in terms of peak loads are very large, around 50%, showing again that the reduction of the compressive strength and the reduction of the peak load factor are almost linearly correlated. The failure mode varied in both analyses, when the compressive strength was reduced to half, the structure behaves almost ideally in compression and, oppositely, when the compressive strength was doubled, collapse became much more brittle, being the structural response practically linear until collapse. Failure occurs very explosively at the ground floor. Correspondingly, the variation of the compressive fracture energy illustrated in Figure 21e, has a large influence on the failure mode of the structure. This influence was previously discussed in Section 4.1.1, where the ductility index was modified in order to obtain a less explosive and localized collapse. In accordance with the previous results, the collapse is much brittle when the compressive fracture energy is reduced and the structural response is almost linear until collapse. The difference in terms of peak load is rather large (over 20%) because the structural response is controlled by the brittle failure taking place close to an opening at the ground floor. In contrast, the structure behaves almost ideally in compression when the compressive fracture energy is increased. Failure mode did not vary and the difference to the reference peak load is quite low (3.8%).

FIGURE 21 Influence of the material parameters on the load-displacement diagram of the building: (a) elasticity modulus; (b) tensile strength; (c) mode I fracture energy; (d) compressive strength; and (e) compressive fracture energy.
