Rui Tiago Pinto dos Santos Beleza de Seabra Assessment of a Gothic steel church: San Sebastian Church

Portugal | 2016

Master's Thesis

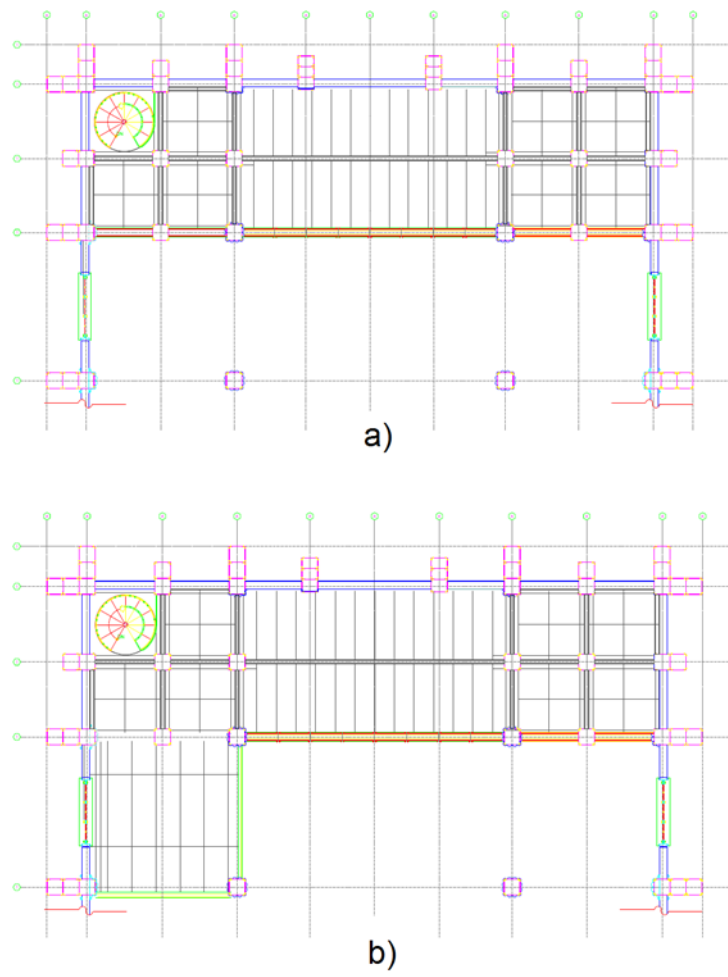
The interior suffered less interventions, but was subjected to a major intervention. The choir loft initially was not like as observed presently. In the beginning, the choir loft was located in the first three sets of columns (Figure 32a). This change happened in the 1930's, when a pipe organ needed to be installed in the east end of the choir loft, which became possible by extending this part of the choir in the direction of the altar (Figure 32b). The organ hides a part of a window, which was punched to channel the organ's blower pipe. This addition becomes perceptible, because the floor pattern for each part is different. The original choir floor has alternating planks of lighter and darker wood, unlike the new part.

Figure 32 – Plans of the choir loft: a) choir loft before intervention; b) choir loft after intervention.

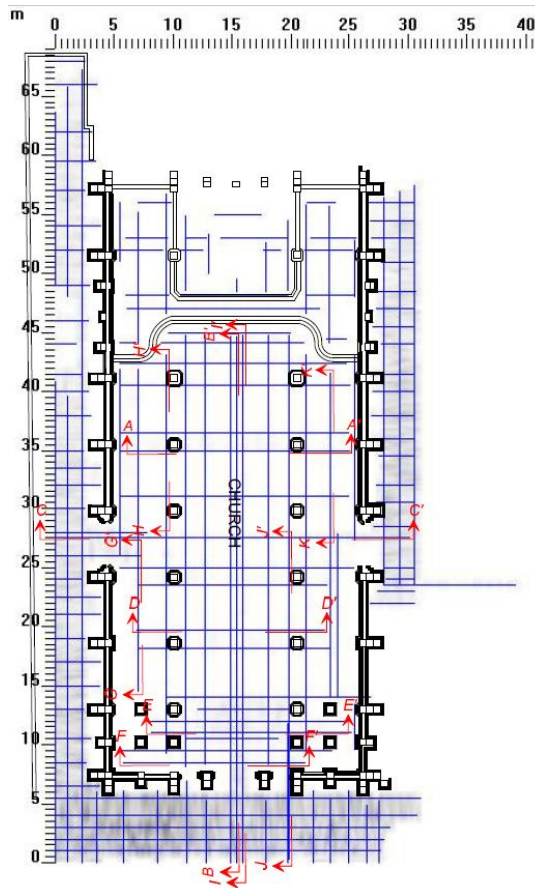
The 100MHz allowed to find that at a depth of 0.25m there are drainage lines that start at the interior corners of the two towers, converging in the central area of the church, and go to the outside of the church by the entrance (Figure 38). Some metal objects were also found in the subsoil, however, the accuracy of results is not the best one, since some air wave reflections might have affected the results.

It was also possible to realize that the top of the tie beams might be at a depth of 0.60m, since the hyperbola apex is located at this level. Nevertheless, this test also allowed to include other metallic objects that seem to be out of place, taking into account the position of the columns and tie-beams (Conservation and Development Foundation 2014).

Figure 38 – 100MHz GPR scan lines.

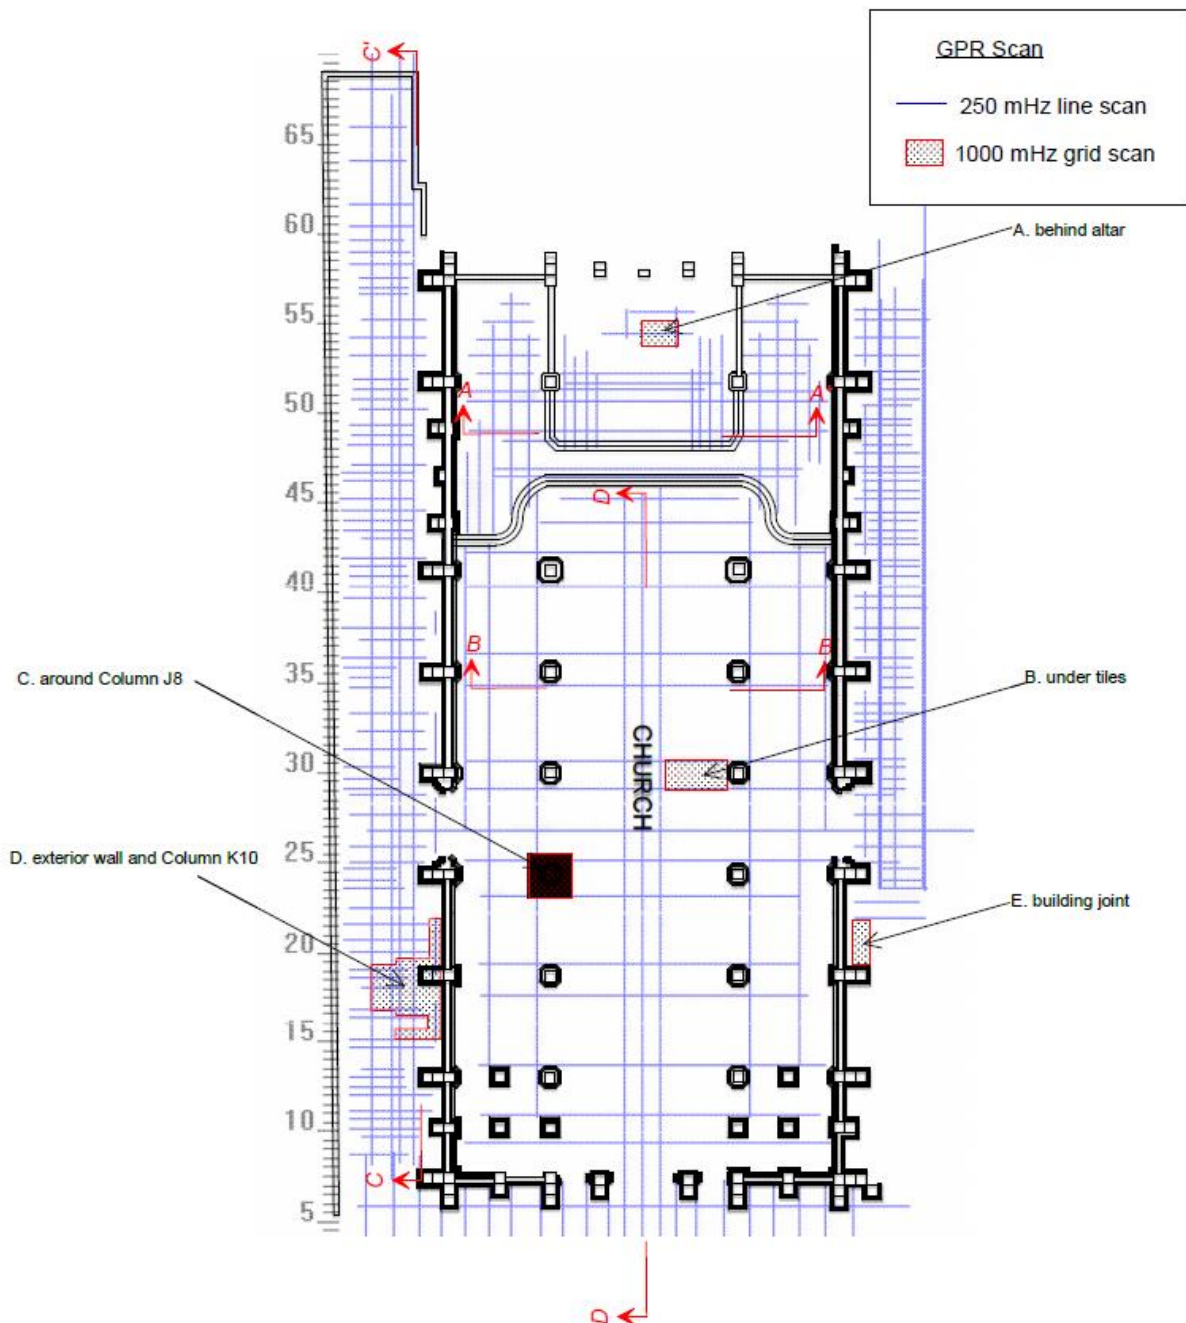
In order to have a higher image resolution, a second set of tests was performed, with a 250MHz frequency. These tests helped to confirm the existence of the drainage lines along the lateral walls. These tests also helped to conclude that there are some metallic objects located near the surface. Moreover, some objects were found spaced approximately every 0.50m, at a depth of 15 to 20cm that might correspond to the previous floor joints that were part of the original wooden floor of the church.

A third set of tests was performed using a frequency of 1GHz, which was used in specific areas to have higher image definition, to properly characterize them. These tests were performed to locate old floor joints under the nave tiles, and allowed to conclude that there is a possibility of its existence spaced every 0.35m at a depth of 0.15m. However, the continuity and uniformity of these elements around the columns is not perceptible. It was also tried to locate concrete or brick pedestals, and confirm drainage line along the walls. No pedestal was detected and the drainage line was detected. Another purpose for

this new campaign was to check if the church was linked to the adjacent building, and the conclusion is that the two buildings are not connected. There is only an area filled with rubble or gravel infill.

Figure 39 – 250 and 1000MHz scan lines.

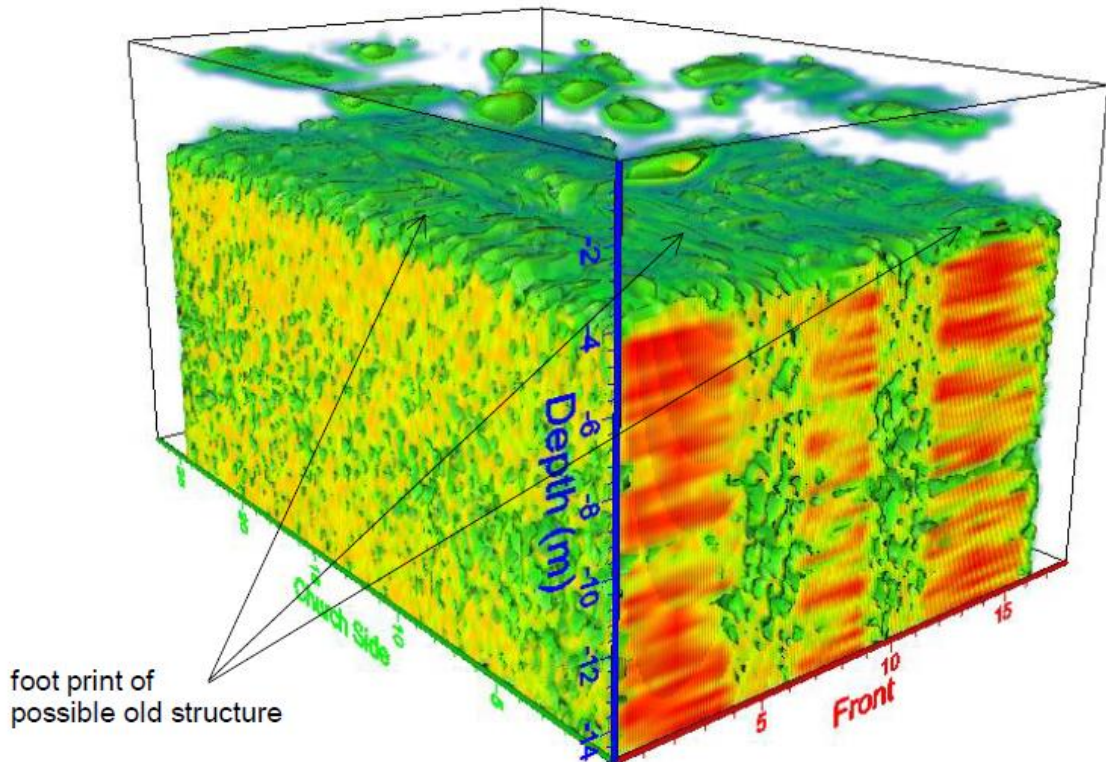
Throughout all the campaigns performed with the GPR, there was a very interesting discovery. In one of the scans performed on the courtyard, it seems that there are some parts of an ancient wall with thickness equal to 2m, possibly from an old version of the church, approximately 4m below the surface.

Figure 40 – GPR scanning of the soil.

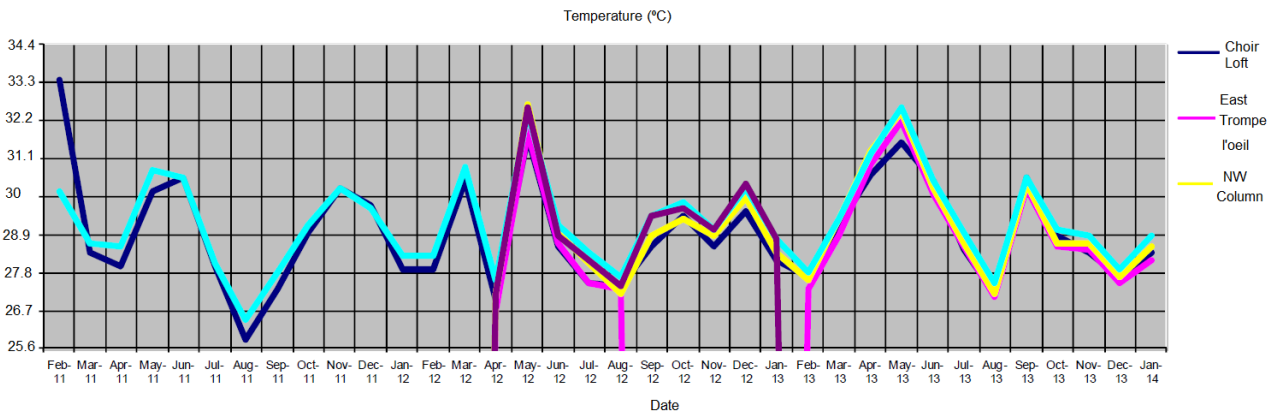
Figure 43 – Temperature evolution for two years.

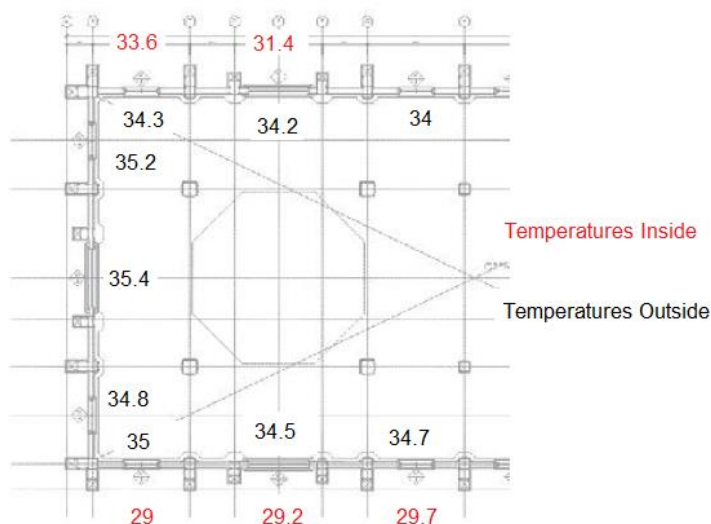
Figure 44 – Average temperatures for the inside and outside of the walls.

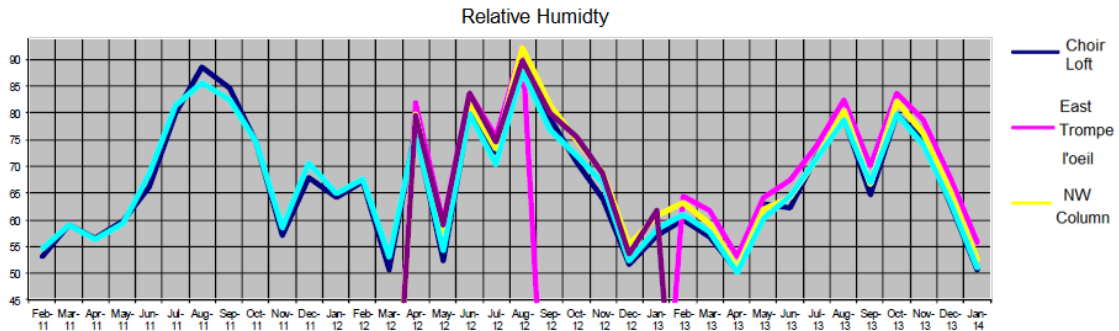
Analysing the relative humidity, and taking into consideration that it is recognized by experts that the percentage of relative humidity that can promote corrosion is 60% to 65%, and that the average relative

humidity is 68% (Figure 45), it can be stated that the San Sebastian environment is favourable to cause more damage due to this phenomenon. This can become more dangerous, if the effect of environmental pollutants and saline deposits are taken into account.

Figure 45 – Relative humidity values along two years (average equal to 68%).
