## Selected research and case studies in ancient Portuguese structures

### Summary

The present paper presents some of the recent activity of University of Minho, regarding case studies for Portuguese timber structures in four ancient buildings, including the Cathedral of Porto, a Church in Coimbra and a Church in Braga. NDT is combined with analysis methods aiming at non-invasive strengthening solutions or replacement of the timber structure (only as a last resort). Research studies carried out in UM and currently running on LNEC and UM are also presented, being showed the relevance of this research studies for the assessment and analysis of historical timber structures.

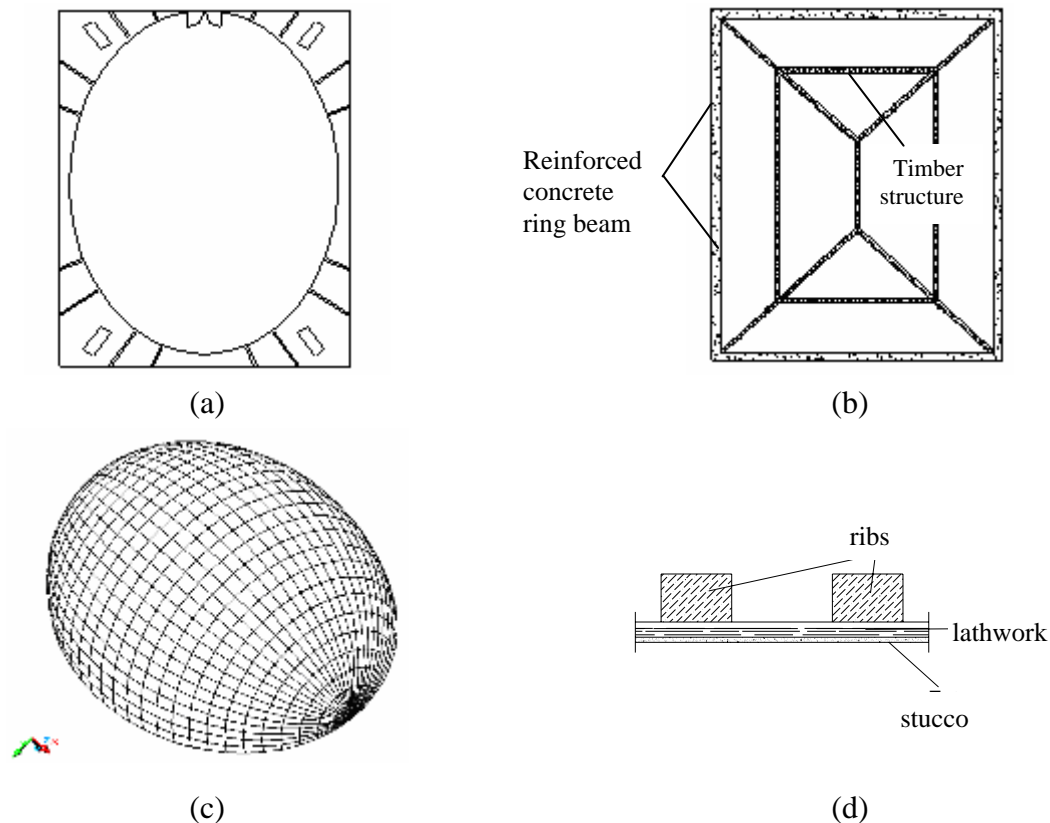
The origin of this monastery dates back to 1131. The reliquary room exhibits considerable deformation and cracking of a timber vault, due to deformation of the roof above it, see [1] for details. The dimensions of the room are  $12.5 \times 15 \text{ m}^2$  in plan, with a four-sloping roof with clay tiles and a timber lathwork vault rendered with stucco, see Fig. 1.

Fig. 1 Reliquary Room: (a) plan with main vault and secondary vaults; (b) main roof structure; (c) view of lathwork vault; (d) detail of vault structure

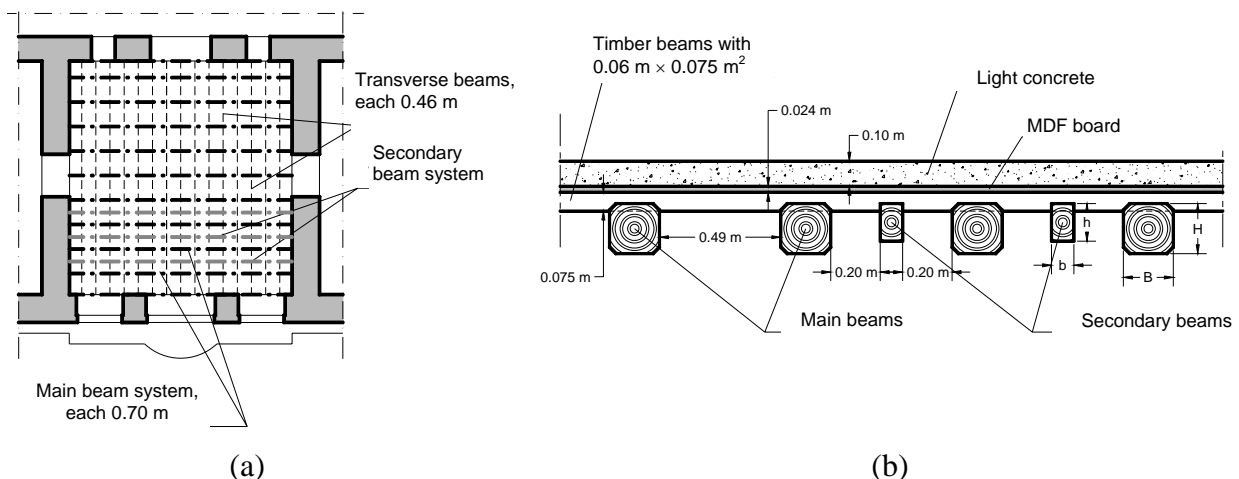
The load test was carried out for a live load of  $3 \text{ kN/m}^2$ , see [4] for more details. The oak timber structure of the floor has a span around 6.5 m, see Fig. 8, being composed by: (a) a set of main beams, placed each 0.70 m; (b) secondary beams located only in the area closer to the main façade; (c) a set of transverse beams, placed each 0.46 m. On top of the transverse beams, a 24 mm thick MDF board has been laid and a 10 cm thick light concrete levelling layer as also been added. Such additions multiplied the self-weight of the floor around three times (per square meter).

Fig. 7: Arcos de Valdevez City Hall's floor structure: (a) plan; (b) cross-section

The structure was visually inspected and tapped. It was possible to verify that the timber is globally in good condition and exhibits no structural damage, even if treatment against xylophagous insects in needed. Before carrying out the load test, the structure was analysed and it could be concluded that, without the floorboard, the structure would not be able to withstand the requested live load. Therefore, a safety system using temporary propping was required (minimum distance between props and floor was 50 mm, so that contact with the floor structure was impossible during the loading process).

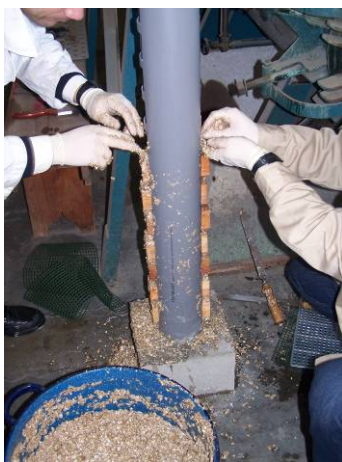
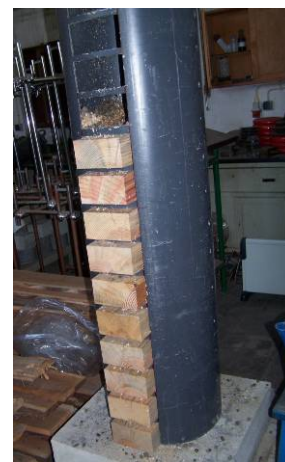
The apparatus to create decayed test specimens is to place them into a tube filled with an optimum environment for the development of fungus, composed by sawdust, LECA, vermiculite and malt extract, together with the fungus itself. In Fig. 16 is shown some decay columns actually mounted in LNEC. There will be used pine wood (*Pinus Pinaster ait.*) and chestnut wood (*Castanea Sativa Mill.*) in these tests, due to it wide use in Portuguese timber structures.

Fig. 16: Decay tests currently running on LNEC: (a, b) mounting of a decay column; (c) Detail of the mixture used to fill the tube; (d) incipient decay detected in some test specimens
