# PERFORMANCE OF MASONRY BUILDINGS AND CHURCHES IN THE 22 FEBRUARY 2011 CHRISTCHURCH EARTHQUAKE

## SUMMARY

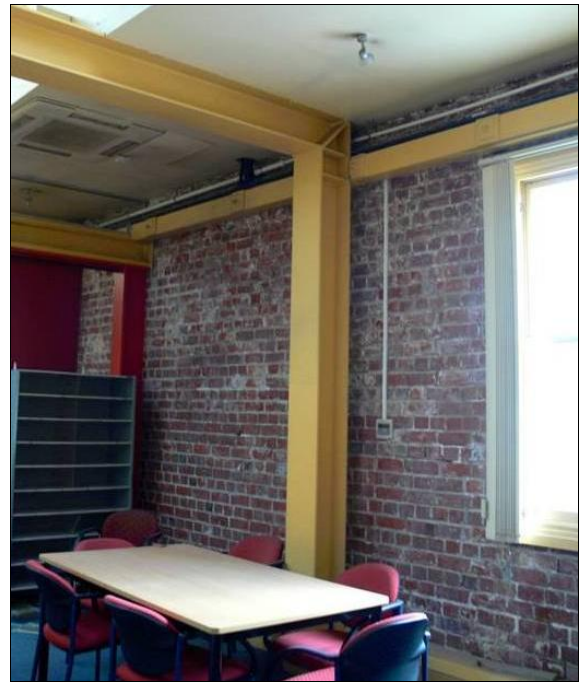
- Steel moment frames, which increased the lateral capacity of a building (see Figure 18);
- Steel strong-backs, which helped to prevent out-of-plane failure of URM walls (see Figure 19 and 20);
- Application of shotcrete, which increased the in-plane and out-of-plane wall strength (see Figure 21).

Figure 18: Internal view of steel moment frame retrofit.

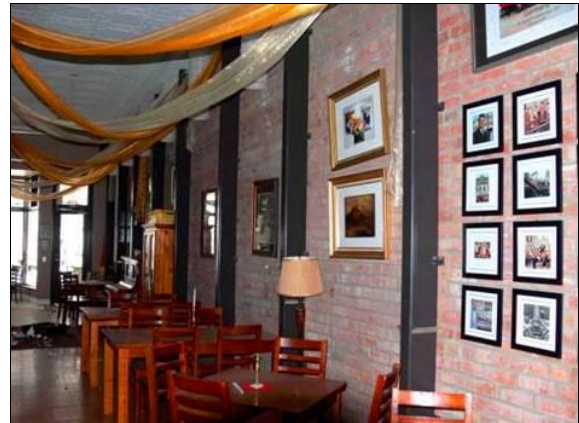
Figure 19: Steel strong-backs provided out-of-plane support for URM walls.

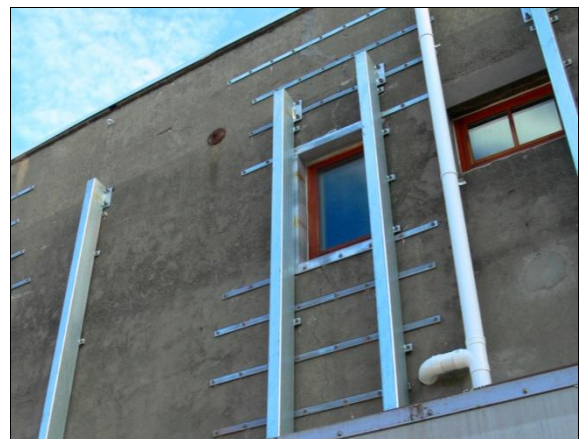
Figure 20: Externally positioned steel strong backs prevented out-of-plane failure of a tall and slender URM wall.

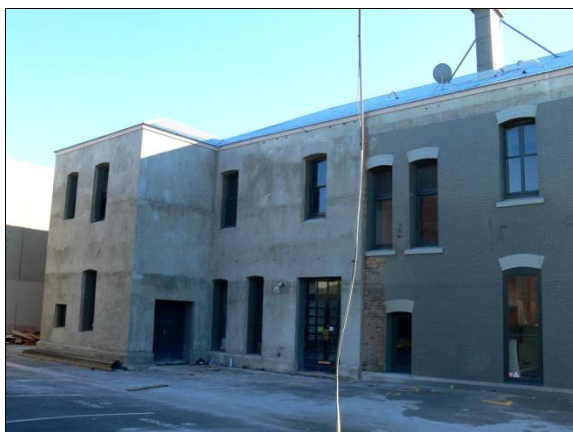
**Figure 21:** Rear of a building retrofitted using shotcrete.

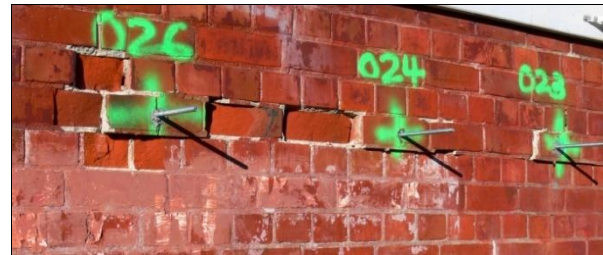
- Failure modes included pullout of the anchors (especially in weaker masonry and shorter embedment depths), masonry breakout/anchor pullout (where the leading brick, or part of it, is pulled out with the anchor as shown in Figure 32), and anchor yielding (and fracture in some cases);
- Failures approximating the ideal breakout failure, in which rupture occurs in a roughly conical masonry failure surface, were not observed in any of the tests;
- The quality and strength of the masonry was found to be an important variable, as well as the strength of the adhesive, the size of the anchor, and the embedment depth;

Figure 32: Typical masonry pullout type failure observed.

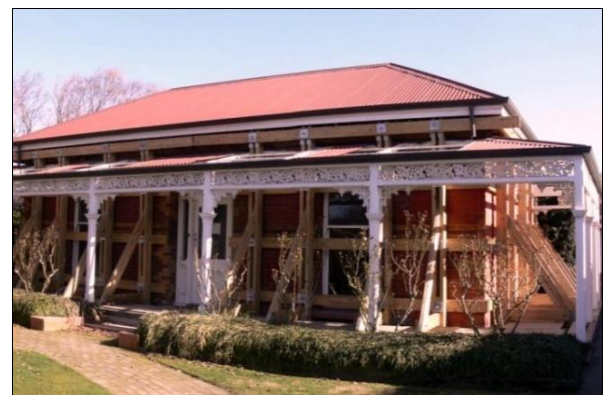
For URM buildings damaged in the September 2010 earthquake, temporary shoring was commonly used to prevent further out-of-plane wall damage or collapses. Hence the performance of temporary shoring was assessed following the major aftershocks. Figure 33 and Figure 34 shows post-September 2010 shoring that assisted in preventing collapse of URM buildings in February 2011.

Figure 33: Extensive timber temporary shoring of a residential URM building following 4<sup>th</sup> Sept earthquake.

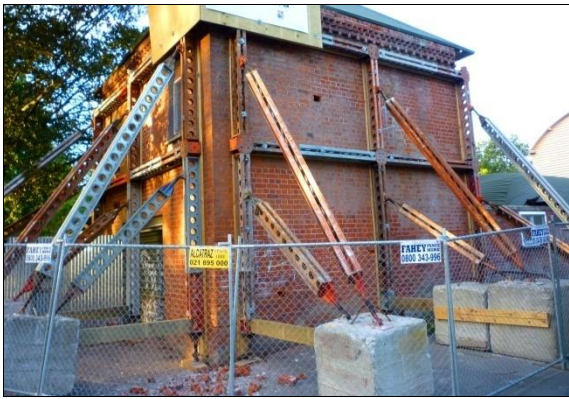
**Figure 34:** Extensive steel temporary shoring of a URM building following the 4<sup>th</sup> Sept earthquake.

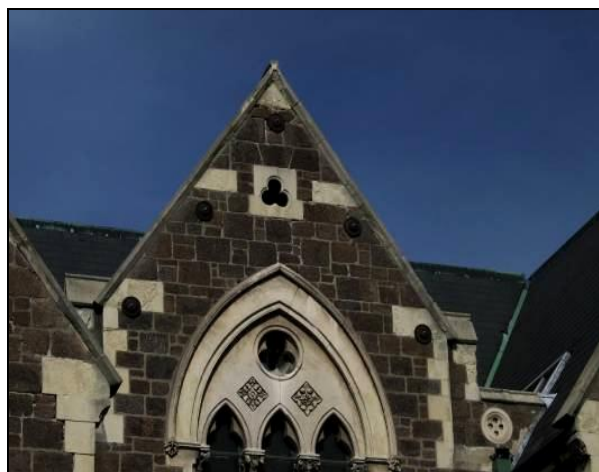
Two cases are presented to show the different behaviour induced by the presence and effectiveness of anchorage. Figure 38 shows the damage resulting from overturning of the gable of the main façade of the former Trinity Church in the Christchurch CBD, where anchors were insufficient in size and spacing to secure the wall in place. Figure 39 shows an example of successful wall-to-roof anchorage in an Arts Centre building.

*Figure 39: The Christchurch Arts Centre, showing successful use of wall-diaphragm anchorages.*
