Seismic analysis of the Roman Temple of Évora, Portugal

15 WCEE
LISBOA 2012

SUMMARY

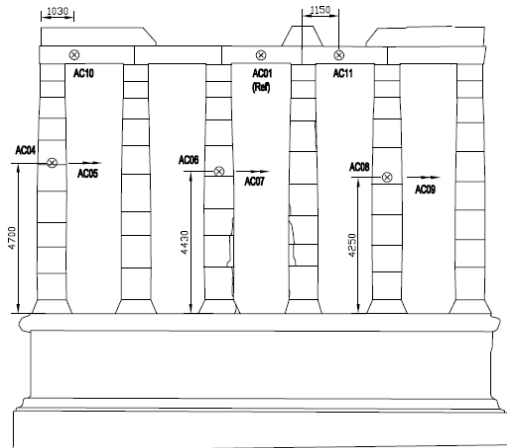
Dynamic identification tests were also conducted. The tests involved the placement of twelve uniaxial accelerometers throughout the structure in five different configurations, see Figure 4. Two tests were carried out for each configuration, the first test recorded only the ambient vibration, so as to be a baseline for analysis. The second test used a hammer to introduce an external excitation in the structure. Figure 5 provides the frequencies and damping ratios measured for one of the freestanding columns. This information was then used to calibrate the joint stiffness of the numeric models for discrete element analysis.

Figure 4. Dynamic identification tests: (a) accelerometer positions for one test setup; (b) photograph showing accelerometers setup on top of architrave.

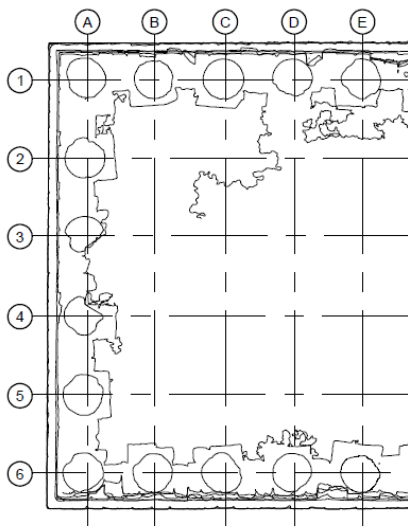
Figure 5. Experimental results: (a) Column grid references; (b) dynamic identification results of column E6.

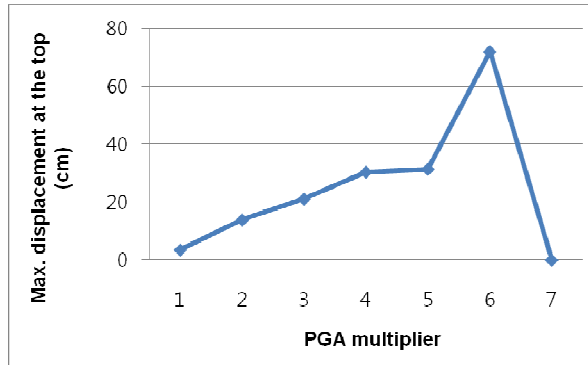
For a PGA multiplier factor of 2, the column did not explicitly fail, but the maximum displacement at the head of the column was 13.9 cm and the maximum residual displacement was approximately 4 cm. The results obtained by increasing the PGA multiplier show a similar qualitative response. The critical intensity of earthquake that causes failure of the column was estimated for a PGA multiplier factor around 7. Figure 7 shows the maximum displacement at the top as a function of the PGA multiplier. The values of normal joint stiffness and shear joint stiffness are equal to 3490 MPa/m and 1750 MPa/m, respectively.

As the earthquake intensity increases, the column response is dominated by rocking and sliding. Up to a PGA multiplying factor of 6, the magnified earthquake did not lead to collapse despite large displacements at the top of the structure. The maximum displacement reached 72 cm with a PGA multiplier factor of 6. It is noted that the maximum displacement at the top is significantly large enough to lead to failure in usual cases. However, the drums of the column did not fall because the column was subjected to the lateral force generated by the ground motion in the direction opposite to the displacement vector. Above a PGA multiplier factor of 7, however, the applied earthquakes led to column failure.

Figure 7. Maximum displacement of the top of freestanding column.

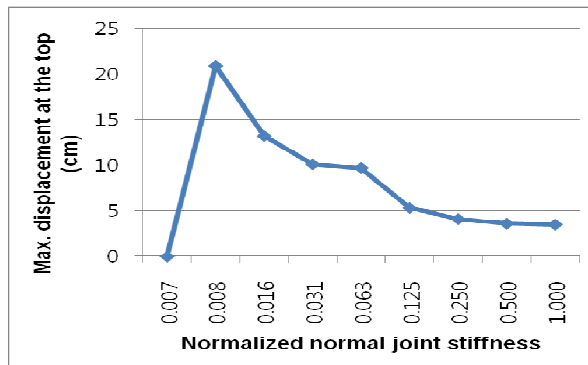
In order to estimate the influence of the joint stiffness on seismic response, the calibrated value of the joint stiffness (3490 MPa/m) was reduced and the smaller values were normalized and assigned to each analysis. Figure 8 shows the maximum displacement of the top with normalized joint stiffness's. A critical value of 25.5 MPa/m led to failure of the column excited by the non-magnified earthquake. The critical value of the normal stiffness was 0.73% of the calibrated normal joint stiffness.

Figure 8. Maximum displacement of the top of freestanding column with varying joint stiffness.

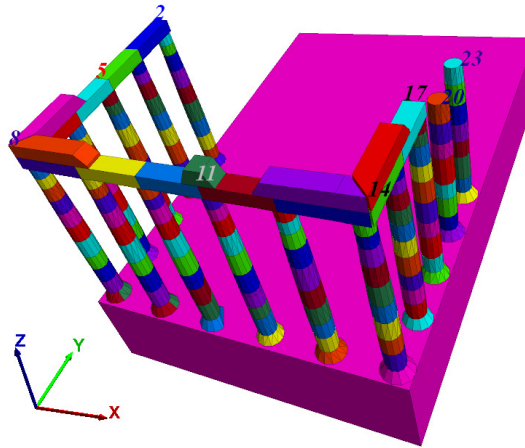
Table 3 presents the maximum seismic displacements, at each monitoring position, due to increasing PGA multiplier factors of the earthquake applied in the x-direction. The maximum displacement was monitored at positions 17 and 20. As expected, displacement increased with the increase of PGA multiplier factors.

Figure 9. View of the temple model with monitoring points.
