## Conservation of cultural heritage buildings: Methodology, practice and challenges

P.B. Lourenço

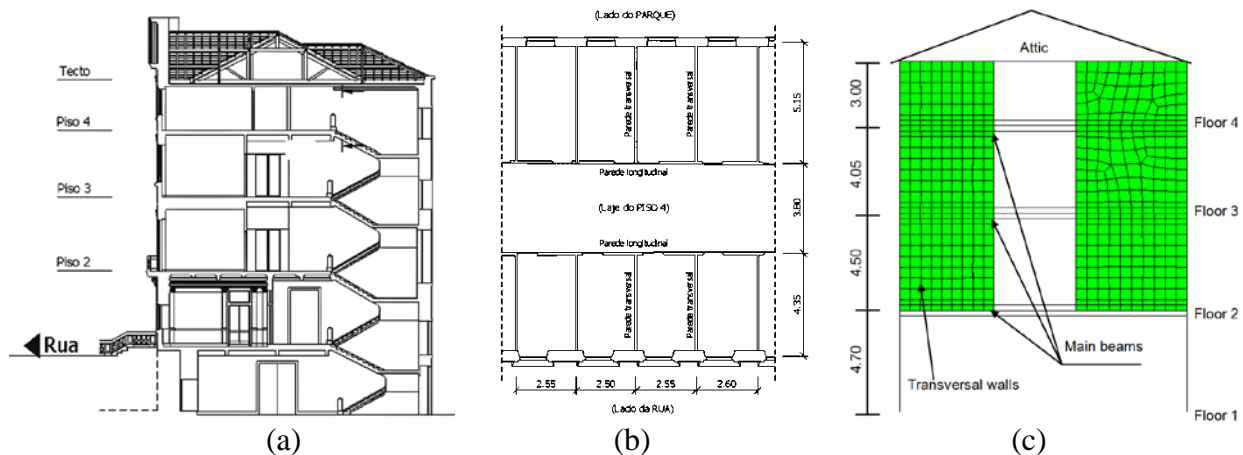
Figure 9: Theological school: (a) Vertical section; (b) Plan; (c) Main transversal structure.

Figures 9b,c present the geometrical survey of the building and the main structure. Cores and steel samples were obtained from the building in order to characterize the materials used. The transversal walls are separated each 2.6 m, with asymmetric location of the longitudinal walls. The thickness of the external masonry walls varies between 0.30 and 0.60 m. The transversal beams have cross sections of  $0.25 \times 0.50 \text{ m}^2$  (floors 3 and 4) and  $0.30 \times 0.60 \text{ m}^2$  (floor 2). The thickness of the slabs is 0.12 m and the internal walls have a thickness of 0.06 m. The concrete strength found was  $24.6 \text{ N/mm}^2$  (slabs) and  $11.9 \text{ N/mm}^2$  (walls). All the reinforcement found is unribbed and mild steel. The slabs have a single layer of reinforcement with  $\phi 3/8''@0.125$  for the main reinforcement and  $\phi 3/8''@0.25$  for the secondary reinforcement. The walls have also a single layer of reinforcement with  $\phi 3/16''@0.25$  in the vertical direction and  $\phi 5/32''@0.25$  in the horizontal direction. The lower reinforcement in the transversal beams is  $3\phi 1''$  (floors 3 and 4) and  $4\phi 1\frac{1}{4}'' + 4\phi 1''$  (floor 2). Besides the dead load, for the current use of the building the live load according to the Portuguese code is  $3.0 \text{ kN/m}^2$  in general with  $5.0 \text{ kN/m}^2$  is the access zones. With the new use, the planned live load is  $14.8 \text{ kN/m}^2$  for floor 2,  $13.5 \text{ kN/m}^2$  for floor 3 and  $11.0 \text{ kN/m}^2$  for floor 4.
