## Conservation of cultural heritage buildings: Methodology and application to case studies

P.B. Lourenço

### ABSTRACT

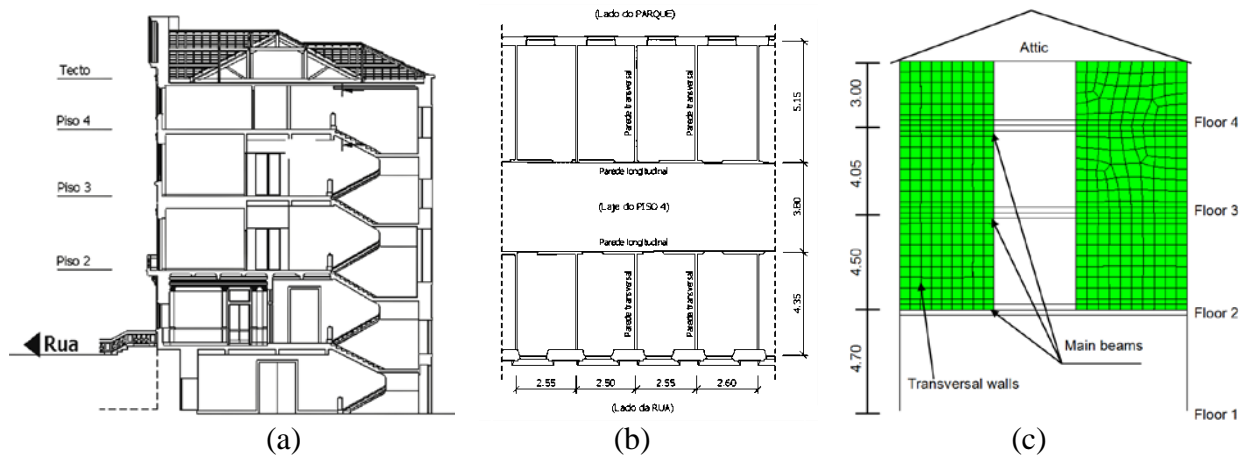
Figure 9: Theological school: (a) Vertical section; (b) Plan; (c) Main transversal structure.

Figures 9b,c present the geometrical survey of the building and the main structure. Cores and steel samples were obtained from the building in order to characterize the materials used. The transversal walls are separated each 2.6 m, with asymmetric location of the longitudinal walls. The thickness of the external masonry walls varies between 0.30 and 0.60 m. The transversal beams have cross sections of  $0.25 \times 0.50 \text{ m}^2$  (floors 3 and 4) and  $0.30 \times 0.60 \text{ m}^2$  (floor 2). The thickness of the slabs is 0.12 m and the internal walls have a thickness of 0.06 m. The concrete strength found was  $24.6 \text{ N/mm}^2$  (slabs) and  $11.9 \text{ N/mm}^2$  (walls). All the reinforcement found is unribbed and mild steel. The slabs have a single layer of reinforcement with  $\phi 3/8''@0.125$  for the main reinforcement and  $\phi 3/8''@0.25$  for the secondary reinforcement. The walls have also a single layer of reinforcement with  $\phi 3/16''@0.25$  in the vertical direction and  $\phi 5/32''@0.25$  in the horizontal direction. The lower reinforcement in the transversal beams is  $3\phi 1''$  (floors 3 and 4) and  $4\phi 1\frac{1}{4}'' + 4\phi 1''$  (floor 2). Besides the dead load, for the current use of the building the live load according to the Portuguese code is  $3.0 \text{ kN/m}^2$  in general with  $5.0 \text{ kN/m}^2$  is the access zones. With the new use, the planned live load is  $14.8 \text{ kN/m}^2$  for floor 2,  $13.5 \text{ kN/m}^2$  for floor 3 and  $11.0 \text{ kN/m}^2$  for floor 4.
