# Structural Monitoring and Damage Identification on a Masonry Chimney by a Spectral-based Identification Technique

**ABSTRACT:** The present work deals with the damage identification of a historical masonry chimney located in Guimarães (Portugal), including a detailed survey, inspection and diagnosis. The chimney was object of a continuous monitoring campaign carried out to catch the evolution of the modal parameters and evaluate the success of the rehabilitation works planned after a lightning accident. Based on the dynamic features extracted from the OMA data, a damage identification analysis was performed making use of different damage identification techniques. Considering the explicit dependence of output-only power spectral densities on frequency contents, a spectral-based identification method was used to detect the damage. Finally, an appropriate localization index was defined combining evolutionary complex eigenvectors obtained from the decomposition of the power spectral density matrix. The results allow to conclude that the spectral-based dynamic identification method is a non-destructive tool able to capture the global behavior of a structure and may reveal itself of

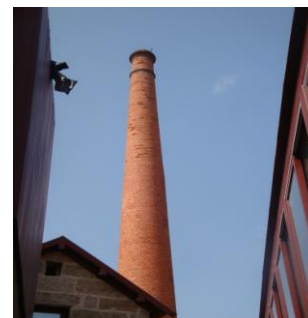
The masonry chimney object of this paper belonged to a former industrial complex (**Errore. L'origine riferimento non è stata trovata.** Figure 1) located in the city center of Guimarães, historical town in the North of Portugal. The structure was already monitored by the University of Minho between November 2010 and June 2011 and then subjected to a series of topographic measurements and visual inspections that pointed out its poor structural condition. Further information about this experimental campaign are provided in Ramos et al. **Errore. L'origine riferimento non è stata trovata.**

Figure 1. The masonry chimney.

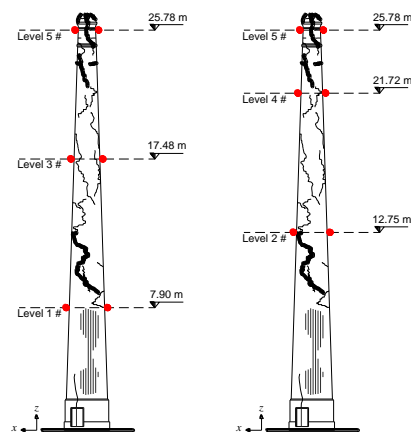
Figure 4. Test setups and measuring points.

Keeping the transducers on the top of the chimney as reference, 2 test setups, 3 levels for each setup and 4 accelerometers for each level were used (Figure 4) since it was necessary to measure an additional y direction, in

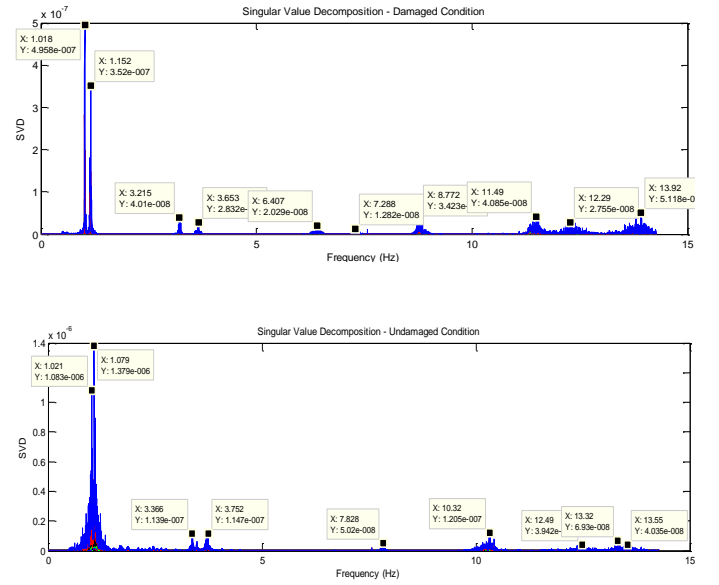
Figure 7. Eigenvalues plotting for damaged (before) and undamaged (after) conditions.

As highlighted in Table 5, the maximum percentage error between the resonant frequencies values is lower than 0.8% (except for mode 2 in the undamaged condition), so it is stressed that the results are highly accurate. The frequency shift concerning the higher modes and already pointed out in the previous section is perfectly caught as well and it proves to be a qualitatively indicator in the damage identification analysis.

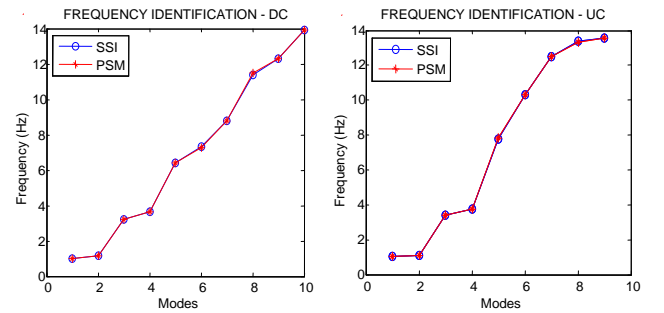
Figure 8. Comparison between PSM and SSI-PC methods.

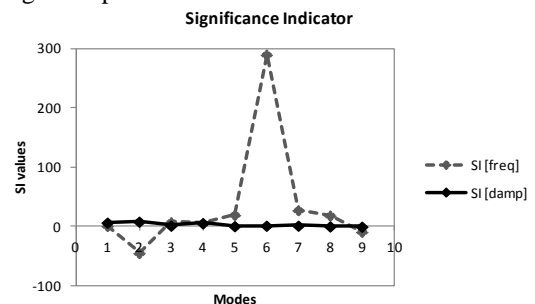
The first method applied was the USI, a statistical analysis method providing a sensitive indicator of structural damage based on frequencies shifts and estimated standard deviations [14]. A similar significance indicator defined for estimated damping ratios was also computed. Because of the presence of only one damage scenario, the sum of all the frequency and damping significance indicators over the measured modes to get a unified indicator was not possible. Therefore SI values were calculated for each single mode and the presence of damage was clearly identified from the frequency shifts (Figure 9). Being a Level 1 damage identification method, no additional information regarding the possible location of the damage was provided.

Figure 10. Damage detection by Significance Indicators.

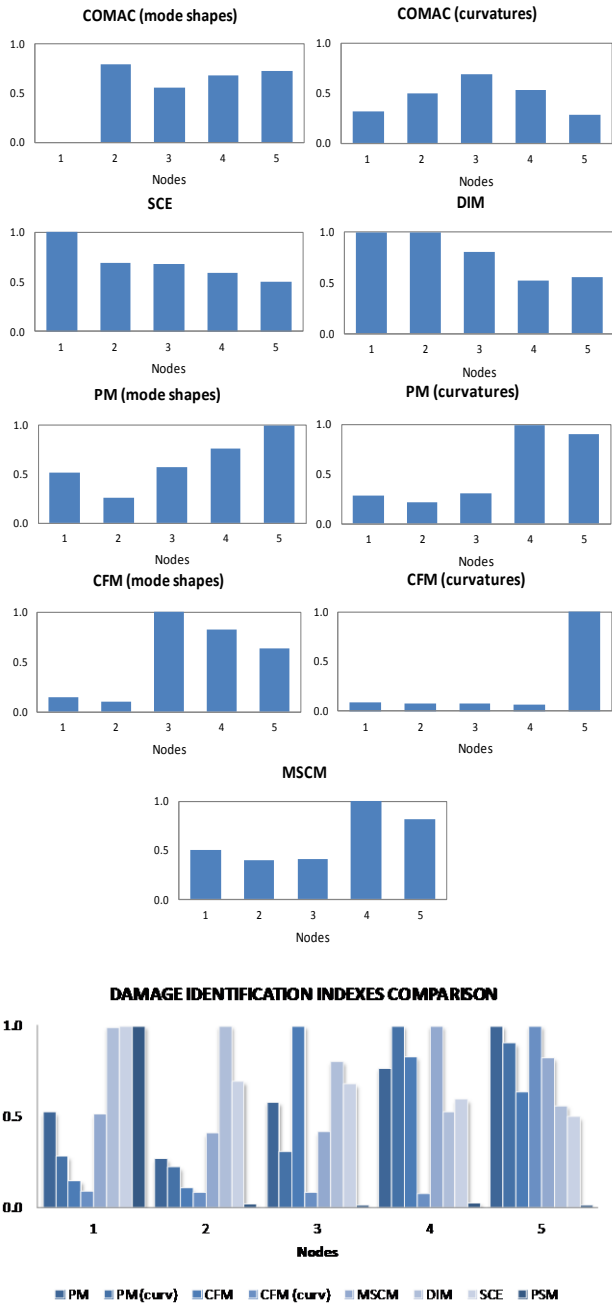
Concerning the other non-model based methods (Levels 2 and 3), all the indexes were computed taking into account the responses in  $x$  and  $y$  directions separately. Figure 11 shows the results obtained in terms of damage location making use of  $x$  direction outputs. From the comparison with the undamaged configuration, it is possible to draw the following conclusions:

- the COMAC values for modal displacements pinpoints the presence of damage at position 1, whereas the COMAC for modal curvatures at positions 1 and 5;
- the SCE indicates the first node as possible damage location;
- the DIM shows no accurate results, but positions 1 and 2 seem the most affected;
- the PM for both modal displacements and curvatures identifies possible damage locations in the upper part of the chimney (nodes 4 and 5) and so do the MSCM;
- the CFM for modal curvatures highlights the presence of damage in node 5, while the CFM for modal displacements in nodes 3 and 4.

Figure 11. Damage localization by non-model based methods (x direction).

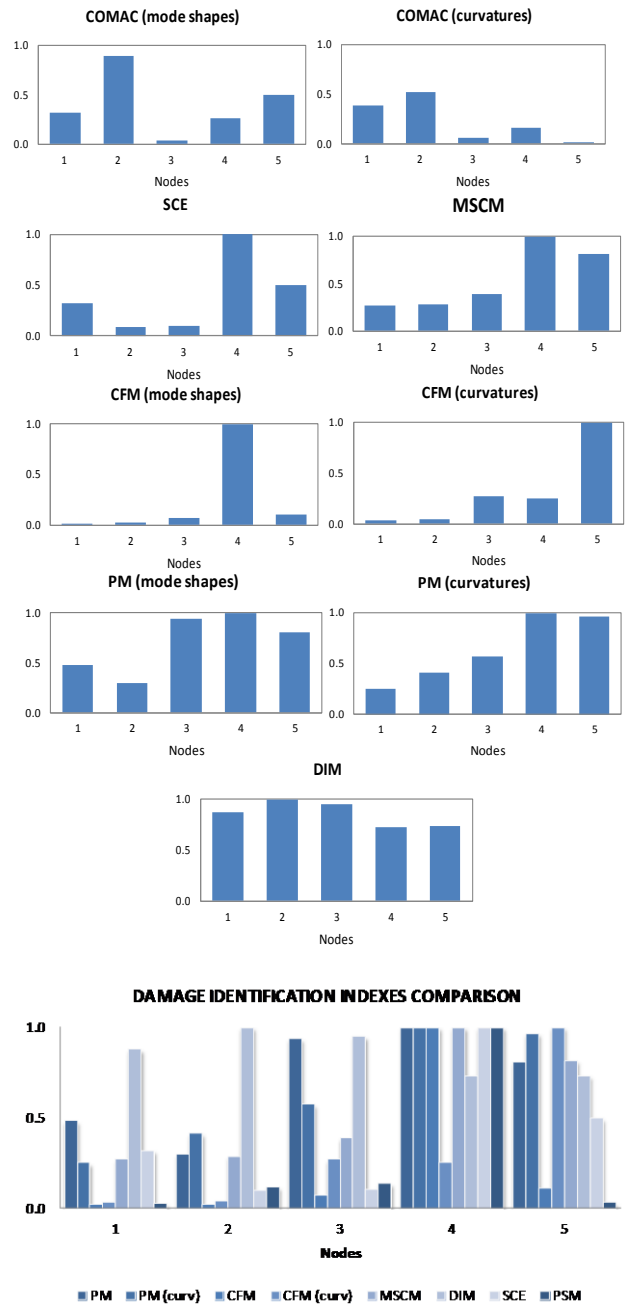
Figure 12 shows the results obtained computing the indexes from y direction outputs. From the damage analysis, the following considerations can be stressed:

- the SCE, the MSCM and the CFM for modal displacements clearly indicate the presence of damage at position 4, whereas the CFM for modal curvatures shows node 5 as possible damage location;
- the PM for modal curvatures and the MSCM values locate damage in the upper part of the chimney at both positions 4 and 5;
- the COMAC values for modal curvatures and the PM for modal displacements indicate the damage in three points, namely 3, 4 and 5;

- the COMAC values for modal displacements identify the damage at position 3, followed by nodes 4 and 1;
- the DIM gives inconclusive results.

Figure 12. Damage localization by non-model based methods (y direction).
