## Seismic assessment of Christchurch Catholic Basilica, New Zealand

SILVA, LUIS C.<sup>1</sup>; LOURENÇO, PAULO B.<sup>2</sup>; MENDES, NUNO<sup>3</sup>

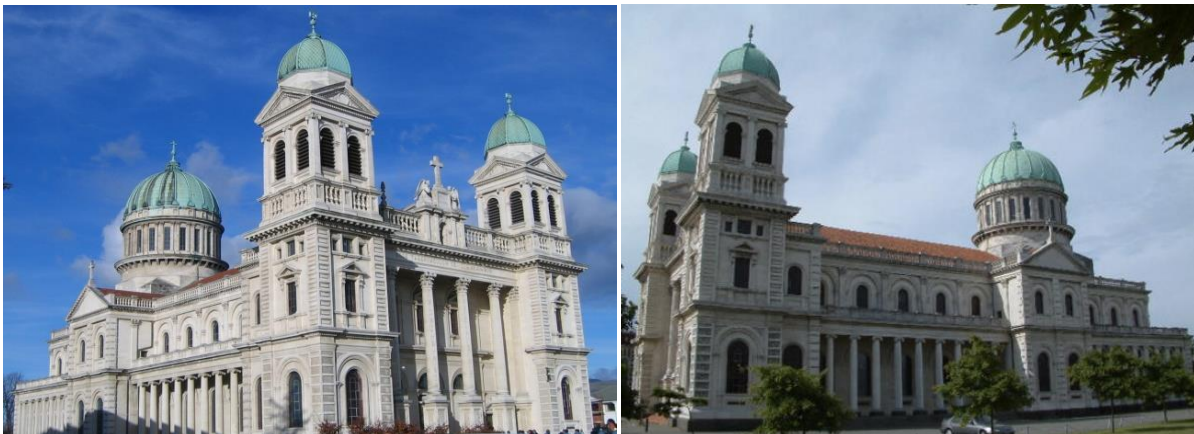
**Figure 1.** Cathedral of the Blessed Sacramento: North and West façades (left); South façade (right).

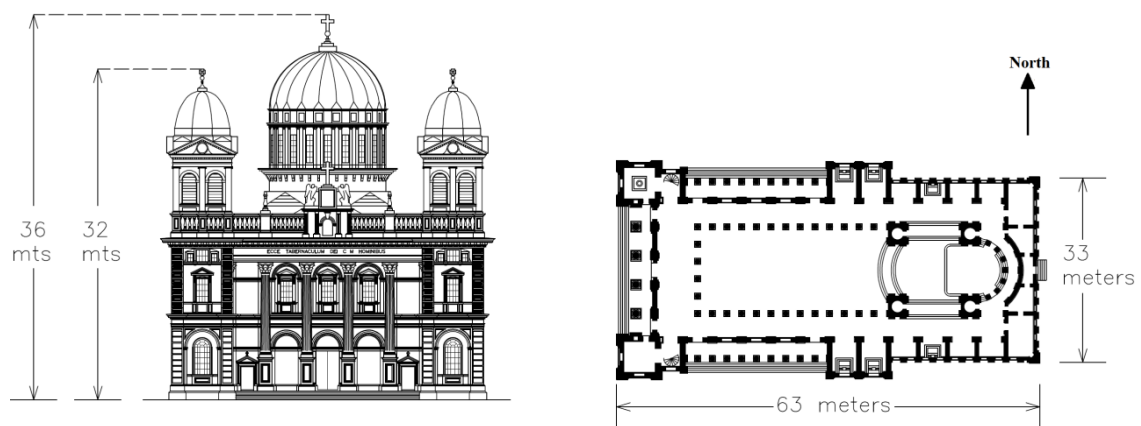
**Figure 2.** Basilica of the Blessed Sacrament: West elevation (left); plan (right).

In order to assure an appropriated behavior for seismic events, a structural study was performed in 2002, adopting basic preliminary analyses and engineering practical knowledge for the conclusion [6]. The strengthening process introduced: (i) a new reinforced concrete slab (RC) with 100 mm of thickness in the first floor and roof level, aiming at obtaining the diaphragm action; (ii) a steel brace with 32 mm of thickness and RC ring-beams with a section  $200 \times 600 \text{ mm}^2$  in the front of the two bell towers, above and below the window openings; (iii) RC ring beams with a section of  $200 \times 600 \text{ mm}^2$  at the top section of the main dome, above and below the windows; (iv) the post-tensioning at alternate columns of the nave colonnade and the grouting of external parapets and ornaments; (v) the attachment of the gable ends of the roof, the transepts and ornaments [6].

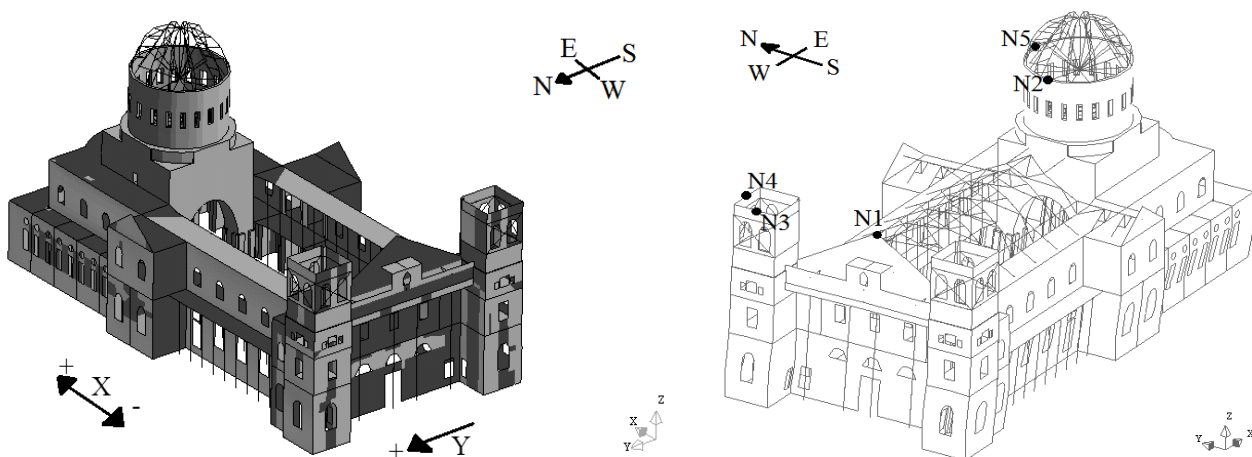
**Figure 6.** Numerical model: Applied load directions (longitudinal – X; transversal – Y) (left); Nodes of control (right).

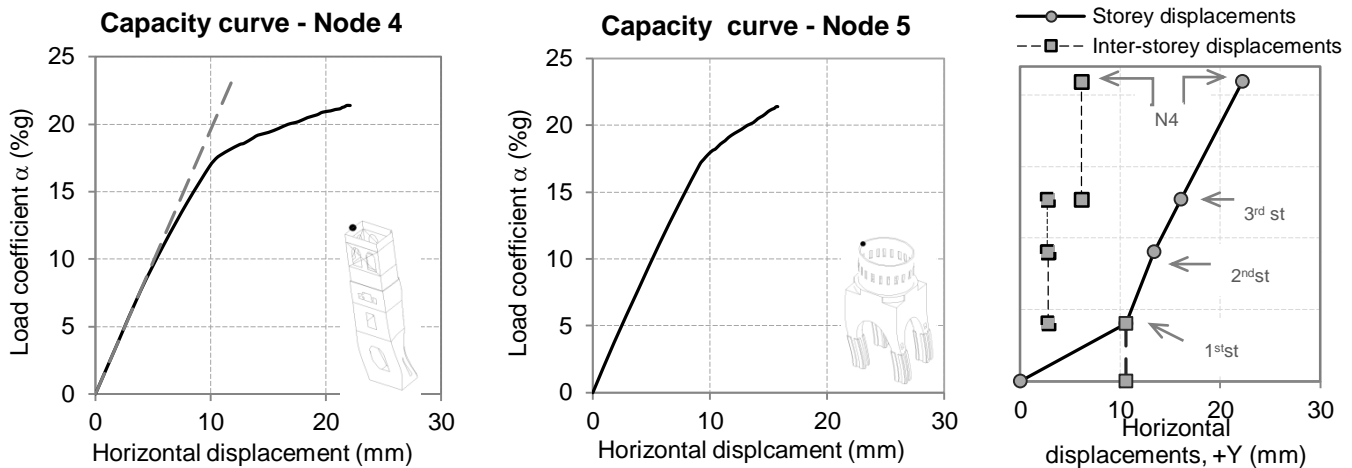
Concerning the pushover analysis in the direction  $+Y$ , different control nodes were used from the previous analysis. Node 1 was not assumed, because the gable West wall is transversally positioned with respect to the  $Y$  direction. This wall has a high stiffness and a maximum displacement of  $12\text{ mm}$  was obtained for this action, which are much smaller than the displacements obtained in the  $X$  direction. In Figure 11 it is possible to observe that for the considered capacity curves the initial cracking load ranges from  $10\%$  to  $13\%$  of the self-weight. For both nodes a maximum load coefficient of  $22\%$  was obtained and it is possible to conclude that the main dome node has, for the same load, a less significant non-linear behavior.

**Figure 11.** Capacity curve in +Y direction: (a) Node 4; (b) Node 5 (left and middle). Bell tower storeys displacements (+Y); st: storey; N4: node 4).
