## Evaluation of structural intervention in the *Quartel das Esquadras*, Almeida (Portugal)

**ABSTRACT:** The *Quartel das Esquadras* is an 18th century infantry barrack located within the limits of the bulwarked fortress of Almeida, in Portugal. An ongoing adaptive reuse project of the building aims to recover its full capacity and also its importance to the fortified village of Almeida, by implementing a variety of new uses. While adaptive reuse projects of historical buildings are a very recommendable solution for maintaining those constructions whose use has become obsolete, these projects demand careful study because they may introduce changes in the structural behaviour of the buildings to preserve.

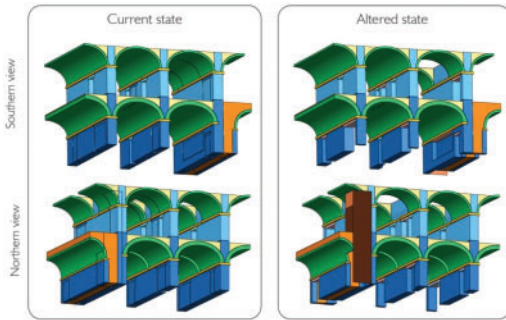
Figure 9. Different views of the partial models of the structure, on both current and altered state.

The main conclusion extracted from the comparative safety analysis is that the altered state of the structure presents a safety factor (2.00) lower than the one of the structure in its current condition (5.63). Crushing of the stone masonry at the base of the ground floors leads the structure to failure (see Figure 10).
