# ***Fábrica do Paleão: Structural Assessment of Iron in Portugal's Industrial Heritage***

KRICHKO Kori<sup>1,a</sup>, VALENTE Isabel B.<sup>2\*,b</sup>

*Fábrica do Paleão: Structural Assessment of Iron in Portugal's Industrial Heritage.*  
Paper submitted to Proceedings of the Institution of Civil Engineers –  
Engineering History and Heritage, ISSN 1757-9430.

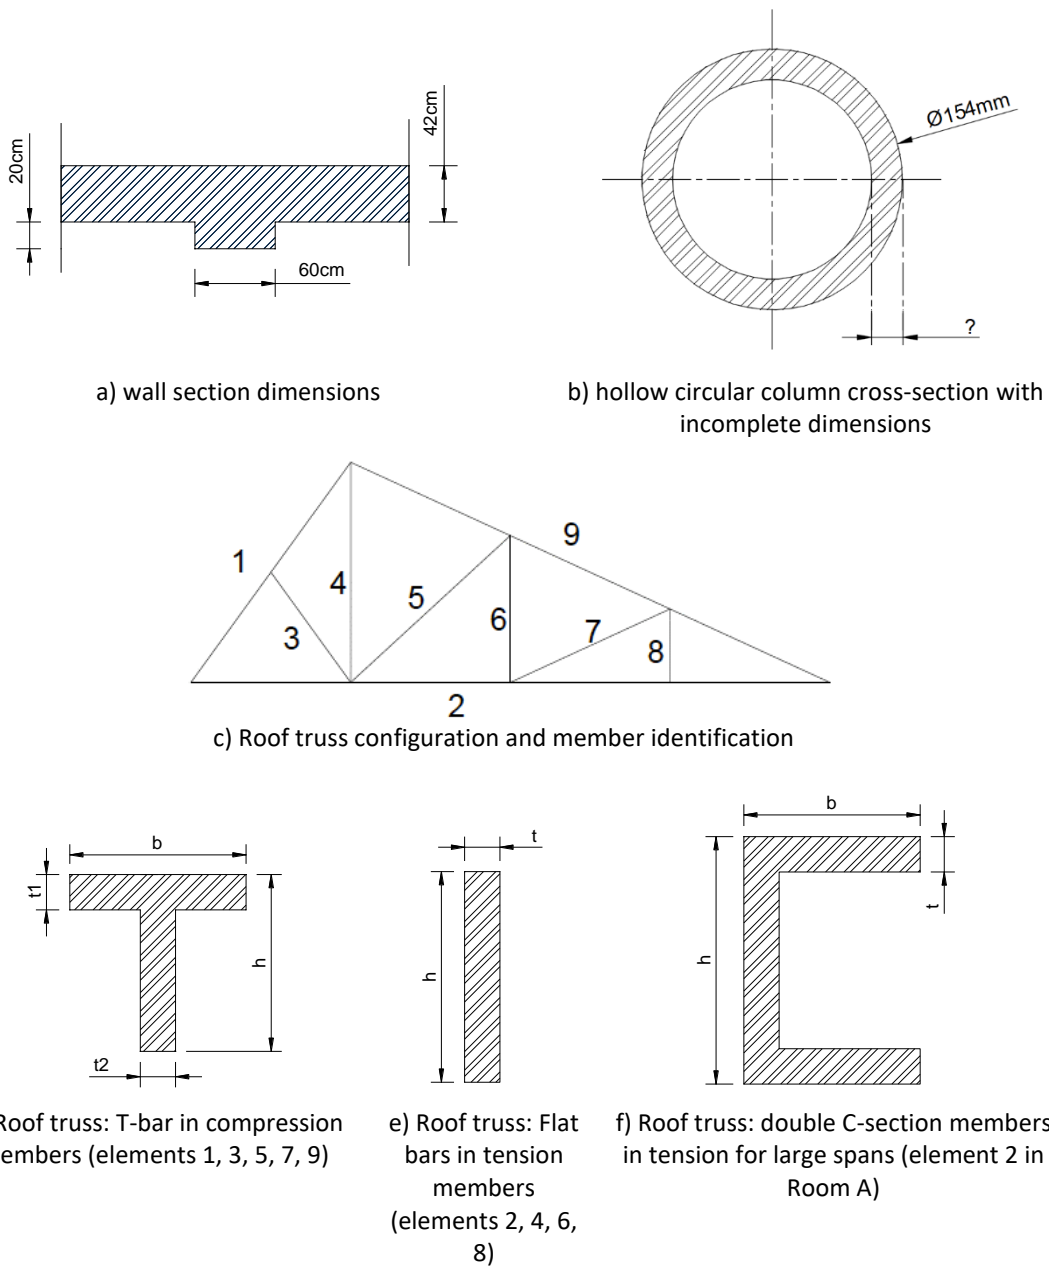
Figure 4 – Truss element dimensions

A number of measurements were taken of the interior and exterior walls. With the exception of narrow partition walls and thicker sections, marked in the plan, the majority of the walls are 42 cm wide with thicker sections supporting the roof trusses. An overall view of the design can be viewed in the plan of the factory, with the specific geometric configuration displayed in Figure 4.a.

While already suspected due to the common column sections utilized at the time of construction (Bates, 1991), knocking on the columns with a hard object confirmed that the round columns are hollow. The outer diameter of the member could be measured, but it was not possible to determine the wall thickness or interior diameter during the visual inspection. The proposed section and measured exterior diameter is given in Figure 4.b.

The roof truss configuration displayed in Figure 4.c is valid for both of the main rooms in the factory. Dimensions are not included, as the measurements vary by the total length of the truss, with longer spans and thicker dimensions for the larger trusses. However, the configuration has been labeled to identify the members measured.

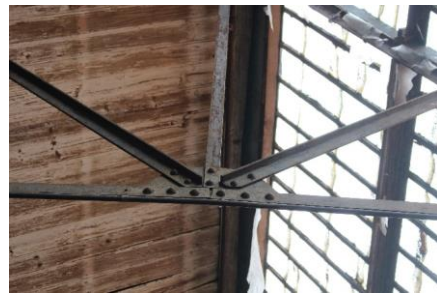
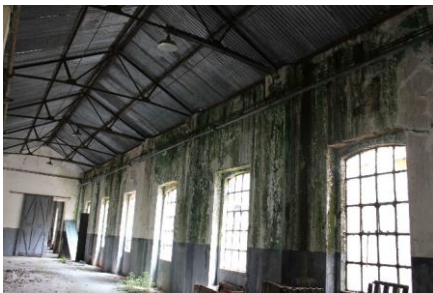
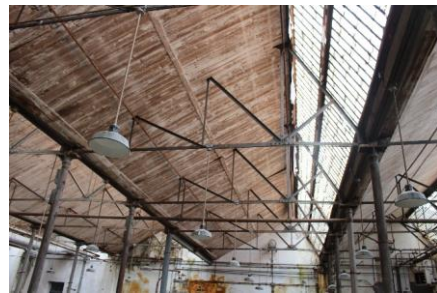
The metal in the columns was easily identified by visual inspection, application and confirmed by the date of erection. Photographic evidence has been provided to illustrate the identifying features in Figure 6.

(b) decoration and square bolts

(c) Flat and angle-shaped members in the roof truss with riveting

(d) Corrugated steel roof (a) left exposed in a workshop space

(e) Corrugated steel roof covered by wood paneling in the main rooms

Figure 6 – Cast iron detailing for columns (a, b) and Roof detailing (c, d, e)

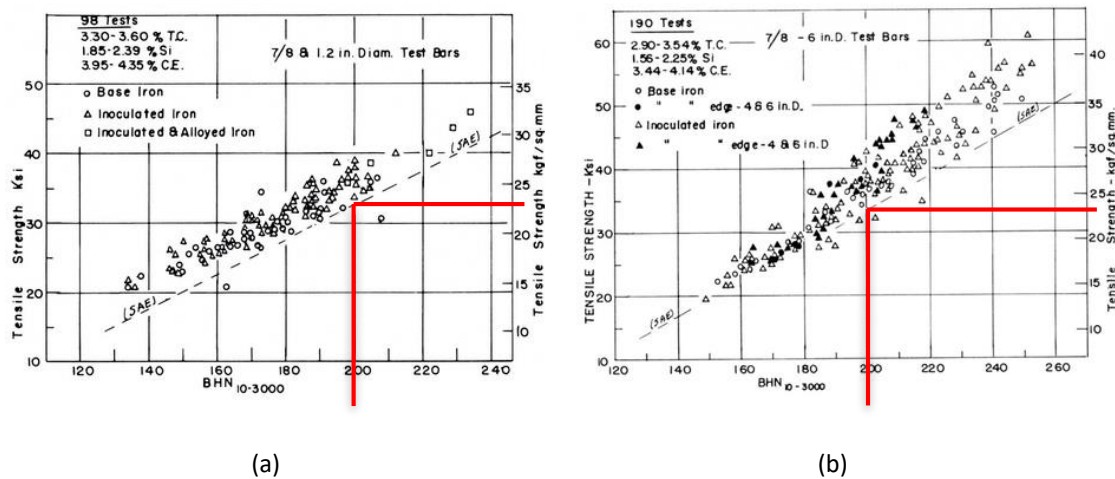
Figure 8 – Brinell hardness-tensile strength relationship for Foundry F (Krause, 1969)

To demonstrate the variability in testing and dependence on the size of the sample, the results of two studies with two test bars diameter ranges have been provided. Figure 8.a is the result of tests on 7/8 to 1.2 inches (approximately 22 millimeter to 30 millimeter) in diameter and Figure 8.b is the result of tests on 7/8 to 6 inches (approximately 22 millimeter to 152 millimeter) in diameter. A conservative regression line labeled SAE is drawn in each figure, representing minimum Brinell hardness values being considered by the SAE Division 9 ISTC Committee (Krause, 1969). While the scatter varies between the two diameter ranges, the approximated tensile strength from each is essentially the same, approximately 23 kgf/mm<sup>2</sup>, or 230 MPa.

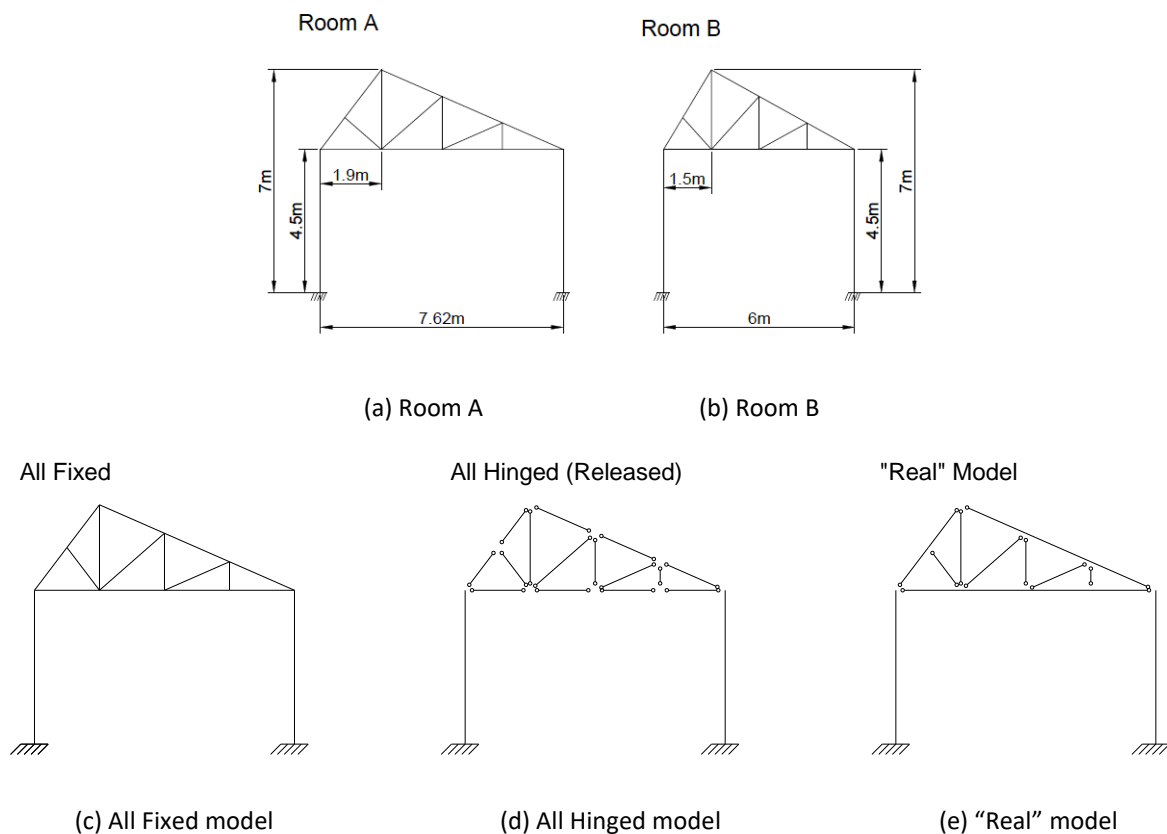
Figure 9 – Geometric configuration of the frames modeled in rooms A and B and connection combinations tested

Due to the repetitive structural design in the factory, only one frame in each of the main rooms was modeled. The input measurements for each frame shown in Figure 9.a and in Figure 9.b were taken from the geometric survey. The frames have the same height and geometric configuration, but differ in length. As depicted in the plan of the structure, the spacing between frames also varies between rooms A and B, where the distance between trusses in room A measures 4.90 m and 3.35 m for room B.

During the visual inspection, all of the connections in the frame were observed in an attempt to select the most accurate joints for the model. In this approximation, the imbedded columns are assumed fixed, while the remaining joints are fixed or hinged depending on the continuity of the truss members. Continuous members, such as the top chords, are modeled as fixed, while the ends of members are assumed hinged. These assumptions are represented in the scenario labeled "real" model in Figure 9.e.

This model is approximate, as it is difficult to estimate exactly how observed connections will behave. To account for this uncertainty, a sensitivity analysis was performed to quantify the effect of the selection of various connections. With particular attention to fixed or hinged joints, the three scenarios depicted in see Figure 9.c, Figure 9.d and Figure 9.e were tested. As illustrated, the "real" model assumed to be the closest to reality, is between the two extreme cases of all hinged

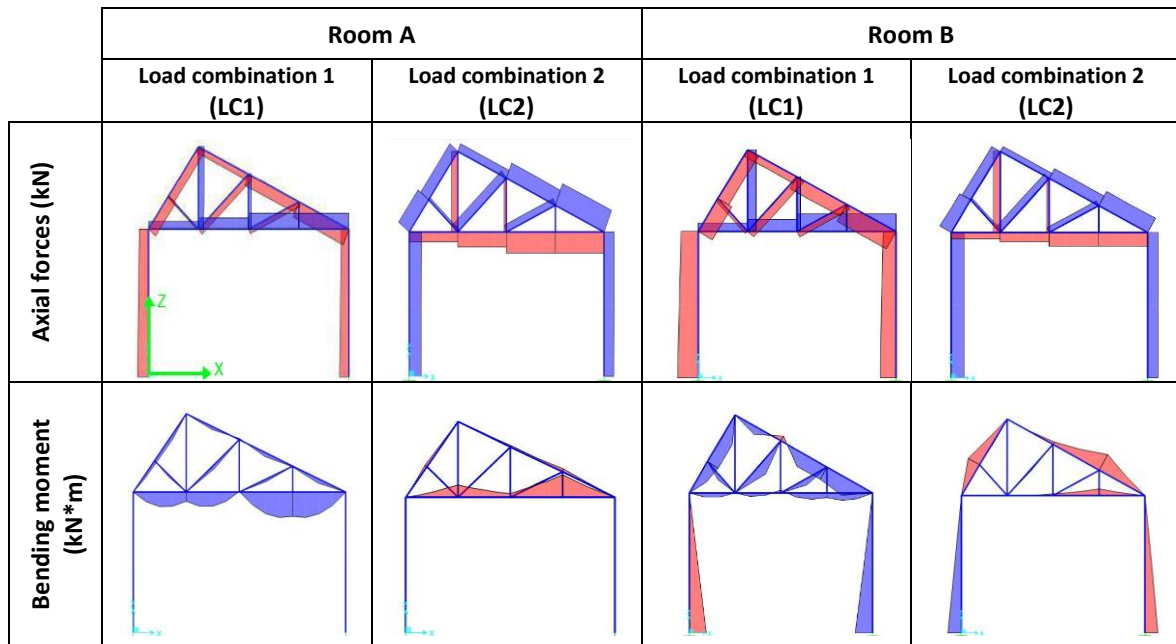
Table 8 – Force and bending moment diagrams for the truss in Room A and Room B

After establishing loads, the model was run for the two load combinations considered. To visually compare the results of the scenarios, the axial force and bending moment diagrams have been provided in Table 8 for the two frames in each of the main rooms in the factory. The blue represents positive values (tensile stress and sagging bending moment) and the red is denotes negative values (compressive stresses and hogging bending moment).

Due to the matching geometric configuration and nearly identical connection assignment, the axial force diagrams follow the same pattern for each of the load cases. Load combination 1, considering dead loads and roof live loads all acting in the negative z direction, follows the intended design of the structure where all compression members are working in compression and all tensile members in tension. In the case of strong winds, modeled by load combination 2, the internal wind pressures act in the positive z direction imposing negative pressures to the frame, forcing compression members to act in tension and tensile members to act in compression.

For both trusses in each of the load combinations the greatest and most frequent bending moments are in the chords of the truss. However, for Room A the most apparent bending moments are concentrated in the bottom chords of the truss, where a stiff, continuous double c-channel section is implemented. Due to the opposing direction of the load combinations, the bending moments have opposite signs for each of the bending combinations with generally positive bending moments for the first combination and negative for the second. While these patterns are worthy of note, it should be emphasized that the bending moments are minimal in comparison to the axial forces due to the geometric configuration of the frame. With the exception of the columns, the frame is mainly acting as a truss designed to resist axial forces.
