## NOVEL PREFABRICATED PANELS FOR THE REPAIR OF DAMAGED INTERIOR RC BEAM-COLUMN JOINTS

**ABSTRACT:** A novel prefabricated panel is introduced for the repair and strengthening of damaged interior RC beam-column joints. This prefabricated hybrid composite plate (HCP) is made of a Strain Hardening Cementitious Composite (SHCC) reinforced with CFRP materials. Besides the higher durability of this system when compared to EB-FRP, thanks to the high ductility of the SHCC, anchors can be used in combination with adhesive to attach the HCP to the concrete substrate. The first section of this paper reports the methodologies to apply HCP for the repair of two severely damaged interior RC beam-column systems. To evaluate the performance of this rehabilitation technique, the repaired specimens were subjected to the same loading pattern as it was imposed to their virgin states. Since both repaired specimens showed a higher lateral load and energy dissipation capacities than the corresponding values in their undamaged state, the effectiveness of the HCP for the repair of damaged interior beam-column joints is proved.

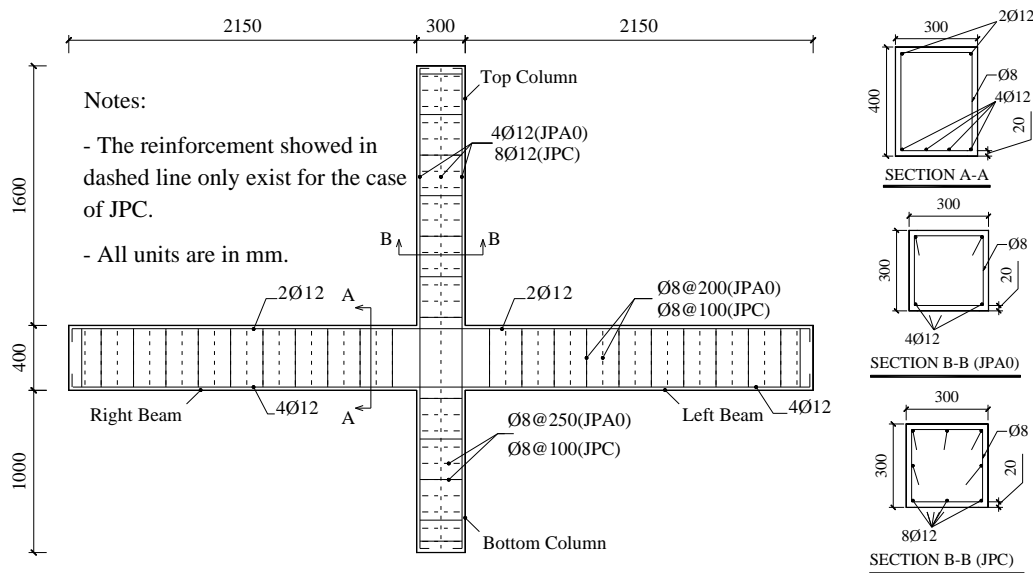
The details of the geometry and configurations of the specimens are shown in Fig. 1. For JPC more four longitudinal bars for the column and also closer spacing for beams stirrups was adopted as compared to JPA0.

**Fig. 1 - Details of Adopted Configurations for the Interior Beam-Column Joints**

Two damaged interior RC beam-column joints, namely JPA0 and JPC, are selected between a series of already tested specimens (Fernandes et al., 2013). Full-scale interior beam-column joints were reinforced with plain steel bars to be representative of the reinforcement generally found at construction practices before the 1970s. No transverse reinforcement was placed in the joint region and the stirrups of the beams and columns had 90° hooks.
