FRP-TO-MASONRY BOND DURABILITY ASSESSMENT WITH INFRARED THERMOGRAPHY METHOD

ABSTRACT

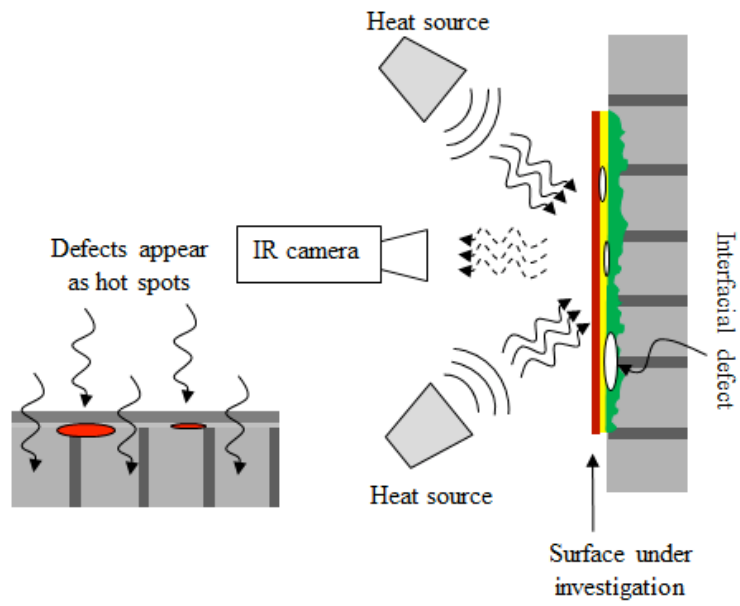
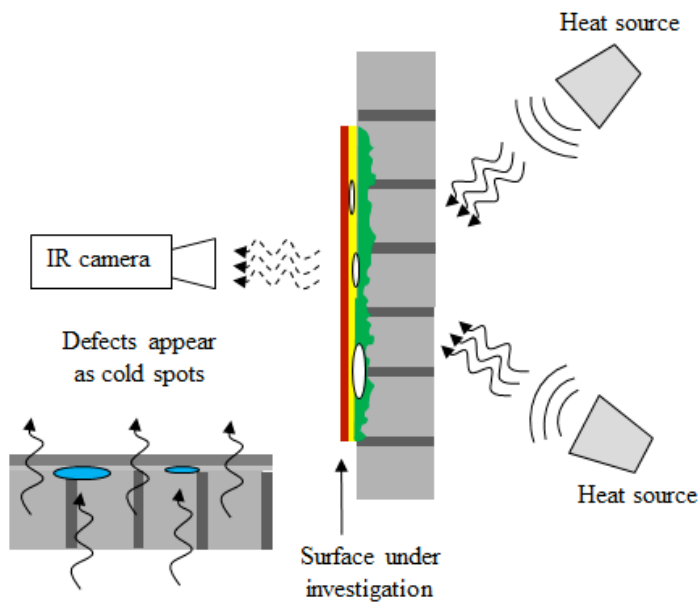
Fig. 1. Different heat observation methods in IR thermography technique: (a) reflection observation method; (b) transmission observation method.

Fig. 1. Different heat observation methods in IR thermography technique: (a) reflection observation method; (b) transmission observation method.

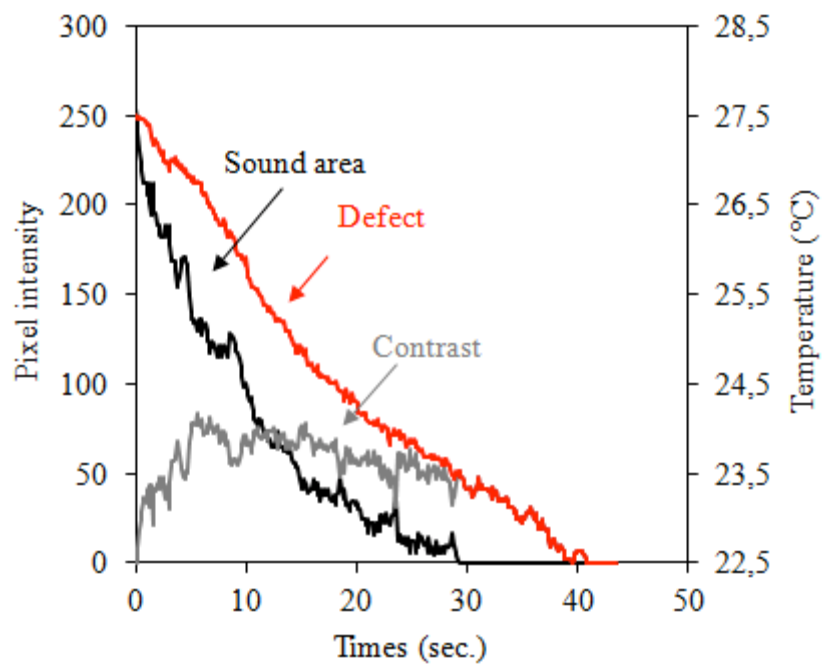
Fig. 2. Thermal history curves of sound and delaminated areas.

Fig. 2. Thermal history curves of sound and delaminated areas.

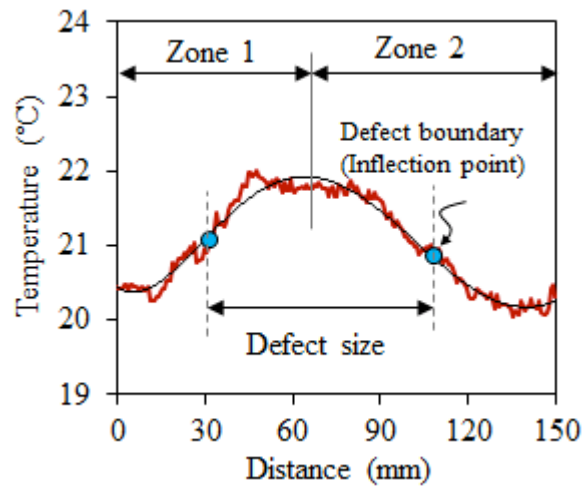
Fig. 4. Defect boundaries. Zone 1 and Zone 2 represent different left and right sections of the defect around the center point.

Fig. 4. Defect boundaries. Zone 1 and Zone 2 represent different left and right sections of the defect around the center point.

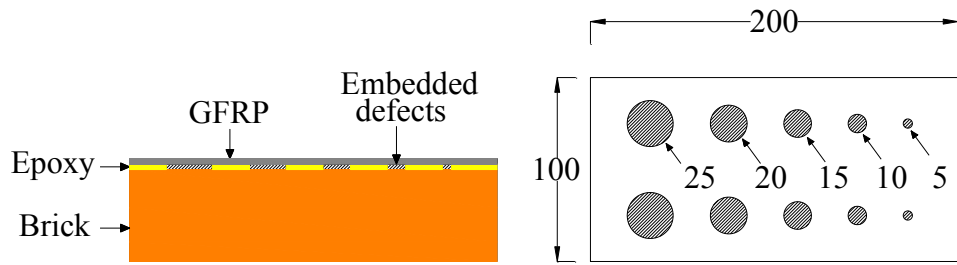
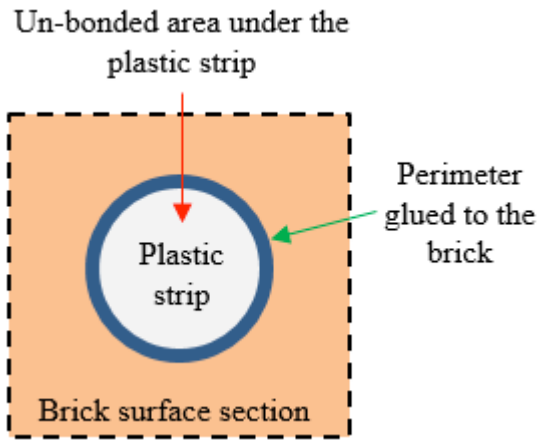
Fig. 5. Details of the specimens with embedded interfacial defects: (a) defects details; (b) attachment details.

Fig. 5. Details of the specimens with embedded interfacial defects: (a) defects details; (b) attachment details.

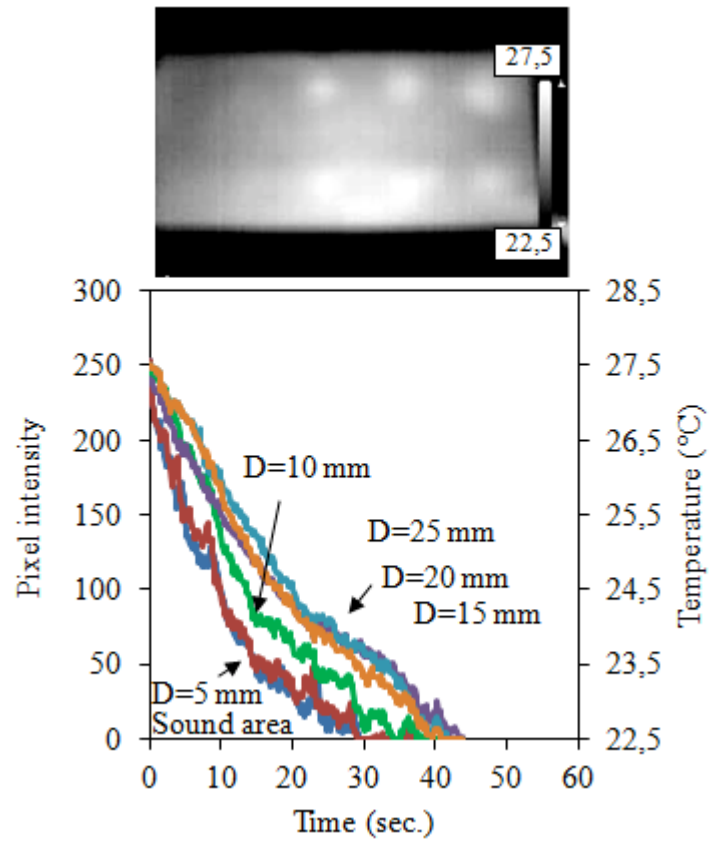
Fig. 6. Thermal history curves at defect locations and a typical thermogram.

The temperature history curves of defects with different sizes are shown in Fig. 6. These curves are obtained at the pixel corresponding to the centroid of each defect. It can be observed

Fig. 6. Thermal history curves at defect locations and a typical thermogram.

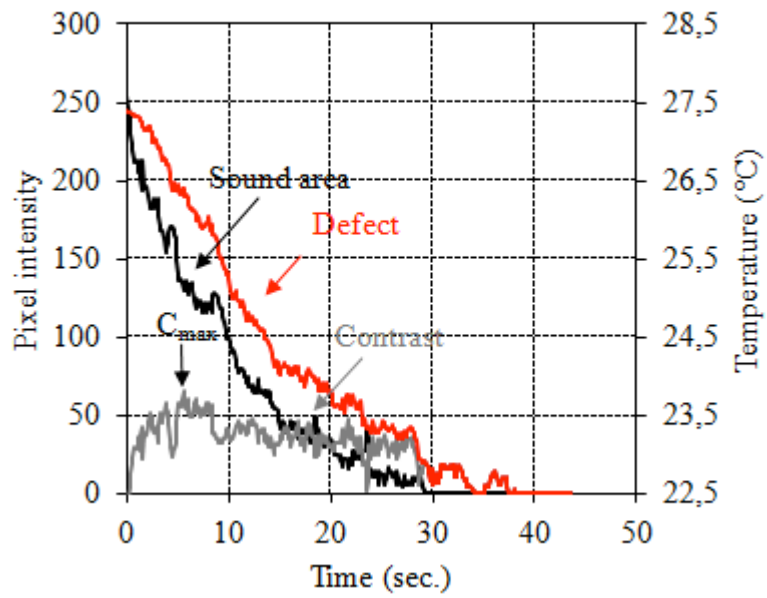
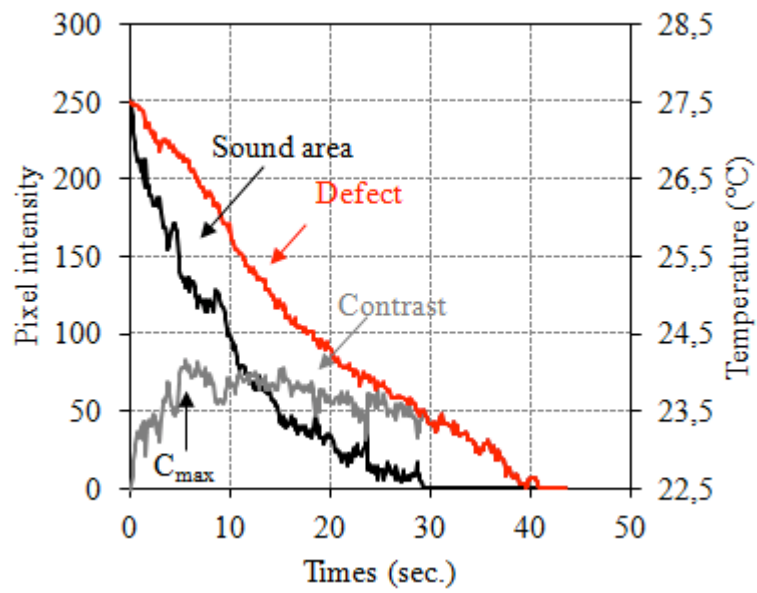
Fig. 7. Maximum thermal contrast evaluation for: (a) 10 mm defect; (b) 25 mm defect.

Fig. 7. Maximum thermal contrast evaluation for: (a) 10 mm defect; (b) 25 mm defect.

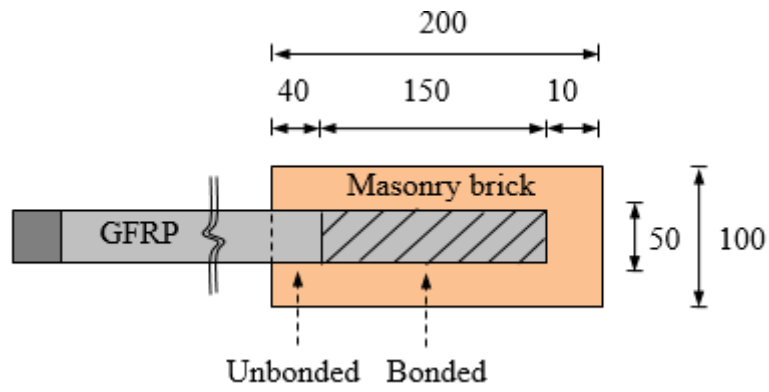
Fig. 9. Details of the specimens used for accelerated ageing tests.

Fig. 9. Details of the specimens used for accelerated ageing tests.

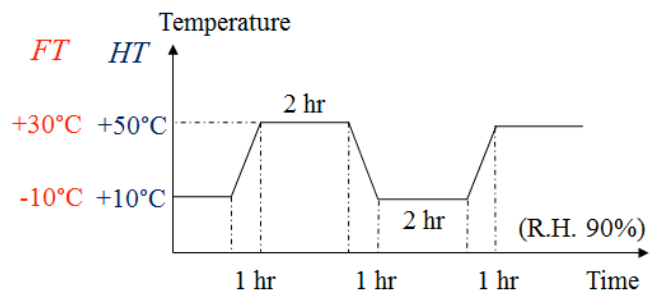
Fig. 10. Accelerated hydrothermal exposures for two different diagrams (FT and HT).

Fig. 10. Accelerated hygrothermal exposures for two different diagrams (FT and HT).

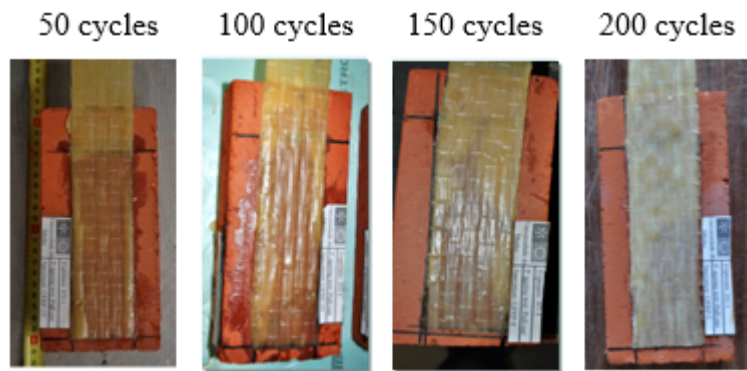
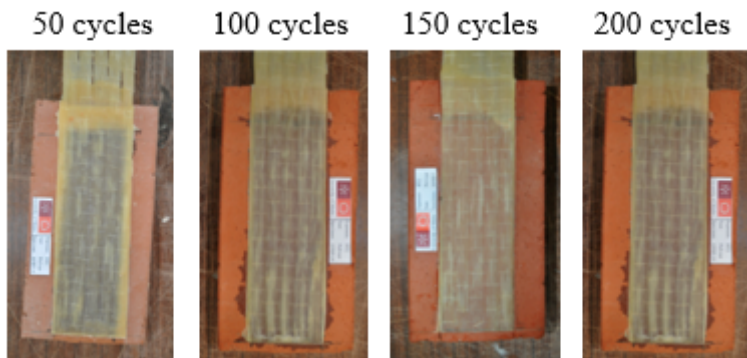
Fig. 11. Specimens exposed to different periods of: (a) HT exposure; (b) FT exposure.

Fig. 11 shows typical examples of specimens for each exposure period. Visual inspection and qualitative IR thermography were used for localization of FRP delaminations. Relatively large FRP delaminations were observed in the specimens exposed to HT conditions. On the contrary, the specimens exposed to FT conditions had very small delaminations. The thermal images and detected FRP delaminated areas, from IR thermography tests, for the specimens exposed to HT conditions are presented in Fig. 12. It can be observed that the FRP delaminations progressively increased with the exposure time. It should be noted that due to the physical properties of the materials used in this study, delaminations were also observable with visual assessment. This advantage could assist us in validating the IR technique in localization of interfacial delaminations. However, in case of strengthening with other composite materials and matrices or application of renderings over the strengthening visual observation is not applicable.

Fig. 11. Specimens exposed to different periods of: (a) HT exposure; (b) FT exposure.

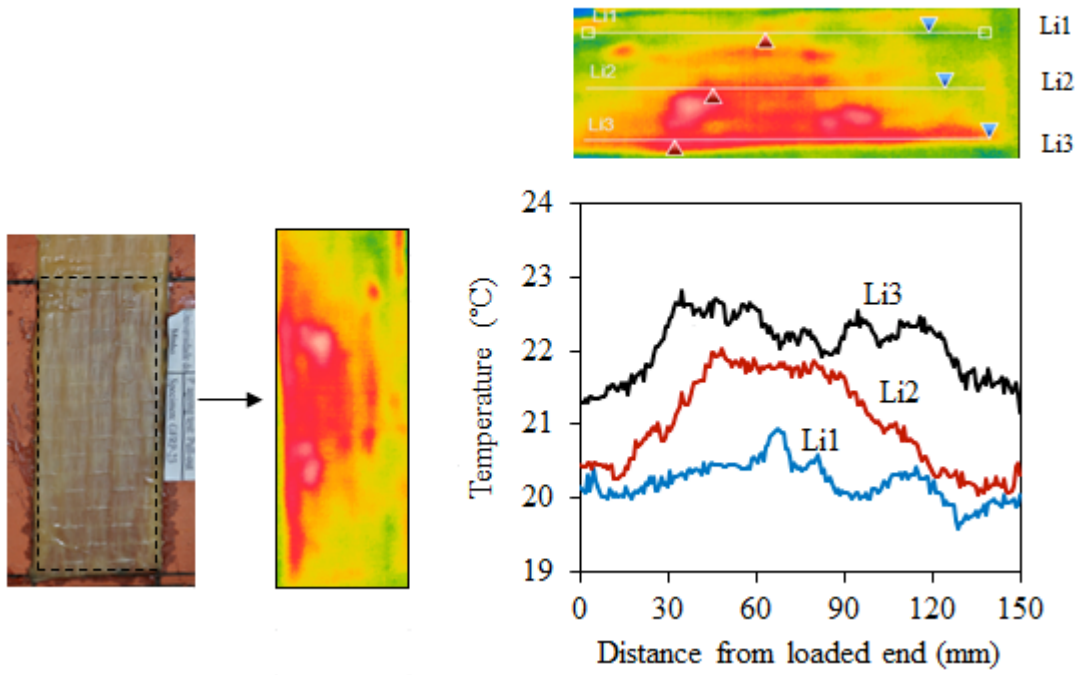
Fig. 13. Temperature profiles in a specimen exposed to 100 cycles of HT exposure.

In the specimen exposed to 100 cycles, delamination was observed in the center of the bonded length, shown as a hot spot in the thermogram presented in Fig. 13. Therefore, it was necessary to obtain the boundaries of the delaminated area on both sides of the defect in the longitudinal direction, as indicated in Fig. 14. However, the delamination in the specimen

Fig. 13. Temperature profiles in a specimen exposed to 100 cycles of HT exposure.

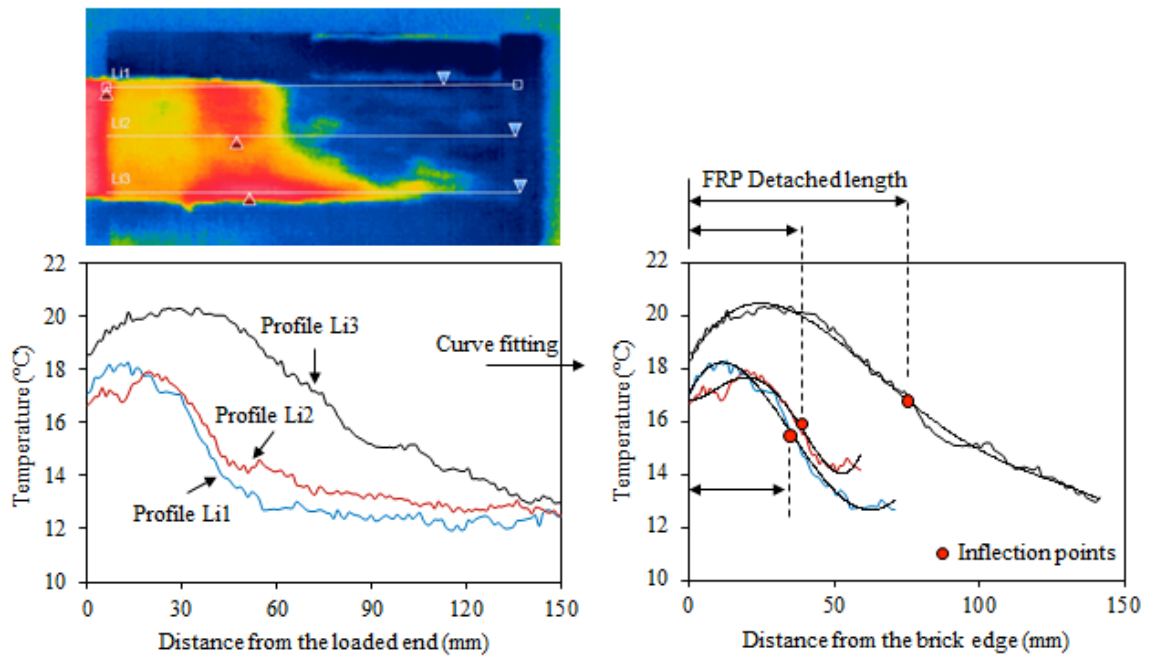
Fig. 15. Temperature profiles and quantitative assessment of delaminated areas in a specimen exposed to 200 cycles of HT exposure.

exposed to 200 cycles started from the loaded end of the specimen and progressed along the bonded length, see Fig. 15. Therefore, just one boundary in the longitudinal direction should be located for obtaining the delamination size. The large FRP delaminated area in the specimen exposed to 200 cycles of HT exposure shows the severity of the thermal incompatibility in the specimens used in this study.

Fig. 15. Temperature profiles and quantitative assessment of delaminated areas in a specimen exposed to 200 cycles of HT exposure.

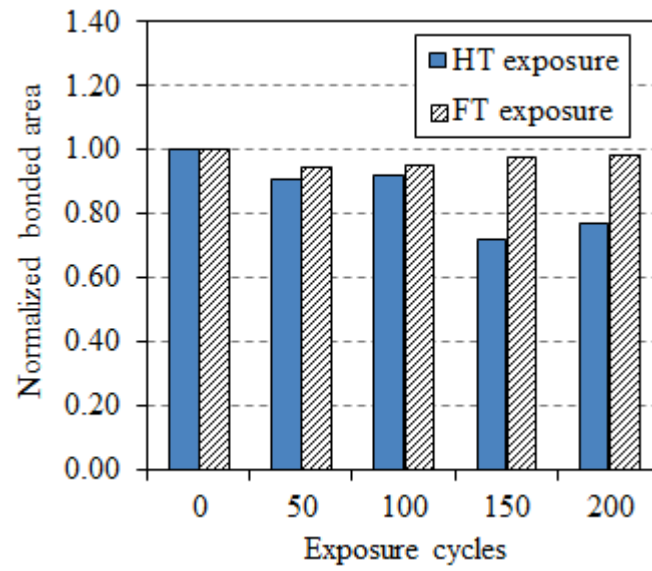
Fig. 16. Reduction of the bonded area with exposure cycles.

The results of the quantitative IR thermography are presented in Fig. 16 as the remaining bonded area normalized to the initial bonded area. The presented values are obtained as the average of five tested specimens. 23% reduction of bonded area after 200 cycles of HT exposure can be observed, while the reduction in the bonded area in the specimens exposed to FT conditions is very limited (2% after 200 cycles).

Fig. 16. Reduction of the bonded area with exposure cycles.
